LMA: **NA0010 U23 Lower San Joaquin** Waterway: **RB San Joaquin River**  
 Site ID: **NA0010U23RM224.27** Status: **Repaired Site**

Latitude: **36.802116** Longitude: **-120.173847** River\_Mile: **224.27** Levee\_Mile: **9.15** Overall Rating:

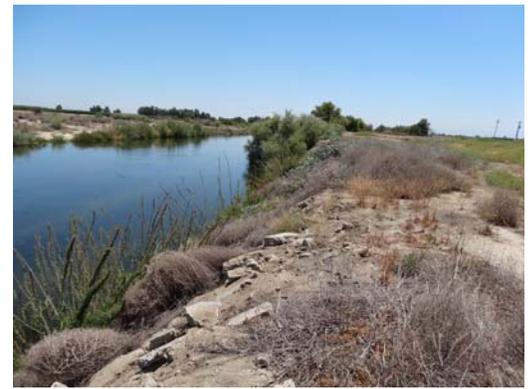
7/22/2014: No significant change observed.  
 07/11/2013: No significant change observed. Dense vegetation and small trees cover the entire site.  
 07/24/2012: Site has been repaired with riprap rocks and broken concrete blocks, but loose material and cracking are visible at the top of the repaired site. The site needs close monitoring for performance evaluation.  
 08/16/2011: This site is immediately downstream of the riparian protection section. Dense vegetation growing on the toe and slope of the bank seems to indicate the most part of the erosion occurred prior to last winter. The closest spot is 12 feet away from the levee toe.

Close view of the repaired site.

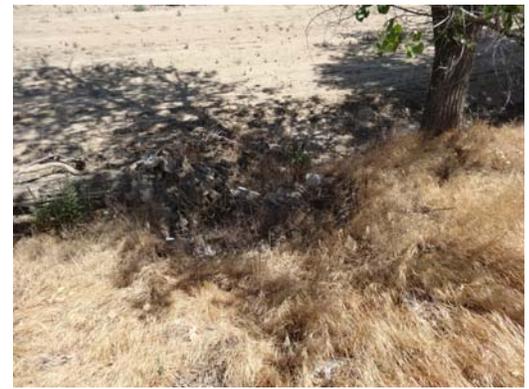
07/22/2014: No significant change observed.  
 08/30/2013: No significant change observed.  
 07/31/2012: Site was visited on 07/24/2012. No significant change observed. Dense vegetation around the site  
 08/09/2011: Site was inspected. No visible change was observed from the previous condition. A fallen tree was seen at the levee toe about 20 feet upstream, and tree root exposed. There has been no report from the district that this site was corrected.  
 11/30/2010: Site was not inspected due to time constraints. There have been no reports from the district that the site was corrected. Continue to monitor site during flood events.  
 08/05/2010: Recommended for annual assessment and monitoring during flood events, per CLRO.  
 2009: Site is recommended as a local maintenance issue, per Critical Levee Repair Office, Critical Erosion Sites Evaluation 2008 Report; site was previously rated "M"

9/6/2007: Undercutting of the toe; several trees along the WS slope with roots exposed.

View of the erosion site from the levee crest.

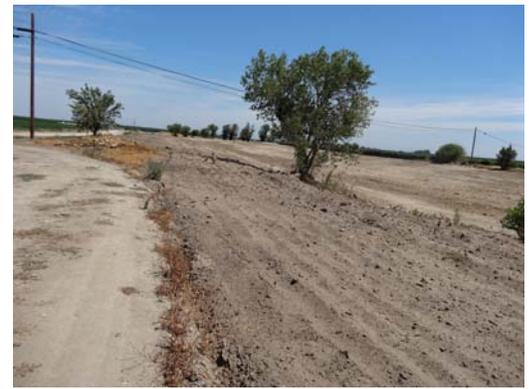
07/22/2014: No significant change observed.  
 08/30/2013: No significant change observed  
 07/31/2012: Site was visited on 07/26/2012. No significant change observed  
 08/09/2011: Site was inspected. No visible change was observed from the previous condition. There have been no reports from the district that this site was corrected.  
 11/30/2010: Site was not inspected this year due to time constraints. There have been no reports from the district that this site was corrected. Continue monitor during flood events.  
 08/05/2010: Recommended for annual assessment and monitoring during flood events, per CLRO.  
 2009: Site is recommended as a local maintenance issue, per CLRO CES Evaluation 2008 Report; it was previously rated "M".  
 8/26/2008: Undulating waterside slope surface; vehicular damage along the waterside slope possibly caused by farming equipment; levee crown is composed of sandy material; there is a collection of concrete rubble on the waterside crown hinge; vehicular damage extends from levee toe to crown surface.

9/6/2007: Farmer degraded levee on water-ward slope and crown.

Close view of the site. The site has been plowed by the farm vehicle and the erosion is not visible any longer.

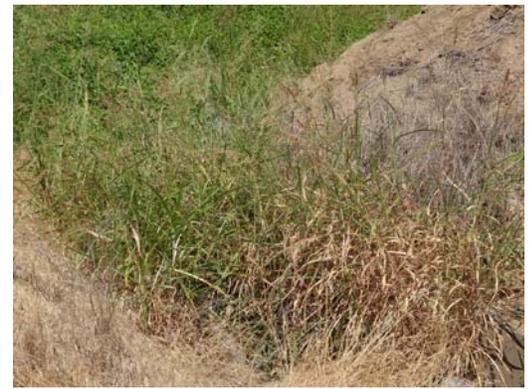
7/31/2014: Soil has been added near the site. More vegetation is visible.  
 7/16/2013: The site was reported in the 2013 Spring Levee Inspection Reports. The erosion was caused by the water from the discharge line crossing the levee. Above the erosion a concrete discharge structure is present at the levee toe. The site is covered with dense vegetation.

Looking down at the erosion site.

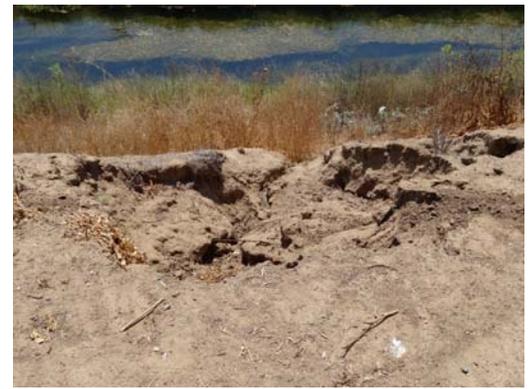
8/20/2014: No significant change observed.  
 09/12/2013: The erosion has been caused by runoff.

Looking down at the erosion from the levee crest.

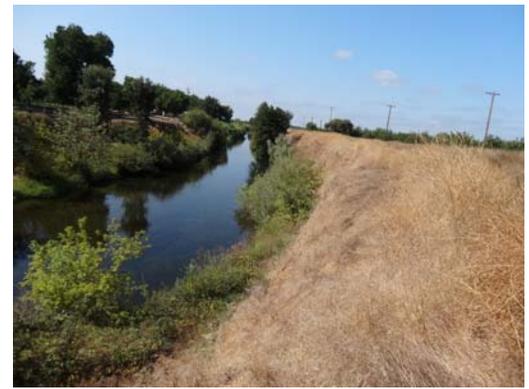
8/20/2014: No significant change has been observed.  
 9/12/2013: No significant change observed.  
 08/22/2012: Site has been revisited. No significant change observed.  
 09/02/2011: No significant change observed on site.  
 11/02/2010: No significant change observed. The mile-long erosion continues to degrade the bank. There are a few trees along the mile-long stretch on the lower bank slope that are affected by the scarp. WS Levee Slope was changed to 2:1. As a result, normalized score increased from 62 to 65.  
 08/05/2010: Recommended for waterside repair, per CLRO; "water velocity is a major factor for accelerating bank slope erosion."  
 8/12/2009: Near-vertical bank erosion; degrading channel is incising the banks; recommend annual assessment and monitoring of critical erosion site, per CLRO CES Evaluation 2008 Report; district is monitoring site for change in condition; site was previously rated "U".

2007: Visited site 02/06/2007; possible critical site.

Downstream view of the site.

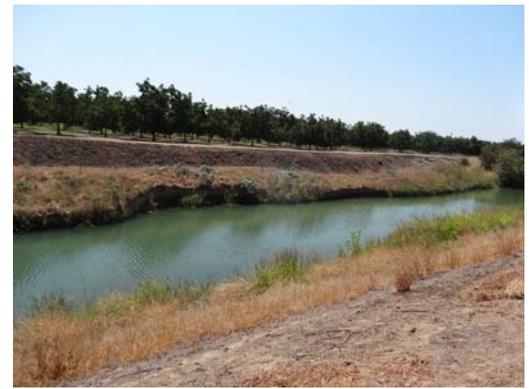
8/20/2014: No significant change observed.  
 9/12/2013: No significant change observed.  
 08/22/2012: The erosion is on berm. The berm width is estimated. There is no levee structure on site. The levee crest width and levee height were not measured or estimated in the field.

Upstream view of the erosion.

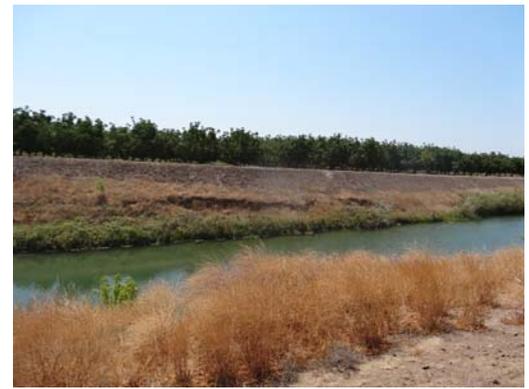
8/20/2014: No significant change observed.  
 9/12/2013: No significant change observed.  
 08/22/2012: The erosion is covered with dense vegetation. There is no levee structure on site. The levee crest width and levee height were not measured or estimated in the field.

Upstream view of the erosion.

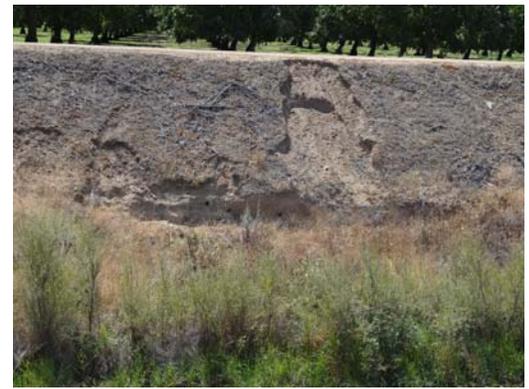
8/20/2014: No significant change observed.  
 9/12/2013: The erosion might have been caused by river flow combined with runoff. Dense vegetation is presents at the site. There is no levee structure on site. The levee crest width and levee height were not measured or estimated in the field.

View of the site from the right river bank.

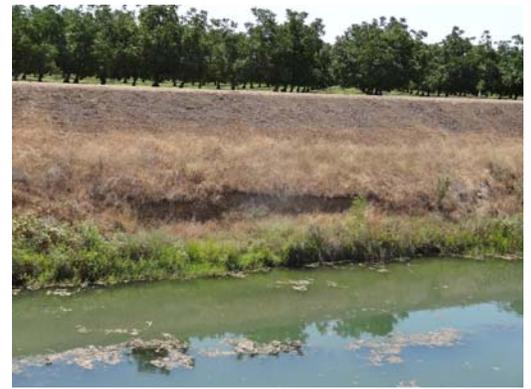
8/20/2014: No significant change observed.  
 9/12/2013: No significant change observed.  
 08/22/2012: Pocket erosion at the levee toe and slope. The erosion is covered with dense vegetation. There is no levee structure on site. The levee crest width and levee height were not measured or estimated in the field.

Front view of the erosion.

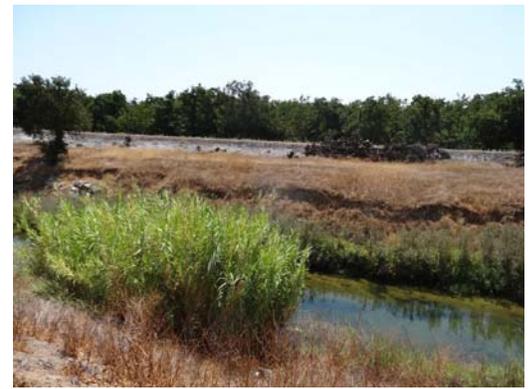
8/20/2014: No significant change observed.  
 9/12/2013: No significant change observed.  
 08/22/2012: The erosion occurred on a berm of approximately 25 ft. wide. Site is covered with dense vegetation. There is no levee structure on site. The levee crest width and levee height were not measured or estimated in the field.

View of the site from the right river bank.

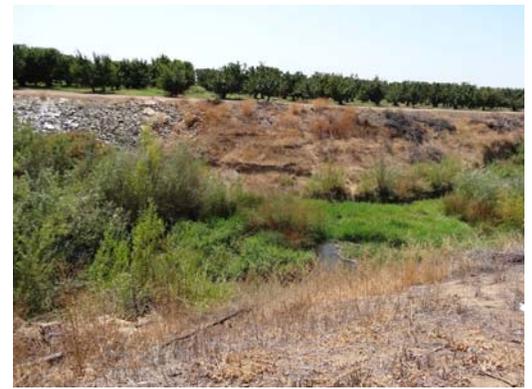
8/20/2014: No significant change observed. Note the site ID changed from NA0017U16RM10.82 to NA0017U16RM15.57 to reflect the correct river mile.  
 09/12/2013: The site is located at immediately downstream of a levee segment protected by broken concrete. There is no levee structure on site. The levee crest width and levee height were not measured or estimated in the field.

View of the site from the right river bank.

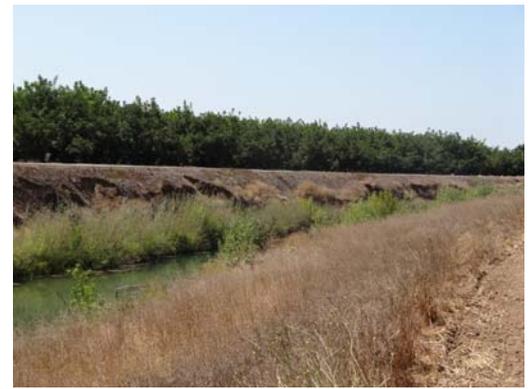
8/20/2014: No significant change observed.  
 9/12/2013: Site has been surveyed and the erosion has worsened since last year.  
 08/22/2012: Discontinuous scarp or pocket erosions occurred along a long stretch of the river, with an erosion height greater than 25 ft. at certain points. There is no levee structure on site. The levee crest width and levee height were not measured or estimated in the field.

Downstream view of the site from the right river bank.

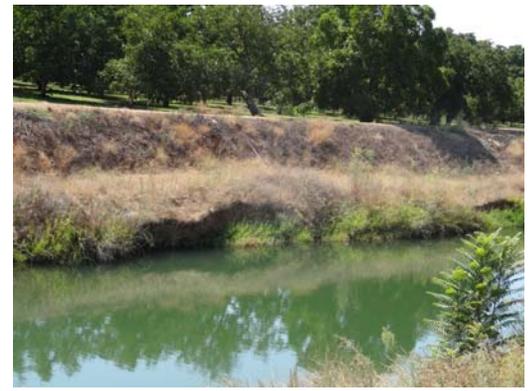
8/20/2014: No significant change observed.  
 9/12/2013: The erosion seems to be caused by high river flow. Dense vegetation is present at the site. Signs of animal activities are visible. There is no levee structure on site. The levee crest width and levee height were not measured or estimated in the field.

View from the right river bank.

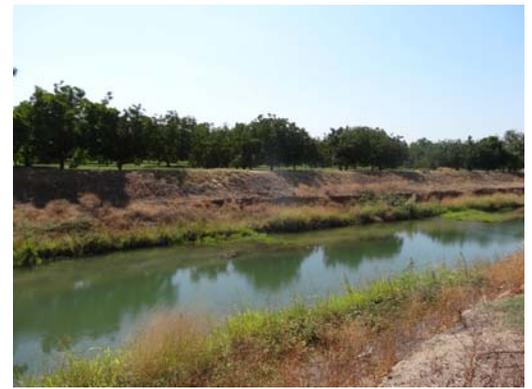
8/20/2014: No significant change observed.  
 9/12/2013: No significant change observed.  
 08/22/2012: The site is located at the opposite river bank of E. Tobacco Road. There is no levee structure on site. The levee crest width and levee height were not measured or estimated in the field.

Upstream view of the site.

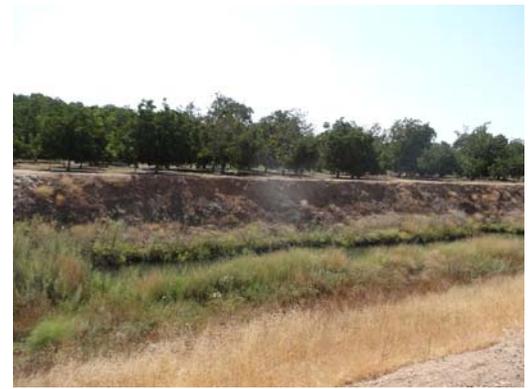
8/20/2014: No significant change observed.  
 9/12/2013: Site has been surveyed and the pocket erosion has developed toward levee crest.  
 08/22/2012: A pocket erosion at the levee toe and on lower slope. The levee surface at the upper slope also shows signs of erosion due to poor maintenance. There is no levee structure on site. The levee crest width and levee height were not measured or estimated in the field.

View from right river bank.

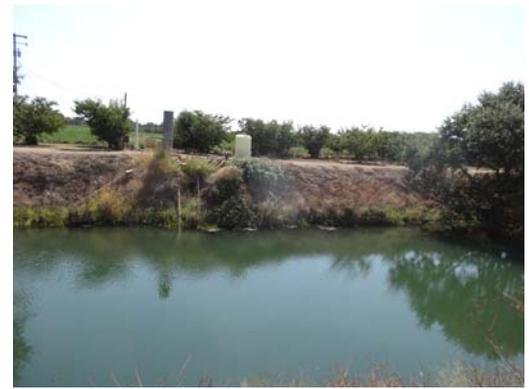
8/20/2014: No significant change observed.  
 9/12/2013: No significant change observed.  
 08/22/2012: An irrigation pipe is present at the site, but probably did not cause the erosion. There is no levee structure on site. The levee crest width and levee height were not measured or estimated in the field.

View of the erosion site.

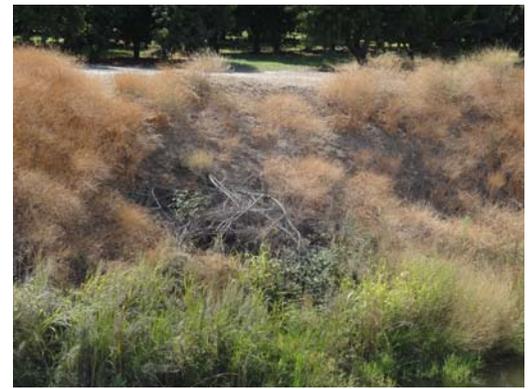
8/20/2014: No significant change observed.  
 9/12/2013: This site was repaired prior to this survey.  
 08/22/2012: The erosion is covered with grass and shrubs. There is no levee structure on site. The levee crest width and levee height were not measured or estimated in the field.

Front view of repaired site.

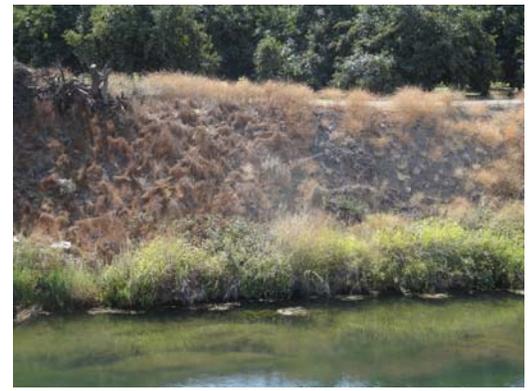
8/20/2014: No significant change observed.  
 9/12/2013: This site has been repaired prior to this survey, but new erosion has developed immediately downstream of the site.  
 08/22/2012: Tow large-size pocket erosions. Site is covered with dense vegetation. There is no levee structure on site. The levee crest width and levee height were not measured or estimated in the field.

View of the repaired site.

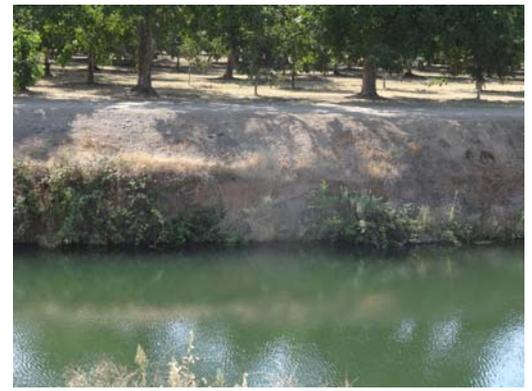
8/20/2014: No significant change has been observed.  
 9/12/2013: No significant change observed.  
 08/22/2012: The erosion was first reported in the 2012 spring levee inspection report. There is no levee structure on site. The levee crest width and levee height were not measured or estimated in the field.

Front view of the site.

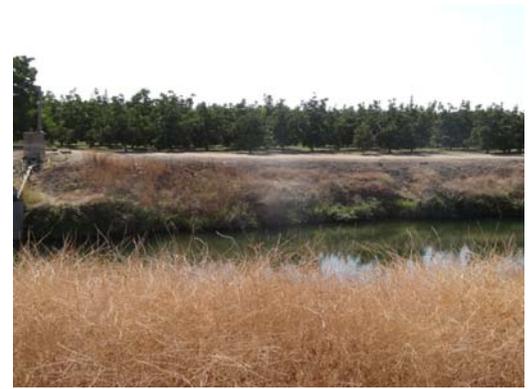
8/20/2014: No significant change observed  
 9/12/2013: No significant change observed.  
 08/22/2012: Site is covered by dense vegetation. Berm width is estimated as 5 ft. There is no levee structure on site. The levee crest width and levee height were not measured or estimated in the field.

Looking at the erosion from right river bank.

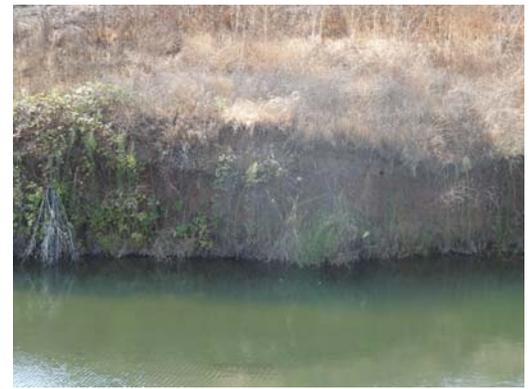
8/20/2014: No significant change observed.  
 9/12/2013: No significant change observed.  
 08/22/2012: The erosion is covered by dense vegetation. There is no levee structure on site. The levee crest width and levee height were not measured or estimated in the field.

Front view of the erosion site.

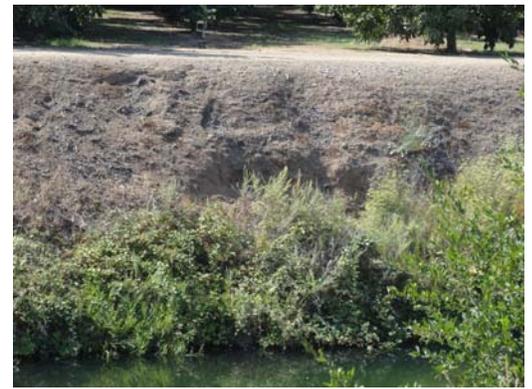
8/20/2014: No significant change observed.  
 9/12/2013: No significant change observed.  
 08/22/2012: Site is covered with dense vegetation. A scarp erosion is adjacent to a pocket erosion at the downstream. There is no levee structure on site. The levee crest width and levee height were not measured or estimated in the field.

Front view of the erosion site from the left river bank.

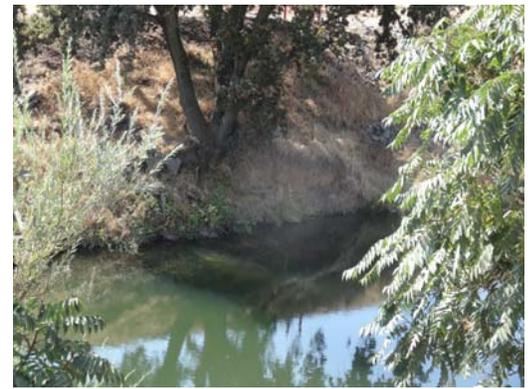
8/20/2014: No significant change observed.  
 9/12/2013: No significant change observed.  
 08/22/2012: The erosion is at the outside corner of a river bend, and next to a tree at the levee toe. Irrigation structure presents at the site. There is no levee structure on site. The levee crest width and levee height were not measured or estimated in the field.

Front view of the erosion. The erosion is next to a tree at the levee toe.

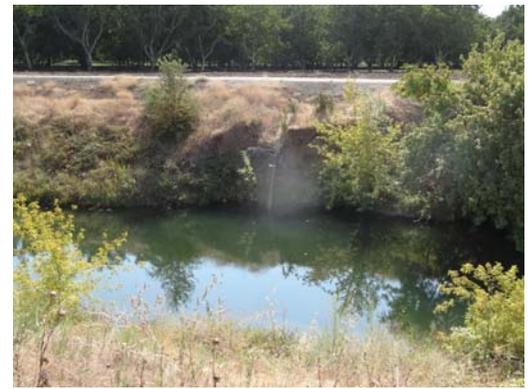
8/20/2014: No significant change observed.  
 09/12/2013: No significant change observed.  
 08/22/2012: The erosion was surveyed and documented for monitoring purpose. There is no levee structure on the site, only high ground protecting the land behind. The levee crest width and levee height were not measured or estimated in the field.  
 There is a drainage pipe at the site, which might have caused the problem at one pocket erosion.

View of the site from right river bank.

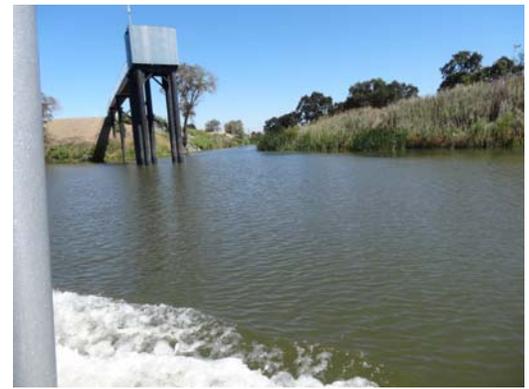
07/02/2014: No significant change observed.  
 08/20/2013: No significant change at this site.  
 08/07/2012: The erosion is at the confluence of Old River and one of its tributary.

Front view of the erosion.

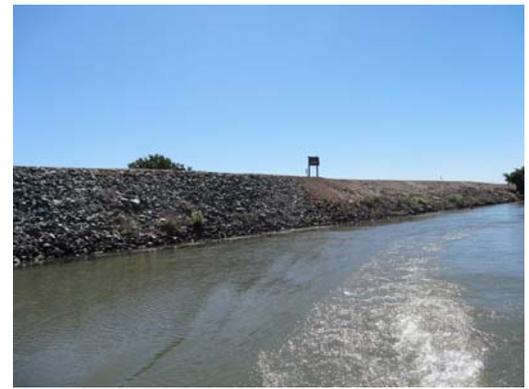
6/19/2014: No significant change observed.  
 08/13/2013: This site was repaired prior to the boat survey. No new erosion discovered.  
 08/07/2012: The erosion is immediately upstream of riprap protection section. The possible cause of the erosion is the rainfall runoff washout.

Downstream view of the repaired site.

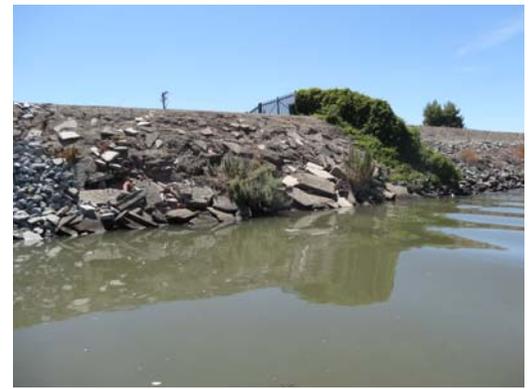
6/19/2014: No significant change observed.  
 08/13/2013: No significant change at this site.  
 08/07/2012: The erosion is nearly vertical, and has developed upward to halfway of the levee slope. The protecting concrete blocks have been washed away. Animal activities are visible.

Front view of the erosion site. Note the concrete blocks and vegetation.

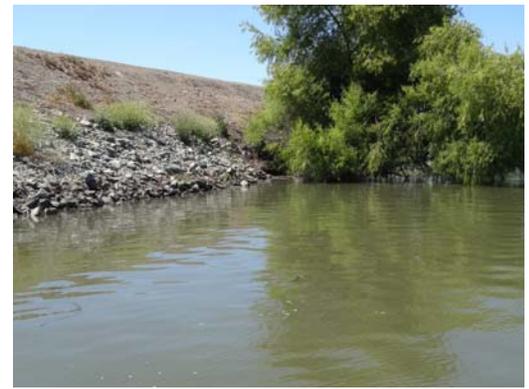
06/19/2014: The erosion has been repaired. A minor erosion is still visible near the tree.  
 08/13/2013: A mid-size tree is present immediately upstream of the erosion, which could block the view of the site. Some debris is visible.

View from downstream.

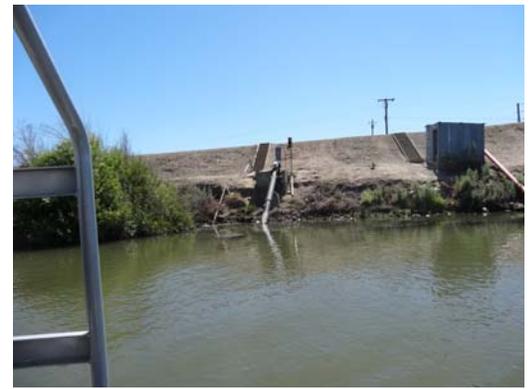
6/19/2014: The erosion was probably caused by the irrigation pipe found at the site.

View of the erosion site from the survey boat. Note the irrigation pipe at the site.

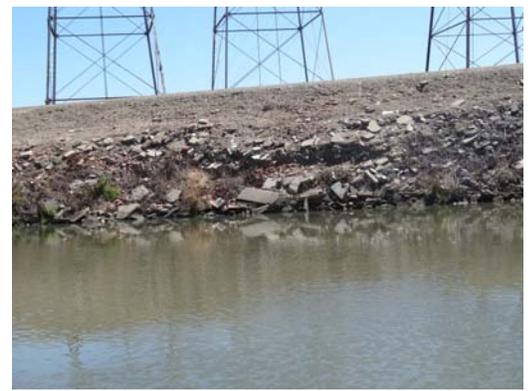
06/19/2014: A pocket erosion was found during the boat survey.

Front view of the erosion.

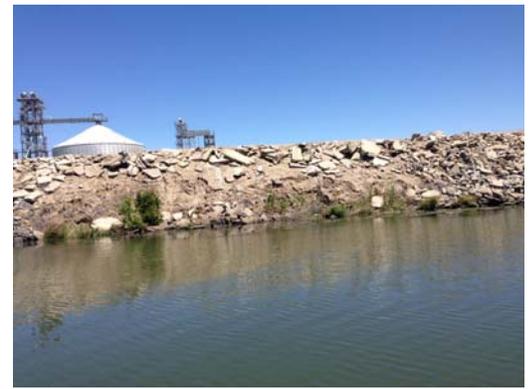
6/19/2014: No significant change observed.  
 08/13/2013: No significant change at this site.  
 8/7/2012: The erosion is next to a repaired site and approximately 400 feet downstream of a river bend. There are broken concretes at the upper levee slope, but not visible at the levee toe or lower slope. Likely the protection concrete blocks have been washed away.

Close view of the site.

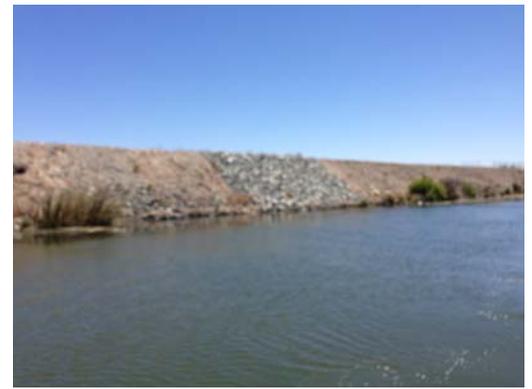
6/19/2014: No significant change observed.  
 08/13/2013: Boat survey found the site has been repaired.  
 08/07/2012: The root-ball of a fallen tree removed material from the levee. Immediately action needed to remove the fallen tree trunk and repair the damage.

Front view of the site.

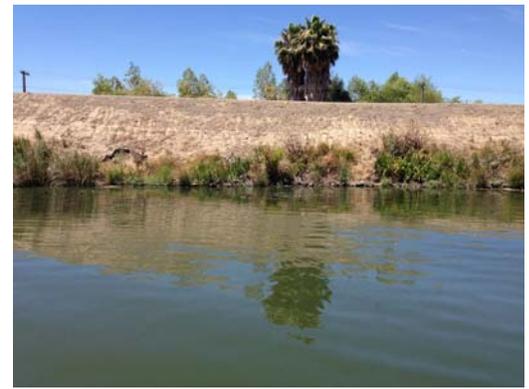
6/19/2014: No significant change observed.  
 08/13/2013: The erosion was discovered during 2013 spring levee inspection. Inspector comment: Erosion is located along the lower level of water-ward slope.

Close view of the erosion.

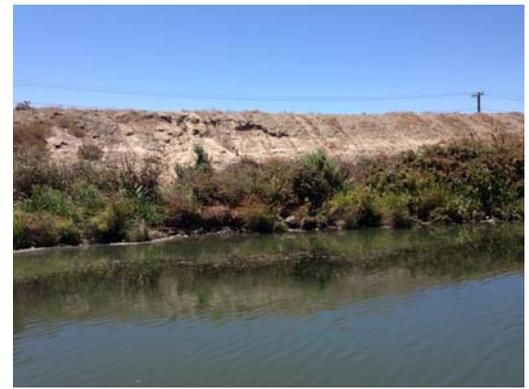
6/19/2014: No significant change observed.  
 08/13/2013: No significant change at this site.  
 8/7/2012: The erosion is at the upper levee slope, and likely caused by slope slip. The lower levee slope is covered with dense vegetation.

Front view of the erosion site. Note the vegetation at the levee toe and lower slope.

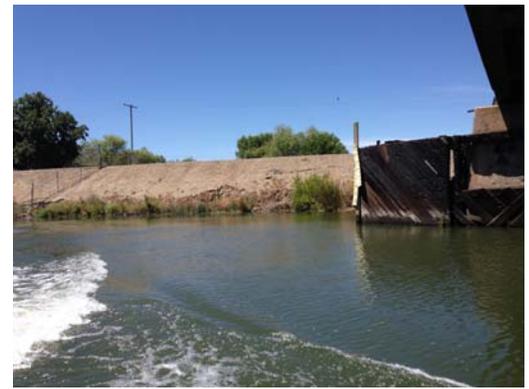
06/19/2014: No significant change observed.  
 08/13/2013: No significant change at this site.  
 08/07/2012: The site has been visited by boat survey. No significant change observed.  
 08/23/2011: The site is located immediately upstream of a Railroad bridge. Dense vegetation at the water line blocks the view of erosion.

Downstream view of the erosion site.

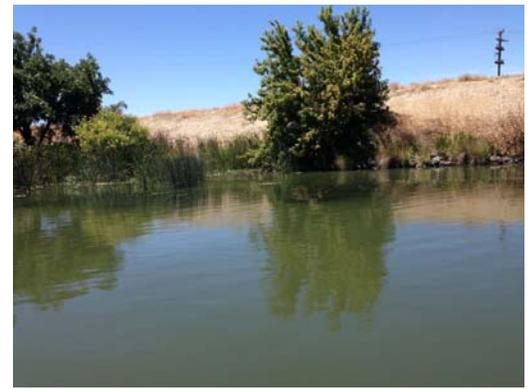
06/19/2014: No significant change observed.  
 08/13/2013: Site was discovered during boat survey. The dense vegetation blocks a clear view of the erosion. Size of erosion site was very roughly estimated.

Front view of the erosion. The tree and vegetation block the view of the site.

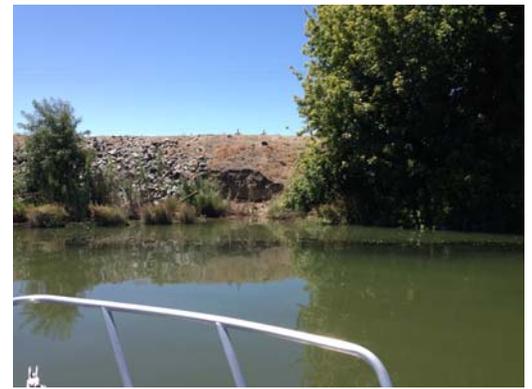
Front view of the erosion. Note the riprap protection near the site.

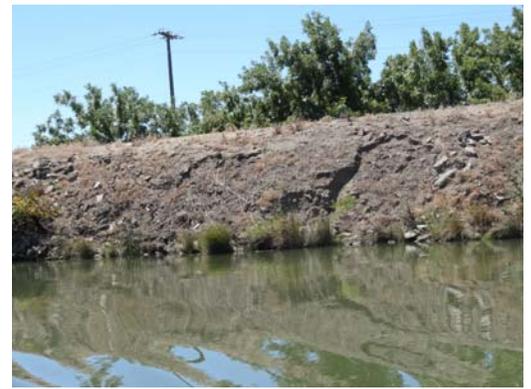
6/19/2014: No significant change observed.  
 08/13/2013: No significant change at this site.  
 08/07/2012: The erosion was discovered during the boat survey.

Front view of the erosion.

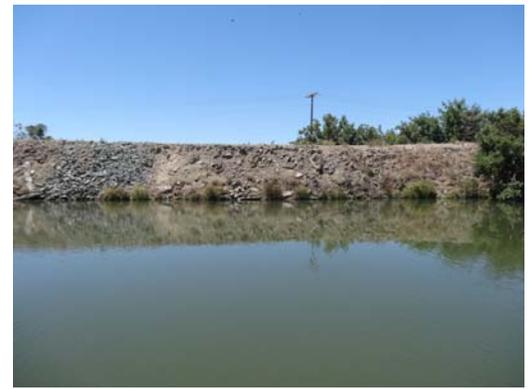
6/19/2014: No significant change observed.  
 08/13/2013: No significant change at this site.  
 08/07/2012: The site has been visited by boat survey. Site has been repaired, but new erosion occurred at the levee slope and immediately upstream of the repaired site.  
 08/23/2011: The site is about 500 ft downstream of bridge. The levee toe seems to be protected, but the protection is being washed away.

Downstream view of the site.

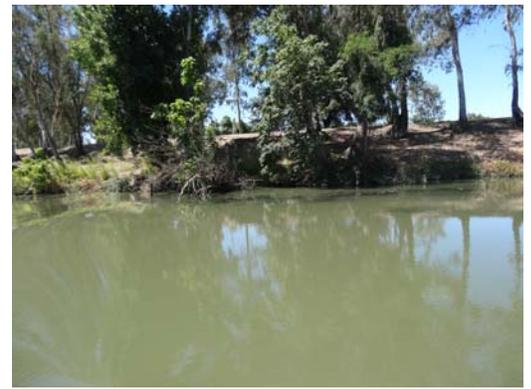
Front view of the site where undermining has occurred.

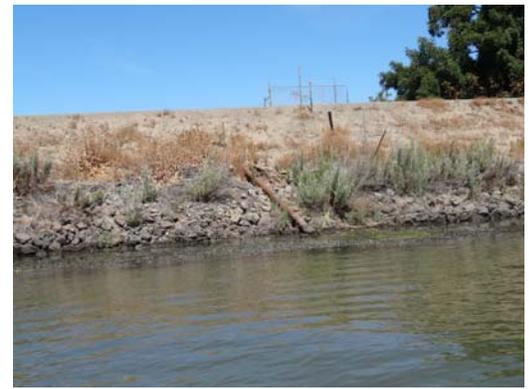
Close view of the erosion and the pipe.

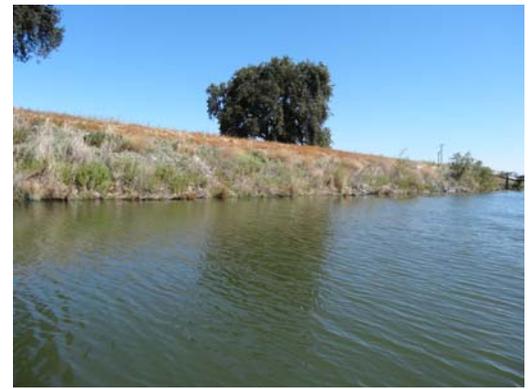
Front view of pocket erosion. Note the vegetation and riprap at the site.

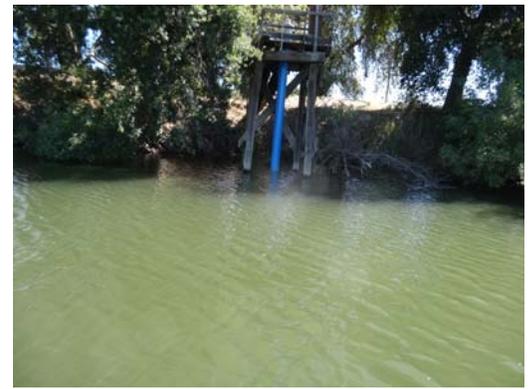
Front view of the erosion site. View is partially blocked by the pump structure and vegetation.

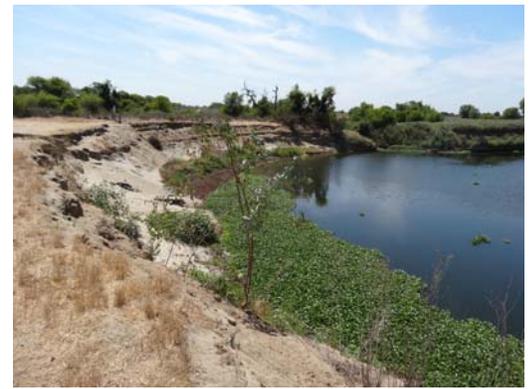
Looking downstream. The erosion has progressed toward levee.

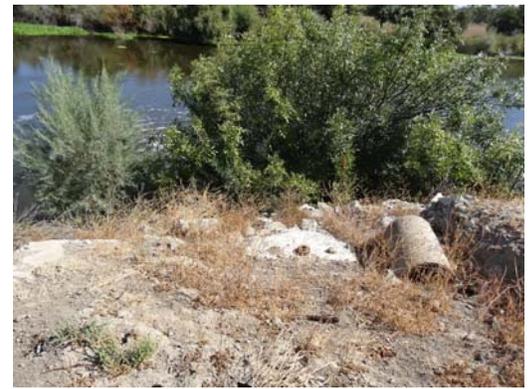
Close view of the site. Note the concrete blocks and vegetation.

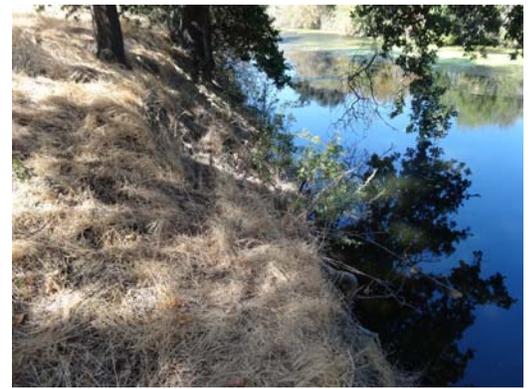
Direct view of a pocket erosion site.

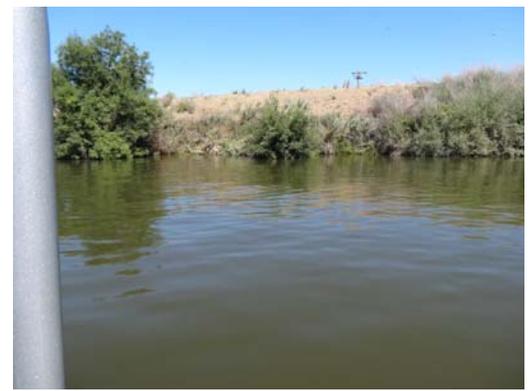
Front view of the site. The scarp is visible on the slope.
