LMA: **NA0011 U02 Madera County FC** Waterway: **RB Ash Slough**  
 Site ID: **NA0011U02RM2.57** Status: **Existing Site**

Latitude: **37.055596** Longitude: **-120.412647** River\_Mile: **2.57** Levee\_Mile: **1.15** Overall Rating: **U**

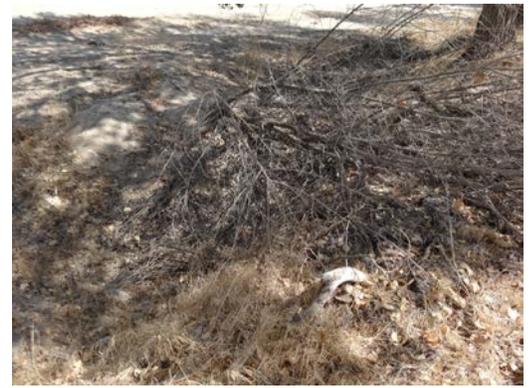
09/08/2015: No significant change observed.  
 07/22/2014: No significant change observed.  
 08/30/2013: No significant change observed.  
 07/31/2012: Site was visited on 07/24/2012. No significant change observed. Dense vegetation around the site  
 08/09/2011: Site was inspected. No visible change was observed from the previous condition. A fallen tree was seen at the levee toe about 20 feet upstream, and tree root exposed. There has been no report from the district that this site was corrected.  
 11/30/2010: Site was not inspected due to time constraints. There have been no reports from the district that the site was corrected. Continue to monitor site during flood events.  
 08/05/2010: Recommended for annual assessment and monitoring during flood events, per CLRO.  
 2009: Site is recommended as a local maintenance issue, per Critical Levee Repair Office, Critical Erosion Sites Evaluation 2008 Report; site was previously rated "M"

9/6/2007: Undercutting of the toe; several trees along the WS slope with roots exposed.

View of the erosion site from the levee crest.

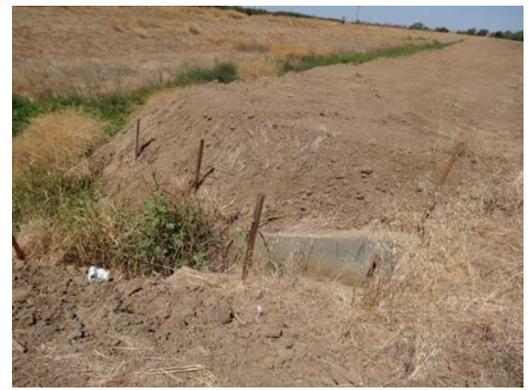
09/03/2015: The ersion site has been repaired, and vegetation has been removed. Minor erosion is still visible at the lower bank slope near the discharge structure.  
 7/31/2014: Soil has been added near the site and more vegetation is visible.  
 7/16/2013: The site was reported in the 2013 Spring Levee Inspection Reports. The erosion was caused by the water from the discharge line crossing the levee. Above the erosion a concrete discharge structure is present at the levee toe. The site is covered with dense vegetation.

Looking at the repaired erosion site.

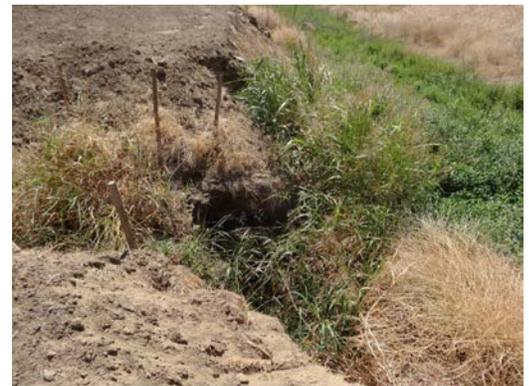
The erosion site has been repaired but a minor erosion at the lower bank slope is still visible.

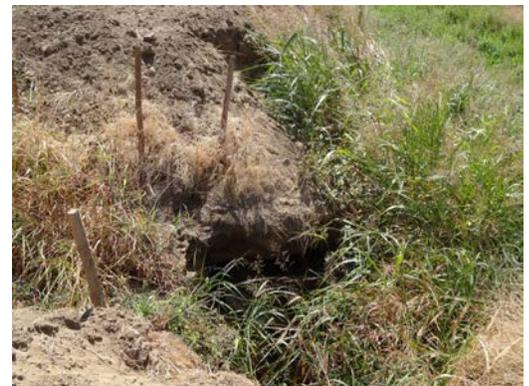
Close view of the minor erosion at the lower bank slope.

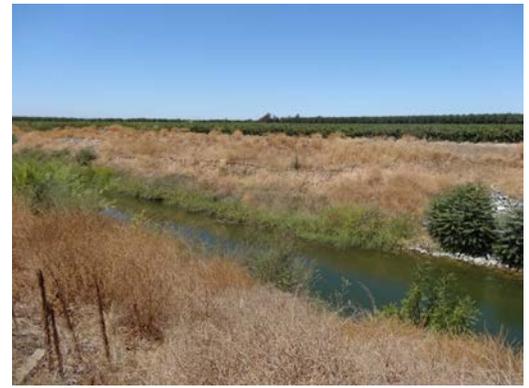
8/12/2015: No significant change observed.  
 8/20/2014: Both ends of the erosion site are protected by riprap.

View of the site from the left river bank.

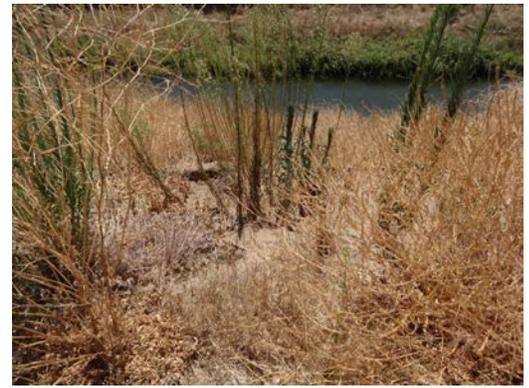
8/12/2015: No significant change observed. More vegetation is observed at the site.  
 8/20/2014: No significant change observed.  
 09/12/2013: The erosion has been caused by runoff.

Looking down at the erosion from the levee crest.

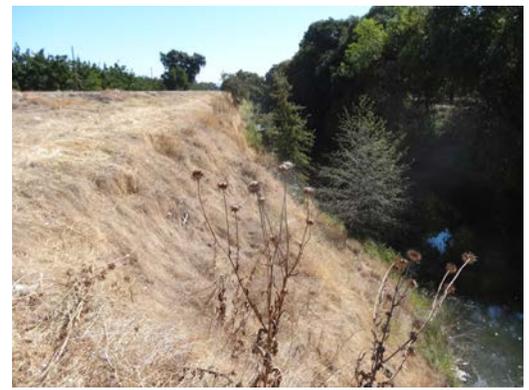
8/12/2015: No significant change observed.  
 8/20/2014: No significant change has been observed.  
 9/12/2013: No significant change observed.  
 08/22/2012: Site has been revisited. No significant change observed.  
 09/02/2011: No significant change observed on site.  
 11/02/2010: No significant change observed. The mile-long erosion continues to degrade the bank. There are a few trees along the mile-long stretch on the lower bank slope that are affected by the scarp. WS Levee Slope was changed to 2:1. As a result, normalized score increased from 62 to 65.  
 08/05/2010: Recommended for waterside repair, per CLRO; "water velocity is a major factor for accelerating bank slope erosion."  
 8/12/2009: Near-vertical bank erosion; degrading channel is incising the banks; recommend annual assessment and monitoring of critical erosion site, per CLRO CES Evaluation 2008 Report; district is monitoring site for change in condition; site was previously rated "U".

Downstream view of the site.

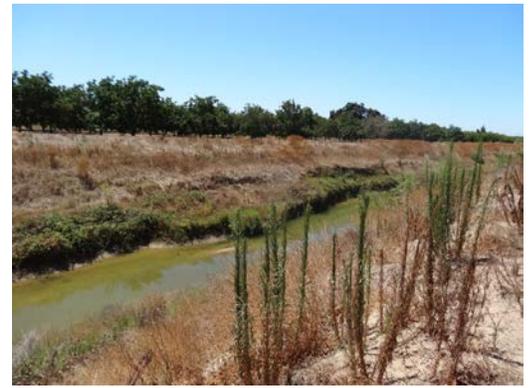
8/12/2015: No significant change observed.  
 8/20/2014: No significant change observed.  
 9/12/2013: No significant change observed.  
 08/22/2012: Dense vegetation on site. There is no levee structure on site. The levee crest width and levee height were not measured or estimated in the field.

Upstream view of the site from the right river bank.

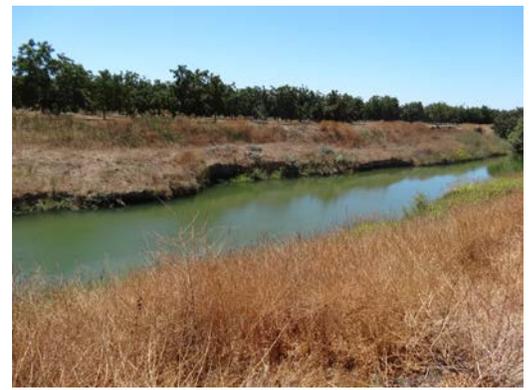
8/12/2015: No significant change observed.  
 8/20/2014: No significant change observed.  
 9/12/2013: No significant change observed.  
 08/22/2012: The erosion is on berm. The berm width is estimated. There is no levee structure on site. The levee crest width and levee height were not measured or estimated in the field.

Upstream view of the erosion.

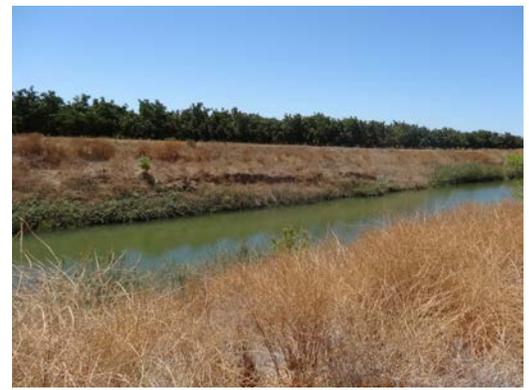
8/12/2015: No significant change observed.  
 8/20/2014: No significant change observed.  
 9/12/2013: No significant change observed.  
 08/22/2012: The erosion is covered with dense vegetation. There is no levee structure on site. The levee crest width and levee height were not measured or estimated in the field.

Upstream view of the erosion.

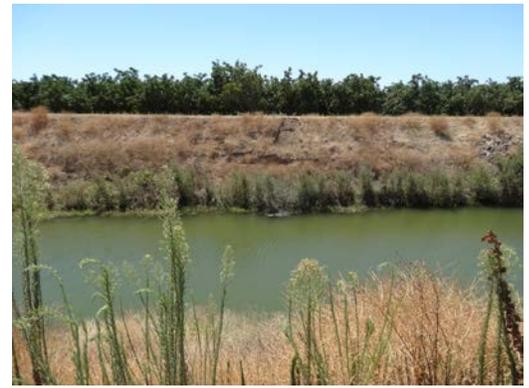
8/12/2015: No significant change observed.  
 8/20/2014: No significant change observed.  
 9/12/2013: The erosion might have been caused by river flow combined with runoff. Dense vegetation is presents at the site. There is no levee structure on site. The levee crest width and levee height were not measured or estimated in the field.

View of the site from the right river bank.

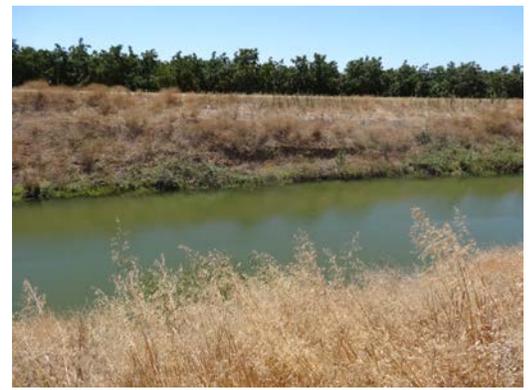
8/12/2015: No significant change observed.  
 8/20/2014: No significant change observed.  
 9/12/2013: No significant change observed.  
 08/22/2012: Pocket erosion at the levee toe and slope. The erosion is covered with dense vegetation. There is no levee structure on site. The levee crest width and levee height were not measured or estimated in the field.

Front view of the erosion.

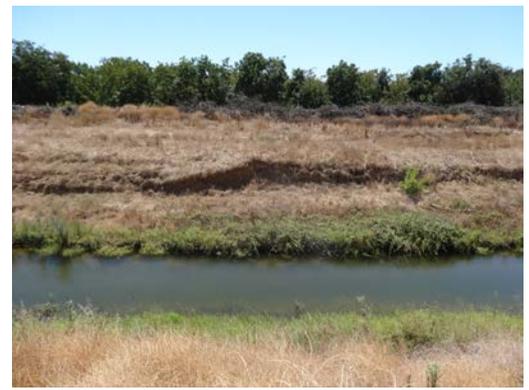
8/12/2015: No significant change observed.  
 8/20/2014: No significant change observed.  
 9/12/2013: No significant change observed.  
 08/22/2012: The erosion occurred on a berm of approximately 25 ft. wide. Site is covered with dense vegetation. There is no levee structure on site. The levee crest width and levee height were not measured or estimated in the field.

View of the site from the right river bank.

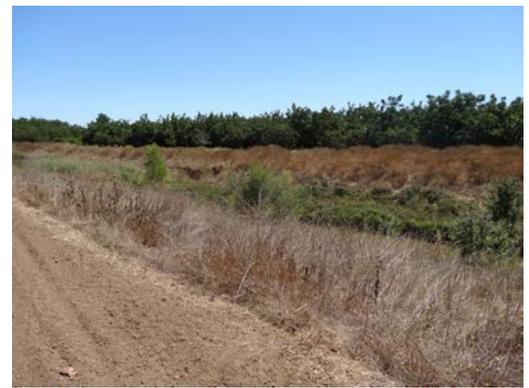
8/12/2015: No significant change observed.  
 8/20/2014: No significant change observed.  
 9/12/2013: Site has been surveyed and the erosion has worsened since last year.  
 08/22/2012: Discontinuous scarp or pocket erosions occurred along a long stretch of the river, with an erosion height greater than 25 ft. at certain points. There is no levee structure on site. The levee crest width and levee height were not measured or estimated in the field.

Downstream view of the site from the right river bank.

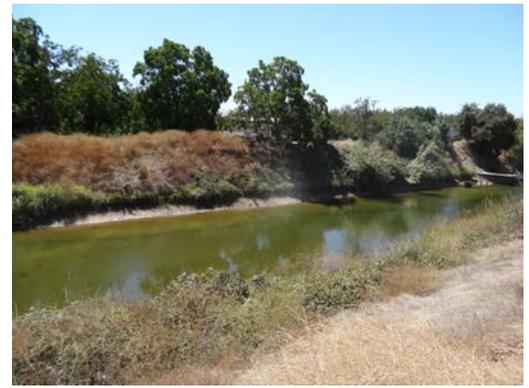
8/12/2015: No significant change observed.  
 8/20/2014: The erosion is near a tree and probably has been made worse by the unstable bank slope.

View of the site from the right river bank.

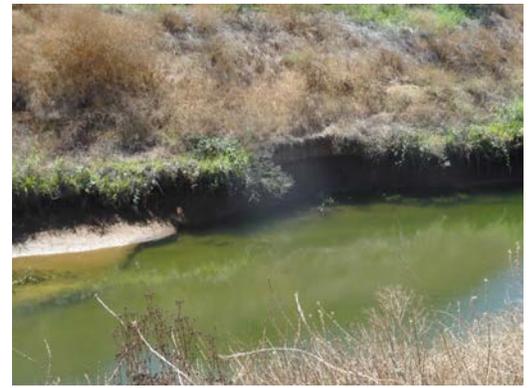
8/12/2015: No significant change observed.  
 8/20/2014: No significant change observed.  
 9/12/2013: The erosion seems to be caused by high river flow. Dense vegetation is present at the site. Signs of animal activities are visible. There is no levee structure on site. The levee crest width and levee height were not measured or estimated in the field.

View from the right river bank.

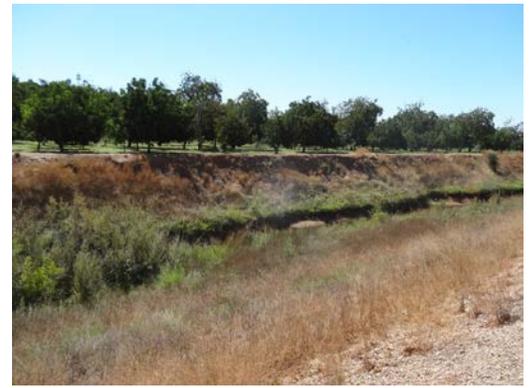
8/12/2015: No significant change observed.  
 8/20/2014: No significant change observed.  
 9/12/2013: Site has been surveyed and the pocket erosion has developed toward levee crest.  
 08/22/2012: A pocket erosion at the levee toe and on lower slope. The levee surface at the upper slope also shows signs of erosion due to poor maintenance. There is no levee structure on site. The levee crest width and levee height were not measured or estimated in the field.

View from right river bank.

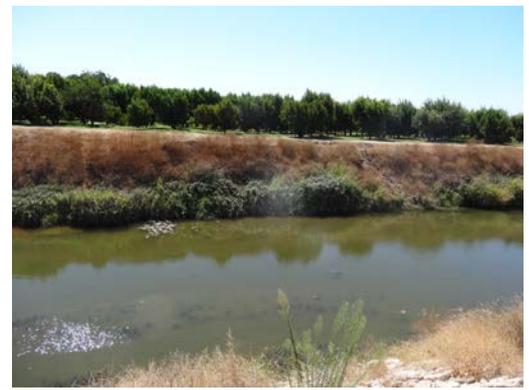
8/12/2015: No significant change observed.  
 8/20/2014: No significant change observed.  
 9/12/2013: This site was repaired prior to this survey.  
 08/22/2012: The erosion is covered with grass and shrubs. There is no levee structure on site. The levee crest width and levee height were not measured or estimated in the field.

Front view of repaired site.

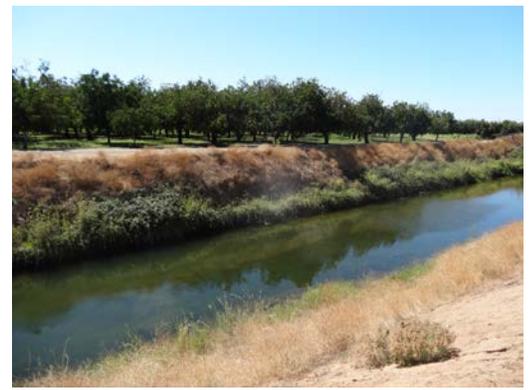
8/12/2015: No significant change observed.  
 8/20/2014: A pocket erosion was found near the water's edge.

View of the site from the right river bank.

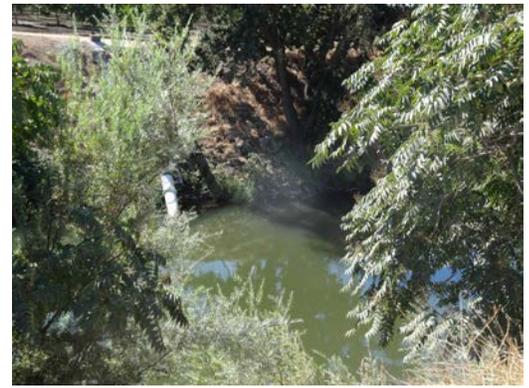
8/12/2015: No significant change observed.  
 8/20/2014: No significant change observed.  
 9/12/2013: No significant change observed.  
 08/22/2012: The erosion is at the outside corner of a river bend, and next to a tree at the levee toe. Irrigation structure presents at the site. There is no levee structure on site. The levee crest width and levee height were not measured or estimated in the field.

Front view of the erosion. The erosion is next to a tree at the levee toe.

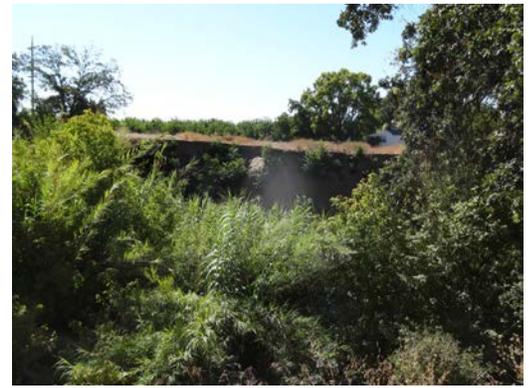
8/12/2015: The erosion progressed at the site. Newly collapsed material is observed at the bottom of the erosion.  
 8/20/2014: The erosion at the site has worsened. The erosion increased in both length and in height.  
 09/12/2013: Site has been visited and signs of new erosion are visible.  
 08/22/2012: The erosion was surveyed and documented for monitoring purpose. There is no levee structure on the site, only high ground protecting the land behind. The levee crest width and levee height were not measured or estimated in the field.

Front view of the erosion. Looking from the right side of the river.

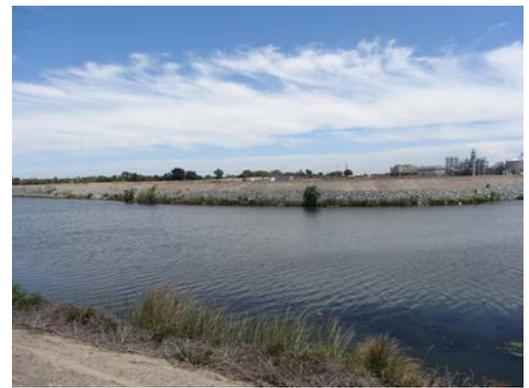
06/24/2015: The erosion site has been repaired. Minor erosion is visible at the water edge.  
 06/19/2014: No significant change observed.  
 08/13/2013: The pocket erosion is located at immediately upstream of a small oak tree.

Front view of the repaired erosion site.

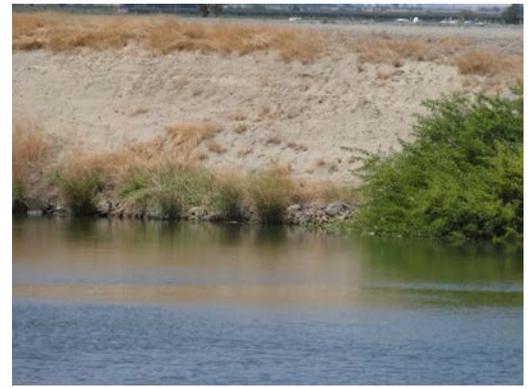
06/24/2015: No significant change observed.  
 6/19/2014: No significant change observed.  
 08/13/2013: No significant change at this site.  
 8/7/2012: The erosion is next to a repaired site and approximately 400 feet downstream of a river bend. There are broken concretes at the upper levee slope, but not visible at the levee toe or lower slope. Likely the protection concrete blocks have been washed away.

Close view of the site.

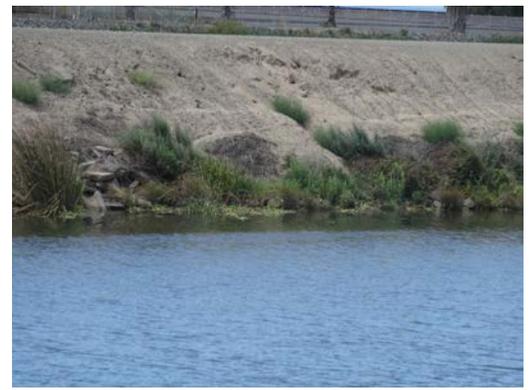
Front view of the erosion site. Note the vegetation at the levee toe and on the lower slope.

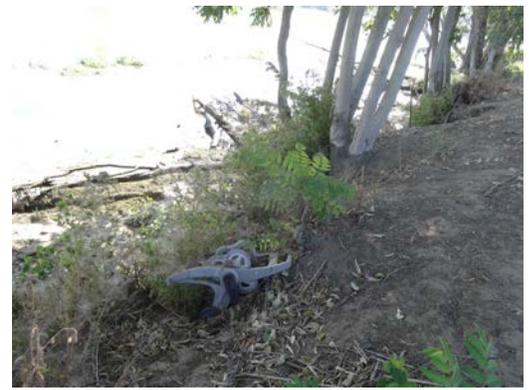
Front view of the site where undermining has occurred.

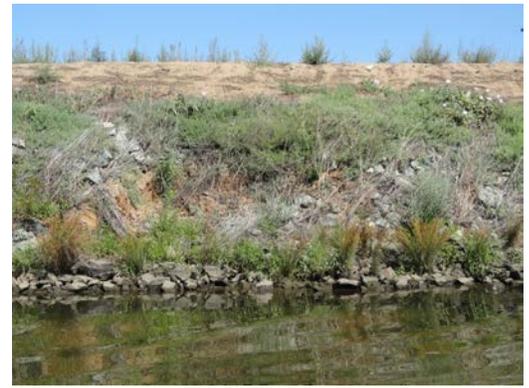
Front view of pocket erosion. Note the vegetation and riprap at the site.

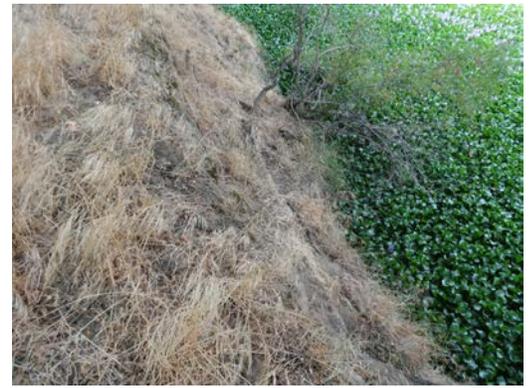
09/10/2008: Two large trees (2-3' DBH) with partial roots exposed.  
 2007: Visited site 03/13/2007.

Direct view of a pocket erosion site.

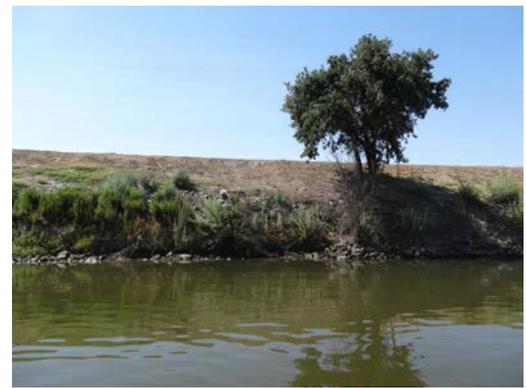
View of the pocket erosion and the tree.

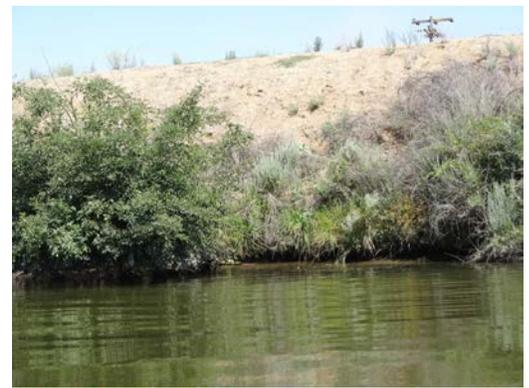
Front view of the site. The scarp is visible on the slope.

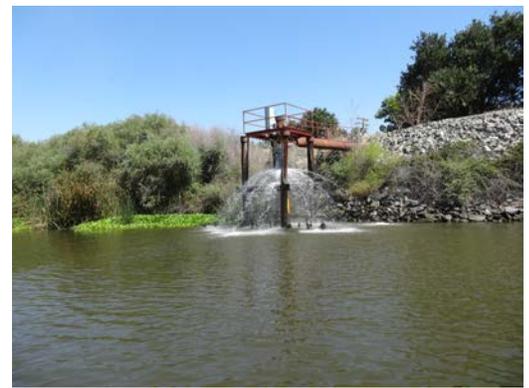
Front view of the site. The irrigation pipe is functioning and leaking water at the site.
