LMA: **NA0010 U23 Lower San Joaquin Levee District**

Waterway: **RB San Joaquin River**

Site ID: **NA0010U23RM224.27**

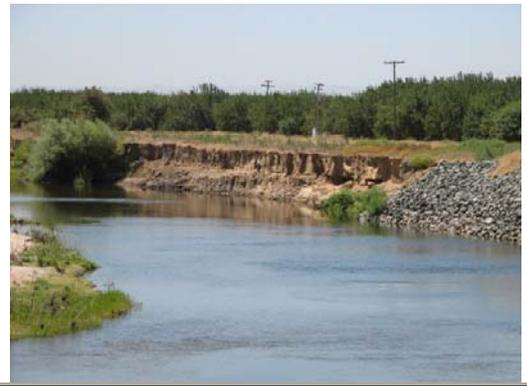
08/16/2011: This site is immediately downstream of the riparian protection section. Dense vegetation growing on the toe and slope of the bank seems to indicate the most part of the erosion occurred prior to last winter. The closest spot is 12 feet away from the levee toe.

Looking downstream at the downstream erosion site from the upstream site location. The boulders show the riparian protection.

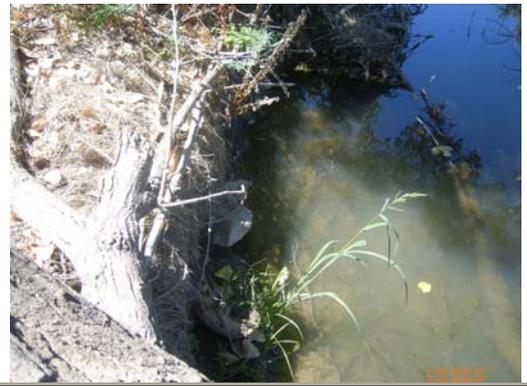
08/09/2011: Site was inspected. No visible change was observed from the previous condition. A fallen tree was seen at the levee toe about 20 feet upstream, and tree root exposed. There has been no report from the district that this site was corrected.  
 11/30/2010: Site was not inspected due to time constraints. There have been no reports from the district that the site was corrected. Continue to monitor site during flood events.  
 08/05/2010: Recommended for annual assessment and monitoring during flood events, per CLRO.  
 2009: Site is recommended as a local maintenance issue, per Critical Levee Repair Office, Critical Erosion Sites Evaluation 2008 Report; site was previously rated "M"  
 9/6/2007: Undercutting of the toe; several trees along the WS slope with roots exposed.

Close-in view at the erosion site

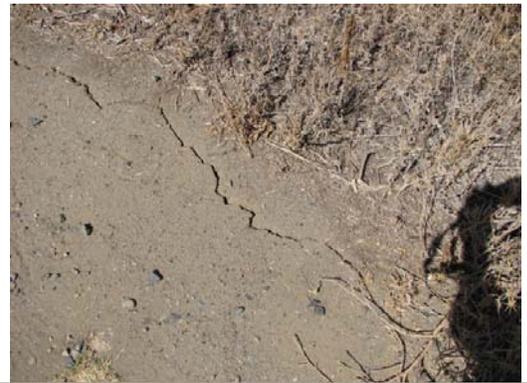
Some cracking on the site.

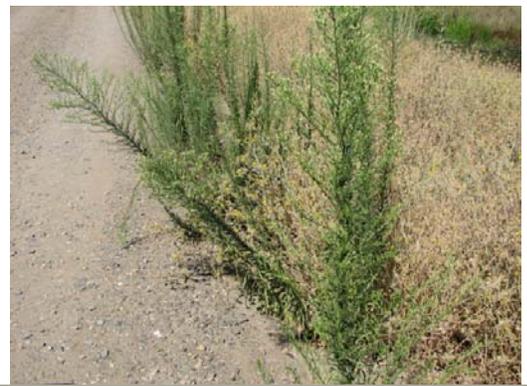
08/16/2011: No significant change was visible. Minor cracking on the waterside levee slope was spotted. 100 percent vegetation coverage with star thistles.  
 11/30/2010: Site was not inspected this year due to time constraints. There have been no reports from the district that the site has been corrected.  
 2009: Site recommended as local maintenance issue, per CLRO CES Evaluation 2008 Report; previously rated "U".  
 9/10/2007: GPS extended from opposite bank using Google Earth; signs of vehicular damage on levee.

The site is covered with dense star thistles. No significant changes visible

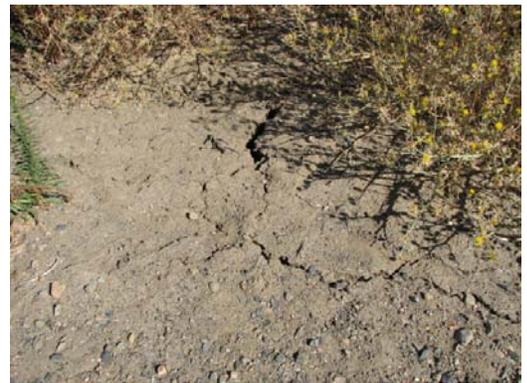
Minor cracking visible on the site

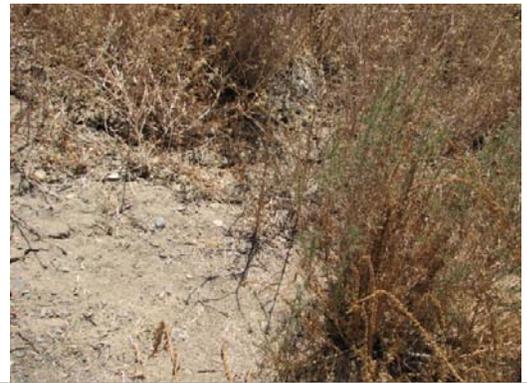
Minor cracking on waterside levee shoulder

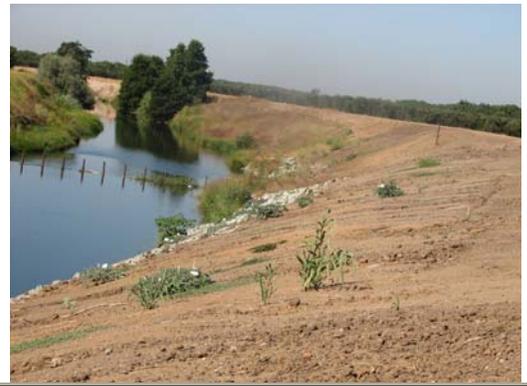
09/02/2011: Site was repaired in 2011 summer by the district. Needs to monitor during the next flood season for performance. The site was previously rated "U".  
 11/02/2010: No significant changes observed on site. Bank erosion extends approximately 100 feet downstream and 250 feet upstream of the drop structure.  
 8/12/2009: No major change observed; erosion is upstream and downstream of drop structure; bank erosion is associated with high velocities; it is recommended for annual assessment and monitoring of critical erosion site per CLRO CES Evaluation 2008 Report; it was previously rated "U".  
 2007: Visited site 02/06/2007.

Looking at the repaired site upstream of the drop structure.

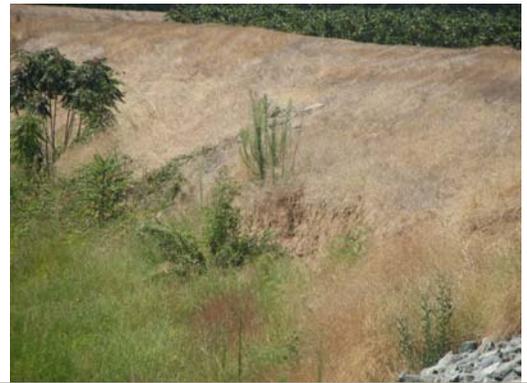
Downstream view of repaired site. Note the pocket erosion downstream of the riparian protection.

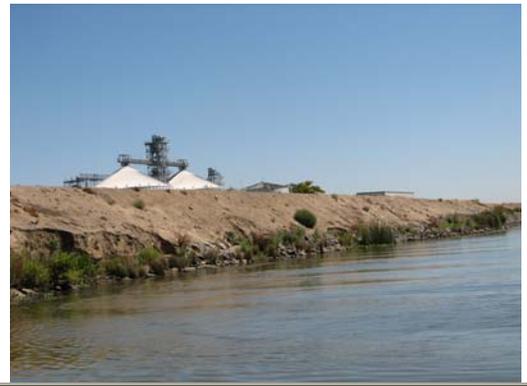
08/23/2011: Pockets erosions observed by last survey seem have progressed during the last food season. Continuous monitoring of this site suggested  
 9/07/2010: No significant change observed on site. There is emergent vegetation at the water line. Several pocket erosions lined along the lower slope that stretches from RM 40.86 to RM 41.14.  
 9/30/2009: No major change observed; the site was combined with other existing sites are RM's 40.93, 40.98, and 41.14 as one site; several pocket erosion just above non-uniform toe rip rap; previously rated "U"; bare spots along the upper slope.  
 2008: Possibly caused by wave wash erosion; several pocket erosion along the lower slope; site is inside of a bend.  
 2006: Visited site 09/12/06.

Upstream view of Site. Progressing pocket erosion visible.

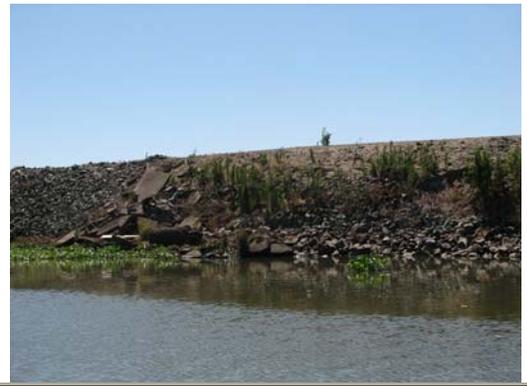
08/23/2011: No significant changes observed on site.  
 09/07/2010: No significant changes observed on site. Some emergent vegetation at the lower and middle slope. Existing revetment is no longer adequately protecting the oversteepened slope. Some of the broken concrete used as revetment has slid, dragging levee materials away from the slope and creating notches.  
 09/29/2009: Erosion site extends from RM 41.11 to 41.18; existing revetment is no longer adequately protecting the oversteepened slope.  
 2008: Existing concrete slabs were placed as temporary fix; some of the slabs have started to slide, dragging levee materials away from the slope and creating notches; note that a sewage treatment plant is located on the landside of the levee.

Upstream view of the site. Broken concrete used as revetment is sliding, dragging down levee materials.

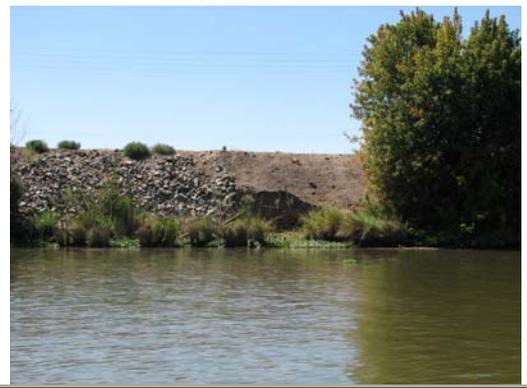
08/23/2011: The erosion site is immediately donstream of the riprap protection.

Front view of the erosion. Not the riprap protection near the site

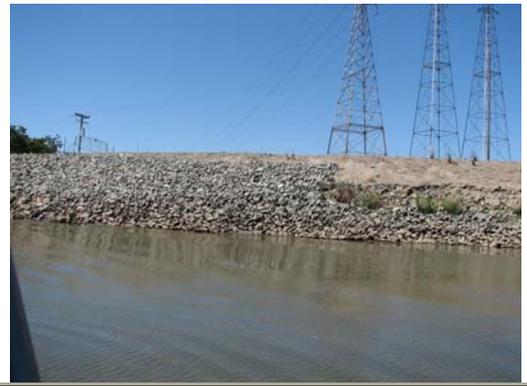
08/23/2011: No significant changes observed on site.  
 09/07/2010: No significant changes observed on site. Erosion site is located beneath Howard Road Bridge. Majority of the existing rip rap has slipped, dragging away levee materials and exposing the underlying soft soil.  
 08/06/2010: Recommend for annual assessment and monitoring during flood events, per CLRO.  
 09/30/2009: No major changes observed since the last visit; upper portion of existing revetment has slipped, exposing the degrading bank; note that site # is the same as RM46.30, LM5.69 found in the CLRO CES Evaluation 2008 Report; site was previously rated "M".  
 11/04/2008: Previously repaired using rock revetment; upper portion of th revetment is sliding, causing deformation on the levee slope; site is upstream of Howards Road Bridge.

Sloughing rip rap just below the Howard Bridge abutment.

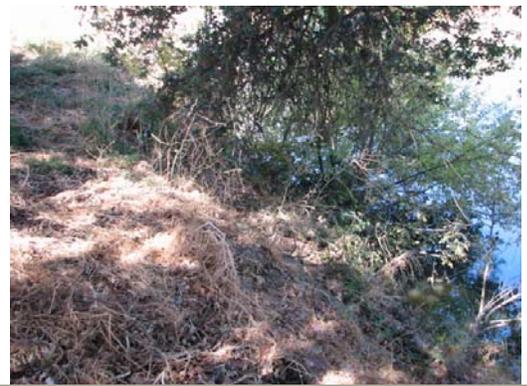
Downstream view. Seasonal vegetation covering one of several pocket erosions lined along the bank.

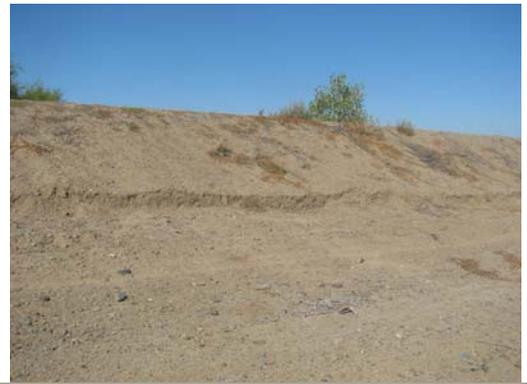
Downstream view of site. Note the vertical scarp at the toe.

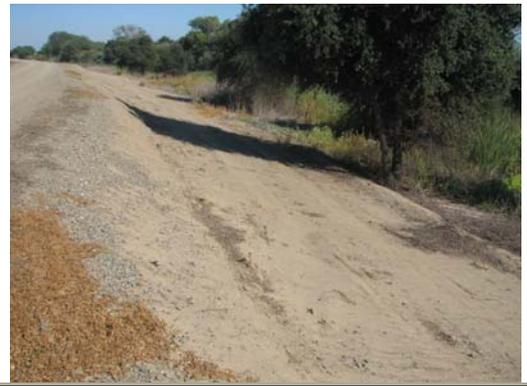
Downstream view of scarp caused by a maintenance equipment.

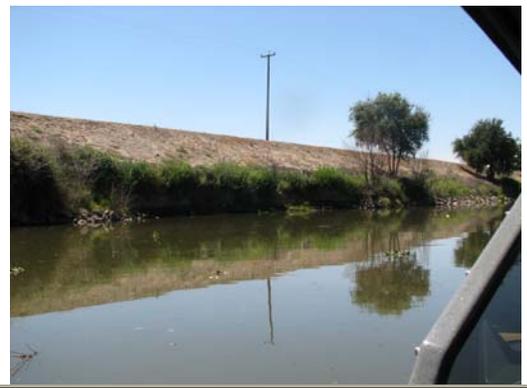
Downstream view of the 5-ft vertical scarp .

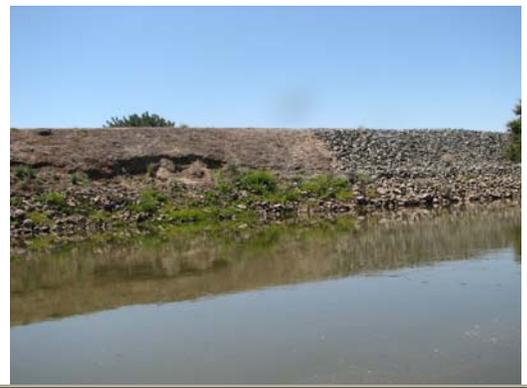
Front view of the site. Existing scalloped erosion is immediately downstream of rip rap section.
