LMA: **NA0010 U23 Lower San Joaquin Levee District**

Waterway: **RB San Joaquin River**

Site ID: **NA0010U23RM224.27**

Status: **Repaired Site**

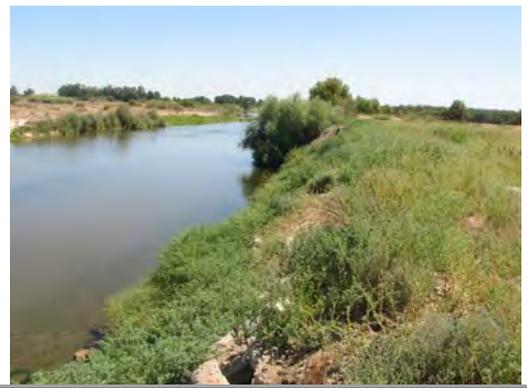
07/24/2012: Site has been repaired with riprap rocks and broken concrete blocks, but loose material and cracking are visible at the top of the repaired site. The site needs close monitoring for performance evaluation.

Looking downstream at the repaired site

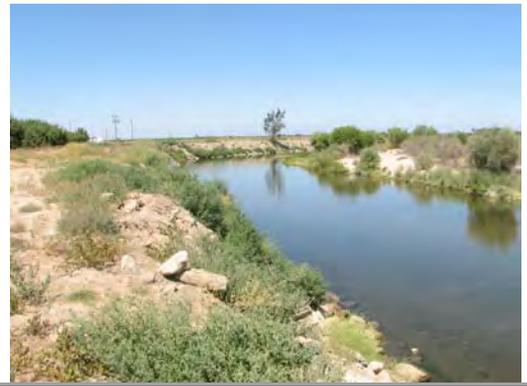
07/24/2012: The site has been repaired with clay material, riprap rocks, and broken concrete blocks, but the loose material and large crackings at the repaired site are visible. Need monitoring for the performance during the coming high flow events.

08/16/2011: The erosion is cutting into the levee. The site is located at the outside of a river bend, and the erosions were caused by river flows during the last flooding season. The ground was covered by dense grasses. Animal burrow holes are visible.

Looking upstream at the repaired site.

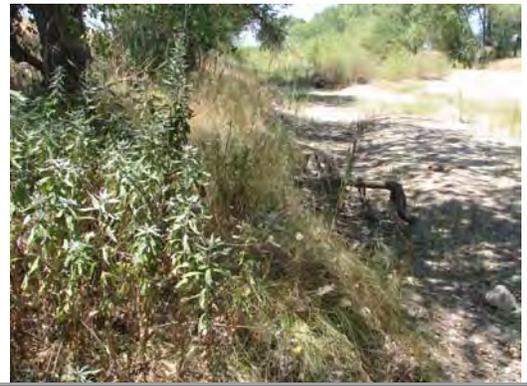
07/31/2012: Site was visited on 07/24/2012. No significant change observed. Dense vegetation around the site
 08/09/2011: Site was inspected. No visible change was observed from the previous condition. A fallen tree was seen at the levee toe about 20 feet upstream, and tree root exposed. There has been no report from the district that this site was corrected.
 11/30/2010: Site was not inspected due to time constraints. There have been no reports from the district that the site was corrected. Continue to monitor site during flood events.
 08/05/2010: Recommended for annual assessment and monitoring during flood events, per CLRO.
 2009: Site is recommended as a local maintenance issue, per Critical Levee Repair Office, Critical Erosion Sites Evaluation 2008 Report; site was previously rated "M"
 9/6/2007: Undercutting of the toe; several trees along the WS slope with roots exposed.

Close-in view at the erosion site

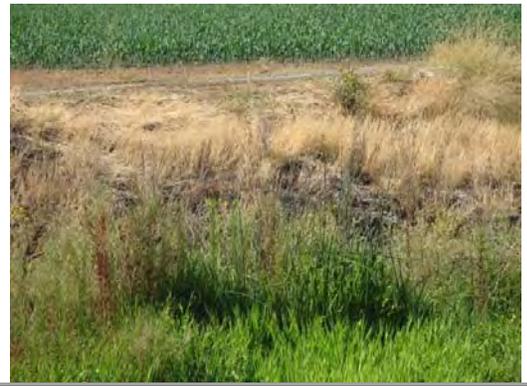
07/31/2012: Site was visited on 07/26/2012. No significant changes observed. Dense vegetation presents at the site.
 08/16/2011: No visible change. 100 percent vegetation coverage with star thistles. Minor cracking visible on the waterside slope.
 11/30/2010: Site was not inspected this year due to time constraint. There have been no reports from the district that this site was corrected. Continue to monitor during flood events.
 2009: Site is recommended as local maintenance issue, per CLRO CES Evaluation 2008 Report; it was previously rated "U".
 8/26/2008: Terracetting erosion; frequent livestock traversing the slopes has caused deformation of the waterside levee slope.
 9/11/2007: GPS extended from opposite bank using Google Earth.

A close look at the site, which is covered by thick vegetation

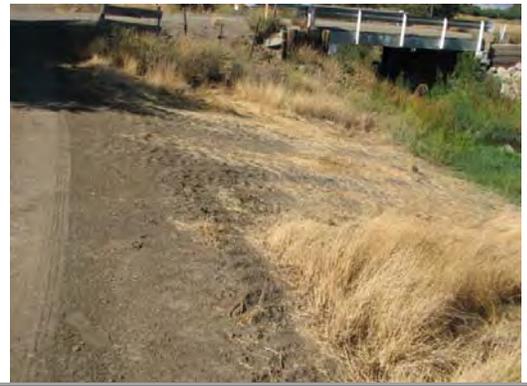
07/31/2012: Site was visited on 07/24/2012. No significant changes observed. Dried grass covered the site. Dense vegetation.
 08/16/2011: No visible change. 100 percent vegetation coverage with star thistles. Minor cracking visible on the waterside slope. Burrow holes visible.
 11/30/2010: Site was not inspected this year due to time constraint. There have been no reports from the district that the site was repaired. Continue to monitor during flood events.
 2009: Bank erosion scour that is immediately downstream of Mission Avenue bridge; noticeable terracetting damage from livestock traversing the slope; site is recommended as local maintenance issue, per CLRO Evaluation 2008 Report; site was previously rated "M".
 8/26/2008: Terracetting damage from livestock; there is now a pocket erosion developing on the levee toe; site is 100 feet downstream of Mission Avenue bridge.

The site is covered with dense thistles.

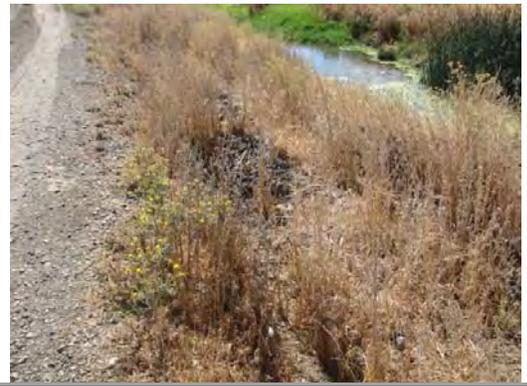
07/31/2012: No significant changes observed
 08/16/2011: No significant change was visible. Minor cracking on the waterside levee slope was spotted. 100 percent vegetation coverage with star thistles.
 11/30/2010: Site was not inspected this year due to time constraints. There have been no reports from the district that the site has been corrected.
 2009: Site recommended as local maintenance issue, per CLRO CES Evaluation 2008 Report; previously rated "U".
 9/10/2007: GPS extended from opposite bank using Google Earth; signs of vehicular damage on levee.

The site is covered with dense star thistles. No significant changes visible

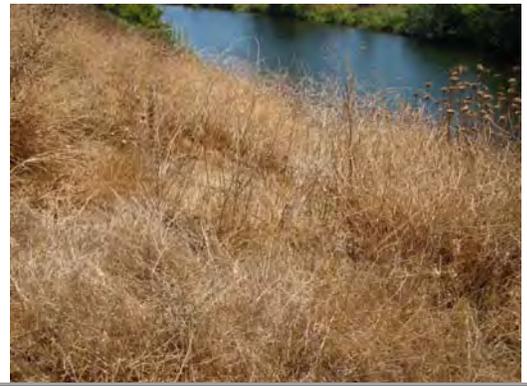
08/22/2012: Site was visited. No new erosion has been found. Dense vegetation developed at the repaired site.
 09/02/2011: Site was repaired in 2011 summer by the district. Needs to monitor during the next flood season for performance. The site was previously rated "U".
 11/02/2010: No significant changes observed on site. Bank erosion extends approximately 100 feet downstream and 250 feet upstream of the drop structure.
 8/12/2009: No major change observed; erosion is upstream and downstream of drop structure; bank erosion is associated with high velocities; it is recommended for annual assessment and monitoring of critical erosion site per CLRO CES Evaluation 2008 Report; it was previously rated "U".
 2007: Visited site 02/06/2007.

Looking at the repaired site. Dense vegetation covered the repaired slope.

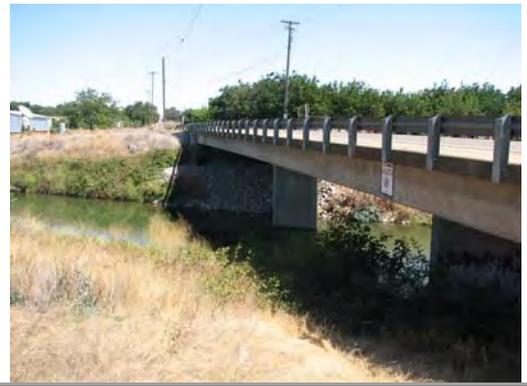
08/22/2012: Site is visited and no new erosion activity found at the repaired site, but new pocket erosion has developed at the toe downstream of the bridge.
 09/02/2011: The site has been repaired by the district. The site was previously rated "M".
 11/02/2010: No significant changes observed on site. Bridge scour has created a pocket erosion, exposing a portion of the underlying concrete padding.
 8/11/2009: Site is adjacent to abutment on Milton Road Bridge; pocket erosion has developed and will continue to expose the bridge foundation; this erosion appears to be critical as it may affect the bridge foundation.

Looking at the site from right bank, immediately upstream of the bridge

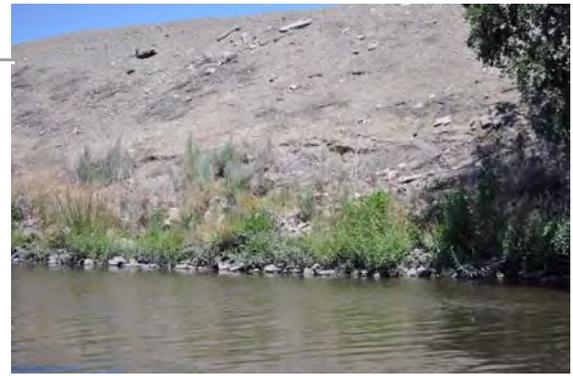
08/07/2012: The erosion is at the confluence of Old River and one of its tributary.

Front view of the erosion

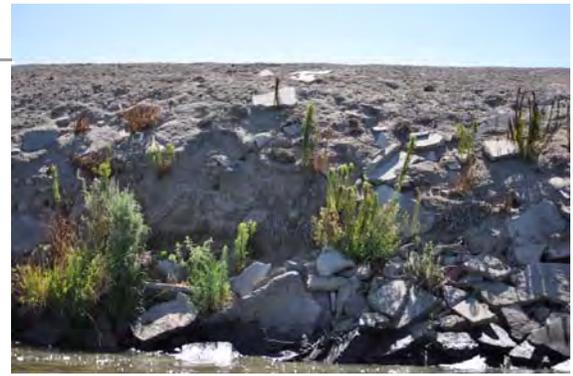
08/07/2012: The erosion is nearly verticle, and has developed upward to halfway of the levee slope. The protecting concrete blocks have been washed away. Animal activities are visible.

Front view of erosion site. Note the concrete blocks and vegetation.

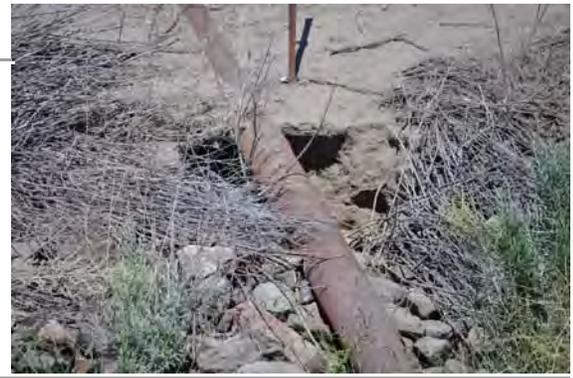
08/07/2012: Erosion is underneath an irrigation pipe. The likely cause of the erosion is the pipe leakage.

Close view of the erosion and the pipe

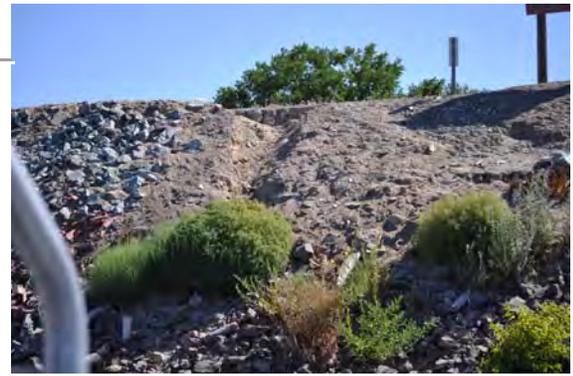
08/07/2012: The erosion is immediately upstream of riprap protection section. The possible cause of the erosion is the rainfall runoff washout.

Front view of the site. Note the riprap protection next to the site.

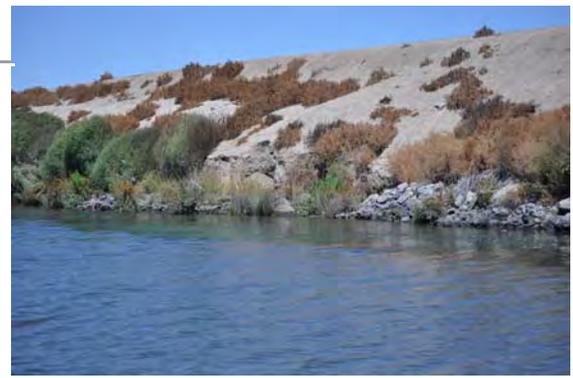
08/07/2012: The site has been visited by boat survey. The erosion has developed in size, and more pocket erosions found.
 8/23/2011: Pockets erosions observed by last survey seem have progressed during the last food season. Continuous monitoring of this site suggested
 9/07/2010: No significant change observed on site. There is emergent vegetation at the water line. Several pocket erosions lined along the lower slope that stretches from RM 40.86 to RM 41.14.
 9/30/2009: No major change observed; the site was combined with other existing sites are RM's 40.93, 40.98, and 41.14 as one site; several pocket erosion just above non-uniform toe rip rap; previously rated "U"; bare spots along the upper slope.
 2008: Possibly caused by wave wash erosion; several pocket erosion along the lower slope; site is inside of a bend.
 2006: Visited site 09/12/06.

Downstream view of Site. Progressing pocket erosion visible.

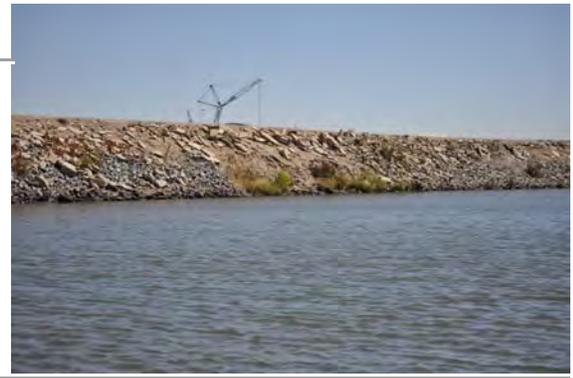
8/7/2012: The erosion is next to a repaired site and approximately 400 feet downstream of a river bend. There are broken concretes at the upper levee slope, but not visible at the levee toe or lower slope. Likely the protection concrete blocks have been washed away

Downstream view of the site.

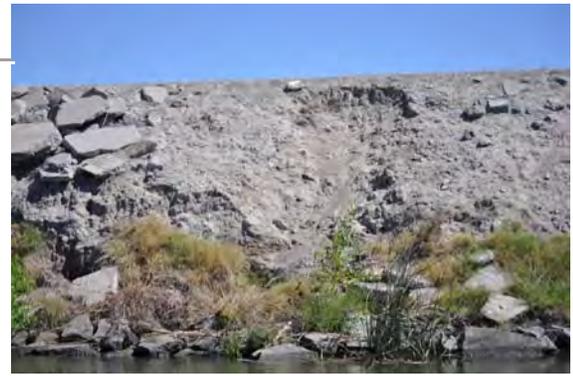
08/07/2012: The site was first discovered by levee inspector in the spring inspection. Levee slope was protected with broken concrete blocks, but those blocks have been washed away during high flows.

Front view of the erosion. Note the slumping erosion at upper slope.

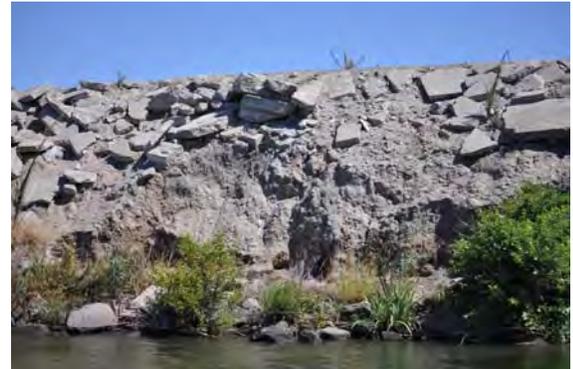
Front view of erosion. Note the broken concrete blocks at the slope.

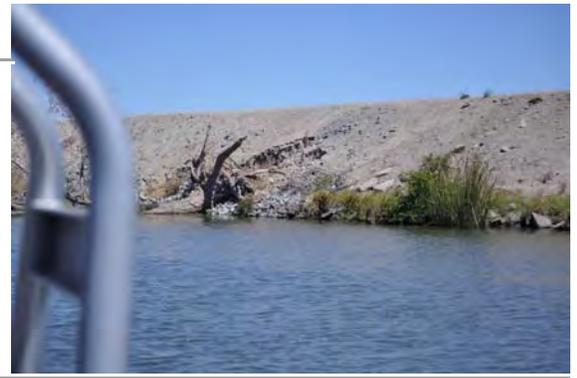
08/07/2012: The rootball of a fallen tree removed material from the levee. Immediately action needed to remove the fallen tree trunk and repair the damage.

Upstream view of the site

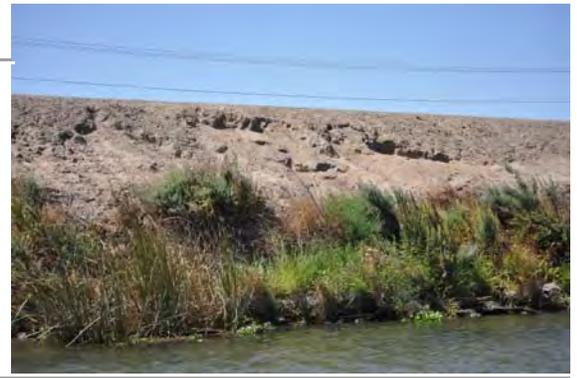
8/7/2012: Erosion is at the upper levee slope, and likely caused by slope slip. The lower levee slope is covered with dense vegetation.

Front view of erosion site. Note the vegetation at the levee toe and lower slope

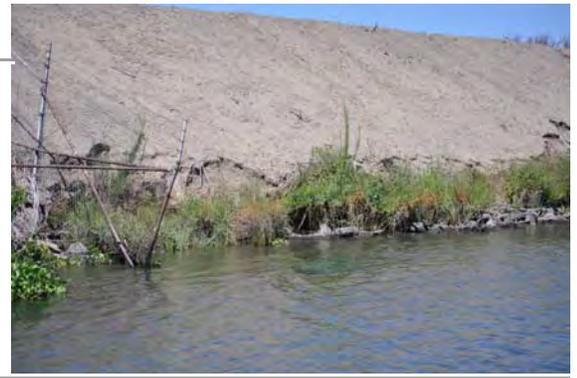
08/07/2012: The site has been visited by boat survey. No significant change observed
 08/23/2011: The site is located immediately upstream of a Railroad bridge. Dense vegetation at the water line interferes the view of erosion.

Upstream view of the erosion site. Note the railroad bridge.

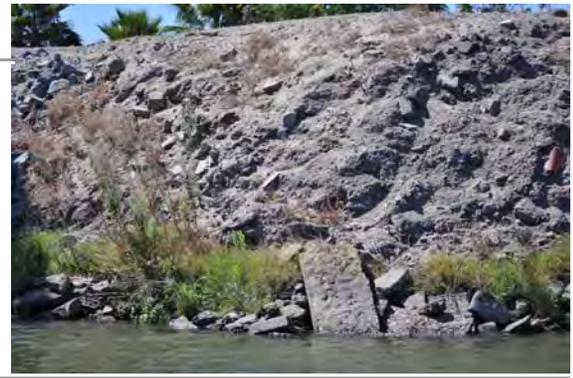
08/07/2012: The site has been visited by boat survey. Site has been repaired, but new erosion occurred at the levee slope and immediately upstream of the repaired site.
 08/23/2011: The site is about 500 ft downstream of bridge. The levee toe seems to be protected, but the protection is being washed away.

Close view of site. New minor erosion developed at the levee slope erosion.

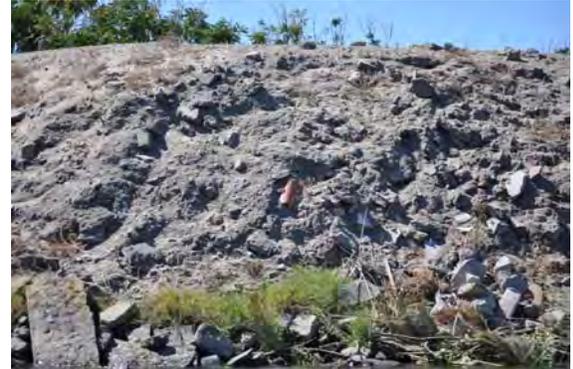
Close view of the erosion. The protection has been loosened and washed away.

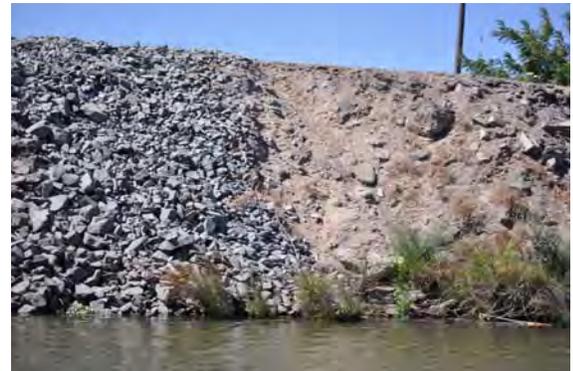
Front view of the erosion. New erosion has developed immediately upstream of the repaired site,

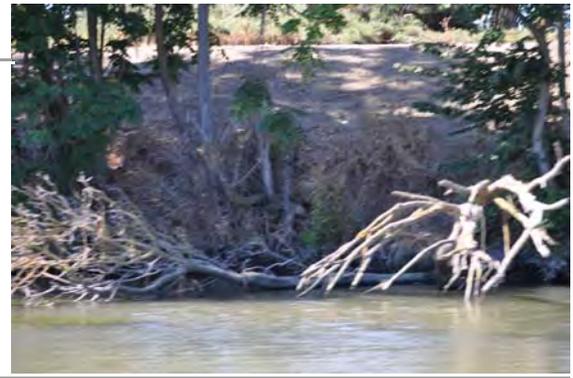
08/07/2012: : The site has been visited by boat survey. No significant change observed
 08/23/2011: No significant changes observed on site. Trees concerned still in place.
 09/07/2010: No significant changes observed on site. The concern here is the undermining of the levee toe where most of trees are. There are erosion pockets lined along the lower slope and at the base of the trees, exposing tree roots. There is minimal slope protection.
 09/29/2009: The lower slope is lined with minor erosion pockets; some tree roots are exposed; there is visible undermining of the levee toe; site is immediately upstream of the Highway 4 Bridge; the bridge is possibly causing a scour to occur, eroding the bank.

Front view of the site where undermining has occurred.

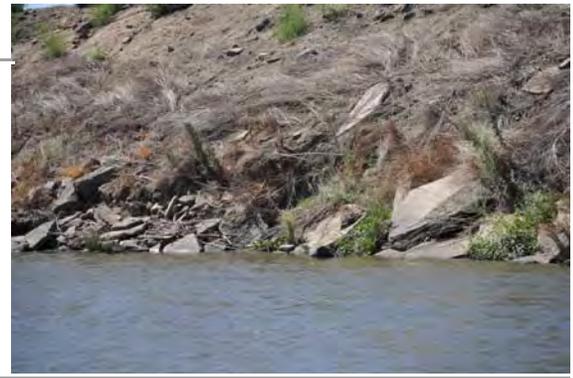
Close view of the pocket erosion

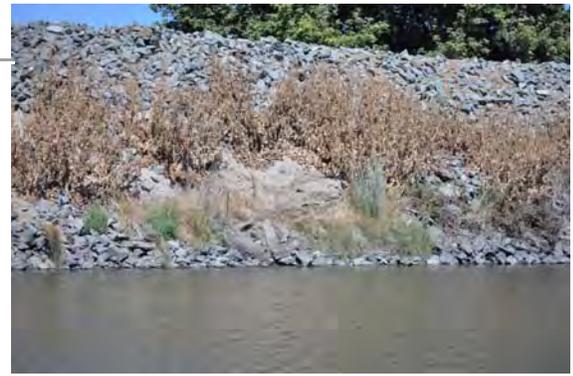
08/07/2012: The site has been repaired. Protecting riprap revetment has been placed at the levee shoulder and slope, but minor erosions are visible at the levee toe.
 08/23/2011: Sloughing rip rap is visible on the site

Direct view of the site.

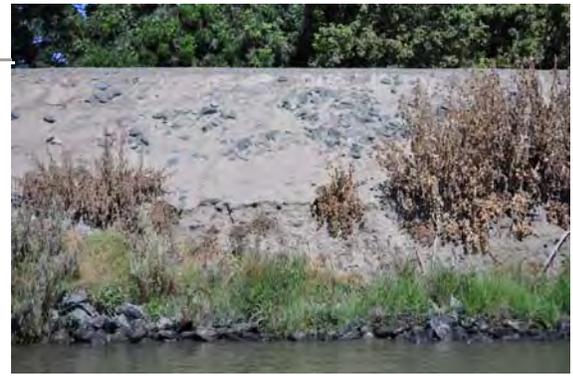
08/07/2012: The levee toe has been cut off along a 150ft long river stretch. The erosion is located just upstream of a river bend.

Front view of erosion

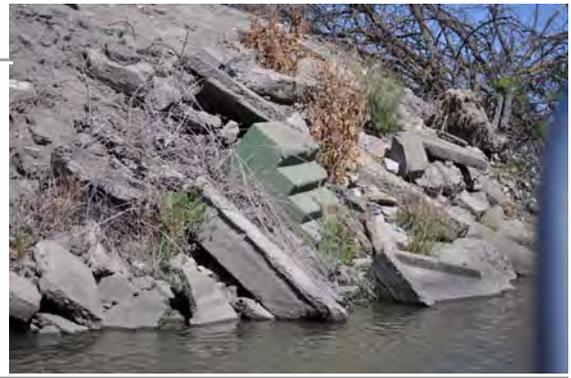
08/07/2012: Erosion is located at the inside of a river bend. Site is covered with broken concrete blocks and other debris.

Front view of the site. Note the loosely placed concrete blocks.

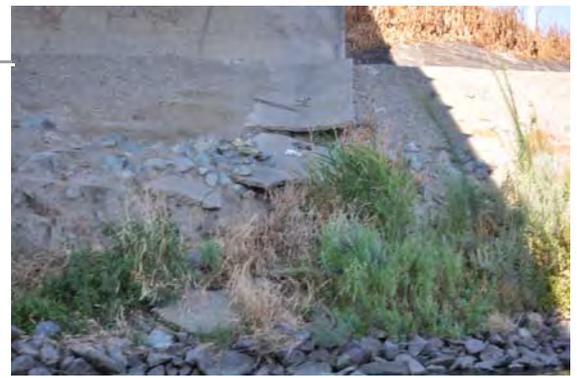
08/07/2012: : The site has been visited by boat survey. No significant change observed
 08/23/2011: No significant changes observed on site.
 09/07/2010: No significant changes observed on site. Erosion site is located beneath Howard Road Bridge. Majority of the existing rip rap has slipped, dragging away levee materials and exposing the underlying soft soil.
 08/06/2010: Recommend for annual assessment and monitoring during flood events, per CLRO.
 09/30/2009: No major changes observed since the last visit; upper portion of existing revetment has slipped, exposing the degrading bank; note that site # is the same as RM46.30, LM5.69 found in the CLRO CES Evaluation 2008 Report; site was previously rated "M".
 11/04/2008: Previously repaired using rock revetment; upper portion of th revetment is sliding, causing deformation on the levee slope; site is upstream of Howards Road Bridge.

Sloughing rip rap just below the Howard Bridge abutment.

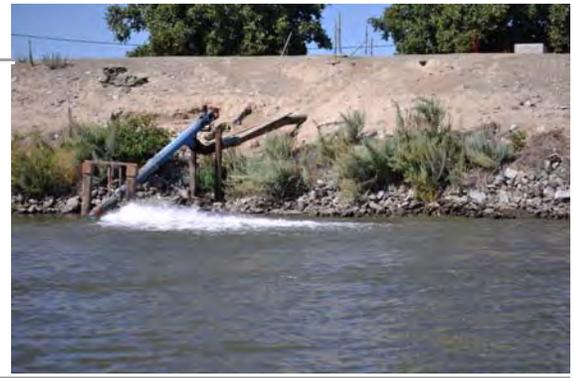
08/07/2012: The erosion is near a water-intake structure. Pipe leakage likely caused the erosion.

Front view of the site

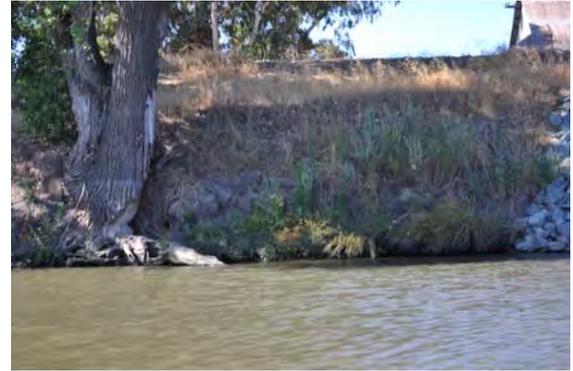
08/07/2012: :The site has been visited by boat survey. The site has been repaired with riprap protection. Rotten tree roots and minor erosion visible immediately upstream of the site
 08/23/2011: No significant changes observed on site.
 09/07/2010: No significant changes observed on site. There are minor pockets of erosion lining the lower slope and undermining of the toe. There are annual grasses and emergent vegetation at the lower slope. Burrow holes were observed along the slope and persist throughout the 200-foot long site.
 08/05/2010: Recommended for annual assessment and monitoring during flood events, per CLRO.
 09/30/2009: No major change observed since last visit; despite dense vegetation, the bank continues to erode and slough; the levee toe is being undermined; note the tree on site; the site was previously rated "U".
 10/21/2008: Undermining of the levee toe; rodent holes in several location; trees with roots partially exposed; sloughing on slope.

Front view of the site. Rotten tree roots and minor erosion visible immediately upstream of the site

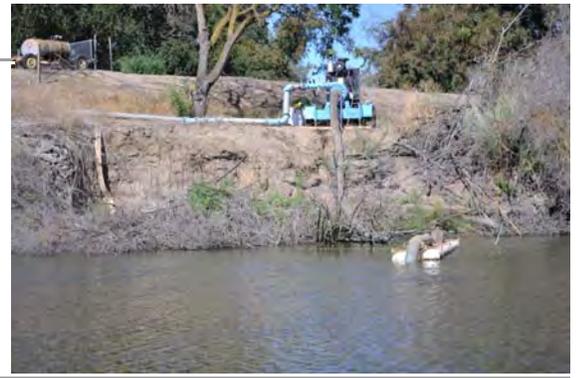
08/07/2012: Erosion is immediately upstream of a river bend. Dense vegetaion is visible at the erosion site.

Front view of the erosion. The pumping machine unlikely the cause of the erosion.

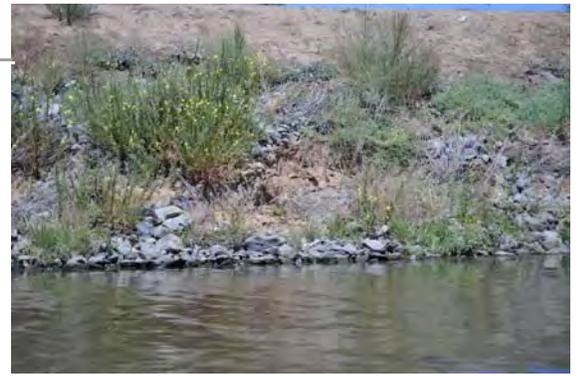
Comments:
 08/07/2012: Series of pocket erosion were discovered at the levee toe during the boat survey. The area is covered with vegetation and riprap rocks, but the rocks have been washed away.

Front view of pocket erosion. Note the vegetation and riprap rocks at the site

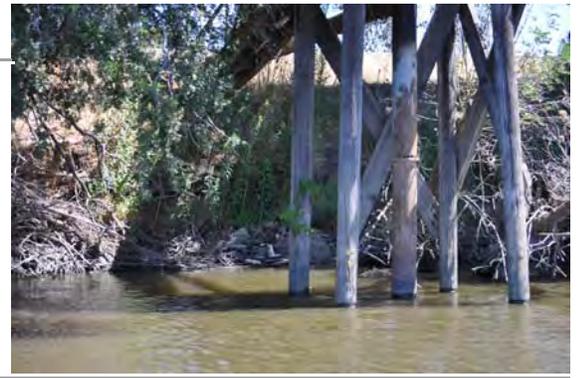
08/07/2012: The site was first reported in 2012 spring levee inspection report. The data were estimated as the site is underneath a irrigation pump station and inaccessible by boat or land survey. It's possible the pump station played a role in the erosion.

Front view of the erosion site. View is partially blocked by the pump structure and vegetation

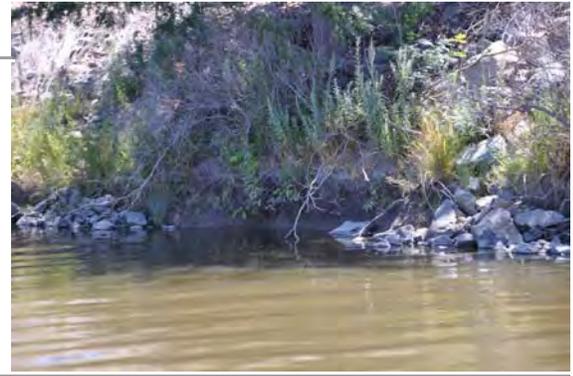
Direct view of the site. The erosion is vertical

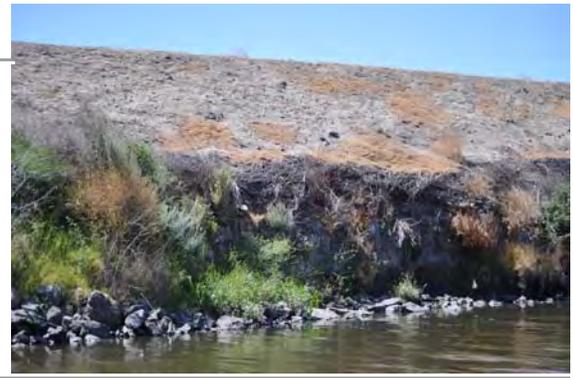
Front view of the 5-ft vertical scarp .

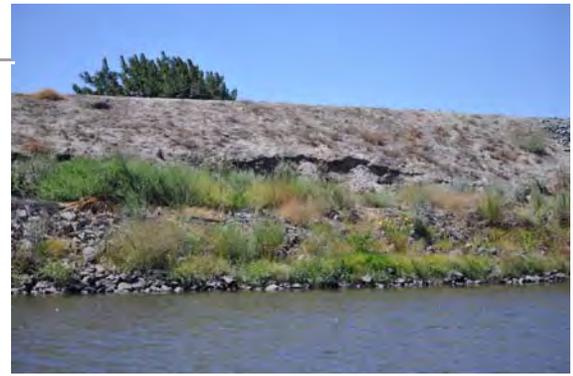
Front view of the site. Existing scalloped erosion is immediately downstream of rip rap section.

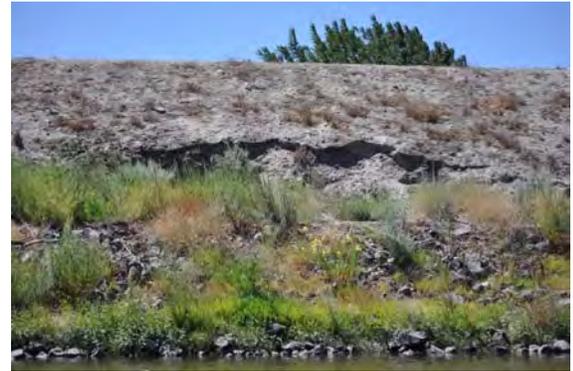
Front view of the site. Note the lateral crack along the middle slope

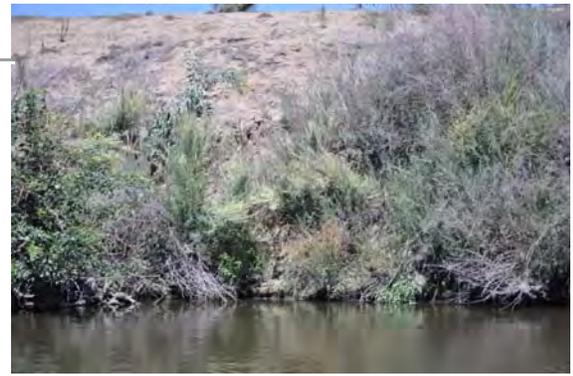
Front view of the site. The scarp is visible on the slope.
