**Flood Control Project Maintenance
Levee Inspections**

Fall 2013 Levee Maintenance Deficiency Summary Report

Levee District No. 0001 (Glenn County)

Waterway		Bank	Unit Miles
Unit No. 01 Sacramento River		Right	12.45
	Spring (March - May)	Summer (June - August)	(September - November) Fall Winter (December - February)
Unit Maintenance Rating (Fall Only)			A
Date of Inspection	03/06/2013 - 03/06/2013		10/02/2013 - 10/02/2013
DWR Inspector	Bob Duffey		Bob Duffey
Accompanied By	Bill Carriere		Bill Carriere

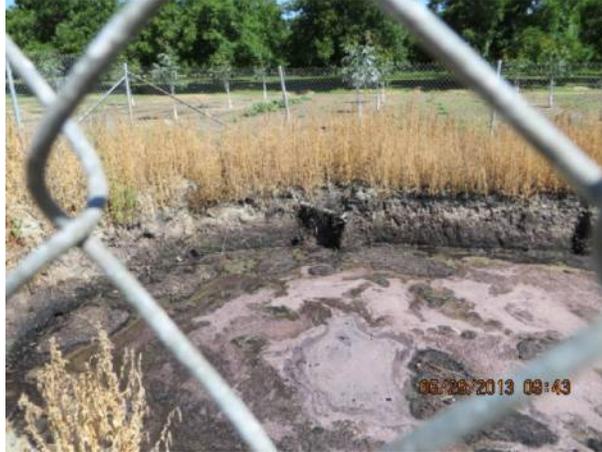
Levee Mile Report Line	4
Start Levee Mile	0.79
End Levee Mile	0.79
Location	Water Side
Category	Supplemental
Item	DWR UCIP Field Study
3-inch pipe at cesspool off WS toe.	
UCIP_7615.jpg

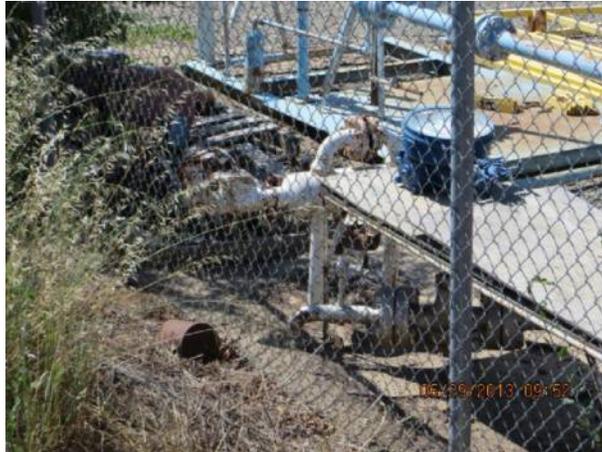
Levee Mile Report Line	5
Start Levee Mile	0.83
End Levee Mile	0.83
Location	Water Side
Category	Supplemental
Item	DWR UCIP Field Study
Possible pipe at crossing, LS toe.	
UCIP_7618.jpg

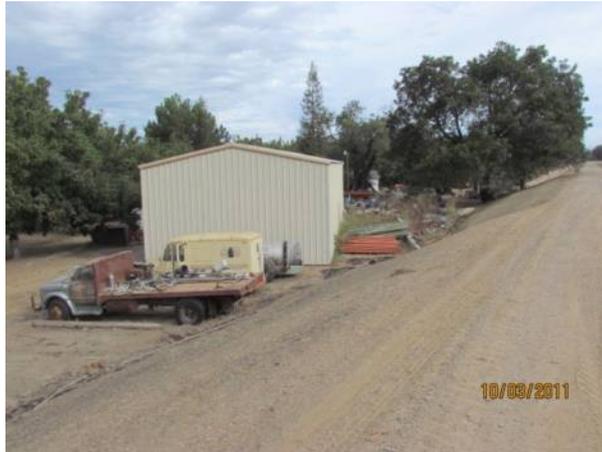
Levee Mile Report Line	6
Start Levee Mile	1.10
End Levee Mile	1.33
Location	Land Side
Category	Earthen Levee
Item	Encroachments
View of vehicles & equipment along the L/S toe.	
rduffey_f_20130919_684.jpg

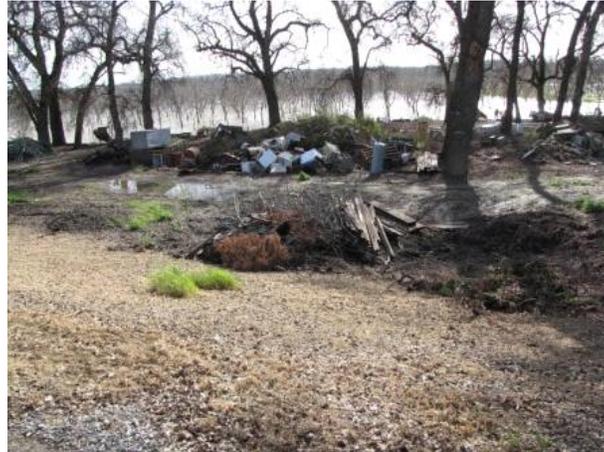
rduffey_f_20130919_683.jpg

View of the debris & garbage along the W/S toe.

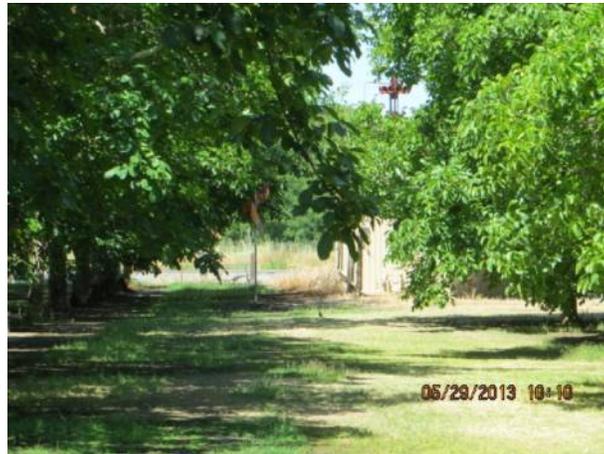
Levee Mile Report Line	9
Start Levee Mile	1.28
End Levee Mile	1.28
Location	Water Side
Category	Supplemental
Item	DWR UCIP Field Study

Gasline markers near where removed pumping plant was located.

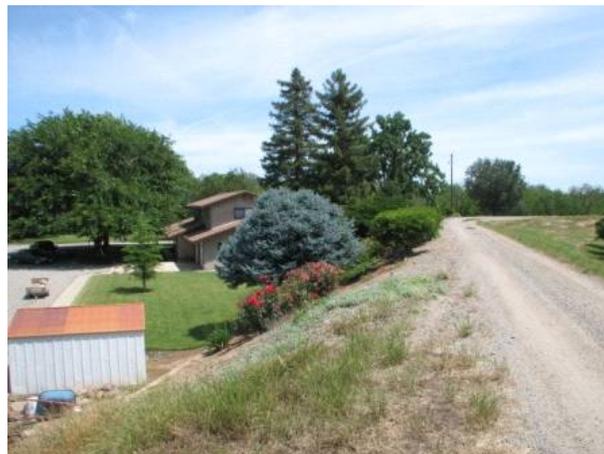
Levee Mile Report Line	10
Start Levee Mile	1.35
End Levee Mile	1.39
Location	Land Side
Category	Earthen Levee
Item	Vegetation

View of the permitted landscape on the landside slope of the levee.

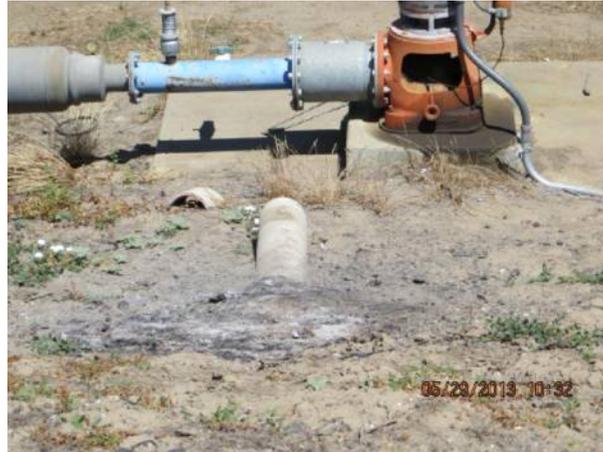
Levee Mile Report Line	14
Start Levee Mile	2.26
End Levee Mile	2.26
Location	Land Side
Category	Supplemental
Item	DWR UCIP Field Study
Pipe next to pump at LS toe.	
UCIP_7622.jpg

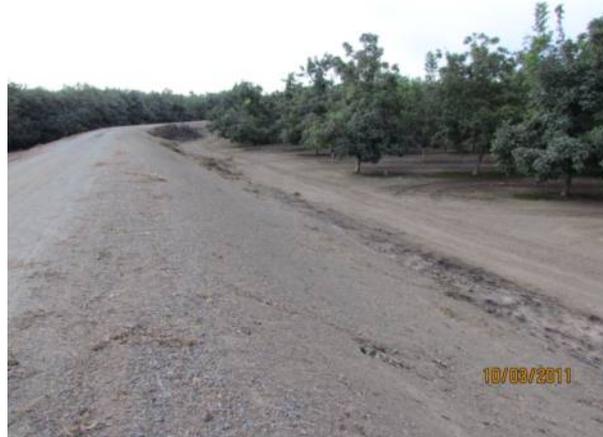
Levee Mile Report Line	15
Start Levee Mile	3.13
End Levee Mile	3.13
Location	Water Side
Category	Earthen Levee
Item	Animal Control
View of repaired rodent holes along the W/S slope.	
rduffey_f_20130919_693.jpg

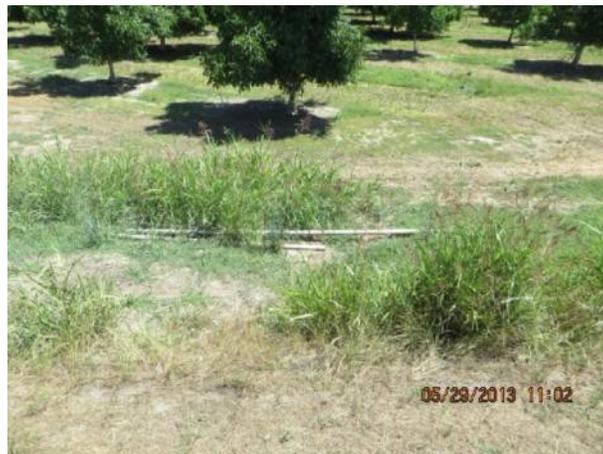
Levee Mile Report Line	17
Start Levee Mile	3.18
End Levee Mile	3.18
Location	Water Side
Category	Supplemental
Item	DWR UCIP Field Study
Flap gate visible at WS toe.	
UCIP_9008.jpg

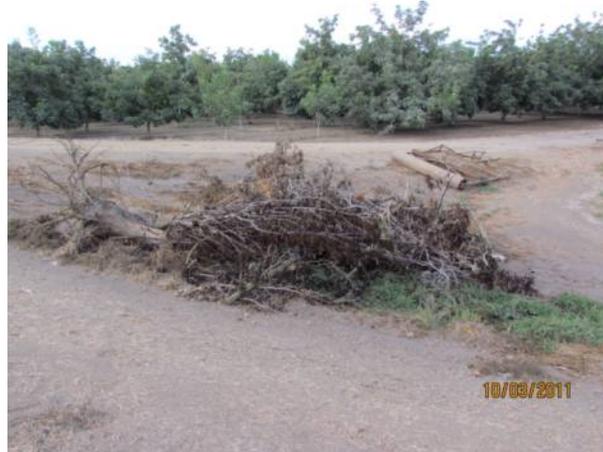
Levee Mile Report Line	18
Start Levee Mile	3.22
End Levee Mile	3.22
Location	Land Side
Category	Earthen Levee
Item	Encroachments
View of the prunings pile along the L/S toe.	
rduffey_f_20130919_691.jpg

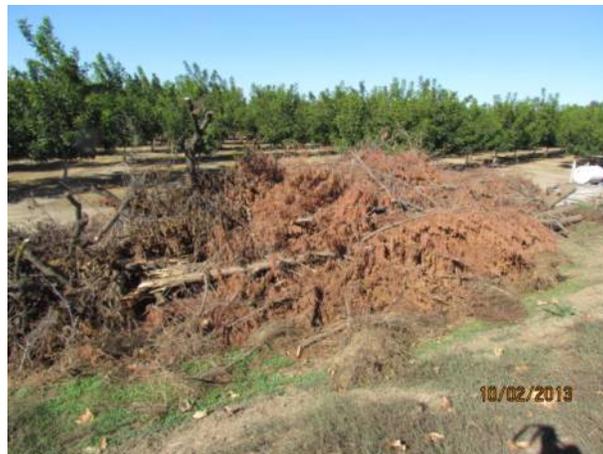
Levee Mile Report Line	19
Start Levee Mile	3.69
End Levee Mile	3.69
Location	Land Side
Category	Earthen Levee
Item	Encroachments
View of the pruning & limb along the slope of the levee.	
rduffey_f_20131021_101.JPG

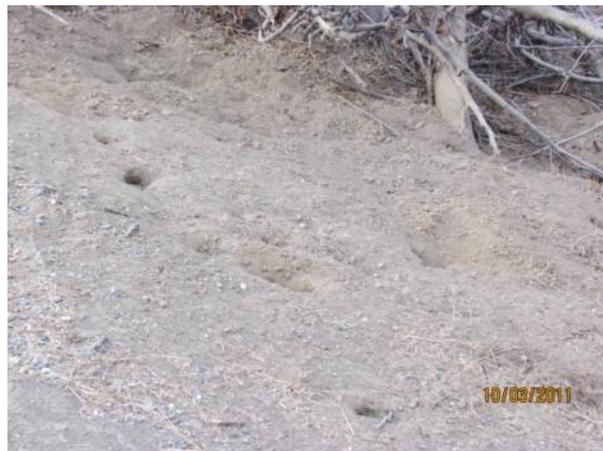
Levee Mile Report Line	21
Start Levee Mile	3.94
End Levee Mile	3.94
Location	Land Side
Category	Earthen Levee
Item	Animal Control
View of the rodent holes along the L/S toe.	
rduffey_f_20130919_695.jpg

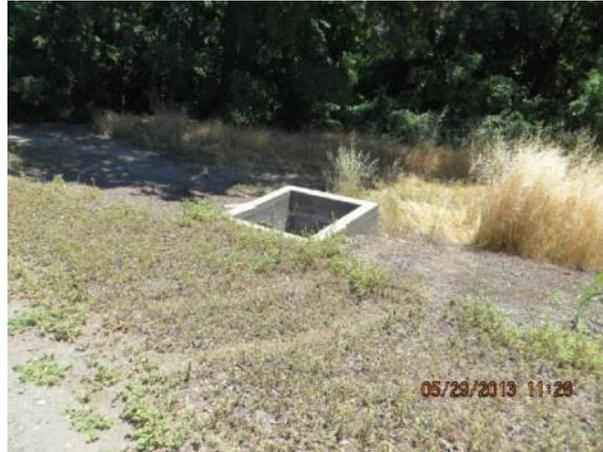
Levee Mile Report Line	23
Start Levee Mile	4.05
End Levee Mile	4.05
Location	Land Side
Category	Supplemental
Item	DWR UCIP Field Study
Distribution box on WS toe.	
UCIP_9018.jpg

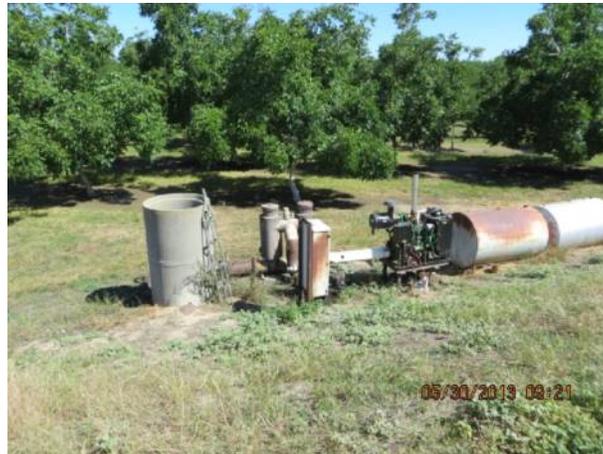
Levee Mile Report Line	26
Start Levee Mile	4.32
End Levee Mile	4.32
Location	Land Side
Category	Supplemental
Item	DWR UCIP Field Study
PUmp, standpipe, and gate valve on LS toe.	
UCIP_7631.jpg

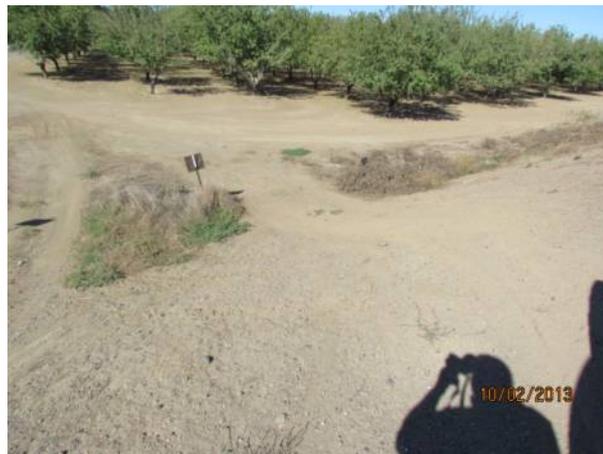
Levee Mile Report Line	27
Start Levee Mile	5.14
End Levee Mile	5.14
Location	Land Side
Category	Earthen Levee
Item	Slope Stability
View of the vehicle erosion along the slope of the levee.	
rduffey_f_20131021_102.JPG

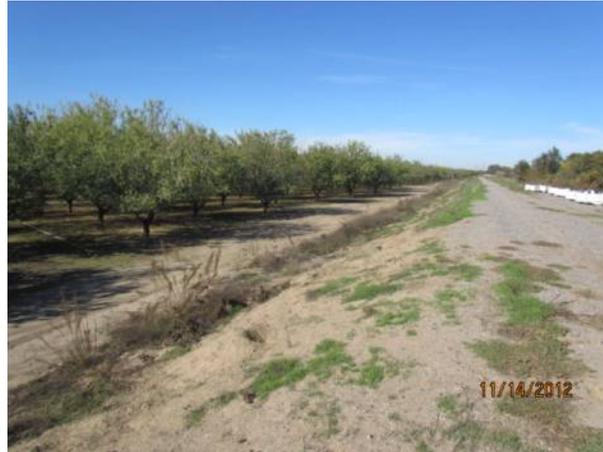
rduffey_f_20130919_686.JPG

View of the rodent hole along the levee slope.

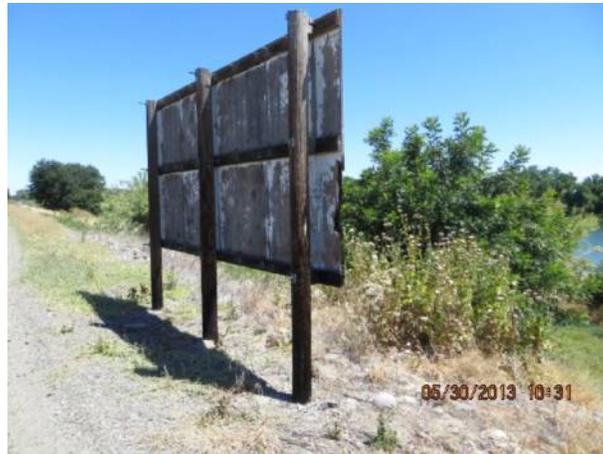
Levee Mile Report Line	31
Start Levee Mile	6.27
End Levee Mile	6.27
Location	Land Side
Category	Supplemental
Item	DWR UCIP Field Study

Gasline sign on WS shoulder.

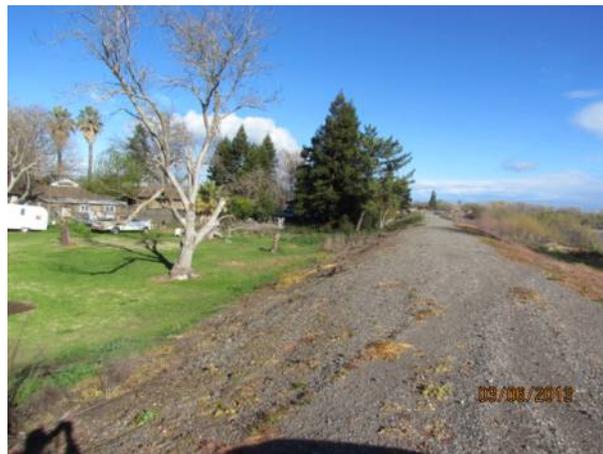
Levee Mile Report Line	34
Start Levee Mile	6.36
End Levee Mile	6.37
Location	Land Side
Category	Earthen Levee
Item	Encroachments

View of the removed prunings from the landside toe.

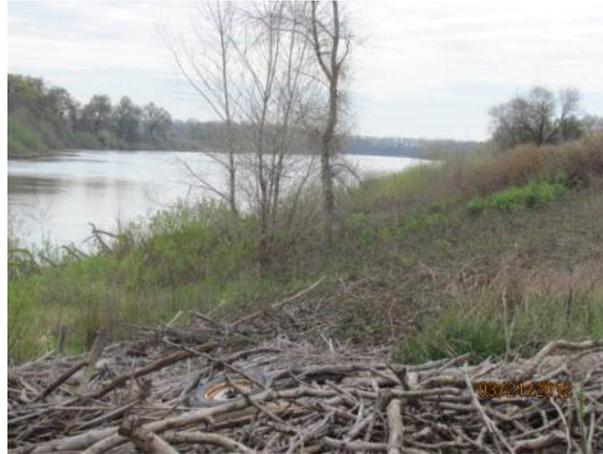
Levee Mile Report Line	35
Start Levee Mile	6.50
End Levee Mile	6.70
Location	Water Side
Category	Earthen Levee
Item	Vegetation
View of the Army Corps of Engineers mitigation site.	
rduffey_f_20130919_688.jpg

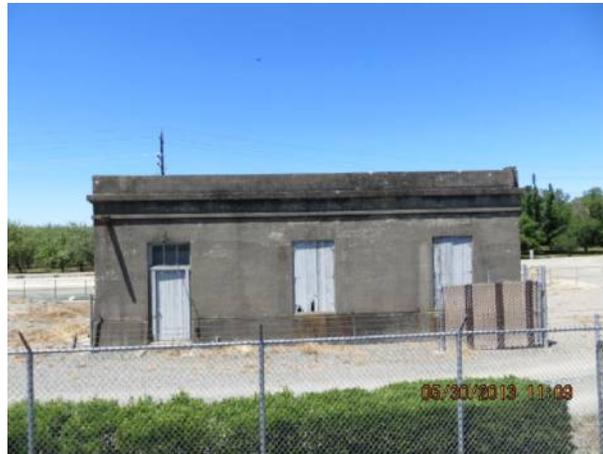
Levee Mile Report Line	36
Start Levee Mile	6.55
End Levee Mile	6.55
Location	Water Side
Category	Supplemental
Item	DWR UCIP Field Study
Pumping plant building on LS shoulder.	
UCIP_7639.jpg

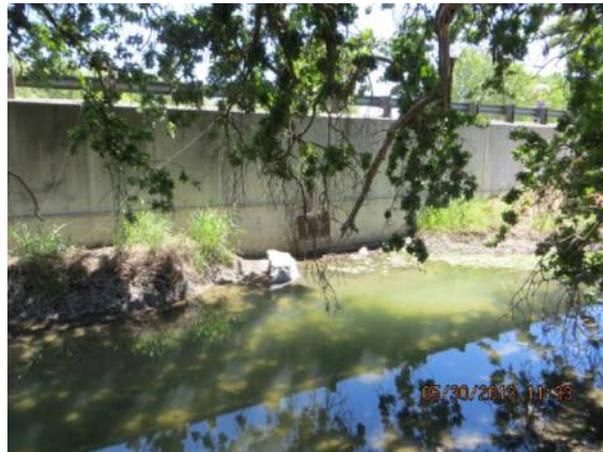
Levee Mile Report Line	40
Start Levee Mile	6.83
End Levee Mile	6.83
Location	Water Side
Category	Supplemental
Item	DWR UCIP Field Study
Pipe with steel plate welded over end on LS of levee crown.	
UCIP_7641.jpg

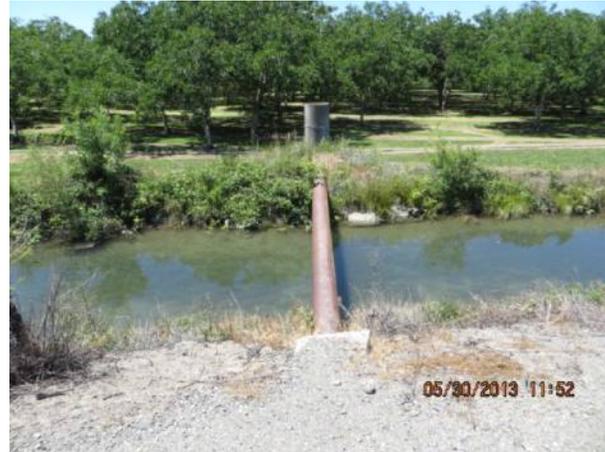
Levee Mile Report Line	41
Start Levee Mile	7.01
End Levee Mile	7.01
Location	Water Side
Category	Supplemental
Item	DWR UCIP Field Study
Pipe on LS toe with concrete standpipe visible.	
UCIP_7644.jpg

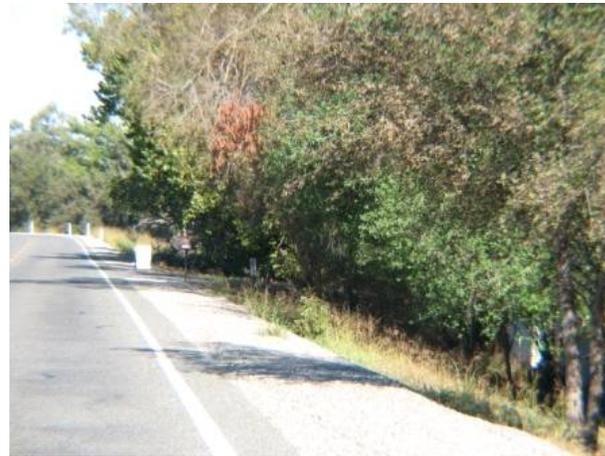
Levee Mile Report Line	42
Start Levee Mile	8.17
End Levee Mile	8.28
Location	Water Side
Category	Earthen Levee
Item	Trim / Thin Trees
View of the trees and vegetation along the waterside slope of the levee.	
rduffey_f_20130919_692.jpg

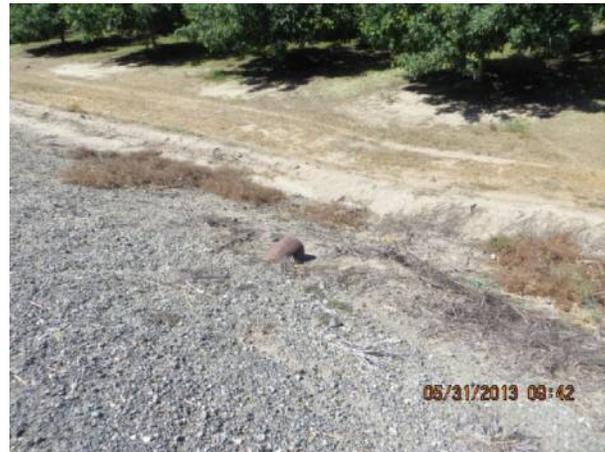
43	8.59	8.59	Supplemental	DWR UCIP Field Study	WS	M En	Inspector Comments: FS_ID:14385 EP_NO: 9563 Repair Type: Non-Urgent Crossing Status: Found UCIP Comments: Pipe open on both ends and damaged on WS slope. Pipe should be abandoned properly if appropriate. FIELD_STRUCT_DESC: *Abandoned* 12-inch pipe through levee 5.0 feet below crown. Pipe open on both ends. One corrugated metal cutoff wall (ABO No. 9563, 1974). Originally included in the 1960 O&M manual. FS Date: 5/31/2013	39.582275 ° -122.007449 °	39.582275 ° -122.007449 °	47 Y
DWR ID: DWR_LD0001G_01_f_2013_47										
44	8.96	8.96	Supplemental	DWR UCIP Field Study	WS	M En	Inspector Comments: FS_ID:16204 EP_NO: N/A Repair Type: Non-Urgent Crossing Status: Found UCIP Comments: Need to determine if this passes completely through levee and what Permit No. was issued for it. FIELD_STRUCT_DESC: 1.5-inch galvanized iron pipe through the levee 6-feet below the crown. 1-inch PVC irrigation line sleeved through this conduit. FS Date: 5/31/2013	39.587028 ° -122.005609 °	39.587028 ° -122.005609 °	48 Y

Levee Mile Report Line	43
Start Levee Mile	8.59
End Levee Mile	8.59
Location	Water Side
Category	Supplemental
Item	DWR UCIP Field Study
Pipe on LS slope.	
UCIP_7648.jpg

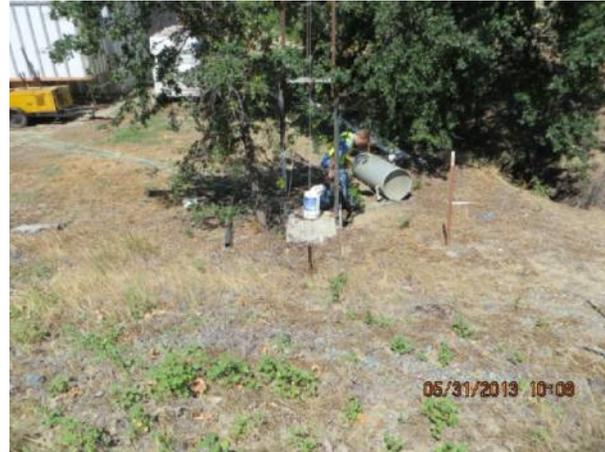
Levee Mile Report Line	44
Start Levee Mile	8.96
End Levee Mile	8.96
Location	Land Side
Category	Supplemental
Item	DWR UCIP Field Study
Pipe visible next to well with bucket over standpipe.	
UCIP_9001.jpg

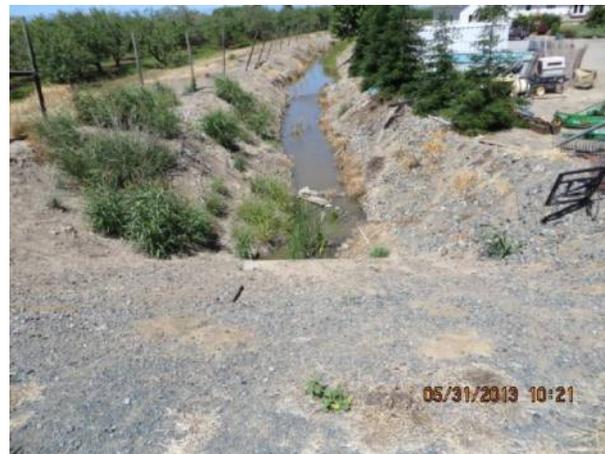
Levee Mile Report Line	45
Start Levee Mile	9.63
End Levee Mile	9.63
Location	Land Side
Category	Supplemental
Item	DWR UCIP Field Study
Pipe and headwall at LS toe.	
UCIP_7652.jpg

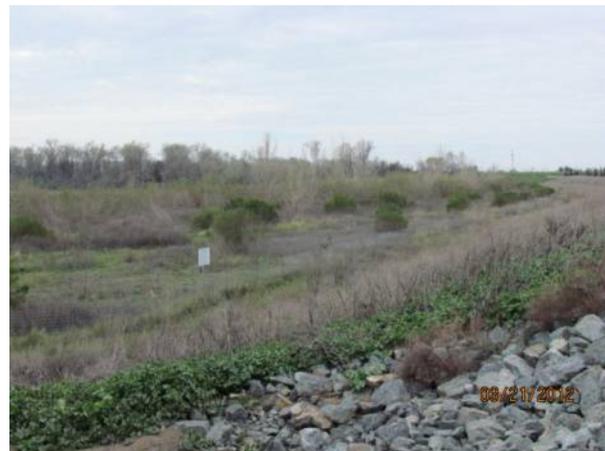
Levee Mile Report Line	46
Start Levee Mile	9.69
End Levee Mile	10.53
Location	Water Side
Category	Earthen Levee
Item	Vegetation
View of the Army Corps of Engineers mitigation site.	
rduffey_f_20130919_687.jpg

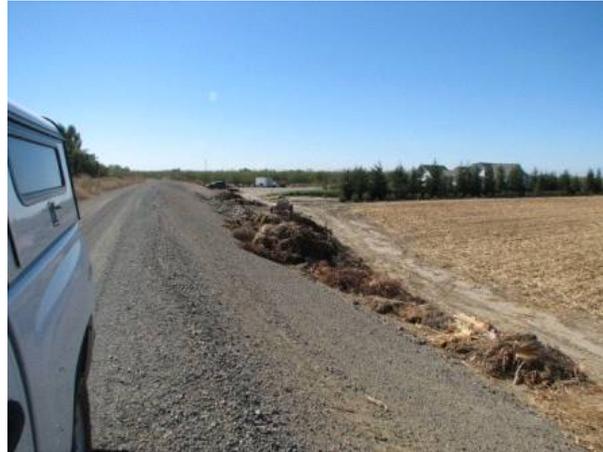
Levee Mile Report Line	47
Start Levee Mile	9.70
End Levee Mile	9.70
Location	Land Side
Category	Earthen Levee
Item	Encroachments
View of debris along the toe of the levee.	
rduffey_f_20130919_689.jpg

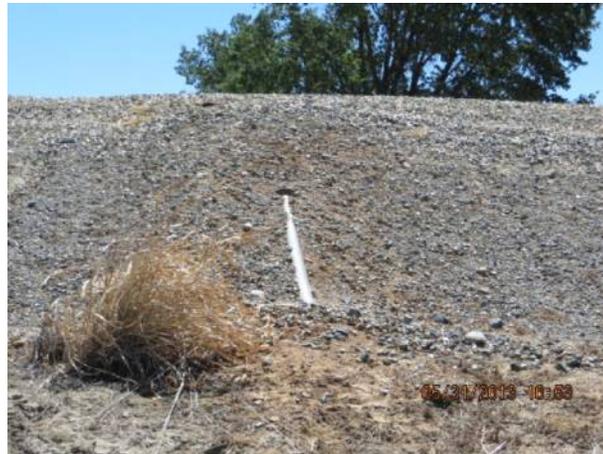
Levee Mile Report Line	49
Start Levee Mile	10.33
End Levee Mile	10.33
Location	Land Side
Category	Supplemental
Item	DWR UCIP Field Study
Pipe on LS slope.	
UCIP_9003.jpg

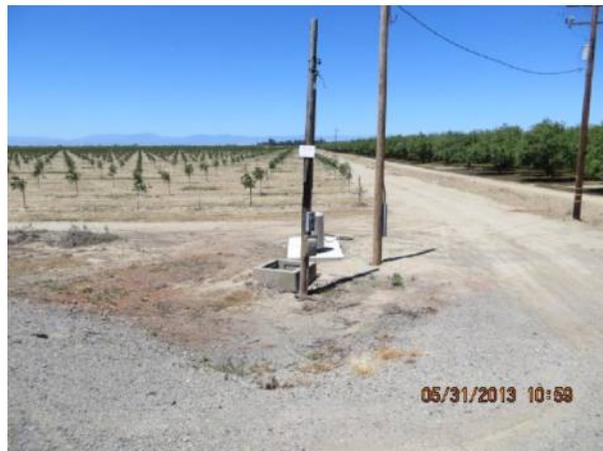
Levee Mile Report Line	50
Start Levee Mile	10.55
End Levee Mile	10.55
Location	Land Side
Category	Supplemental
Item	DWR UCIP Field Study
Concrete distribution box at LS toe.	
UCIP_7734.jpg

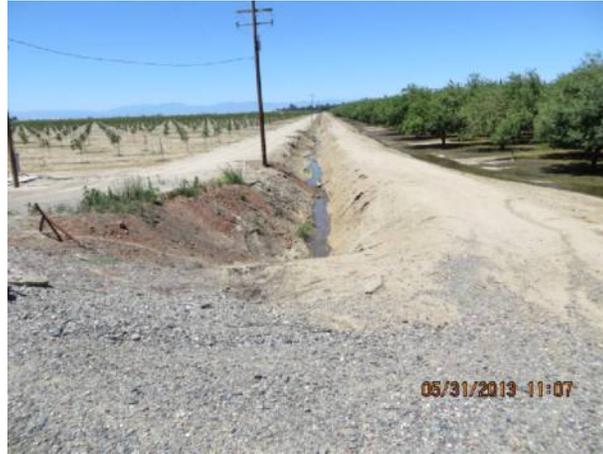
Levee Mile Report Line	52
Start Levee Mile	10.57
End Levee Mile	10.57
Location	Land Side
Category	Supplemental
Item	DWR UCIP Field Study
Drainage channel on LS toe.	
UCIP_7743.jpg

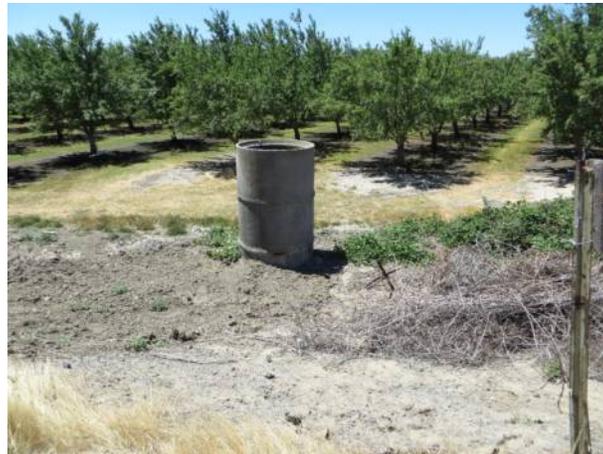
Levee Mile Report Line	54
Start Levee Mile	11.91
End Levee Mile	11.91
Location	Land Side
Category	Supplemental
Item	DWR UCIP Field Study
Concrete standpipe on LS toe.	
UCIP_7746.jpg

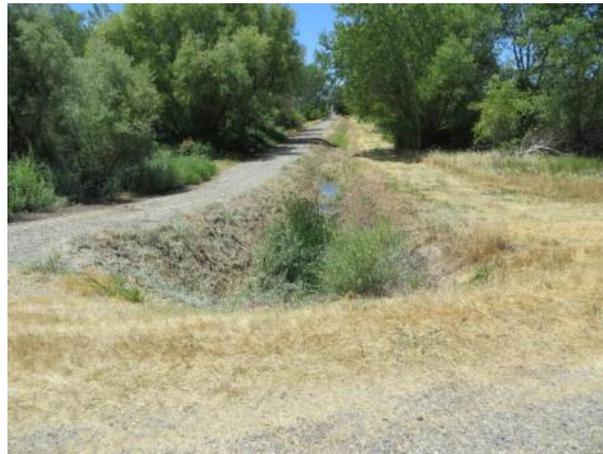
Levee Mile Report Line	55
Start Levee Mile	12.02
End Levee Mile	12.02
Location	Land Side
Category	Supplemental
Item	DWR UCIP Field Study
Drainage channel on LS toe.	
UCIP_7748.jpg
