**Flood Control Project Maintenance
Levee Inspections**

Fall 2010 Levee Maintenance Deficiency Summary Report

Levee District No. 0001 (Glenn County)

Waterway	Bank	Unit Miles
Unit No. 01 Sacramento River	Right	12.45

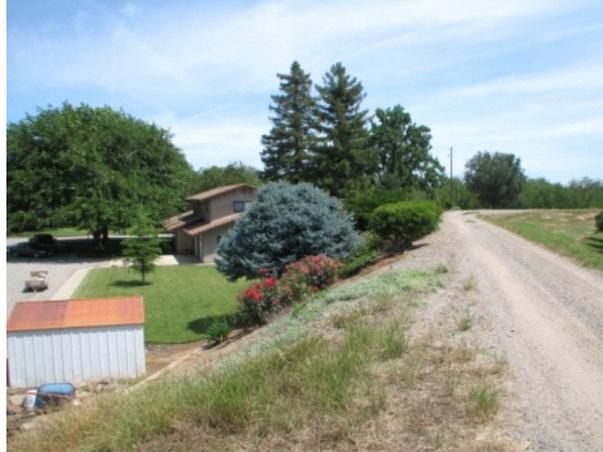
Levee Mile Report Line	6
Start Levee Mile	1.35
End Levee Mile	1.39
Location	Land Side
Category	Earthen Levee
Item	Encroachments
View of the permitted landscape on the landside slope of the levee.	
rduffey_f_20100921_001.jpg

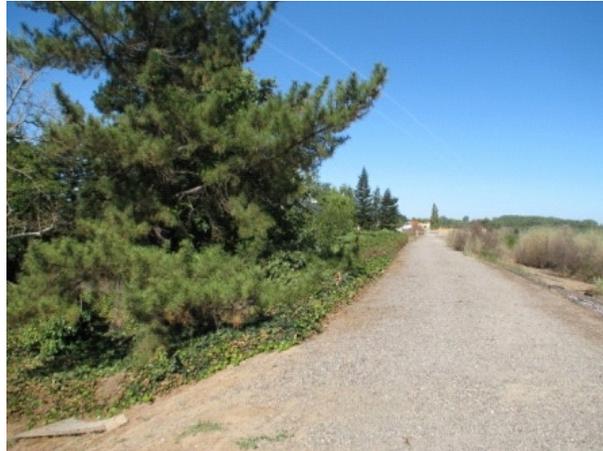
Levee Mile Report Line	25
Start Levee Mile	6.39
End Levee Mile	6.42
Location	Land Side
Category	Earthen Levee
Item	Encroachments
View of the permitted landscape along the landside slope.	
rduffey_f_20101109_244.jpg

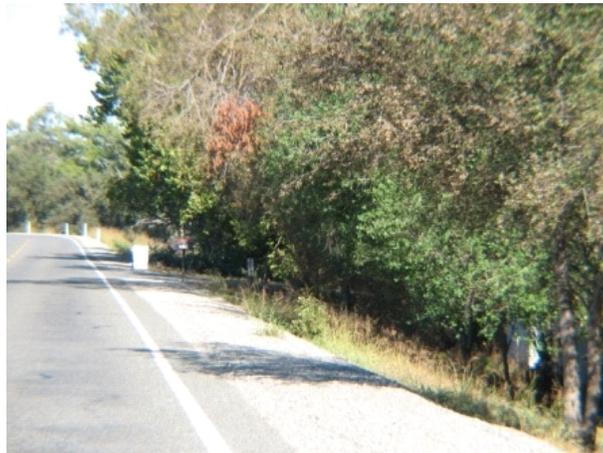
Levee Mile Report Line	28
Start Levee Mile	8.17
End Levee Mile	8.28
Location	Water Side
Category	Earthen Levee
Item	Trim / Thin Trees
View of the trees and vegetation along the waterside slope of the levee.	
rduffey_f_20101109_245.jpg

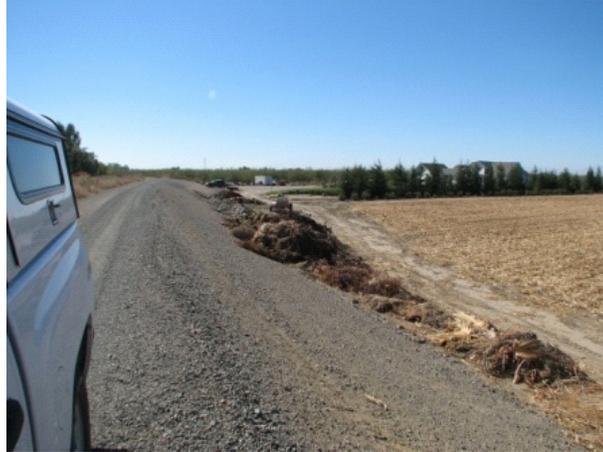
Levee Mile Report Line	34
Start Levee Mile	9.70
End Levee Mile	9.70
Location	Land Side
Category	Earthen Levee
Item	Encroachments
View of debris along the toe of the levee.	
rduffey_f_20101109_246.jpg
