**Flood Control Project Maintenance
Levee Inspections
LMA District Cover Sheet
Spring 2013 Levee Inspection Results**

Levee District No. 0001 (Glenn County)

Spring 2013 Levee Inspection Results

Waterway		Bank	Unit Miles
Unit No. 01 Sacramento River		Right	12.45

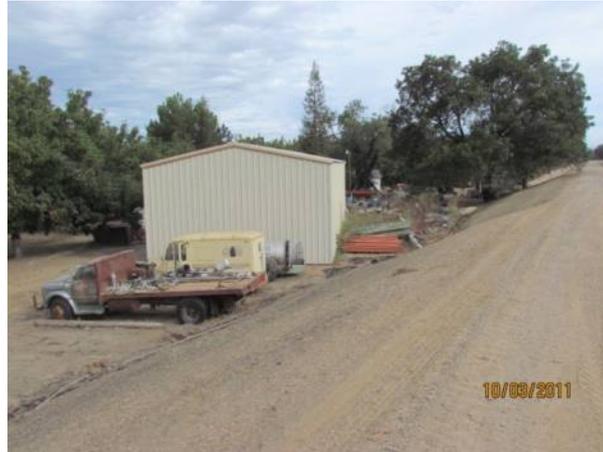
Levee Mile Report Line	4
Start Levee Mile	1.10
End Levee Mile	1.33
Location	Land Side
Category	
Item	Encroachments
View of vehicles & equipment along the L/S toe.	
rduffey_s_20130225_002.jpg

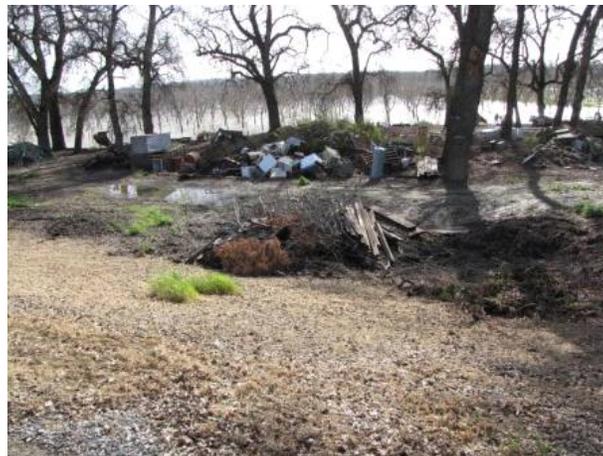
Levee Mile Report Line	5
Start Levee Mile	1.23
End Levee Mile	1.23
Location	Water Side
Category	
Item	Encroachments
View of the debris & garbage along the W/S toe.	
rduffey_s_20130225_001.jpg

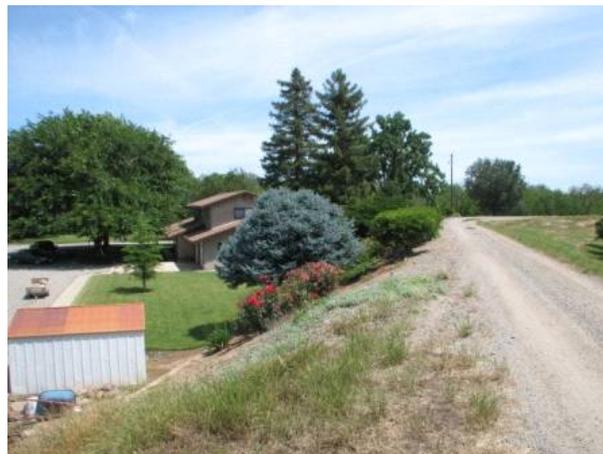
Levee Mile Report Line	6
Start Levee Mile	1.35
End Levee Mile	1.39
Location	Land Side
Category	
Item	Vegetation
View of the permitted landscape on the landside slope of the levee.	
rduffey_s_20130225_003.jpg

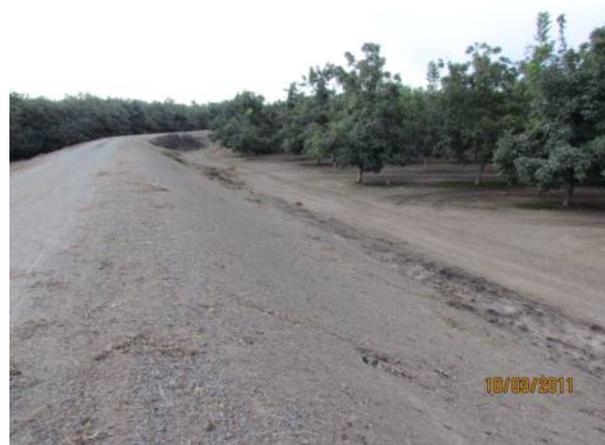
Levee Mile Report Line	7
Start Levee Mile	3.13
End Levee Mile	3.13
Location	Water Side
Category	
Item	Animal Control
View of repaired rodent holes along the W/S slope.	
rduffey_s_20130225_010.jpg

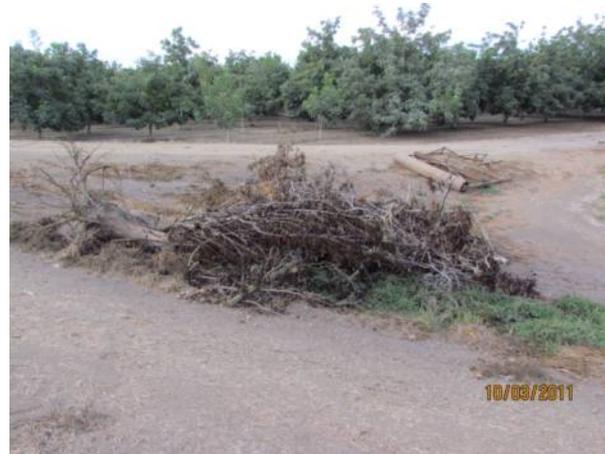
Levee Mile Report Line	8
Start Levee Mile	3.22
End Levee Mile	3.22
Location	Land Side
Category	
Item	Encroachments
View of the prunings pile along the L/S toe.	
rduffey_s_20130225_008.jpg

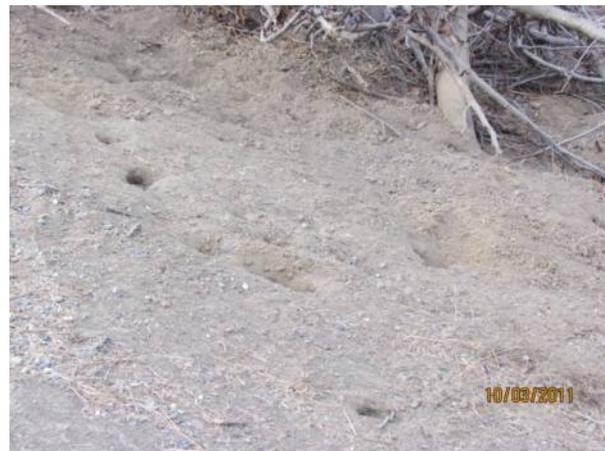
Levee Mile Report Line	10
Start Levee Mile	3.94
End Levee Mile	3.94
Location	Land Side
Category	
Item	Animal Control
View of the rodent holes along the L/S toe.	
rduffey_s_20130225_012.jpg

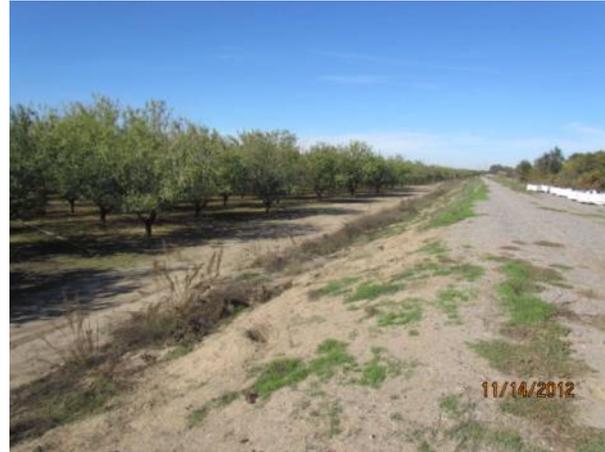
Levee Mile Report Line	11
Start Levee Mile	5.16
End Levee Mile	5.23
Location	Land Side
Category	
Item	Animal Control
View of the rodent hole along the levee slope.	
rduffey_s_20130225_004.JPG

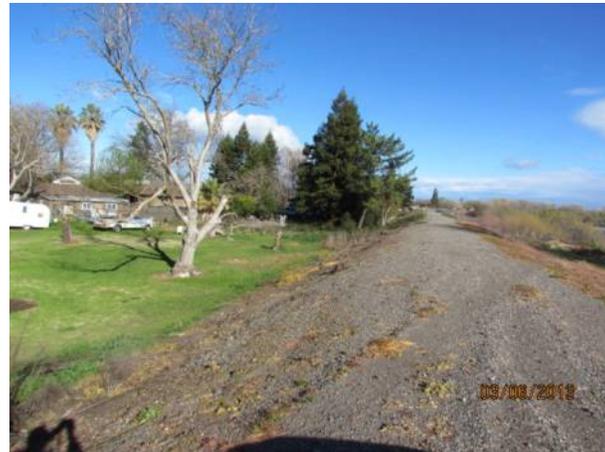
Levee Mile Report Line	14
Start Levee Mile	6.36
End Levee Mile	6.37
Location	Land Side
Category	
Item	Encroachments
View of the removed prunings from the landside toe.	
rduffey_s_20130312_315.JPG

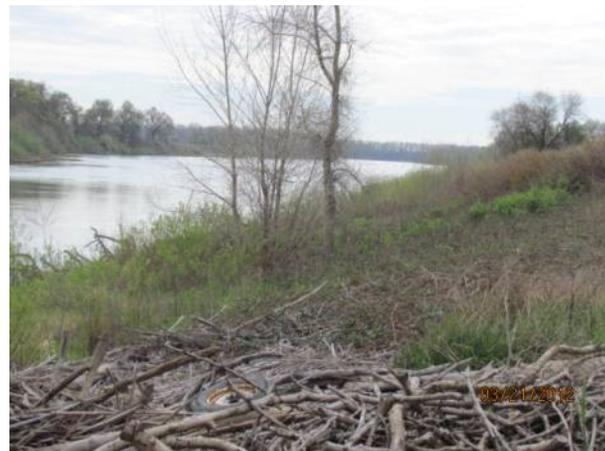
Levee Mile Report Line	15
Start Levee Mile	6.50
End Levee Mile	6.70
Location	Water Side
Category	
Item	Vegetation
View of the Army Corps of Engineers mitigation site.	
rduffey_s_20130225_006.jpg

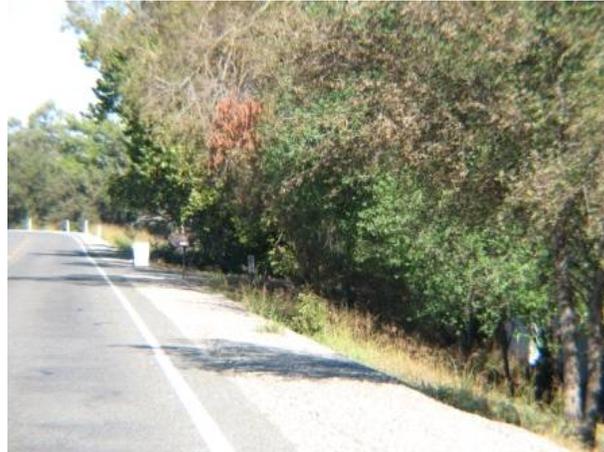
Levee Mile Report Line	16
Start Levee Mile	8.17
End Levee Mile	8.28
Location	Water Side
Category	
Item	Trim / Thin Trees
View of the trees and vegetation along the waterside slope of the levee.	
rduffey_s_20130225_009.jpg

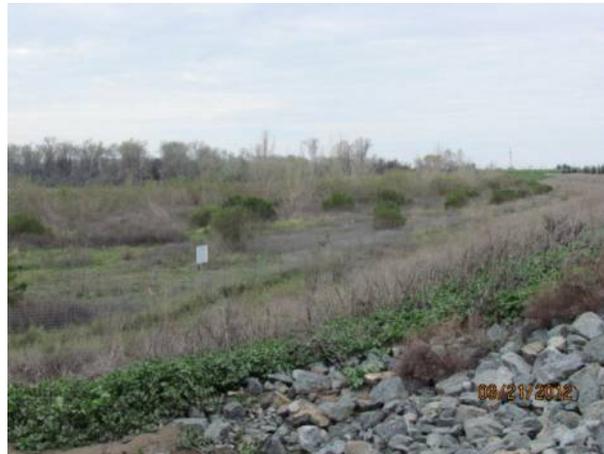
Levee Mile Report Line	17
Start Levee Mile	9.69
End Levee Mile	10.53
Location	Water Side
Category	
Item	Vegetation
View of the Army Corps of Engineers mitigation site.	
rduffey_s_20130225_005.jpg

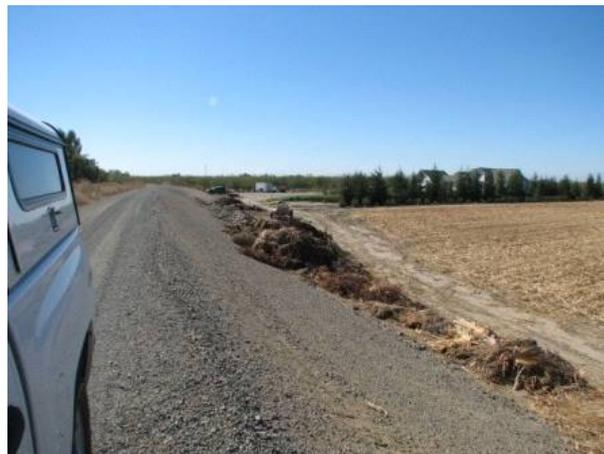
Levee Mile Report Line	18
Start Levee Mile	9.70
End Levee Mile	9.70
Location	Land Side
Category	
Item	Encroachments
View of debris along the toe of the levee.	
rduffey_s_20130225_007.jpg

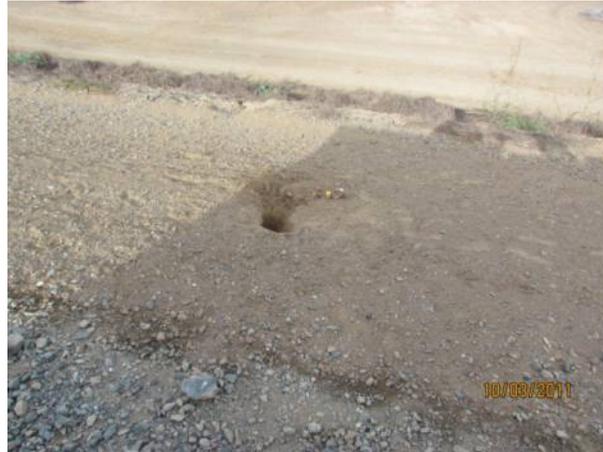
Levee Mile Report Line	19
Start Levee Mile	10.21
End Levee Mile	10.21
Location	Land Side
Category	
Item	Animal Control

View of the rodent holes along the L/S slope.
