**Flood Control Project Maintenance  
Levee Inspections**  
**LMA District Cover Sheet**  
**Spring 2016 Levee Inspection Results**

**Levee District No. 0001 (Glenn County)**

**Spring 2016 Levee Inspection Results**

**Levee Inspection Report By Mile - Spring 2016**

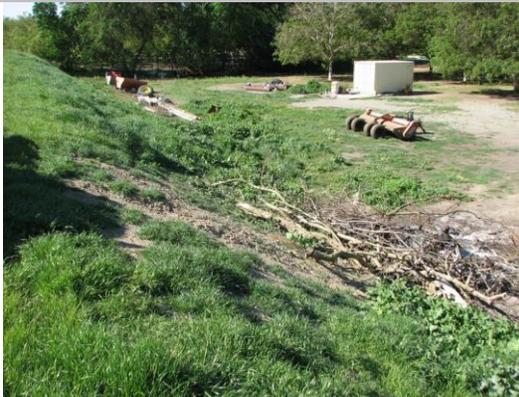
Photo 1 of 1 : SP\_2016\_LD0001G\_432\_40\_20160418\_00089.jpg

Remove prunings from L/S toe.

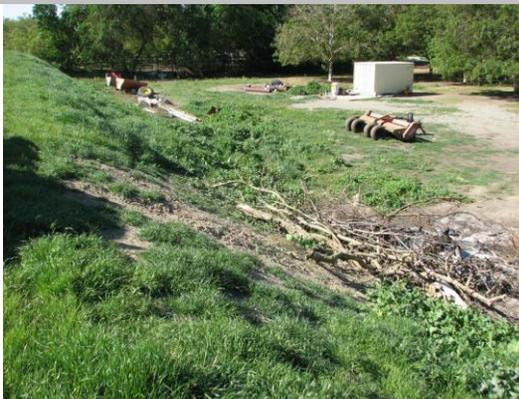
Photo 1 of 1 : SP\_2016\_LD0001G\_432\_73\_20160510\_00092.jpg

LM Start	<b>0.02</b>	Rating **	M	Issue No.	<b>73</b>
LM End	<b>0.05</b>	Issue Type +	En	Location *	LS
Category	Earthen Levee		GPS Latitude/Longitude		
			Start	End	
Item	Encroachments		39.477372 °	39.477833 °	
			-122.017602 °	-122.017484 °	
DWR ID	DWR_LD0001G_01_s_2016_73				
Comment Code					
EQ : Equipment					
Inspector Comment					
Remove ag equipment at toe LS toe

Remove equipment from L/S toe.

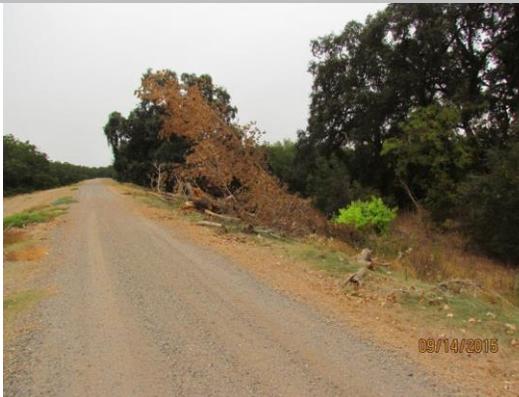
Photo 1 of 1 : SP\_2016\_LD0001G\_432\_41\_20160316\_00011.jpg

LM Start	<b>0.25</b>	Rating **	M	Issue No.	<b>41</b>
LM End	<b>0.25</b>	Issue Type +	Ma	Location *	WS
Category	Earthen Levee		GPS Latitude/Longitude		
			Start	End	
Item	Encroachments		39.480769 °	39.480769 °	
			-122.017301 °	-122.017301 °	
DWR ID	DWR_LD0001G_01_f_2015_41				
Comment Code					
TR : Tree or limb					
Inspector Comment					
Remove the tree from the waterside slope.

View of the tree on the waterside slope.

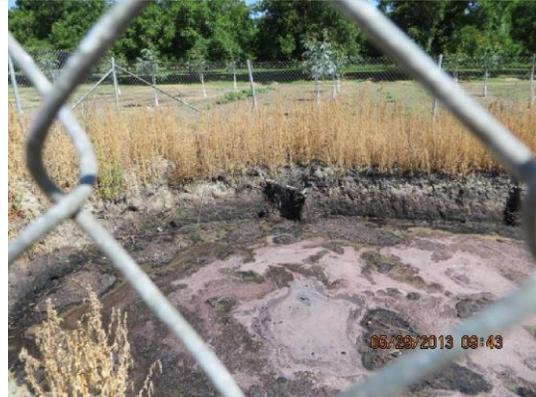
Photo 1 of 2 : UCIP\_SP\_2016\_14324\_23564.jpg

LM Start	<b>0.77</b>	Rating **	M	Issue No.	<b>402</b>
LM End	<b>0.77</b>	Issue Type +	En	Location *	WS
Category	Supplemental			GPS Latitude/Longitude	
				Start	End
Item	DWR UCIP Field Study			39.487806 °	39.487806 °
				-122.019414 °	-122.019414 °
DWR ID					
Comment Code					
Inspector Comment					
FS_ID:14324 DS_ID:22893 EP_NO: 11782 Repair Type: Non-Urgent Crossing Status: Found UCIP Comments: Siphon breaker missing from WS shoulder. FIELD_STRUCT_DESC: 3-inch pipe through levee 2.0 feet below crown. Hose bib style siphon breaker on WS shoulder. Pipe runs from concrete sump next to barn on LS to cesspool off WS toe (Permit No. 11782, 1977). FS Date: 5/29/2013

3-inch pipe at cesspool off WS toe.

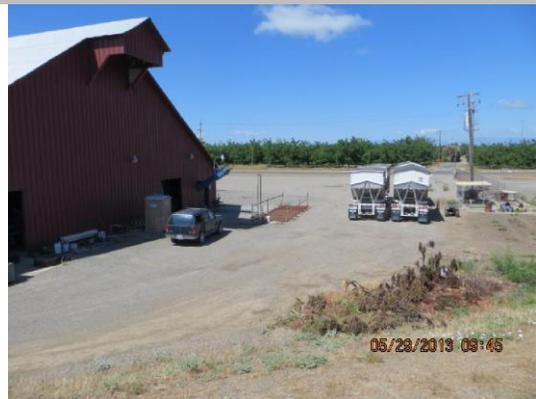
Photo 2 of 2 : UCIP\_SP\_2016\_14324\_23563.jpg

LM Start	<b>0.77</b>	Rating **	M	Issue No.	<b>402 (cont)</b>
LM End	<b>0.77</b>	Issue Type +	En	Location *	WS

Concrete sump next to barn off LS toe.

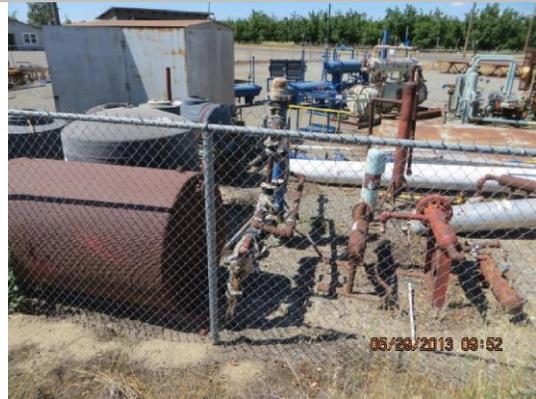
Photo 1 of 2 : UCIP\_SP\_2016\_14325\_23568.jpg

LM Start	<b>0.80</b>	Rating **	M	Issue No.	<b>403</b>
LM End	<b>0.80</b>	Issue Type +	En	Location *	WS
Category	Supplemental			GPS Latitude/Longitude	
				Start	End
Item	DWR UCIP Field Study			39.488160 °	39.488160 °
				-122.019888 °	-122.019888 °
DWR ID					
Comment Code					
Inspector Comment					
FS_ID:14325 DS_ID:22894 EP_NO: 1837 Repair Type: Non-Urgent Crossing Status: Indicator Found UCIP Comments: Gasline appears abandoned, need to verify abandonment or mark actual pipe location. FIELD_STRUCT_DESC: 3-inch gas line through the levee 2.0 feet below the crown (Permit No. 1837, 1959). Fenced in pumping plant area next to levee with appurtenances. FS Date: 5/29/2013

Gas pumping plant and appurtenances.

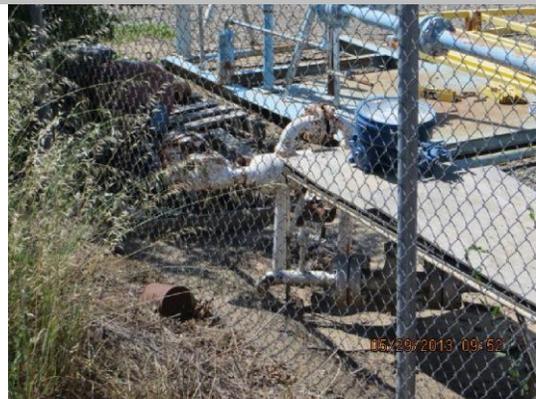
Photo 2 of 2 : UCIP\_SP\_2016\_14325\_23567.jpg

LM Start	<b>0.80</b>	Rating **	M	Issue No.	<b>403 (cont)</b>
LM End	<b>0.80</b>	Issue Type +	En	Location *	WS

Possible pipe at crossing, LS toe.

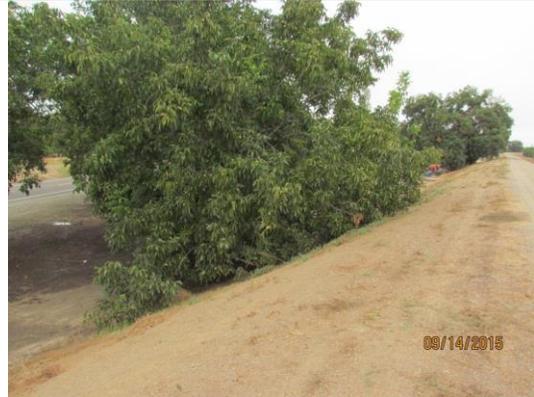
Photo 1 of 1 : SP\_2016\_LD0001G\_432\_43\_20160316\_00012.jpg

View of the tree limbs on the landside slope.

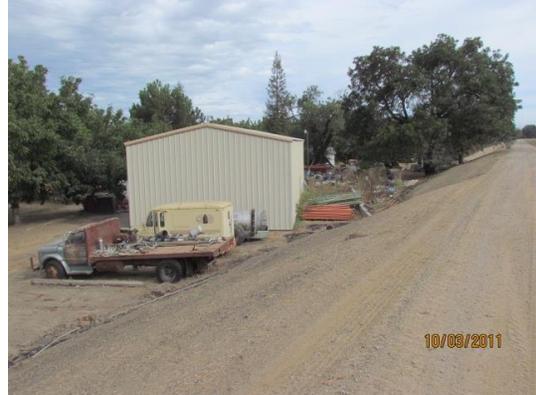
Photo 1 of 1 : SP\_2016\_LD0001G\_432\_74\_20160509\_00090.jpg

View of vehicles & equipment along the L/S toe.

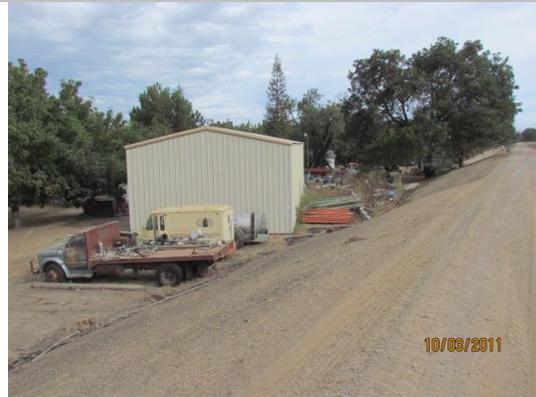
Photo 1 of 1 : SP\_2016\_LD0001G\_432\_4\_20160316\_00002.jpg

LM Start	<b>1.11</b>	Rating **	M	Issue No.	<b>4</b>
LM End	<b>1.11</b>	Issue Type +	En	Location *	LS
Category	Earthen Levee		GPS Latitude/Longitude		
			Start	End	
Item	Encroachments		39.491887 °	39.494572 °	
			-122.020238 °	-122.017840 °	
DWR ID	DWR_LD0001G_01_s_2012_4				
Comment Code					
BU : Building					
Inspector Comment

View of unpermitted building L/S toe.

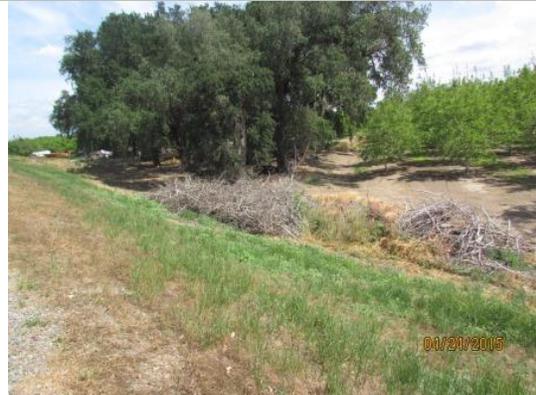
Photo 1 of 1 : SP\_2016\_LD0001G\_432\_58\_20160316\_00025.jpg

LM Start	<b>1.15</b>	Rating **	A/W	Issue No.	<b>58</b>
LM End	<b>1.15</b>	Issue Type +	En	Location *	WS
Category	Earthen Levee		GPS Latitude/Longitude		
			Start	End	
Item	Encroachments		39.492788 °	39.492788 °	
			-122.019437 °	-122.019437 °	
DWR ID	DWR_LD0001G_01_s_2015_58				
Comment Code					
PR : Prunings					
Inspector Comment					
Remove the prunings from the waterside toe.

View of the prunings along the waterside toe.

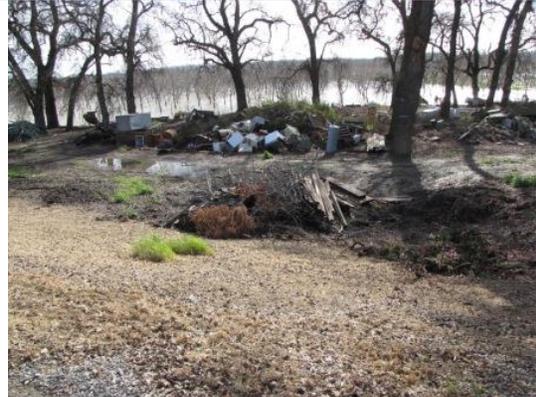
Photo 1 of 1 : SP\_2016\_LD0001G\_432\_1\_20160316\_00001.jpg

View of the prunings along the W/S toe.

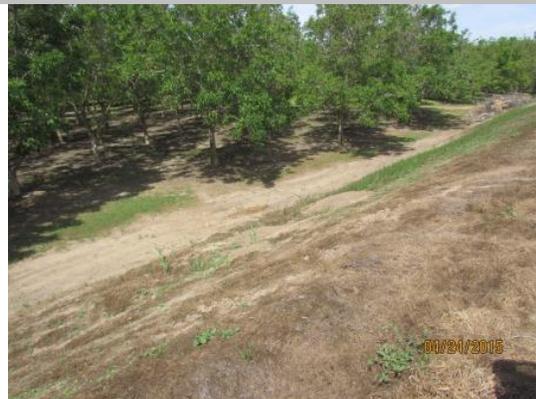
Photo 1 of 1 : SP\_2016\_LD0001G\_432\_59\_20160316\_00026.jpg

LM Start	<b>1.22</b>	Rating **	M	Issue No.	<b>59</b>
LM End	<b>1.22</b>	Issue Type +	Ma	Location *	LS
Category	Earthen Levee		GPS Latitude/Longitude		
			Start	End	
Item	Animal Control		39.493667 °	39.493667 °	
			-122.018643 °	-122.018643 °	
DWR ID	DWR_LD0001G_01_f_2015_59				
Comment Code					
A3 : No rodents visible, but rodent burrows visible; need to backfill and compact or grout burrows.					
Inspector Comment					
The levee district has a rodent program in place.

View of the rodent holes along the landside slope.

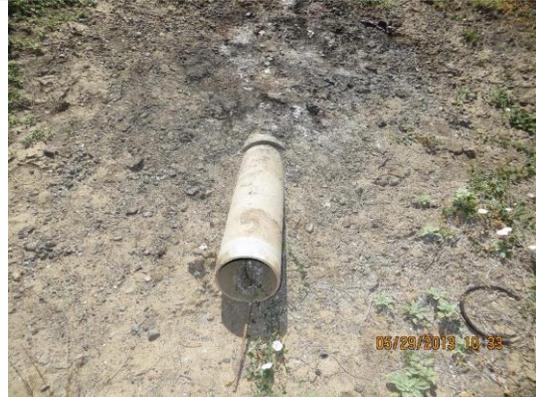
Photo 2 of 2 : UCIP\_SP\_2016\_14331\_23578.jpg

LM Start	<b>2.22</b>	Rating **	M	Issue No.	<b>407 (cont)</b>
LM End	<b>2.22</b>	Issue Type +	En	Location *	LS
Category	Supplemental			GPS Latitude/Longitude	
				Start	End
Item	DWR UCIP Field Study			39.501690 °	39.501690 °
				-122.006100 °	-122.006100 °
DWR ID					
Comment Code					
Inspector Comment					
FS_ID:14331 DS_ID:22898 EP_NO: 5717A Repair Type: Non-Urgent Crossing Status: Found UCIP Comments: Pipe abandoned and should be done so properly. FIELD_STRUCT_DESC: 8-inch pipe sleeved through 12-inch though the levee 5-feet below the crown. Pump on landward side. Meter pole at landward toe, guy wire anchor in landward slope (Permit No. 5717A, 1969). FS Date: 5/29/2013

8-inch pipe visible at LS toe.

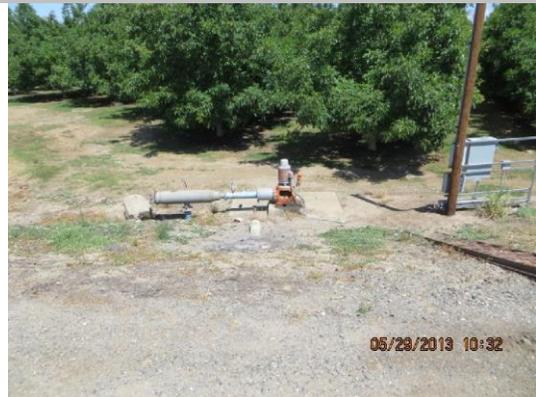
Photo 1 of 2 : UCIP\_SP\_2016\_14332\_23582.jpg

LM Start	<b>2.22</b>	Rating **	M	Issue No.	<b>408</b>
LM End	<b>2.22</b>	Issue Type +	En	Location *	LS
Category	Supplemental			GPS Latitude/Longitude	
				Start	End
Item	DWR UCIP Field Study			39.501690 °	39.501690 °
				-122.006099 °	-122.006099 °
DWR ID					
Comment Code					
Inspector Comment					
FS_ID:14332 DS_ID:22944 EP_NO: N/A Repair Type: Non-Urgent Crossing Status: Found UCIP Comments: Appears abandoned and should be done so properly. FIELD_STRUCT_DESC: 12-inch pipe through levee 5-feet below crown. Flap gate on W.S. 8-inch pipe sleeved through 12-inch. Open on LS. Originally included in the 1960 O&M manual. FS Date: 5/29/2013

Pump at location of pipe on LS toe.

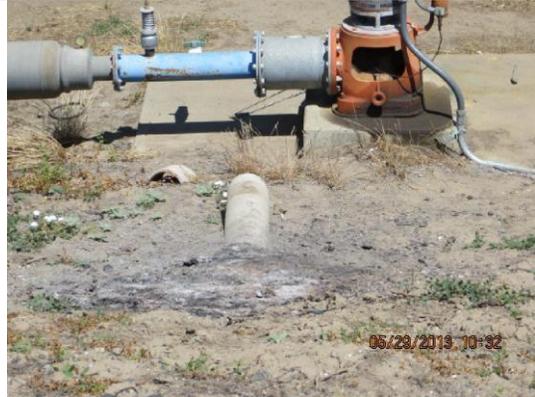
Photo 2 of 2 : UCIP\_SP\_2016\_14332\_23581.jpg

LM Start	<b>2.22</b>	Rating **	M	Issue No.	<b>408 (cont)</b>
LM End	<b>2.22</b>	Issue Type +	En	Location *	LS
Category	Supplemental			GPS Latitude/Longitude	
				Start	End
Item	DWR UCIP Field Study			39.501690 °	39.501690 °
				-122.006099 °	-122.006099 °
DWR ID					
Comment Code					
Inspector Comment					
FS_ID:14332 DS_ID:22944 EP_NO: N/A Repair Type: Non-Urgent Crossing Status: Found UCIP Comments: Appears abandoned and should be done so properly. FIELD_STRUCT_DESC: 12-inch pipe through levee 5-feet below crown. Flap gate on W.S. 8-inch pipe sleeved through 12-inch. Open on LS. Originally included in the 1960 O&M manual. FS Date: 5/29/2013

Pipe next to pump at LS toe.

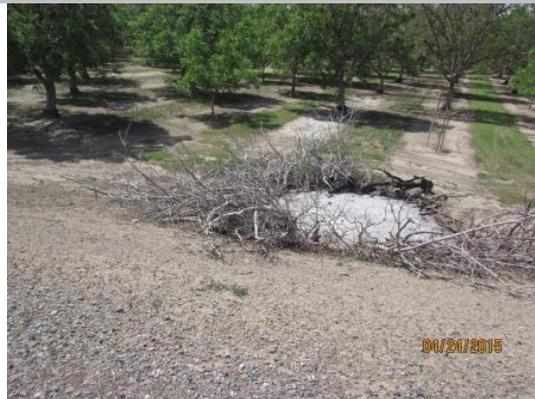
Photo 1 of 1 : SP\_2016\_LD0001G\_432\_61\_20160316\_00028.jpg

LM Start	<b>2.48</b>	Rating **	M	Issue No.	<b>61</b>
LM End	<b>2.48</b>	Issue Type +	En	Location *	LS
Category	Earthen Levee			GPS Latitude/Longitude	
				Start	End
Item	Encroachments			39.505237 °	39.505237 °
				-122.006493 °	-122.006493 °
DWR ID	DWR_LD0001G_01_s_2015_61				
Comment Code					
PR : Prunings					
Inspector Comment

View of the prunings along the landside toe.

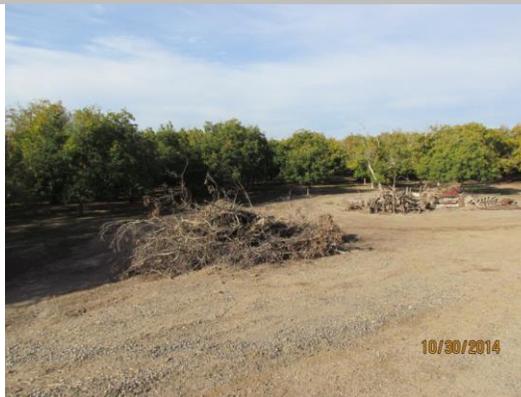
Photo 1 of 1 : SP\_2016\_LD0001G\_432\_49\_20160316\_00017.jpg

View of the prunings along the landsides toe.

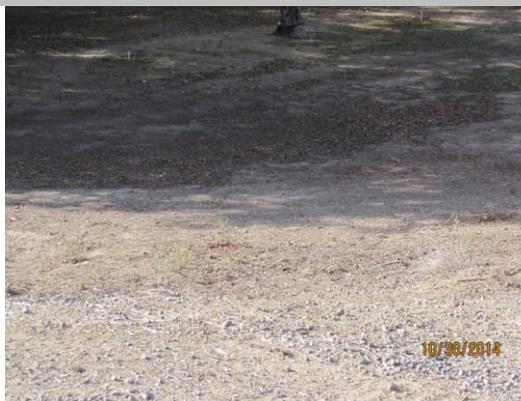
Photo 1 of 1 : SP\_2016\_LD0001G\_432\_50\_20160316\_00018.jpg

View of the rodent activity along the landside slope.

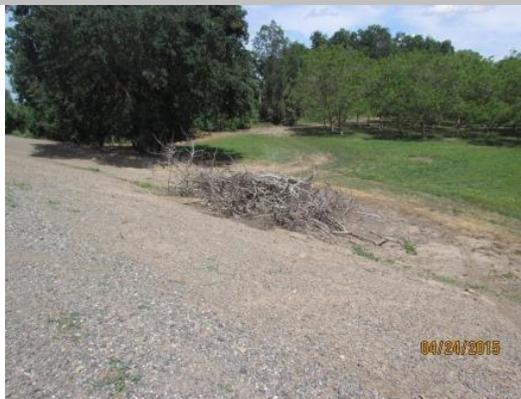
Photo 1 of 1 : SP\_2016\_LD0001G\_432\_62\_20160316\_00029.jpg

View of the pruning on the waterside toe.

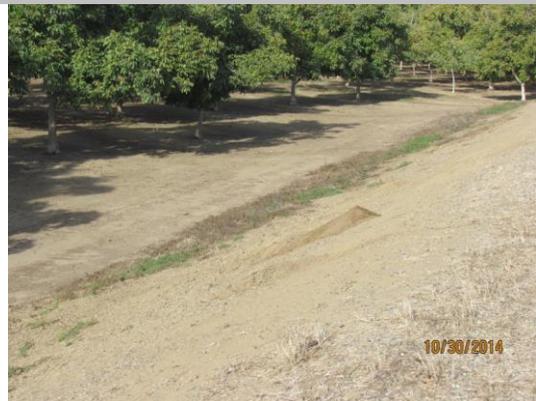
Photo 1 of 1 : SP\_2016\_LD0001G\_432\_51\_20160316\_00019.jpg

View of the rodent activity along the landside slope.

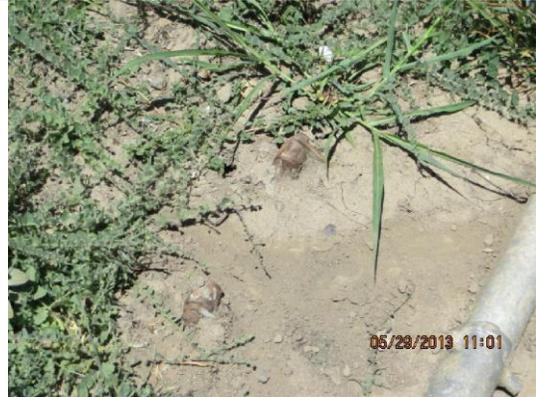
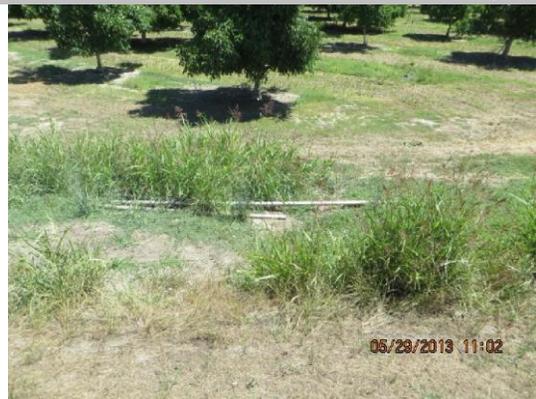
Photo 1 of 2 : UCIP\_SP\_2016\_16223\_27343.jpg

LM Start	<b>3.13</b>	Rating **	M	Issue No.	<b>398</b>
LM End	<b>3.13</b>	Issue Type +	En	Location *	LS
Category	Supplemental			GPS Latitude/Longitude	
				Start	End
Item	DWR UCIP Field Study			39.513835 °	39.513835 °
				-122.010029 °	-122.010029 °
DWR ID					
Comment Code					
Inspector Comment					
FS_ID:16223 DS_ID:22901 EP_NO: 9575 Repair Type: Non-Urgent Crossing Status: Found UCIP Comments: Appears to have been abandoned. Need to verify pipe was grouted/abandoned properly. FIELD_STRUCT_DESC: 12-inch pipe through levee 14.0 feet below crown. Flap Gate on waterward end (ABO No. 9575, 1974). FS Date: 5/29/2013

Flap gate visible at WS toe.

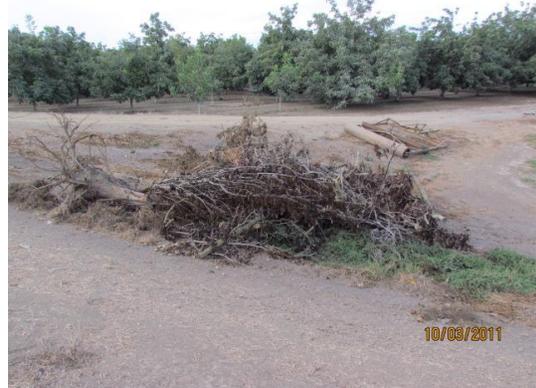
Photo 1 of 1 : SP\_2016\_LD0001G\_432\_16\_20160316\_00008.jpg

View of the pruning pile along the L/S toe.

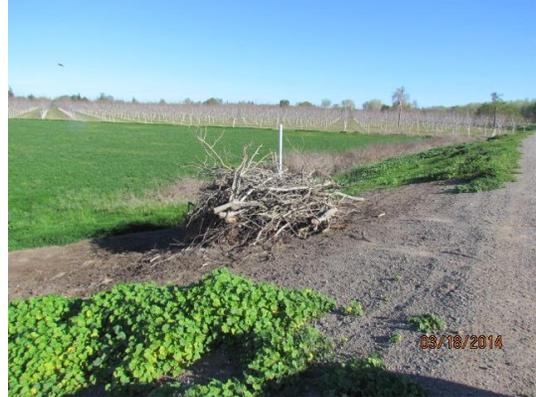
Photo 1 of 1 : SP\_2016\_LD0001G\_432\_46\_20160316\_00014.jpg

View of the prunings along the landside slope.

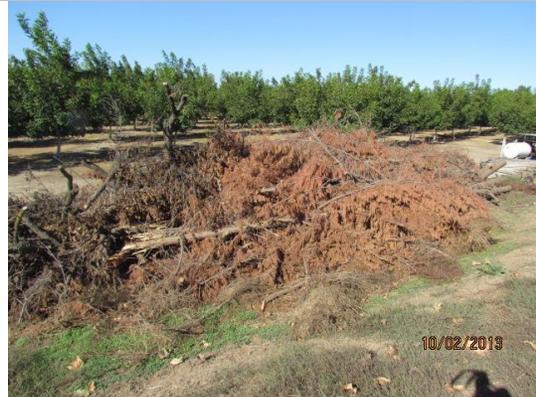
Photo 1 of 1 : SP\_2016\_LD0001G\_432\_56\_20160316\_00023.jpg

View of the prunings & limbs along the slope of the levee.

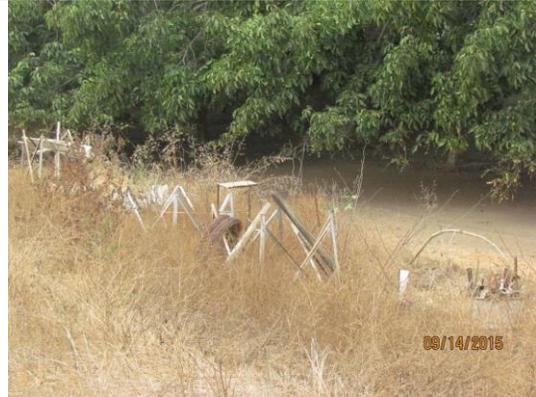
Photo 1 of 1 : SP\_2016\_LD0001G\_432\_23\_20160316\_00010.jpg

View of the equipment along the landside toe.

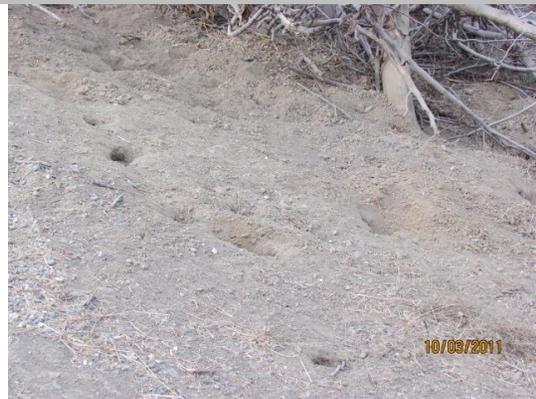
Photo 1 of 1 : SP\_2016\_LD0001G\_432\_395\_20160316\_00034.jpg

LM Start	<b>3.88</b>	Rating **	U	Issue No.	<b>395</b>
LM End	<b>3.88</b>	Issue Type +	Ma	Location *	LS
Category	Earthen Levee		GPS Latitude/Longitude		
			Start	End	
Item	Animal Control		39.523845 °	39.523845 °	
			-122.010745 °	-122.010745 °	
DWR ID	DWR_LD0001G_01_s_2012_395				
Comment Code					
A3 : No rodents visible, but rodent burrows visible; need to backfill and compact or grout burrows.					
Inspector Comment					
Repair the rodent hole on the landside slope.

View of the rodent holes along the L/S toe.

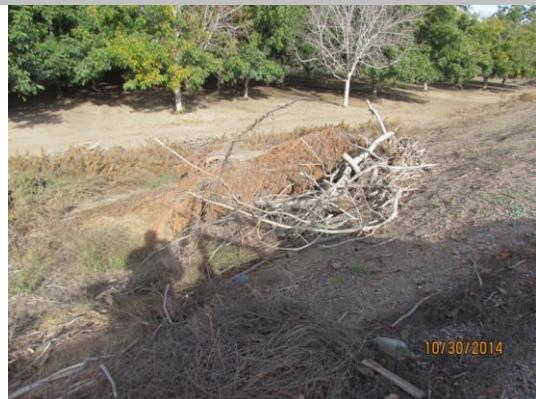
Photo 1 of 1 : SP\_2016\_LD0001G\_432\_52\_20160316\_00020.jpg

View of the prunings along the landside toe.

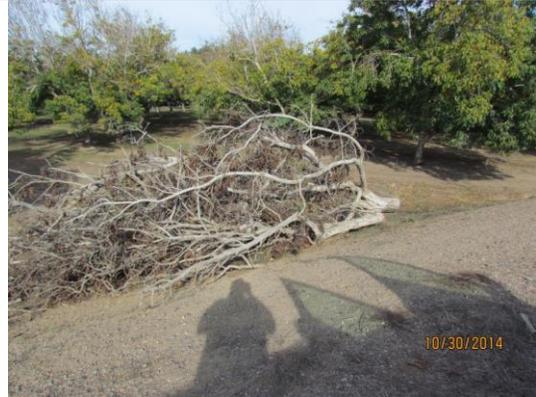
Photo 1 of 1 : SP\_2016\_LD0001G\_432\_53\_20160316\_00021.jpg

View of the prunings along the landside toe.

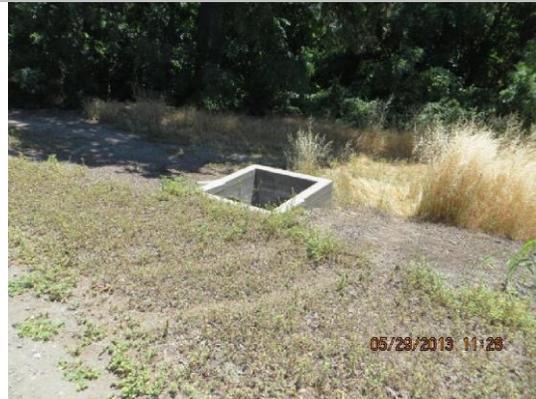
Photo 1 of 2 : UCIP\_SP\_2016\_16243\_27386.jpg

LM Start	<b>3.98</b>	Rating **	U	Issue No.	<b>416</b>
LM End	<b>3.98</b>	Issue Type +	En	Location *	LS
Category	Supplemental		GPS Latitude/Longitude		
			Start	End	
Item	DWR UCIP Field Study		39.524990 °	39.524990 °	
			-122.009575 °	-122.009575 °	
DWR ID					
Comment Code					
Inspector Comment					
FS_ID:16243 DS_ID:22904 EP_NO: 9572 Repair Type: Urgent Crossing Status: Found UCIP Comments: Broken flap gate and Concrete headwall on LS toe possibly tilting. Also a 3-inch aluminum irrigation line through the pipe. FIELD_STRUCT_DESC: 18-inch pipe through levee 7.3 feet below crown. Flap gate in 6'X6'concrete box on waterward end. Concrete bulkhead at landward toe (ABO No. 9572, 1974). Originally included in the 1960 O&M manual. FS Date: 5/29/2013

Distribution box on WS toe.

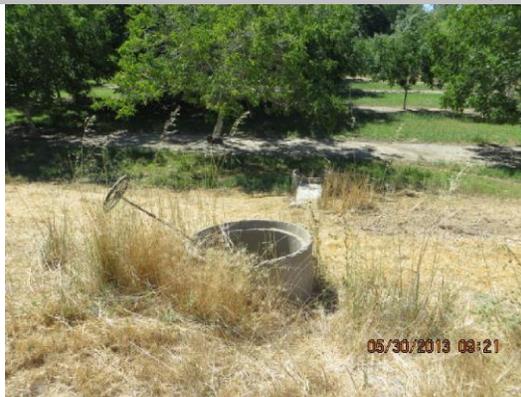
Photo 2 of 2 : UCIP\_SP\_2016\_14343\_23593.jpg

Item	DWR UCIP Field Study			39.527050 °	39.527050 °
				-122.005247 °	-122.005247 °
DWR ID					
Comment Code					
Inspector Comment					
FS_ID:14343 DS_ID:22906 EP_NO: 1229 Repair Type: Urgent Crossing Status: Found UCIP Comments: Gate valve broken off in concrete standpipe on WS shoulder. 8-inch aluminum pipe sleeved through pipe prevents closure of 18-inch pipe. All concrete standpipes have been modified or broken. FIELD_STRUCT_DESC: 16-inch concrete irrigation pipe through the levee 8.6 feet below the crown. Gate valve in concrete well on waterward slope. Pump, service pole, engine, and fuel tank 48-inch standpipe at toe of landward slope (Permit No. 1229, 1947). Included in the 1960 O&M manual. FS Date: 5/30/2013

Gate valve in Concrete riser on WSs holder.

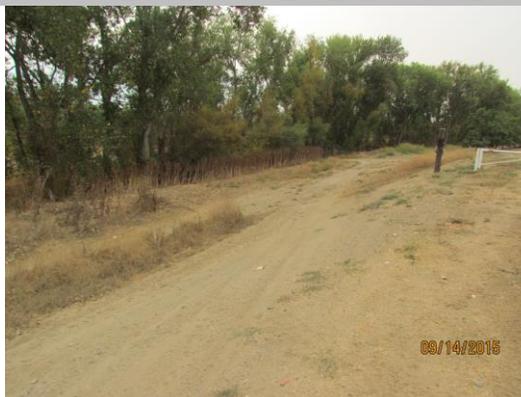
Photo 1 of 1 : SP\_2016\_LD0001G\_432\_63\_20160316\_00030.jpg

LM Start	<b>4.93</b>	Rating **	M	Issue No.	<b>63</b>
LM End	<b>4.93</b>	Issue Type +	Ma	Location *	WS
Category	Earthen Levee			GPS Latitude/Longitude	
				Start	End
Item	Slope Stability			39.532719 °	39.532719 °
				-121.995849 °	-121.995849 °
DWR ID	DWR_LD0001G_01_f_2015_63				
Comment Code					
S3 : Repair the levee slope damaged by vehicle traffic and prevent access where possible.					
Inspector Comment					
Repair the erosion along the waterside slope.

View of the vehicle erosion along the waterside slope.

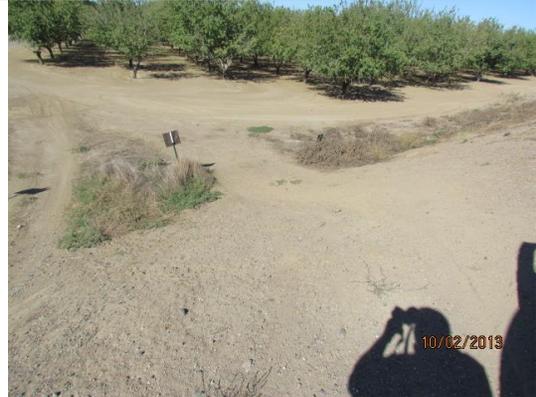
Photo 1 of 1 : SP\_2016\_LD0001G\_432\_57\_20160316\_00024.jpg

LM Start	<b>5.06</b>	Rating **	M	Issue No.	<b>57</b>
LM End	<b>5.06</b>	Issue Type +	Ma	Location *	LS
Category	Earthen Levee		GPS Latitude/Longitude		
			Start	End	
Item	Slope Stability		39.534593 °	39.534593 °	
			-121.995950 °	-121.995950 °	
DWR ID	DWR_LD0001G_01_f_2013_57				
Comment Code					
S3 : Repair the levee slope damaged by vehicle traffic and prevent access where possible.					
Inspector Comment

View of the vehicle erosion along the slope of the levee.

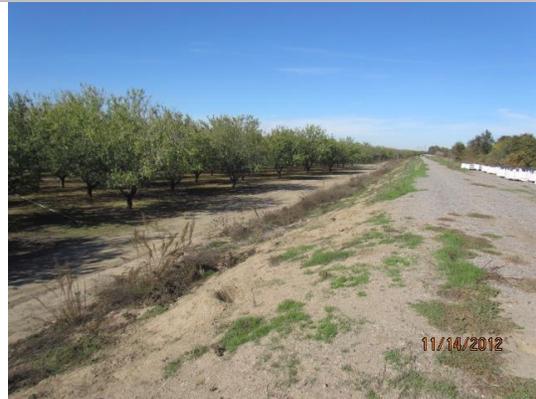
Photo 1 of 1 : SP\_2016\_LD0001G\_432\_7\_20160316\_00004.jpg

View of the rodent hole along the levee slope.

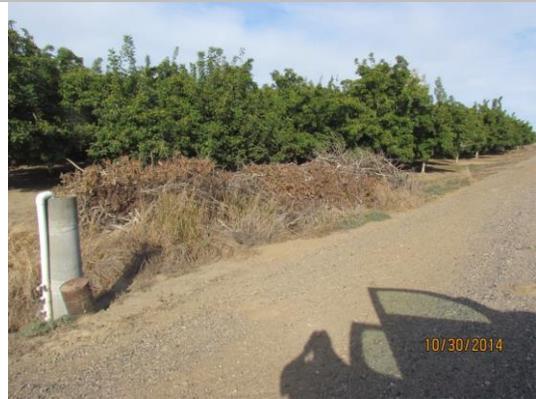
Photo 1 of 1 : SP\_2016\_LD0001G\_432\_54\_20160316\_00022.jpg

View of the prunings along the landside toe.

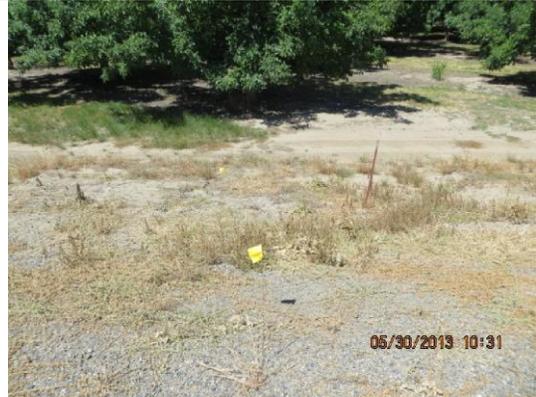
Photo 1 of 2 : UCIP\_SP\_2016\_14352\_23609.jpg

LM Start	<b>6.18</b>	Rating **	M	Issue No.	<b>412</b>
LM End	<b>6.18</b>	Issue Type +	En	Location *	LS
Category	Supplemental			GPS Latitude/Longitude	
				Start	End
Item	DWR UCIP Field Study			39.549911 °	39.549911 °
				-122.002102 °	-122.002102 °
DWR ID					
Comment Code					
Inspector Comment					
FS_ID:14352 DS_ID:22911 EP_NO: 5118 Repair Type: Non-Urgent Crossing Status: Indicator Found UCIP Comments: New gasline markers should be installed as existing signage has been sun faded FIELD_STRUCT_DESC: 1 of 2: 12.75-inch high pressure gas line through levee 3.0 feet below crown (Permit No. 5118, 1965). FS Date: 5/30/2013

Gasline flags on LS slope.

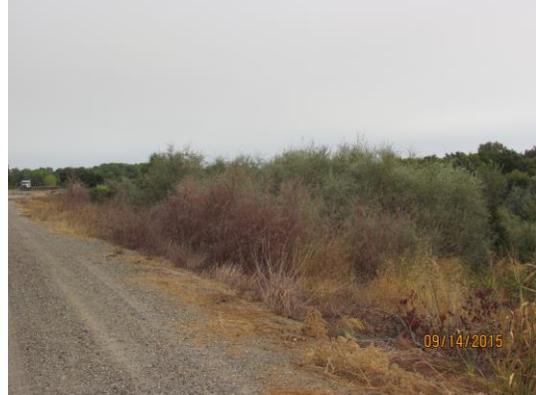
Photo 1 of 1 : SP\_2016\_LD0001G\_432\_65\_20160316\_00032.jpg

View of the vegetation along the waterside slope and toe.

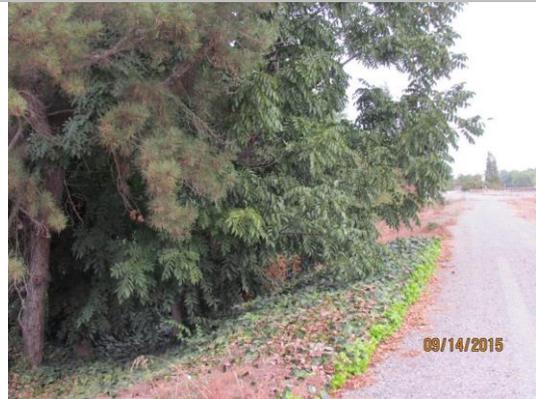
Photo 1 of 1 : SP\_2016\_LD0001G\_432\_64\_20160316\_00031.jpg

View of the trees along the landside toe.

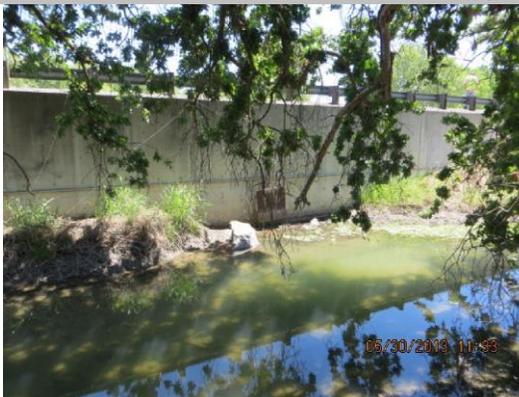
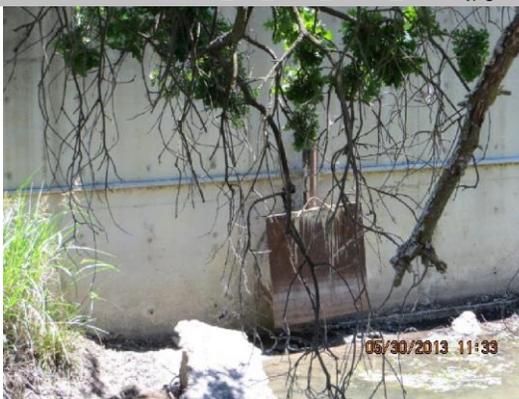
Photo 1 of 2 : UCIP\_SP\_2016\_14373\_23655.jpg

LM Start	<b>6.73</b>	Rating **	M	Issue No.	<b>413</b>
LM End	<b>6.73</b>	Issue Type +	En	Location *	LS
Category	Supplemental			GPS Latitude/Longitude	
				Start	End
Item	DWR UCIP Field Study			39.557721 °	39.557721 °
				-122.004267 °	-122.004267 °
DWR ID					
Comment Code					
Inspector Comment					
FS_ID:14373 DS_ID:22915 EP_NO: 1443A Repair Type: Non-Urgent Crossing Status: Found UCIP Comments: Pipe abandoned, but need to verify if it was abandoned properly. FIELD_STRUCT_DESC: 36-inch concrete encased pipe through levee 9.0 feet below crown. Steel plate welded over pipe at LS toe. 3-inch steel vent pipe on LS toe. Originally included in the 1960 O&M manual. FS Date: 5/30/2013

Pipe with steel plate welded over end on LS of levee crown.

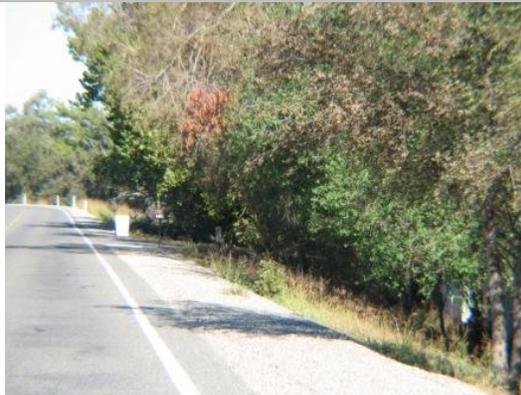
Photo 1 of 1 : SP\_2016\_LD0001G\_432\_20\_20160316\_00009.jpg

View of the trees and vegetation along the waterside slope of the levee.

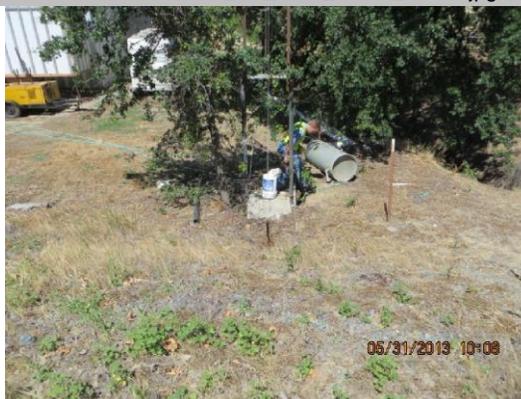
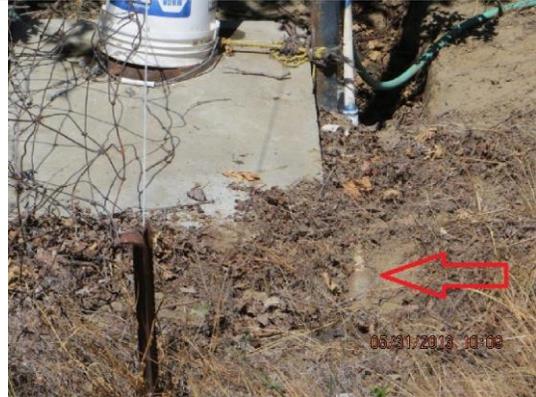
Photo 1 of 2 : UCIP\_SP\_2016\_16204\_27330.jpg

Pipe visible next to well with bucket over standpipe.

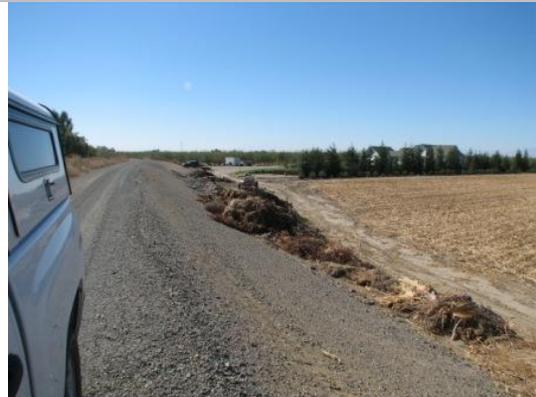
Photo 1 of 1 : SP\_2016\_LD0001G\_432\_11\_20160316\_00007.jpg

View of debris along the toe of the levee.

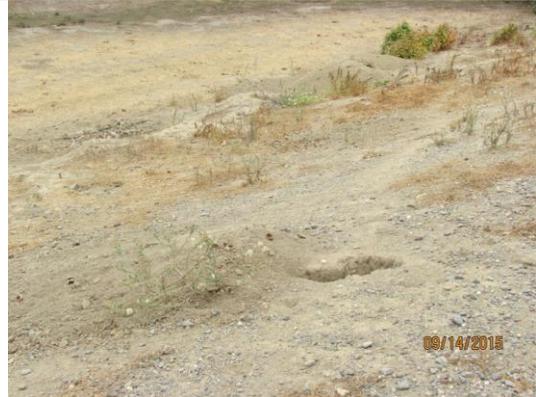
Photo 1 of 1 : SP\_2016\_LD0001G\_432\_66\_20160316\_00033.jpg

View of the rodent holes along the waterside slope.

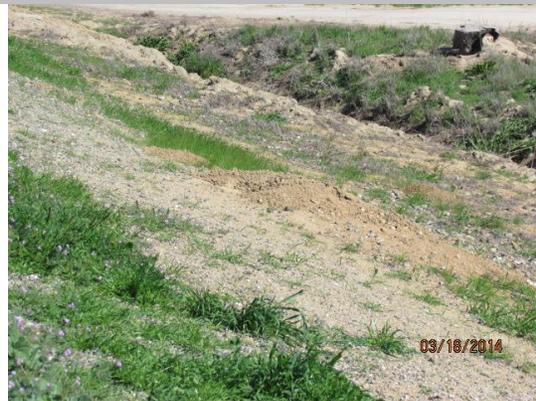
Photo 1 of 1 : SP\_2016\_LD0001G\_432\_48\_20160316\_00016.jpg

View of the rodent activity along the waterside slope.
