**Flood Control Project Maintenance
Levee Inspections**

Maintenance Issue Types Only, Levee Inspection Report By Mile - Spring 2015

Levee District No. 0001 (Glenn County)

Waterway	Bank	Unit Miles	Inspection Start/End	Inspector
Unit No. 01 Sacramento River	Right	12.23	04/07/2015 04/07/2015	Bob Duffey

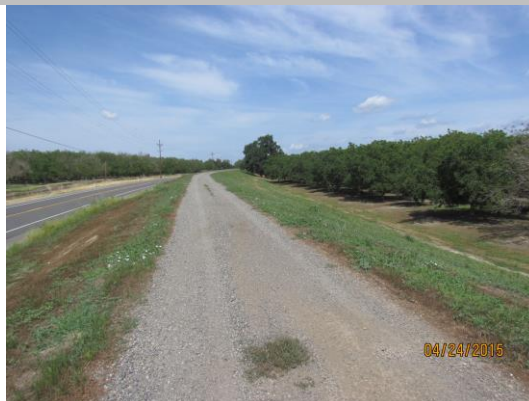
Photo 1 of 1 : SP_2015_LD0001G_432_43_20150428_00047.jpg

LM Start	0.89	Rating **	A	Issue No.	43
LM End	0.89	Issue Type +	Ma	Location *	LS
Category	Earthen Levee			GPS Latitude/Longitude	
				Start	End
Item	Vegetation			39.489262 °	39.489262 °
				-122.020590 °	-122.020590 °
DWR ID	DWR_LD0001G_01_s_2015_43				
Action/Comments					
Control annual grass and weeds on the levee slopes and easements.

View of the levee with vegetation on both slopes.

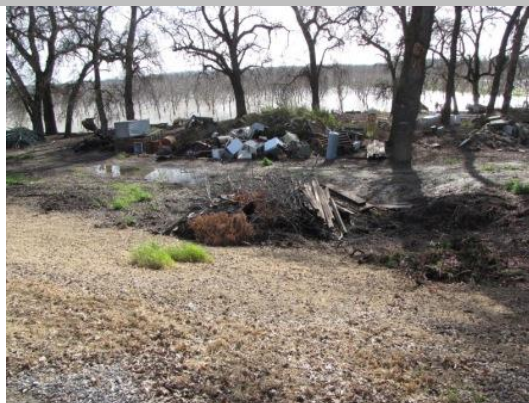
Photo 1 of 1 : SP_2015_LD0001G_432_1_20150310_00001.jpg

LM Start	1.20	Rating **	M	Issue No.	1
LM End	1.20	Issue Type +	Ma	Location *	WS
Category	Earthen Levee			GPS Latitude/Longitude	
				Start	End
Item	Encroachments			39.493423 °	39.493423 °
				-122.018885 °	-122.018885 °
DWR ID	DWR_LD0001G_01_s_2012_1				
Action/Comments					
Debris

View of the debris & garbage along the W/S toe.

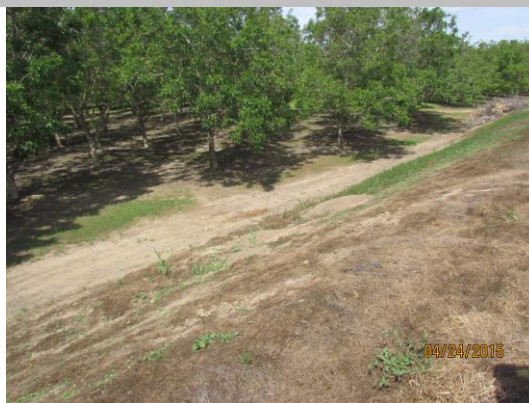
Photo 1 of 1 : SP_2015_LD0001G_432_59_20150428_00049.jpg

LM Start	1.22	Rating **	A/W	Issue No.	59
LM End	1.22	Issue Type +	Ma	Location *	LS
Category	Earthen Levee			GPS Latitude/Longitude	
				Start	End
Item	Animal Control			39.493667 °	39.493667 °
				-122.018643 °	-122.018643 °
DWR ID	DWR_LD0001G_01_s_2015_59				
Action/Comments					
No rodents visible, but rodent burrows visible; need to backfill and compact or grout burrows.					
Inspector Comments: The levee district has a rodent program in place.

View of the rodent holes along the landside slope.

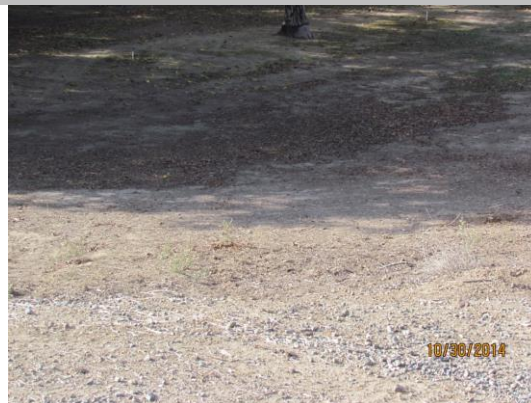
Photo 1 of 1 : SP_2015_LD0001G_432_50_20150310_00016.jpg

LM Start	2.80	Rating **	A/W	Issue No.	50
LM End	2.80	Issue Type +	Ma	Location *	LS
Category	Earthen Levee			GPS Latitude/Longitude	
				Start	End
Item	Animal Control			39.509503 °	39.509503 °
				-122.008732 °	-122.008732 °
DWR ID	DWR_LD0001G_01_f_2014_50				
Action/Comments					
No rodents visible, but rodent burrows visible; need to backfill and compact or grout burrows.

View of the rodent activity along the landside slope.

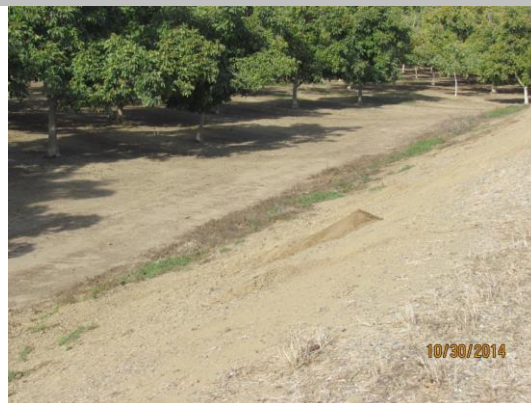
Photo 1 of 1 : SP_2015_LD0001G_432_51_20150310_00017.jpg

LM Start	3.09	Rating **	M	Issue No.	51
LM End	3.09	Issue Type +	Ma	Location *	N/A
Category	Earthen Levee			GPS Latitude/Longitude	
				Start	End
Item	Animal Control			39.513485 °	39.513485 °
				-122.009593 °	-122.009593 °
DWR ID	DWR_LD0001G_01_f_2014_51				
Action/Comments					
No rodents visible, but rodent burrows visible; need to backfill and compact or grout burrows.

View of the rodent activity along the landside slope.

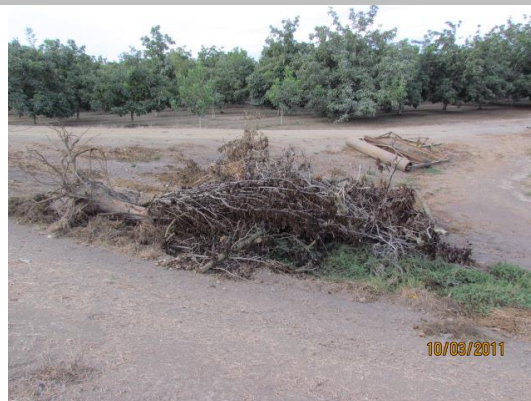
Photo 1 of 1 : SP_2015_LD0001G_432_16_20150310_00009.jpg

LM Start	3.17	Rating **	M	Issue No.	16
LM End	3.17	Issue Type +	Ma	Location *	LS
Category	Earthen Levee			GPS Latitude/Longitude	
				Start	End
Item	Encroachments			39.514378 °	39.514378 °
				-122.010306 °	-122.010306 °
DWR ID	DWR_LD0001G_01_s_2012_16				
Action/Comments					
Prunings

View of the pruning pile along the L/S toe.

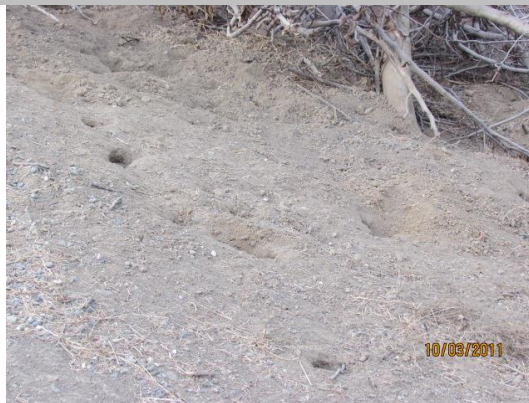
Photo 1 of 1 : SP_2015_LD0001G_432_395_20150310_00024.jpg

LM Start	3.88	Rating **	A/W	Issue No.	395
LM End	3.88	Issue Type +	Ma	Location *	LS
Category	Earthen Levee			GPS Latitude/Longitude	
				Start	End
Item	Animal Control			39.523845 °	39.523845 °
				-122.010745 °	-122.010745 °
DWR ID	DWR_LD0001G_01_s_2012_395				
Action/Comments					
No rodents visible, but rodent burrows visible; need to backfill and compact or grout burrows.

View of the rodent holes along the L/S toe.

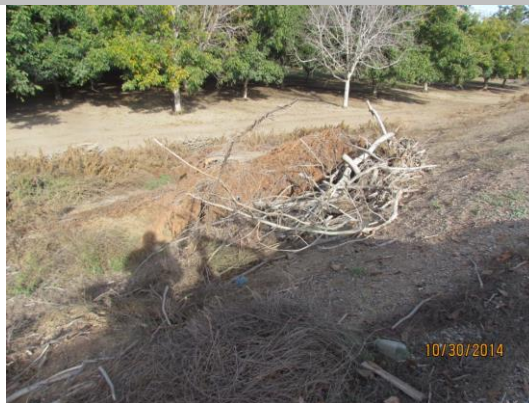
Photo 1 of 1 : SP_2015_LD0001G_432_52_20150310_00018.jpg

LM Start	3.88	Rating **	M	Issue No.	52
LM End	3.88	Issue Type +	Ma	Location *	LS
Category	Earthen Levee			GPS Latitude/Longitude	
				Start	End
Item	Encroachments			39.523855 °	39.523855 °
				-122.010762 °	-122.010762 °
DWR ID	DWR_LD0001G_01_f_2014_52				
Action/Comments					
Prunings

View of the prunings along the landside toe.

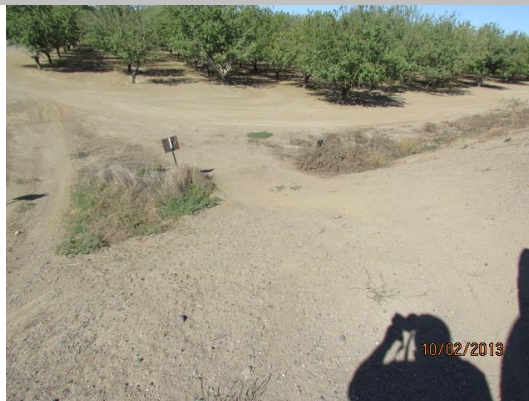
Photo 1 of 1 : SP_2015_LD0001G_432_57_20150310_00023.jpg

LM Start	5.06	Rating **	M	Issue No.	57
LM End	5.06	Issue Type +	Ma	Location *	LS
Category	Earthen Levee			GPS Latitude/Longitude	
				Start	End
Item	Slope Stability			39.534593 °	39.534593 °
				-121.995950 °	-121.995950 °
DWR ID	DWR_LD0001G_01_f_2013_57				
Action/Comments					
Repair the levee slope damaged by vehicle traffic and prevent access where possible.

View of the vehicle erosion along the slope of the levee.

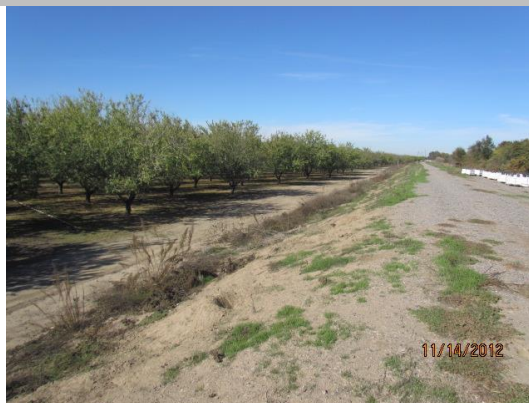
Photo 1 of 1 : SP_2015_LD0001G_432_7_20150310_00004.jpg

LM Start	5.08	Rating **	A/W	Issue No.	7
LM End	5.15	Issue Type +	Ma	Location *	LS
Category	Earthen Levee			GPS Latitude/Longitude	
				Start	End
Item	Animal Control			39.534741 °	39.535738 °
				-121.996024 °	-121.996570 °
DWR ID	DWR_LD0001G_01_f_2012_7				
Action/Comments					
No rodents visible, but rodent burrows visible; need to backfill and compact or grout burrows.

View of the rodent hole along the levee slope.

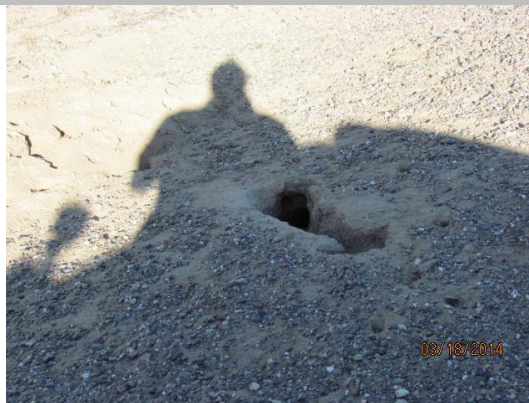
Photo 1 of 1 : SP_2015_LD0001G_432_47_20150310_00013.jpg

LM Start	6.22	Rating **	M	Issue No.	47
LM End	6.22	Issue Type +	Ma	Location *	LS
Category	Earthen Levee			GPS Latitude/Longitude	
				Start	End
Item	Animal Control			39.550533 °	39.550533 °
				-122.002319 °	-122.002319 °
DWR ID	DWR_LD0001G_01_s_2014_47				
Action/Comments					
No rodents visible, but rodent burrows visible; need to backfill and compact or grout burrows.

View of the rodent activity along the l/s slope.

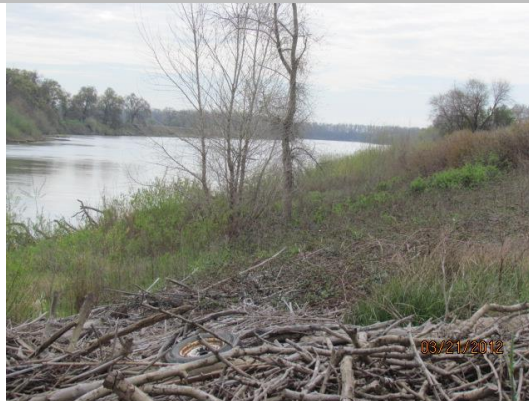
Photo 1 of 1 : SP_2015_LD0001G_432_10_20150310_00006.jpg

LM Start	6.56	Rating **	A/W	Issue No.	10
LM End	6.56	Issue Type +	Ma	Location *	WS
Category	Earthen Levee			GPS Latitude/Longitude	
				Start	End
Item	Vegetation			39.555274 °	39.555274 °
				-122.003505 °	-122.003505 °
DWR ID	DWR_LD0001G_01_s_2012_10				
Action/Comments					
Environmental Requirements.

View of the Army Corps of Engineers mitigation site.

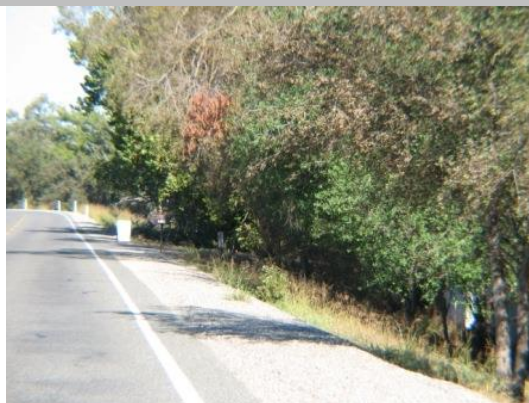
Photo 1 of 1 : SP_2015_LD0001G_432_20_20150310_00010.jpg

LM Start	8.05	Rating **	M	Issue No.	20
LM End	8.16	Issue Type +	Ma	Location *	WS
Category	Earthen Levee			GPS Latitude/Longitude	
				Start	End
Item	Trim / Thin Trees			39.576580 °	39.578187 °
				-122.004962 °	-122.005218 °
DWR ID	DWR_LD0001G_01_s_2012_20				
Action/Comments					
Thin trees to allow visibility of the ground and room to flood fight.

View of the trees and vegetation along the waterside slope of the levee.

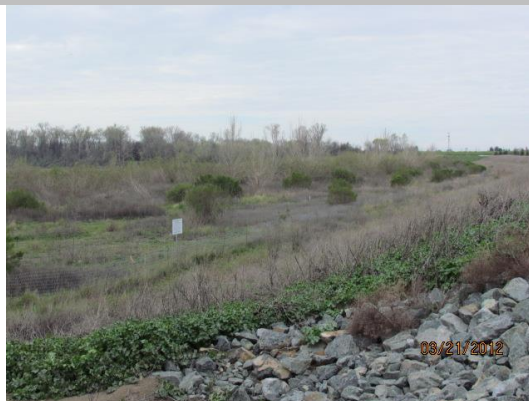
Photo 1 of 1 : SP_2015_LD0001G_432_8_20150310_00005.jpg

LM Start	9.50	Rating **	A/W	Issue No.	8
LM End	10.40	Issue Type +	Ma	Location *	WS
Category	Earthen Levee			GPS Latitude/Longitude	
				Start	End
Item	Vegetation			39.596192 °	39.607288 °
				-122.002573 °	-121.994565 °
DWR ID	DWR_LD0001G_01_s_2012_8				
Action/Comments					
Environmental Requirements.

View of the Army Corps of Engineers mitigation site.

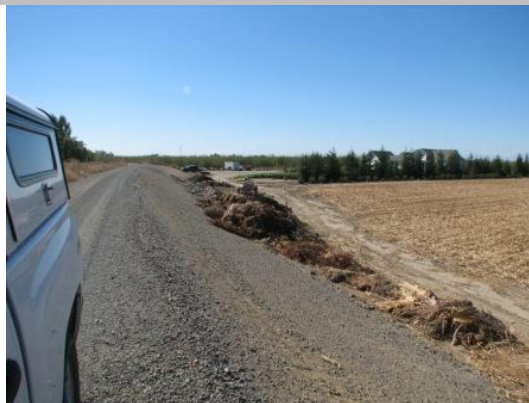
Photo 1 of 1 : SP_2015_LD0001G_432_11_20150310_00007.jpg

LM Start	9.57	Rating **	M	Issue No.	11
LM End	9.57	Issue Type +	Ma	Location *	LS
Category	Earthen Levee			GPS Latitude/Longitude	
				Start	End
Item	Encroachments			39.597078 °	39.597078 °
				-122.002127 °	-122.002127 °
DWR ID	DWR_LD0001G_01_s_2012_11				
Action/Comments					
Debris

View of debris along the toe of the levee.

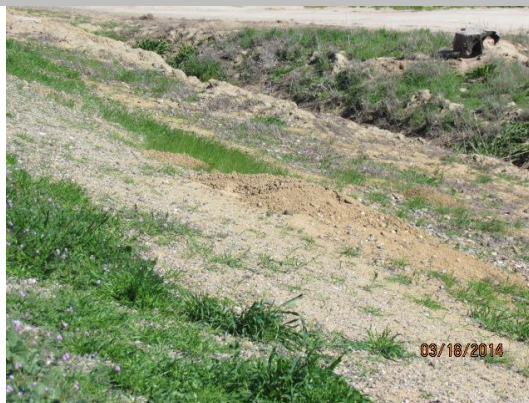
Photo 1 of 1 : SP_2015_LD0001G_432_48_20150310_00014.jpg

LM Start	11.55	Rating **	M	Issue No.	48
LM End	11.55	Issue Type +	Ma	Location *	WS
Category	Earthen Levee			GPS Latitude/Longitude	
				Start	End
Item	Animal Control			39.622652 °	39.622652 °
				-121.999185 °	-121.999185 °
DWR ID	DWR_LD0001G_01_s_2014_48				
Action/Comments					
No rodents visible, but rodent burrows visible; need to backfill and compact or grout burrows.

View of the rodent activity along the waterside slope.
