**Flood Control Project Maintenance
Levee Inspections**

Maintenance Issue Types Only, Levee Inspection Report By Mile - Spring 2016

Levee District No. 0001 (Glenn County)

Waterway	Bank	Unit Miles	Inspection Start/End	Inspector
Unit No. 01 Sacramento River	Right	12.23	04/15/2016 04/15/2016	Keith Millard

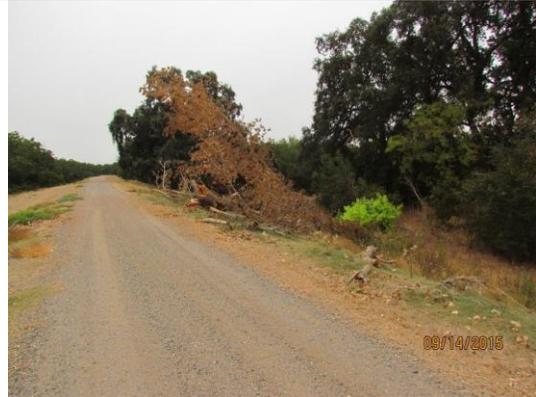
Photo 1 of 1 : SP_2016_LD0001G_432_41_20160316_00011.jpg

LM Start	0.25	Rating **	M	Issue No.	41
LM End	0.25	Issue Type +	Ma	Location *	WS
Category	Earthen Levee		GPS Latitude/Longitude		
			Start	End	
Item	Encroachments		39.480769 °	39.480769 °	
			-122.017301 °	-122.017301 °	
DWR ID	DWR_LD0001G_01_f_2015_41				
Comment Code					
TR : Tree or limb					
Inspector Comment					
Remove the tree from the waterside slope.

View of the tree on the waterside slope.

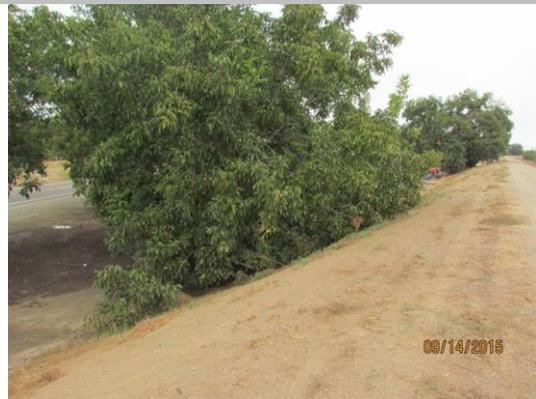
Photo 1 of 1 : SP_2016_LD0001G_432_43_20160316_00012.jpg

LM Start	1.08	Rating **	M	Issue No.	43
LM End	1.08	Issue Type +	Ma	Location *	LS
Category	Earthen Levee		GPS Latitude/Longitude		
			Start	End	
Item	Trim / Thin Trees		39.492001 °	39.492001 °	
			-122.020141 °	-122.020141 °	
DWR ID	DWR_LD0001G_01_f_2015_43				
Comment Code					
T1 : Trim trees to at least five feet above ground level.					
Inspector Comment					
Trim the trees that are overhanging the landside slope.

View of the tree limbs on the landside slope.

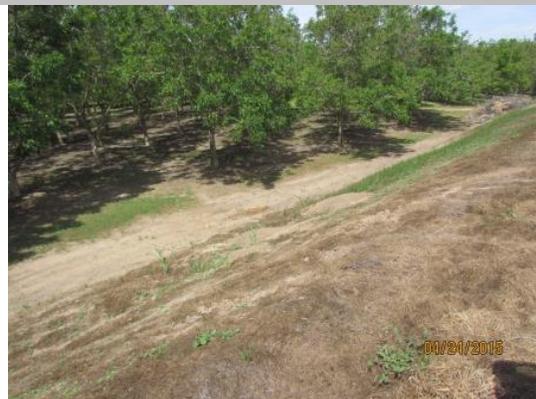
Photo 1 of 1 : SP_2016_LD0001G_432_59_20160316_00026.jpg

LM Start	1.22	Rating **	M	Issue No.	59
LM End	1.22	Issue Type +	Ma	Location *	LS
Category	Earthen Levee		GPS Latitude/Longitude		
			Start	End	
Item	Animal Control		39.493667 °	39.493667 °	
			-122.018643 °	-122.018643 °	
DWR ID	DWR_LD0001G_01_f_2015_59				
Comment Code					
A3 : No rodents visible, but rodent burrows visible; need to backfill and compact or grout burrows.					
Inspector Comment					
The levee district has a rodent program in place.

View of the rodent holes along the landside slope.

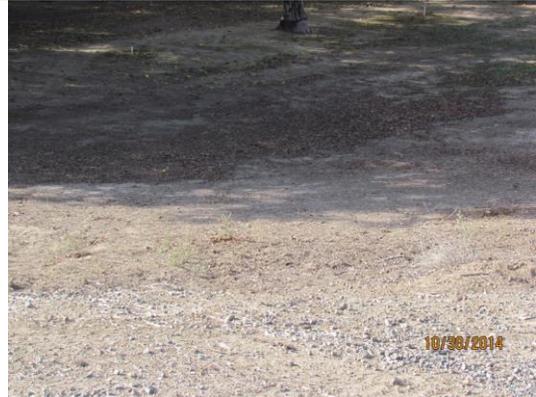
Photo 1 of 1 : SP_2016_LD0001G_432_50_20160316_00018.jpg

LM Start	2.80	Rating **	A/W	Issue No.	50
LM End	2.80	Issue Type +	Ma	Location *	LS
Category	Earthen Levee		GPS Latitude/Longitude		
			Start	End	
Item	Animal Control		39.509503 °	39.509503 °	
			-122.008732 °	-122.008732 °	
DWR ID	DWR_LD0001G_01_f_2014_50				
Comment Code					
A3 : No rodents visible, but rodent burrows visible; need to backfill and compact or grout burrows.					
Inspector Comment

View of the rodent activity along the landside slope.

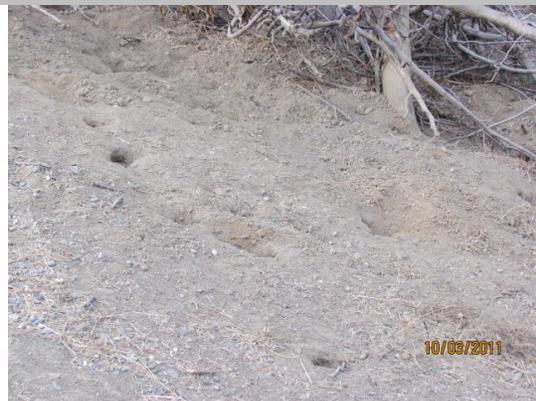
Photo 1 of 1 : SP_2016_LD0001G_432_395_20160316_00034.jpg

LM Start	3.88	Rating **	U	Issue No.	395
LM End	3.88	Issue Type +	Ma	Location *	LS
Category	Earthen Levee		GPS Latitude/Longitude		
			Start	End	
Item	Animal Control		39.523845 °	39.523845 °	
			-122.010745 °	-122.010745 °	
DWR ID	DWR_LD0001G_01_s_2012_395				
Comment Code					
A3 : No rodents visible, but rodent burrows visible; need to backfill and compact or grout burrows.					
Inspector Comment					
Repair the rodent hole on the landside slope.

View of the rodent holes along the L/S toe.

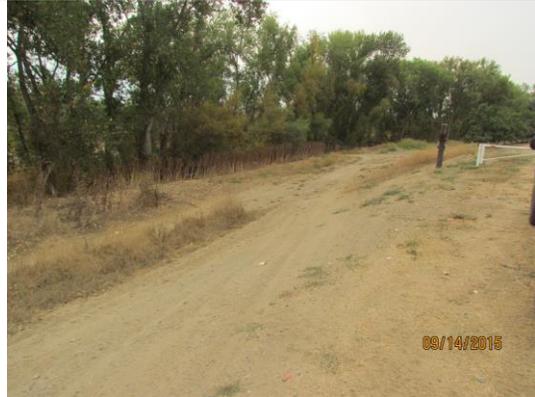
Photo 1 of 1 : SP_2016_LD0001G_432_63_20160316_00030.jpg

LM Start	4.93	Rating **	M	Issue No.	63
LM End	4.93	Issue Type +	Ma	Location *	WS
Category	Earthen Levee		GPS Latitude/Longitude		
			Start	End	
Item	Slope Stability		39.532719 °	39.532719 °	
			-121.995849 °	-121.995849 °	
DWR ID	DWR_LD0001G_01_f_2015_63				
Comment Code					
S3 : Repair the levee slope damaged by vehicle traffic and prevent access where possible.					
Inspector Comment					
Repair the erosion along the waterside slope.

View of the vehicle erosion along the waterside slope.

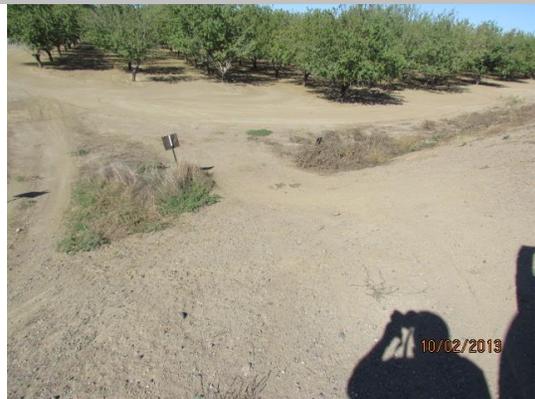
Photo 1 of 1 : SP_2016_LD0001G_432_57_20160316_00024.jpg

LM Start	5.06	Rating **	M	Issue No.	57
LM End	5.06	Issue Type +	Ma	Location *	LS
Category	Earthen Levee		GPS Latitude/Longitude		
			Start	End	
Item	Slope Stability		39.534593 °	39.534593 °	
			-121.995950 °	-121.995950 °	
DWR ID	DWR_LD0001G_01_f_2013_57				
Comment Code					
S3 : Repair the levee slope damaged by vehicle traffic and prevent access where possible.					
Inspector Comment

View of the vehicle erosion along the slope of the levee.

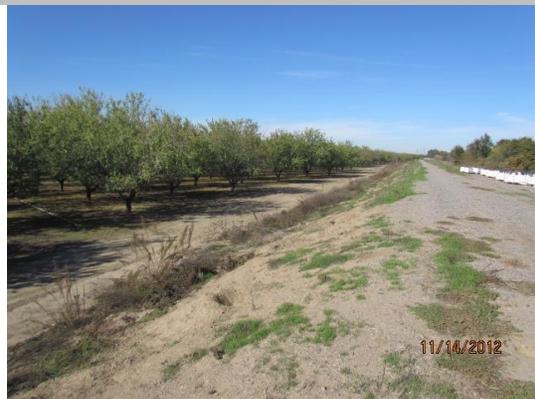
Photo 1 of 1 : SP_2016_LD0001G_432_7_20160316_00004.jpg

LM Start	5.08	Rating **	U	Issue No.	7
LM End	5.17	Issue Type +	Ma	Location *	LS
Category	Earthen Levee		GPS Latitude/Longitude		
			Start	End	
Item	Animal Control		39.534741 °	39.536013 °	
			-121.996024 °	-121.996702 °	
DWR ID	DWR_LD0001G_01_f_2012_7				
Comment Code					
A3 : No rodents visible, but rodent burrows visible; need to backfill and compact or grout burrows.					
Inspector Comment

View of the rodent hole along the levee slope.

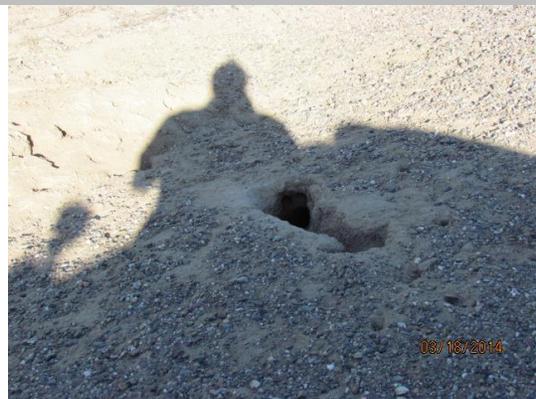
Photo 1 of 1 : SP_2016_LD0001G_432_47_20160316_00015.jpg

LM Start	6.22	Rating **	M	Issue No.	47
LM End	6.22	Issue Type +	Ma	Location *	LS
Category	Earthen Levee		GPS Latitude/Longitude		
			Start	End	
Item	Animal Control		39.550533 °	39.550533 °	
			-122.002319 °	-122.002319 °	
DWR ID	DWR_LD0001G_01_s_2014_47				
Comment Code					
A3 : No rodents visible, but rodent burrows visible; need to backfill and compact or grout burrows.					
Inspector Comment

View of the rodent activity along the l/s slope.

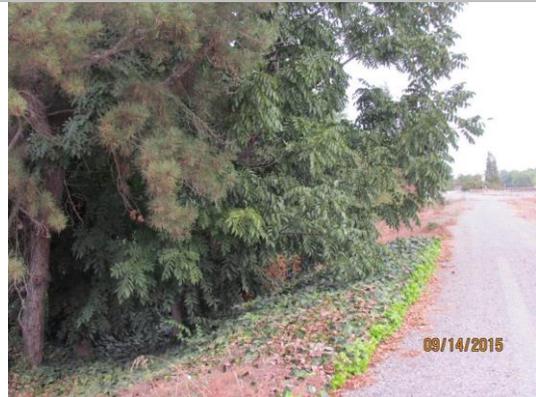
Photo 1 of 1 : SP_2016_LD0001G_432_64_20160316_00031.jpg

LM Start	6.30	Rating **	M	Issue No.	64
LM End	6.30	Issue Type +	Ma	Location *	LS
Category	Earthen Levee		GPS Latitude/Longitude		
			Start	End	
Item	Trim / Thin Trees		39.551666 °	39.551666 °	
			-122.002639 °	-122.002639 °	
DWR ID	DWR_LD0001G_01_f_2015_64				
Comment Code					
T1 : Trim trees to at least five feet above ground level.					
Inspector Comment					
Trim the trees along the landside slope.

View of the trees along the landside toe.

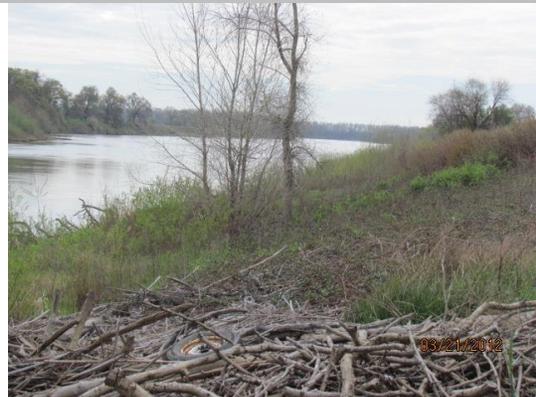
Photo 1 of 1 : SP_2016_LD0001G_432_10_20160316_00006.jpg

LM Start	6.38	Rating **	A/W	Issue No.	10
LM End	6.64	Issue Type +	Ma	Location *	WS
Category	Earthen Levee		GPS Latitude/Longitude		
			Start	End	
Item	Vegetation		39.552691 °	39.556459 °	
			-122.003063 °	-122.003831 °	
DWR ID	DWR_LD0001G_01_s_2012_10				
Comment Code					
V8 : Environmental Requirements.					
Inspector Comment

View of the Army Corps of Engineers mitigation site.

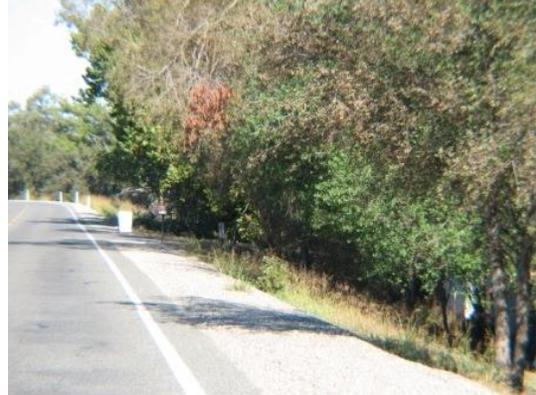
Photo 1 of 1 : SP_2016_LD0001G_432_20_20160316_00009.jpg

LM Start	8.05	Rating **	M	Issue No.	20
LM End	8.16	Issue Type +	Ma	Location *	WS
Category	Earthen Levee		GPS Latitude/Longitude		
			Start	End	
Item	Trim / Thin Trees		39.576580 °	39.578187 °	
			-122.004962 °	-122.005218 °	
DWR ID	DWR_LD0001G_01_s_2012_20				
Comment Code					
T2 : Thin trees to allow visibility of the ground and room to flood fight.					
Inspector Comment

View of the trees and vegetation along the waterside slope of the levee.

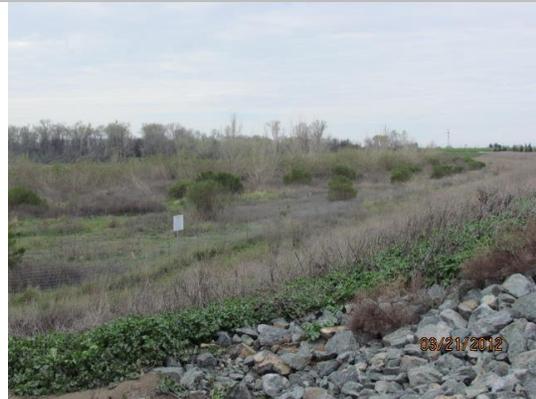
Photo 1 of 1 : SP_2016_LD0001G_432_8_20160316_00005.jpg

LM Start	9.50	Rating **	A/W	Issue No.	8
LM End	10.40	Issue Type +	Ma	Location *	WS
Category	Earthen Levee		GPS Latitude/Longitude		
			Start	End	
Item	Vegetation		39.596192 °	39.607288 °	
			-122.002573 °	-121.994565 °	
DWR ID	DWR_LD0001G_01_s_2012_8				
Comment Code					
V8 : Environmental Requirements.					
Inspector Comment

View of the Army Corps of Engineers mitigation site.

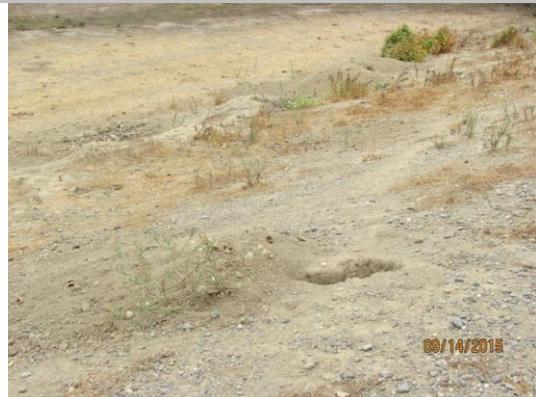
Photo 1 of 1 : SP_2016_LD0001G_432_66_20160316_00033.jpg

LM Start	11.10	Rating **	U	Issue No.	66
LM End	11.18	Issue Type +	Ma	Location *	WS
Category	Earthen Levee		GPS Latitude/Longitude		
			Start	End	
Item	Animal Control		39.617252 °	39.618192 °	
			-121.994605 °	-121.995609 °	
DWR ID	DWR_LD0001G_01_f_2015_66				
Comment Code					
A1 : Exterminate rodents and backfill and compact or grout burrows.					
Inspector Comment					
Repair the rodent holes along the waterside slope.

View of the rodent holes along the waterside slope.

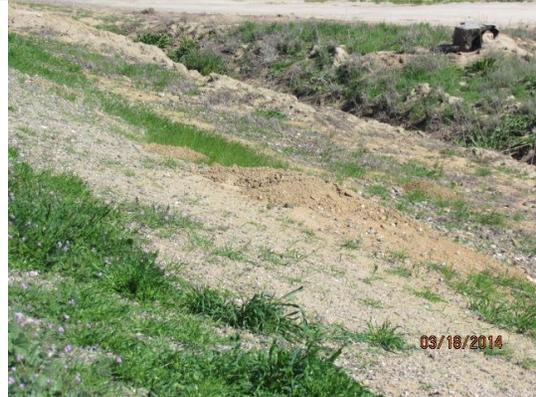
Photo 1 of 1 : SP_2016_LD0001G_432_48_20160316_00016.jpg

LM Start	11.51	Rating **	M	Issue No.	48
LM End	11.57	Issue Type +	Ma	Location *	WS
Category	Earthen Levee		GPS Latitude/Longitude		
			Start	End	
Item	Animal Control		39.622083 °	39.622821 °	
			-121.998858 °	-121.999244 °	
DWR ID	DWR_LD0001G_01_s_2014_48				
Comment Code					
A3 : No rodents visible, but rodent burrows visible; need to backfill and compact or grout burrows.					
Inspector Comment

View of the rodent activity along the waterside slope.
