**Flood Control Project Maintenance  
Levee Inspections**

## Maintenance Issue Types Only, Levee Inspection Report By Mile - Spring 2017

### Levee District No. 0001 (Glenn County)

Waterway	Bank	Unit Miles	Inspection Start/End	Inspector
Unit No. 01 Sacramento River	Right	12.23	03/28/2017 03/28/2017	Bob Duffey

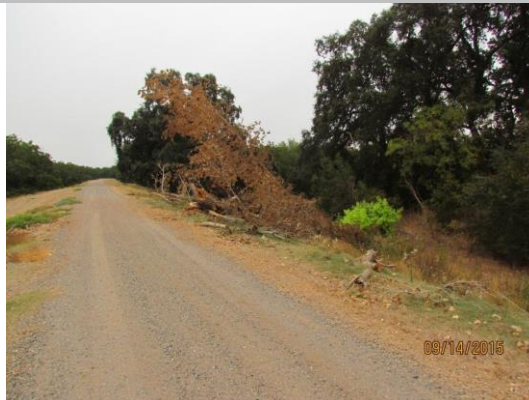
Photo 1 of 2 : SP\_2017\_LD0001G\_432\_41\_20170315\_00010.jpg

LM Start	<b>0.25</b>	Rating **	M	Issue No.	<b>41</b>
LM End	<b>0.25</b>	Issue Type +	Ma	Location *	WS
Category	Earthen Levee		GPS Latitude/Longitude		
			Start	End	
Item	Encroachments		39.480769 °	39.480769 °	
			-122.017301 °	-122.017301 °	
DWR ID	DWR_LD0001G_01_f_2015_41				
Comment Code					
TR : Tree or limb					
Inspector Comment					
Remove tree from the waterside slope.

View of the tree on the waterside slope.

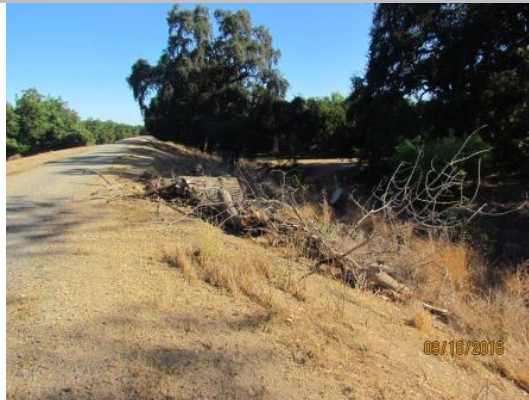
Photo 2 of 2 : SP\_2017\_LD0001G\_432\_41\_20170315\_00011.jpg

View of the fallen tree on the waterside slope looking upstream.

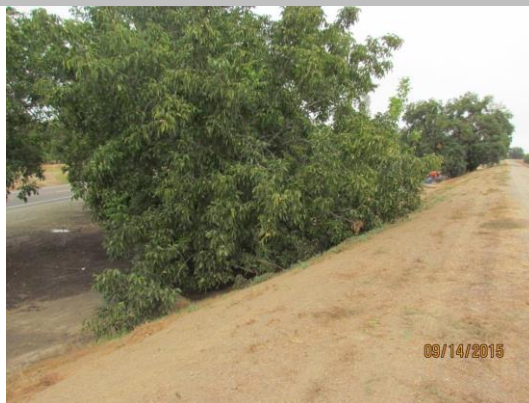
Photo 1 of 1 : SP\_2017\_LD0001G\_432\_43\_20170315\_00012.jpg

View of the tree limbs on the landside slope.

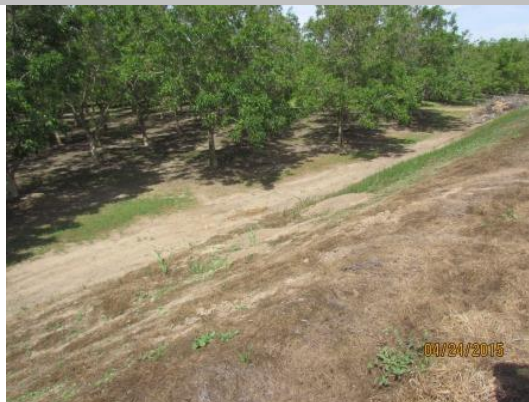
Photo 1 of 2 : SP\_2017\_LD0001G\_432\_59\_20170315\_00025.jpg

LM Start	1.22	Rating **	M	Issue No.	59
LM End	1.22	Issue Type +	Ma	Location *	LS
Category	Earthen Levee			GPS Latitude/Longitude	
				Start	End
Item	Animal Control			39.493667 °	39.493667 °
				-122.018643 °	-122.018643 °
DWR ID	DWR_LD0001G_01_f_2015_59				
Comment Code					
A3 : No rodents visible, but rodent burrows visible; need to backfill and compact or grout burrows.					
Inspector Comment					
The levee district has a rodent program in place.

View of the rodent holes along the landside slope.

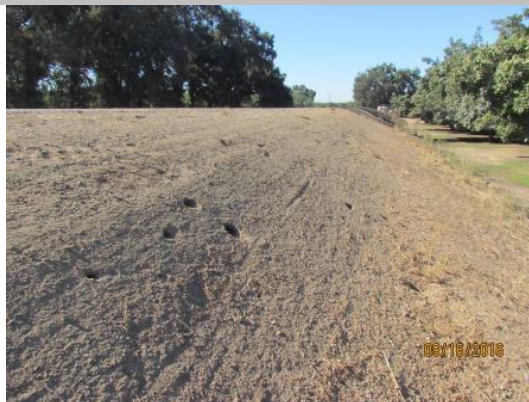
Photo 2 of 2 : SP\_2017\_LD0001G\_432\_59\_20170315\_00026.jpg

View of the rodent holes along the landside slope.

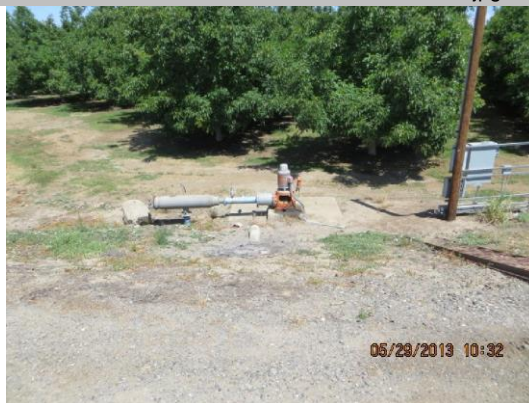
Photo 1 of 3 : UCIP\_SP\_2017\_14332\_23582.jpg

LM Start	2.22	Rating **	M	Issue No.	402
LM End	2.22	Issue Type +	Ma	Location *	LS
Category	Supplemental			GPS Latitude/Longitude	
				Start	End
Item	DWR UCIP LMA Responsibility			39.501690 °	39.501690 °
				-122.006099 °	-122.006099 °
DWR ID					
Comment Code					
Inspector Comment					
FS_ID:14332					
DS_ID:22944					
EP_NO: N/A					
Repair Type: Non-Urgent					
Crossing Status: Found					
UCIP Comments: Appears abandoned and should be done so properly.					
FIELD_STRUCT_DESC: *ABANDONED* 8-inch pipe of unknown material sleeved through a 12-inch pipe of unknown material through levee, 9.5 feet below crown. Flap gate is located on the waterside (WS). Pipe is opened on the landside (LS). [Additional Reference(s): USACE Sacramento O&M Manual Unit 140, May 1960, (HLM 2.27)].					
FS Date: 5/29/2013

Pump at location of pipe on LS toe.

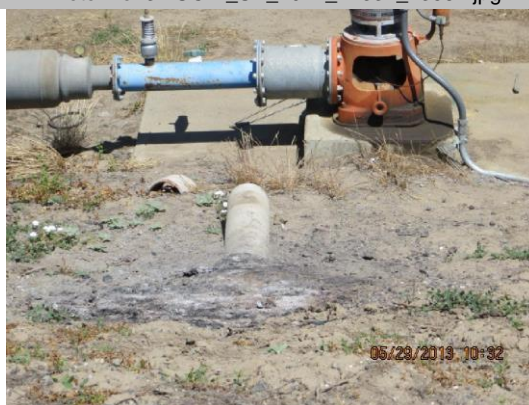
Photo 2 of 3 : UCIP\_SP\_2017\_14332\_23581.jpg

Pipe next to pump at LS toe.

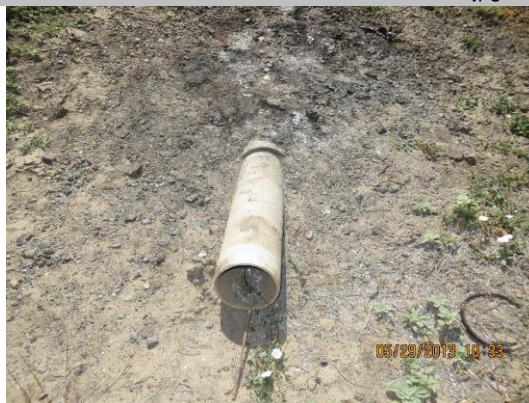
Photo 3 of 3 : UCIP\_SP\_2017\_14332\_23580.jpg

LM Start	2.22	Rating **	M	Issue No.	402 (cont)
LM End	2.22	Issue Type +	Ma	Location *	LS
Category	Supplemental			GPS Latitude/Longitude	
				Start	End
Item	DWR UCIP LMA Responsibility			39.501690 °	39.501690 °
				-122.006099 °	-122.006099 °
DWR ID					
Comment Code					
Inspector Comment					
FS_ID:14332					
DS_ID:22944					
EP_NO: N/A					
Repair Type: Non-Urgent					
Crossing Status: Found					
UCIP Comments: Appears abandoned and should be done so properly.					
FIELD_STRUCT_DESC: *ABANDONED* 8-inch pipe of unknown material sleeved through a 12-inch pipe of unknown material through levee, 9.5 feet below crown. Flap gate is located on the waterside (WS). Pipe is opened on the landside (LS). [Additional Reference(s): USACE Sacramento O&M Manual Unit 140, May 1960, (HLM 2.27)].					
FS Date: 5/29/2013

8-inch pipe sleeved through a 12-inch concrete pipe.

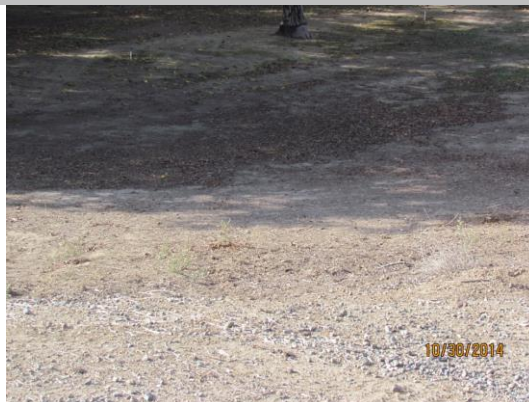
Photo 1 of 1 : SP\_2017\_LD0001G\_432\_50\_20170315\_00017.jpg

LM Start	2.80	Rating **	M	Issue No.	50
LM End	2.80	Issue Type +	Ma	Location *	LS
Category	Earthen Levee			GPS Latitude/Longitude	
				Start	End
Item	Animal Control			39.509503 °	39.509503 °
				-122.008732 °	-122.008732 °
DWR ID	DWR_LD0001G_01_f_2014_50				
Comment Code					
A3 : No rodents visible, but rodent burrows visible; need to backfill and compact or grout burrows.					
Inspector Comment

View of the rodent activity along the landside slope.

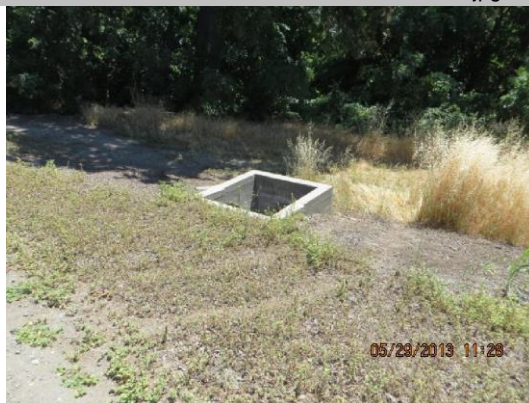
Photo 1 of 3 : UCIP\_SP\_2017\_51463\_27386.jpg

FS\_ID:51463  
DS\_ID:22904  
EP\_NO: 9572  
Repair Type: Urgent  
Crossing Status: Found  
UCIP Comments: 12/21/2016 Flap gate on WS does not appear to be broken however, flap gate does not fully close due to a 3-inch aluminum pipe sleeve through larger pipe. Need to remove 3-inch pipe in order to have WS flap gate close and to be compliant with Title 23. (O. Magana - DWR UCIP)05/29/2013 Broken flap gate and Concrete headwall on LS toe possibly tilting. Also a 3-inch alluminum irrigation line through the pipe. (W. Wylie - DWR UCIP)  
FIELD\_STRUCT\_DESC: 18-inch steel drainage pipe through levee, 7.3 feet below crown. Flap gate in 6-inch by 6-inch concrete box located on the waterside (WS) end. Concrete headwall located on the landside (LS) toe. (18-inch pipe authorized under Automatic Board Order (ABO) issued as Permit No. 9572, 1974 - H. & A. Smith). [Additional Reference(s): DWR Levee Log, 1992. USACE Sacramento O&M Manual Unit 140, May 1960, (HLM 4.05)].

Distribution box on WS toe.

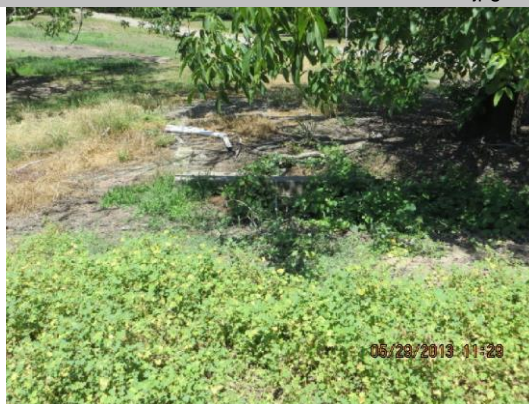
Photo 2 of 3 : UCIP\_SP\_2017\_51463\_27385.jpg

Headwall on LS toe.

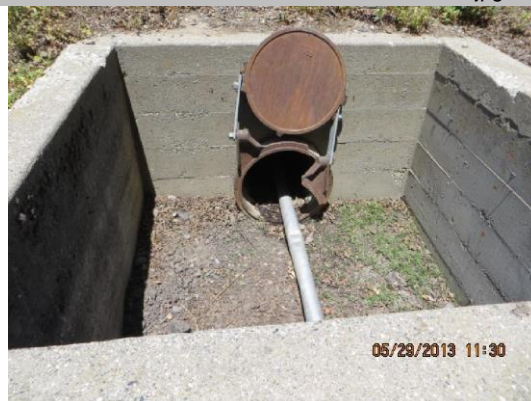
Photo 3 of 3 : UCIP\_SP\_2017\_51463\_27384.jpg

Comment Code					
Inspector Comment					
FS_ID:51463 DS_ID:22904 EP_NO: 9572 Repair Type: Urgent Crossing Status: Found UCIP Comments: 12/21/2016 Flap gate on WS does not appear to be broken however, flap gate does not fully close due to a 3-inch aluminum pipe sleeve through larger pipe. Need to remove 3-inch pipe in order to have WS flap gate close and to be compliant with Title 23. (O. Magana - DWR UCIP)05/29/2013 Broken flap gate and Concrete headwall on LS toe possibly tilting. Also a 3-inch alluminum irrigation line through the pipe. (W. Wylie - DWR UCIP) FIELD_STRUCT_DESC: 18-inch steel drainage pipe through levee, 7.3 feet below crown. Flap gate in 6-inch by 6-inch concrete box located on the waterside (WS) end. Concrete headwall located on the landside (LS) toe. (18-inch pipe authorized under Automatic Board Order (ABO) issued as Permit No. 9572, 1974 - H. & A. Smith). [Additional Reference(s): DWR Levee Log, 1992. USACE Sacramento O&M Manual Unit 140, May 1960, (HLM 4.05)]. FS Date: 12/21/2016

Distribution box on WS toe with broken flap gate and 3-inch aluminum irrigation pipe.

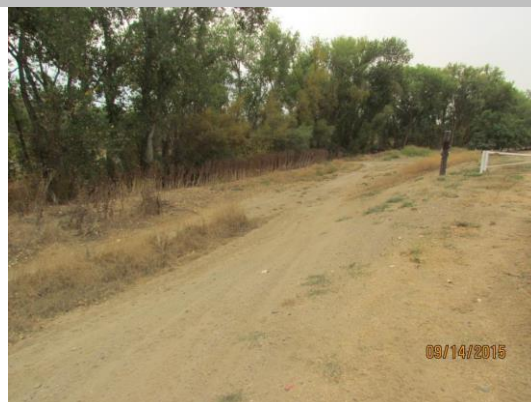
Photo 1 of 1 : SP\_2017\_LD0001G\_432\_63\_20170315\_00030.jpg

LM Start	4.93	Rating **	M	Issue No.	63
LM End	4.93	Issue Type +	Ma	Location *	WS
Category	Earthen Levee			GPS Latitude/Longitude	
				Start	End
Item	Slope Stability			39.532719 °	39.532719 °
				-121.995849 °	-121.995849 °
DWR ID	DWR_LD0001G_01_f_2015_63				
Comment Code					
S3 : Repair the levee slope damaged by vehicle traffic and prevent access where possible.					
Inspector Comment					
Repair the erosion along the WS slope.

View of the vehicle erosion along the waterside slope.

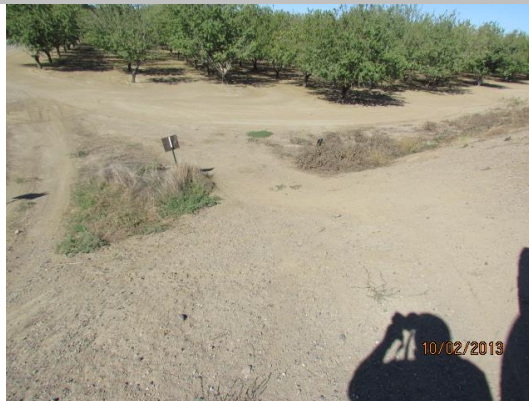
Photo 1 of 1 : SP\_2017\_LD0001G\_432\_57\_20170315\_00023.jpg

LM Start	5.06	Rating **	M	Issue No.	57
LM End	5.06	Issue Type +	Ma	Location *	LS
Category	Earthen Levee			GPS Latitude/Longitude	
				Start	End
Item	Slope Stability			39.534593 °	39.534593 °
				-121.995950 °	-121.995950 °
DWR ID	DWR_LD0001G_01_f_2013_57				
Comment Code					
S3 : Repair the levee slope damaged by vehicle traffic and prevent access where possible.					
Inspector Comment

View of the vehicle erosion along the slope of the levee.

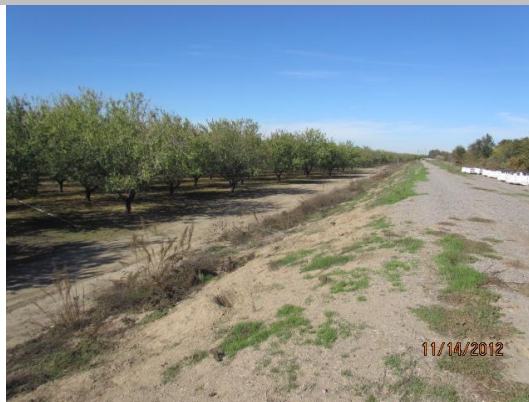
Photo 1 of 1 : SP\_2017\_LD0001G\_432\_7\_20170315\_00003.jpg

LM Start	5.08	Rating **	U	Issue No.	7
LM End	5.17	Issue Type +	Ma	Location *	LS
Category	Earthen Levee			GPS Latitude/Longitude	
				Start	End
Item	Animal Control			39.534741 °	39.536013 °
				-121.996024 °	-121.996702 °
DWR ID	DWR_LD0001G_01_f_2012_7				
Comment Code					
A3 : No rodents visible, but rodent burrows visible; need to backfill and compact or grout burrows.					
Inspector Comment

View of the rodent hole along the levee slope.

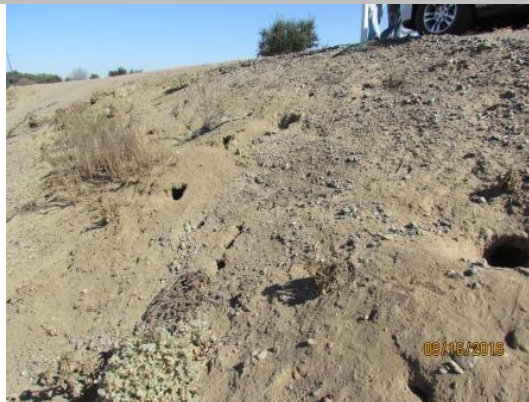
Photo 1 of 1 : SP\_2017\_LD0001G\_432\_67\_20170315\_00034.jpg

LM Start	5.22	Rating **	U	Issue No.	67
LM End	5.22	Issue Type +	Ma	Location *	LS
Category	Earthen Levee			GPS Latitude/Longitude	
				Start	End
Item	Animal Control			39.536750 °	39.536750 °
				-121.997090 °	-121.997090 °
DWR ID	DWR_LD0001G_01_s _ 2016_67				
Comment Code					
A1 : Exterminate rodents and backfill and compact or grout burrows.					
Inspector Comment					
Rodent holes on the LS slope need to be backfilled.

View of the rodent holes along the landside slope.

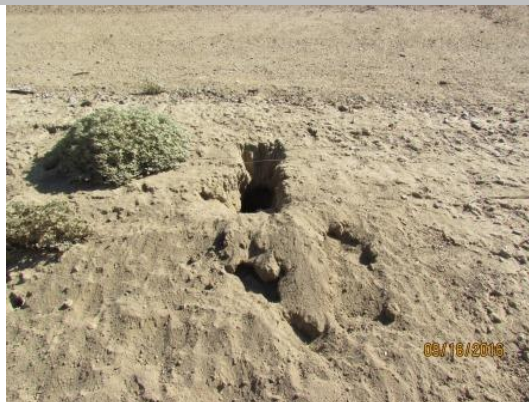
Photo 1 of 1 : SP\_2017\_LD0001G\_432\_75\_20170315\_00039.jpg

LM Start	5.55	Rating **	U	Issue No.	75
LM End	5.55	Issue Type +	Ma	Location *	LS
Category	Earthen Levee			GPS Latitude/Longitude	
				Start	End
Item	Animal Control			39.541110 °	39.541110 °
				-121.999348 °	-121.999348 °
DWR ID	DWR_LD0001G_01_f _ 2016_75				
Comment Code					
A1 : Exterminate rodents and backfill and compact or grout burrows.					
Inspector Comment					
Large rodent hole on the landside toe.

View of the rodent holes along the landside slope.

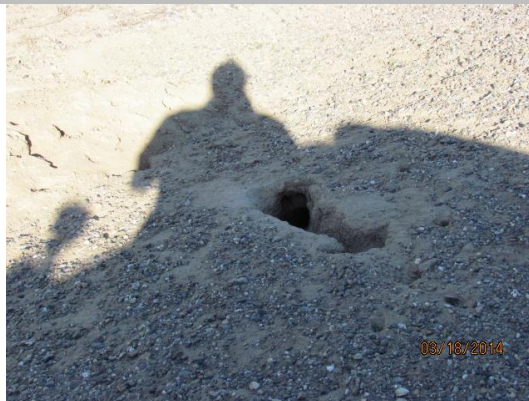
Photo 1 of 1 : SP\_2017\_LD0001G\_432\_47\_20170315\_00014.jpg

View of the rodent activity along the l/s slope.

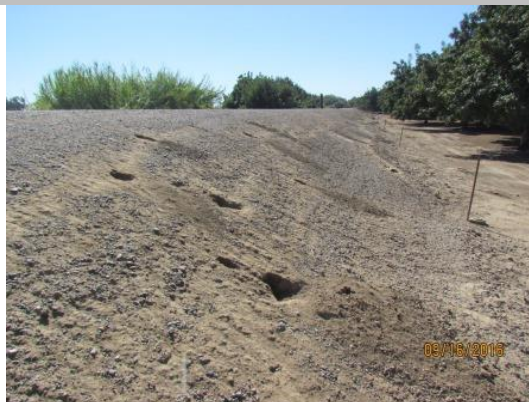
Photo 1 of 1 : SP\_2017\_LD0001G\_432\_76\_20170315\_00040.jpg

LM Start	6.24	Rating **	M	Issue No.	76
LM End	6.24	Issue Type +	Ma	Location *	LS
Category	Earthen Levee			GPS Latitude/Longitude	
				Start	End
Item	Animal Control			39.550725 °	39.550725 °
				-122.002370 °	-122.002370 °
DWR ID	DWR_LD0001G_01_f_2016_76				
Comment Code					
A3 : No rodents visible, but rodent burrows visible; need to backfill and compact or grout burrows.					
Inspector Comment

View of the rodent holes along the landside slope.

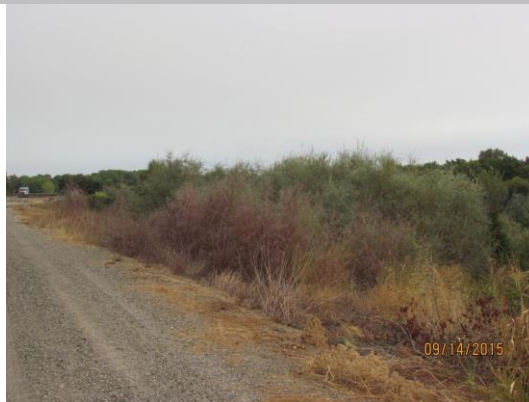
Photo 1 of 1 : SP\_2017\_LD0001G\_432\_65\_20170315\_00032.jpg

LM Start	6.30	Rating **	M	Issue No.	65
LM End	6.30	Issue Type +	Ma	Location *	WS
Category	Earthen Levee			GPS Latitude/Longitude	
				Start	End
Item	Vegetation			39.551665 °	39.551665 °
				-122.002639 °	-122.002639 °
DWR ID	DWR_LD0001G_01_f _ 2015_65				
Comment Code					
V2 : Remove the wild growth other than native grasses from the levee slopes.					
Inspector Comment					
Remove the vegetation from the waterside slope and toe.

View of the vegetation along the waterside slope and toe.

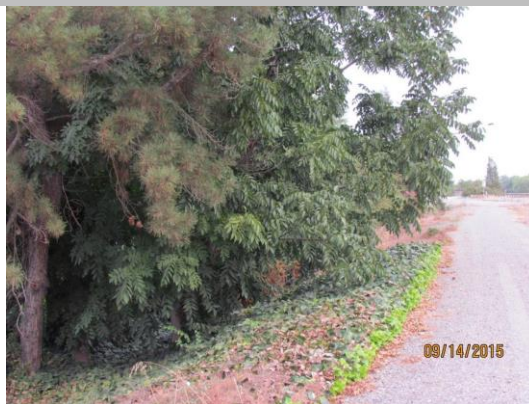
Photo 1 of 1 : SP\_2017\_LD0001G\_432\_64\_20170315\_00031.jpg

View of the trees along the landside toe.

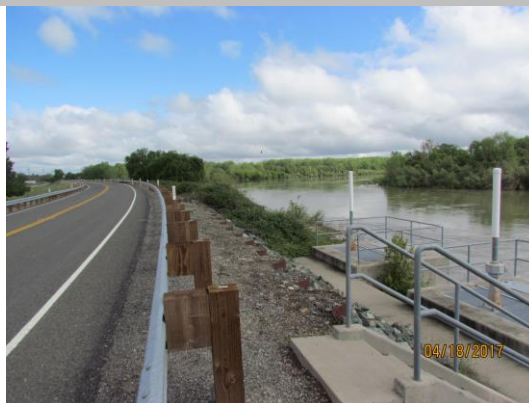
Photo 1 of 1 : SP\_2017\_LD0001G\_432\_77\_20170418\_00122.jpg

View of the vegetation along the waterside slope.

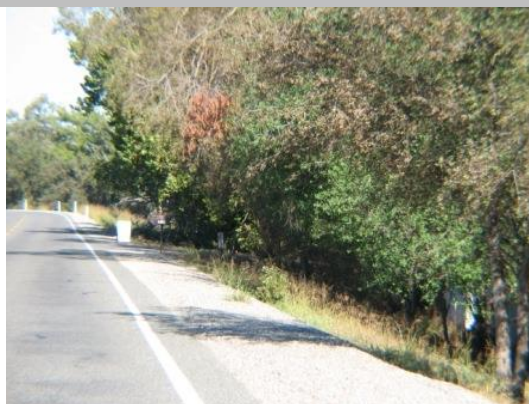
Photo 1 of 1 : SP\_2017\_LD0001G\_432\_20\_20170315\_00008.jpg

LM Start	8.05	Rating **	M	Issue No.	20
LM End	8.16	Issue Type +	Ma	Location *	WS
Category	Earthen Levee			GPS Latitude/Longitude	
				Start	End
Item	Trim / Thin Trees			39.576580 °	39.578187 °
				-122.004962 °	-122.005218 °
DWR ID	DWR_LD0001G_01_s_2012_20				
Comment Code					
T2 : Thin trees to allow visibility of the ground and room to flood fight.					
Inspector Comment

View of the trees and vegetation along the waterside slope of the levee.

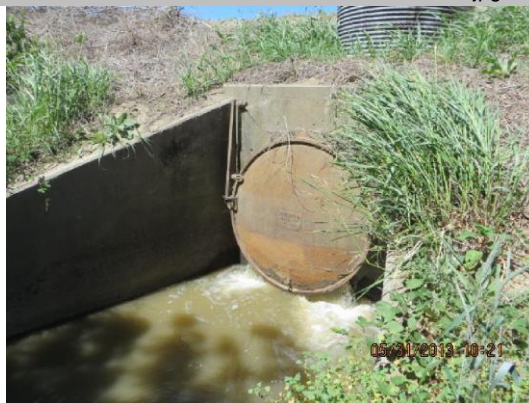
Photo 3 of 3 : UCIP\_SP\_2017\_14389\_23684.jpg

Item	DWR UCIP LMA Responsibility			39.596012 °	39.596012 °	
				-122.002638 °	-122.002638 °	
DWR ID						
Comment Code						
Inspector Comment						
FS_ID:14389						
DS_ID:22920						
EP_NO: 9560						
Repair Type: Non-Urgent						
Crossing Status: Found						
UCIP Comments: Heavy rust along springline of pipe. Pipe has slight deformation at centerline of levee, not noticable on crown.						
FIELD_STRUCT_DESC: 72-inch corrugated metal drainage pipe through levee, 15 feet below crown. Flap gate located on the waterside (WS) end. Slide gate in 8-inch corrugated metal pipe (CMP) riser on WS slope. Concrete headwalls on both ends. Two corrugated metal cutoff walls. (72-inch pipe authorized under Automatic Board Order (ABO) issued under Permit No. 9560, 1974 - J. & L. Friesen).						
[Additional Reference(s): DWR Levee Log, 1992. USACE Sacramento O&M Manual Unit 140, May 1960, (HLM 9.64)].						
FS Date: 5/31/2013

Flap gate and headwall on WS toe.

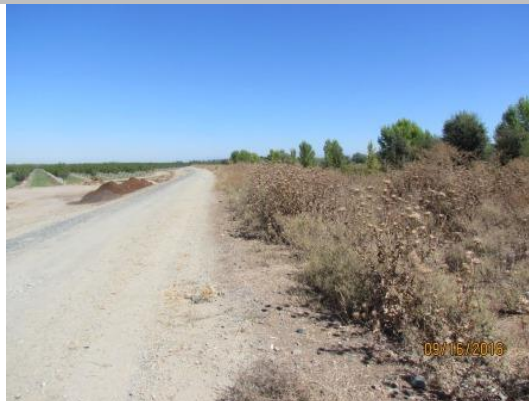
Photo 1 of 1 : SP\_2017\_LD0001G\_432\_78\_20170315\_00041.jpg

View of the waterside vegetation looking upstream.

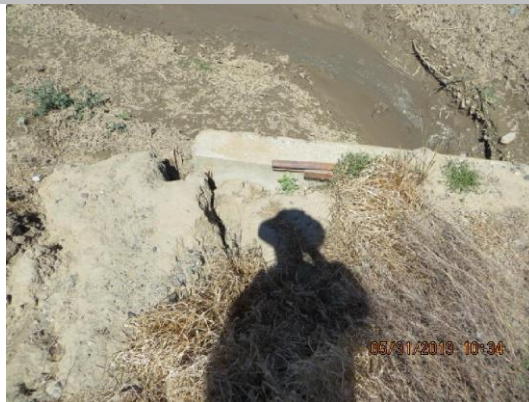
Photo 3 of 3 : UCIP\_SP\_2017\_14390\_23688.jpg

Erosion around headwall at LS toe.

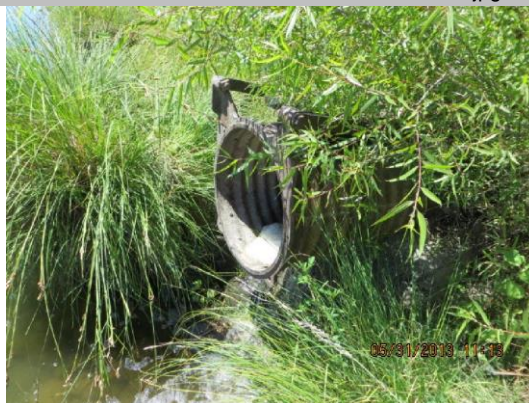
Photo 3 of 3 : UCIP\_SP\_2017\_51286\_24004.jpg

FS\_ID:51286  
DS\_ID:22924  
EP\_NO: 9556  
Repair Type: Urgent  
Crossing Status: Found  
UCIP Comments: 12/21/2016 same as last inspection flap gate disabled in open position. Surface erosion observed on LS slope. Recommend repair on WS flap gate to be able to close flap gate. (O. Magana - DWR UCIP)05/31/2013 Flap gate dissabled in open position. Pipe rusted through at WS toe upstream of Flapgate. (W. Wylie - DWR UCIP)  
FIELD\_STRUCT\_DESC: 24-inch corrugated metal drainage pipe through levee, 15 feet below crown. Flap gate is located on the waterside (WS) end. Slide gate is inside a corrugated metal pipe (CMP) riser located on the WS slope. Two CM cutoff walls. Concrete headwall is located on LS and under outlet at the WS toe. (24-inch pipe authorized under Automatic Board Order (ABO) issued as Permit No. 9556, 1974 - E. R & M. R. Cooper). [Additional Reference(s): DWR Levee Log, 1992. USACE Sacramento O&M Manual Unit 140, May 1960, (HLM 10.59)].

Pipe and flapgate at WS toe.

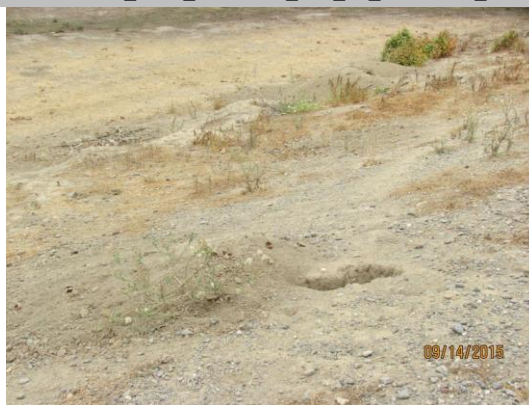
Photo 1 of 1 : SP\_2017\_LD0001G\_432\_66\_20170315\_00033.jpg

View of the rodent holes along the waterside slope.

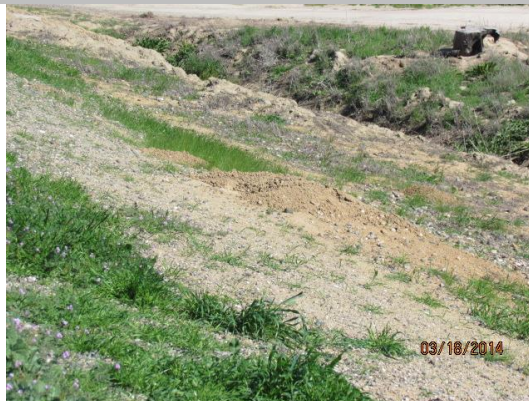
Photo 1 of 1 : SP\_2017\_LD0001G\_432\_48\_20170315\_00015.jpg

View of the rodent activity along the waterside slope.

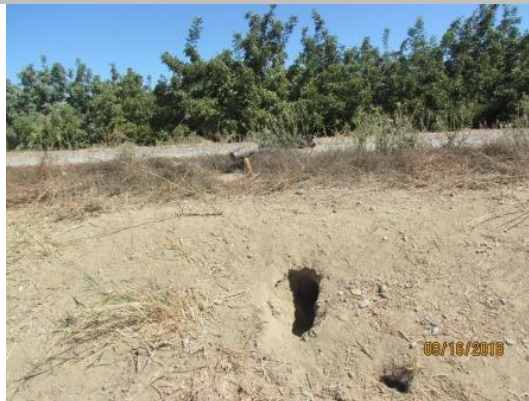
Photo 1 of 2 : SP\_2017\_LD0001G\_432\_79\_20170315\_00042.jpg

View of the rodent holes along the landside slope with large hammer sitting in the hole.

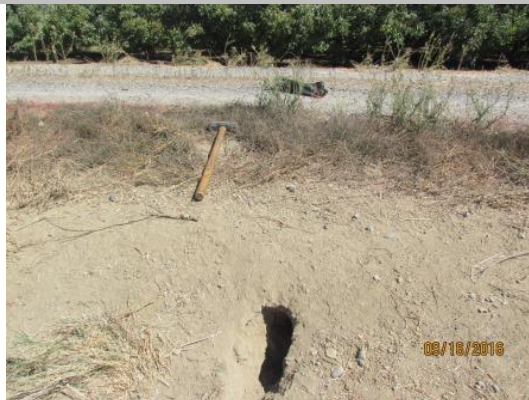
Photo 2 of 2 : SP\_2017\_LD0001G\_432\_79\_20170315\_00043.jpg

Another view of the rodent holes along the landside slope with a large hammer sitting next to the hole.
