**Flood Control Project Maintenance
Levee Inspections**

Maintenance Issue Types Only, Levee Inspection Report By Mile - Spring 2020

Levee District No. 0001 (Glenn County)

Waterway	Bank	Unit Miles	Inspection Start/End	Inspector
Unit No. 01 Sacramento River	Right	12.23	04/02/2020 04/02/2020	Makar Sokol

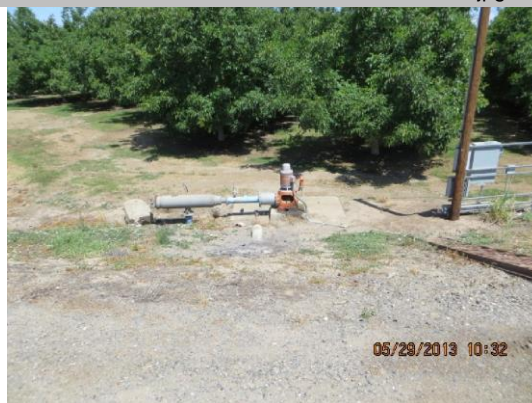
Photo 1 of 3 : UCIP_SP_2020_14332_23582.jpg

LM Start	2.22	Rating **	M	Issue No.	102	
LM End	2.22	Issue Type +	Ma	Location *		
Category	Supplemental			GPS Latitude/Longitude		
				Start		End
Item	DWR UCIP LMA Responsibility			39.501690 °		39.501690 °
				-122.006099 °		-122.006099 °
DWR ID	22944					
Comment Code						
Inspector Comment						
DS_ID:22944 FS_ID:14332 EP_NO: N/A Repair Type: Non-Urgent Crossing Status: Found UCIP Comments: Appears abandoned and should be done so properly. FIELD_STRUCT_DESC: *ABANDONED* 8-inch drainage pipe of an unknown material sleeved through a 12-inch pipe of an unknown material through the levee, 9.5 feet below the crown. Flap gate located on the waterside (WS). Pipe open on the landside (LS). [Additional Reference(s): USACE Sacramento O&M Manual 140, May 1960, (HLM 2.27)]. FS Date: 5/29/2013

Pump at location of pipe on LS toe.

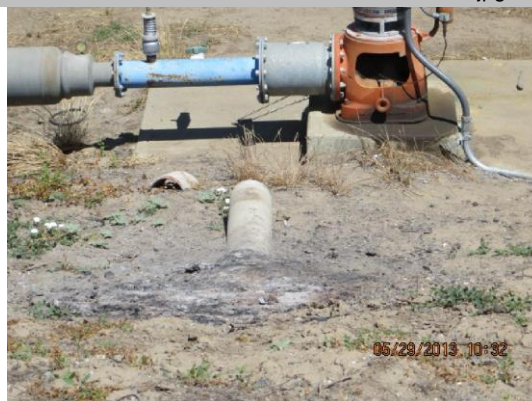
Photo 2 of 3 : UCIP_SP_2020_14332_23581.jpg

Pipe next to pump at LS toe.

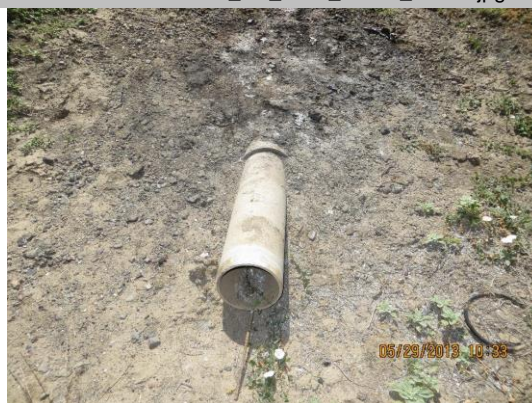
Photo 3 of 3 : UCIP_SP_2020_14332_23580.jpg

8-inch pipe sleeved through a 12-inch concrete pipe.

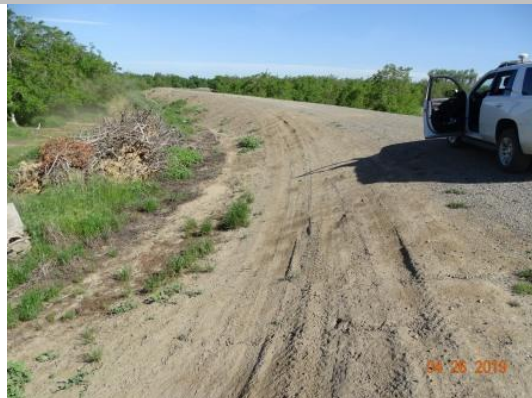
Photo 1 of 1 : SP_2020_LD0001G_432_77_20200226_00024.jpg

LM Start	3.04	Rating **	M	Issue No.	77
LM End	3.04	Issue Type +	Ma	Location *	LS
Category	Earthen Levee			GPS Latitude/Longitude	
				Start	End
Item	Slope Stability			39.512932 °	39.512932 °
				-122.009074 °	-122.009074 °
DWR ID	DWR_LD0001G_01_s_2019_77				
Comment Code					
S3 : Repair the levee slope damaged by vehicle traffic and prevent access where possible.					
Inspector Comment

View of the landside slope damaged by vehicle traffic. Spring 2019.

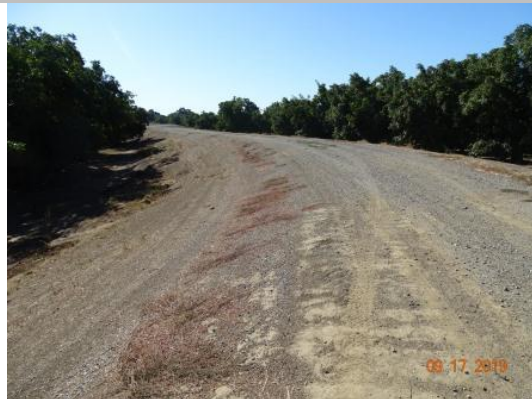
Photo 1 of 1 : SP_2020_LD0001G_432_68_20200226_00019.jpg

LM Start	3.26	Rating **	M	Issue No.	68
LM End	3.26	Issue Type +	Ma	Location *	WS
Category	Earthen Levee			GPS Latitude/Longitude	
				Start	End
Item	Slope Stability			39.515595 °	39.515595 °
				-122.011152 °	-122.011152 °
DWR ID	DWR_LD0001G_01_f_2019_68				
Comment Code					
S3 : Repair the levee slope damaged by vehicle traffic and prevent access where possible.					
Inspector Comment

View of the waterside slope damaged by vehicle traffic. Fall 2019.

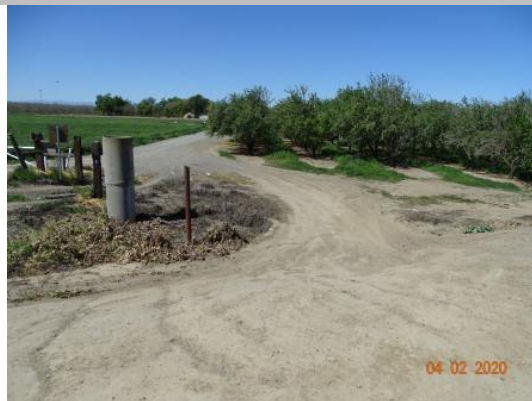
Photo 1 of 1 : SP_2020_LD0001G_432_57_20200413_00099.jpg

LM Start	5.06	Rating **	M	Issue No.	57
LM End	5.06	Issue Type +	Ma	Location *	LS
Category	Earthen Levee			GPS Latitude/Longitude	
				Start	End
Item	Slope Stability			39.534593 °	39.534593 °
				-121.995950 °	-121.995950 °
DWR ID	DWR_LD0001G_01_f_2013_57				
Comment Code					
S3 : Repair the levee slope damaged by vehicle traffic and prevent access where possible.					
Inspector Comment

View of the vehicle erosion along the landside slope Spring 2020.

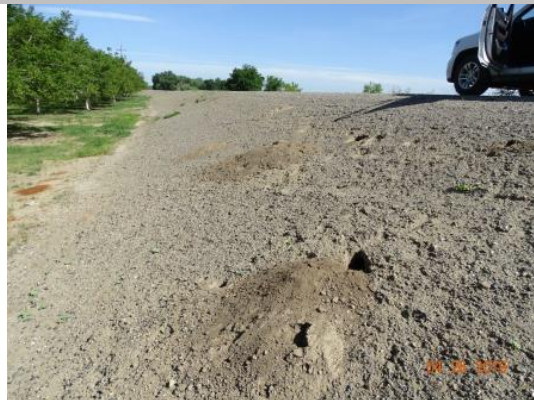
Photo 1 of 1 : SP_2020_LD0001G_432_82_20200226_00026.jpg

View of the rodent activity on the landside slope. Spring 2019.

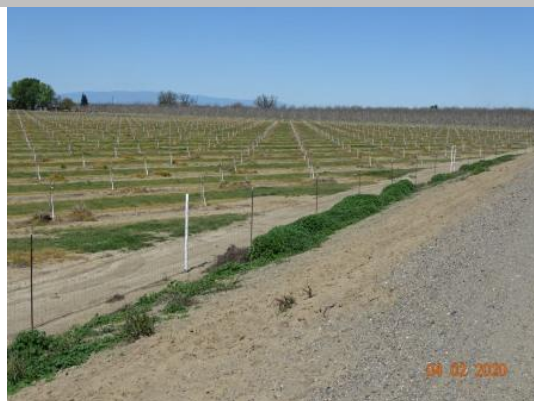
Photo 1 of 1 : SP_2020_LD0001G_432_62_20200413_00100.jpg

LM Start	5.53	Rating **	M	Issue No.	62
LM End	5.59	Issue Type +	Ma	Location *	LS
Category	Earthen Levee			GPS Latitude/Longitude	
				Start	End
Item	Slope Stability			39.540857 °	39.541669 °
				-121.999174 °	-121.999642 °
DWR ID	DWR_LD0001G_01_s_2020_62				
Comment Code					
S3 : Repair the levee slope damaged by vehicle traffic and prevent access where possible.					
Inspector Comment

View of the landside levee slope damaged by vehicle traffic. Spring 2020.

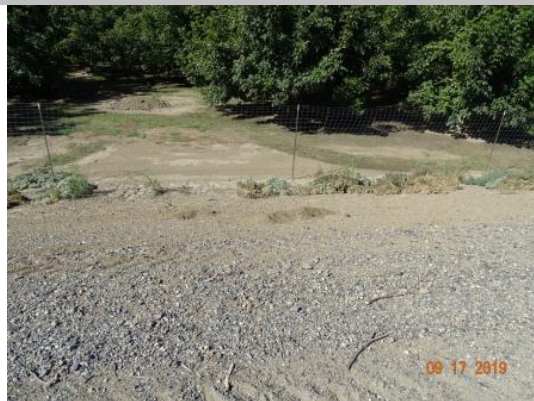
Photo 1 of 1 : SP_2020_LD0001G_432_84_20200226_00027.jpg

LM Start	5.78	Rating **	M	Issue No.	84
LM End	5.81	Issue Type +	Ma	Location *	LS
Category	Earthen Levee			GPS Latitude/Longitude	
				Start	End
Item	Animal Control			39.544295 °	39.544590 °
				-122.000934 °	-122.001047 °
DWR ID	DWR_LD0001G_01_f_2019_84				
Comment Code					
A3 : No rodents visible, but rodent burrows visible; need to backfill and compact or grout burrows.					
Inspector Comment

View of the rodent activity on the landside slope. Fall 2019.

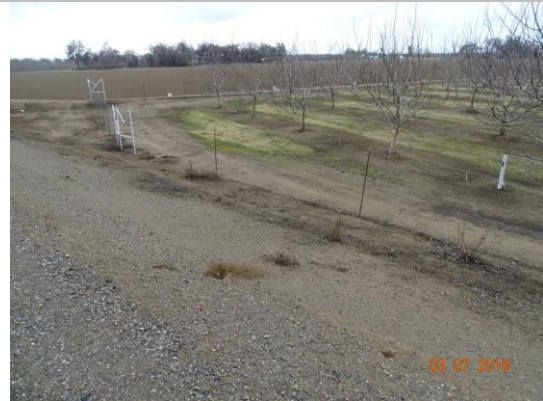
Photo 1 of 1 : SP_2020_LD0001G_432_70_20200226_00020.jpg

View of the rodent holes along the landside slope.

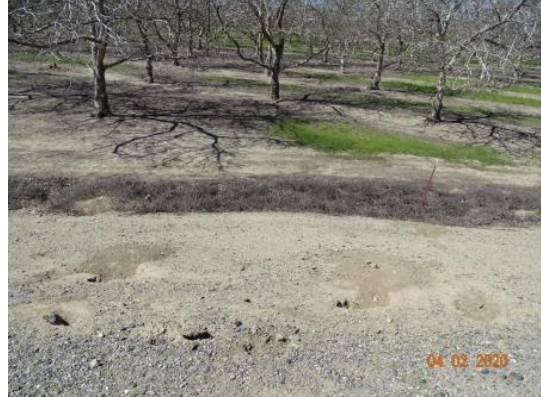
Photo 1 of 1 : SP_2020_LD0001G_432_47_20200413_00102.jpg

View of the rodent holes along the landside slope. Spring 2020.

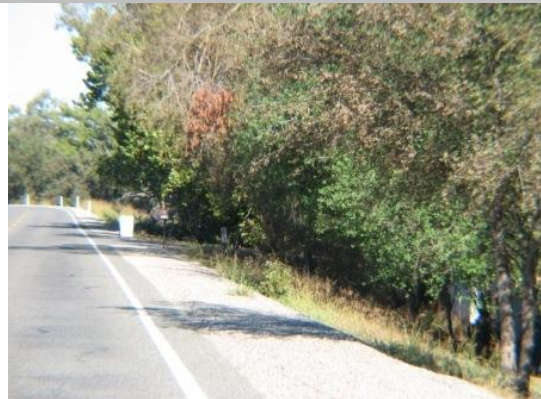
Photo 1 of 1 : SP_2020_LD0001G_432_20_20200226_00006.jpg

View of the trees and vegetation along the waterside slope of the levee.

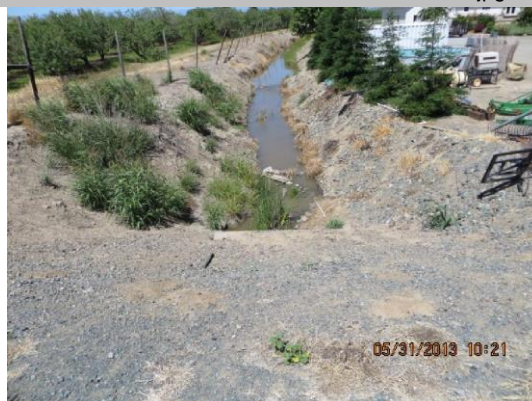
Photo 1 of 3 : UCIP_SP_2020_14389_23686.jpg

Comment Code						
Inspector Comment						
DS_ID:22920						
FS_ID:14389						
EP_NO: 9560						
Repair Type: Non-Urgent						
Crossing Status: Found						
UCIP Comments: Heavy rust along springline of pipe. Pipe has slight deformation at centerline of levee, not noticable on crown.						
FIELD_STRUCT_DESC: 72-inch corrugated metal drainage pipe through the levee, 15 feet below the crown. Flap gate located on the waterside (WS) end. Slide gate in 8-inch corrugated metal riser unit on the WS slope. Concrete headwalls on both ends. Two corrugated metal cutoff walls. (72-inch pipe [HLM 9.64]authorized under Automatic Board Order (ABO) issued as Permit No. 9560, 1974 - John and Lena Friesen). [Additional Reference(s): DWR Levee Log, 1992. USACE Sacramento O&M Manual 140, May 1960, (HLM 9.64)].						
FS Date: 5/31/2013

Pipe and headwall at LS toe.

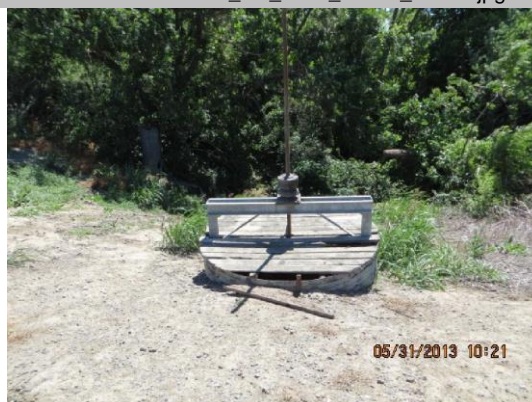
Photo 2 of 3 : UCIP_SP_2020_14389_23685.jpg

Slide gate in 8-foot diameter CMP riser on WS slope.

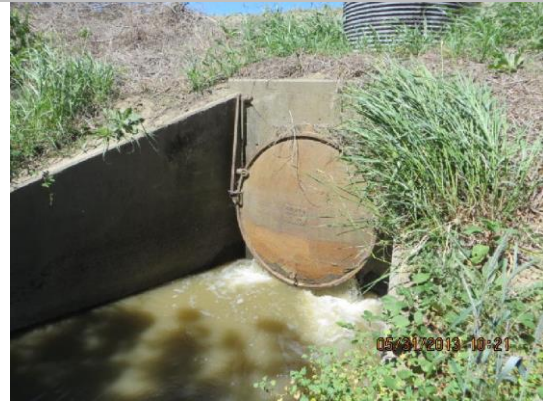
Photo 3 of 3 : UCIP_SP_2020_14389_23684.jpg

Flap gate and headwall on WS toe.

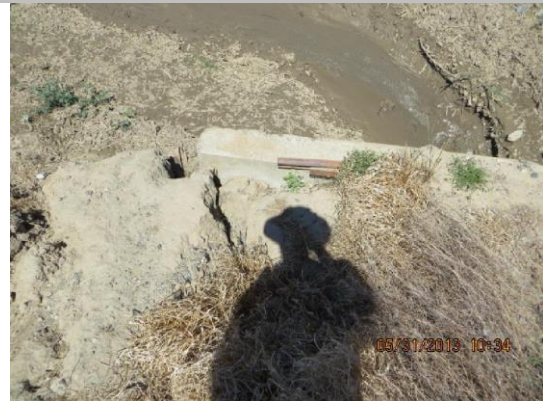
Photo 3 of 3 : UCIP_SP_2020_14390_23688.jpg

Erosion around headwall at LS toe.

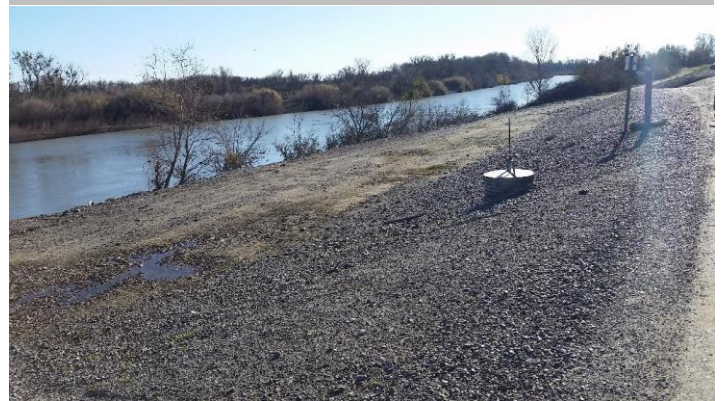
Photo 1 of 3 : UCIP_SP_2020_53340_76411.jpg

DS_ID:22924
 FS_ID:53340
 EP_NO: 9556
 Repair Type: Urgent
 Crossing Status: Found
 UCIP Comments: 10/9/2018 Large rock at the bottom of CMP riser obstructs slide gate from completely closing. Pipe is rusted through at WS end. Recommend internal inspection to determine condition of pipe through levee, and to clean the inside of CMP riser for proper slide gate function. (O.Yakimov - DWR UCIP)12/21/2016 same as last inspection flap gate disabled in open position. Surface erosion observed on LS slope. Recommend repair on WS flap gate to be able to close flap gate. (O. Magana - DWR UCIP)05/31/2013 Flap gate dissabled in open position. Pipe rusted through at WS toe upstream of Flapgate. (W. Wylie - DWR UCIP)
 FIELD_STRUCT_DESC: 24-inch corrugated metal drainage pipe through levee, 15 feet below crown. Flap gate is located on the waterside (WS) end. Slide gate is inside a corrugated metal pipe (CMP) riser located on the WS slope. Two CM cutoff walls. Concrete headwall is located on LS and under outlet at the WS toe. (24-inch pipe [HLM 10.59] authorized under Automatic Board Order (ABO) issued as Permit No. 9556, 1974 - E. R & M. R. Cooper). [Additional Reference(s): DWR Levee Log, 1992. USACE Sacramento O&M Manual Unit 140, May 1960, (HLM 10.59)].

View of WS.

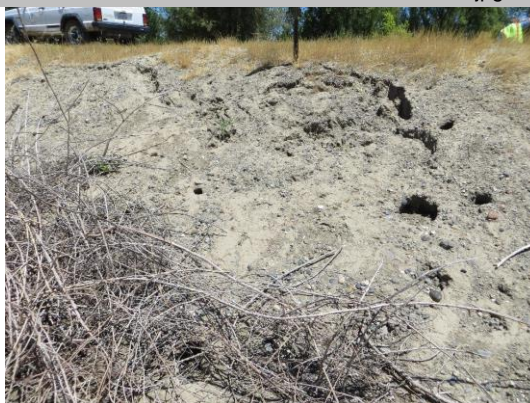
Photo 3 of 3 : UCIP_SP_2020_14567_24015.jpg

Comment Code					
Inspector Comment					
DS_ID:22927 FS_ID:14567 EP_NO: 9554 Repair Type: Non-Urgent Crossing Status: Found UCIP Comments: Erosion and sloughing on LS slope possibly due to rodent activity in area. FIELD_STRUCT_DESC: 24-inch corrugated metal drainage pipe through the levee, 11 feet below the crown. Slide gate in 36-inch corrugated metal riser unit on the waterside (WS) slope. 48-inch concrete standpipe on the landside (LS) toe. Two corrugated metal cutoff walls. (24-inch pipe [HLM 11.93] authorized under Automatic Board Order (ABO) issued as Permit No. 9554, 1974 - Thomas H. Reed). [Additional Reference(s): DWR Levee Log, 1992. USACE Sacramento O&M Manual 140, May 1960, (HLM 11.93)]. FS Date: 5/31/2013

Erosion and sloughing on LS slope possibly due to rodent activity.

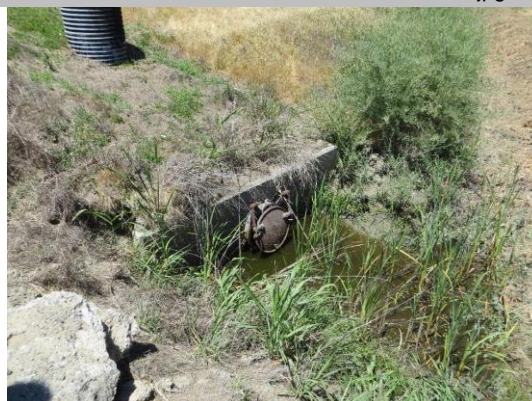
Photo 3 of 3 : UCIP_SP_2020_14569_24024.jpg

Comment Code						
Inspector Comment						
DS_ID:22928 FS_ID:14569 EP_NO: 9554 Repair Type: Non-Urgent Crossing Status: Found UCIP Comments: Flap gate heavily corroded. Good candidate for video inspection. Vegetation interfering with inlet. FIELD_STRUCT_DESC: 24-inch corrugated metal drainage pipe through the levee, 7 feet below the crown. Flap gate on the waterside (WS) end. Slide gate in 36-inch corrugated metal pipe riser unit on the WS slope. Concrete headwalls on both ends. Two corrugated metal cutoff walls. (24-inch pipe [12.04] authorized under Automatic Board Order (ABO) issued as Permit No. 9554, 1974 - Thomas H. Reed). [Additional Reference(s): DWR Levee Log, 1992. USACE Sacramento O&M Manual 140, May 1960, (HLM 12.04)]. FS Date: 5/31/2013

Headwall and flapgate on WS toe.
