**Flood Control Project Maintenance  
Levee Inspections**

**Maintenance Issue Types Only, Levee Inspection Report By Mile - Spring 2021**

**Levee District No. 0001 (Glenn County)**

Waterway	Bank	Unit Miles	Inspection Start/End	Inspector
Unit No. 01 Sacramento River	Right	12.23	04/06/2021 04/06/2021	Makar Sokol

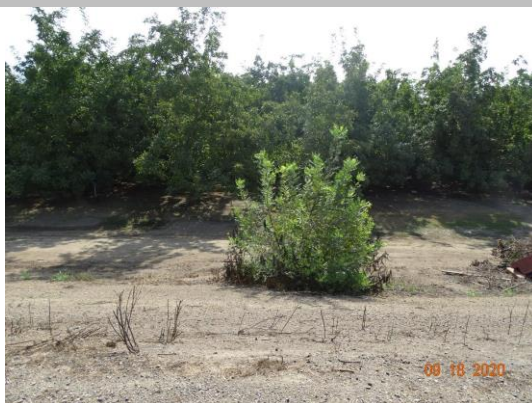
Photo 1 of 1 : SP\_2021\_LD0001G\_432\_59\_20210224\_00011.jpg

LM Start	1.08	Rating **	M	Issue No.	59
LM End	1.08	Issue Type +	Ma	Location *	WS
Category	Earthen Levee			GPS Latitude/Longitude	
				Start	End
Item	Trim / Thin Trees			39.492028 °	39.492028 °
				-122.020116 °	-122.020116 °
DWR ID	DWR_LD0001G_01_s_2019_59				
Comment Code					
T2 : Thin trees to allow visibility of the ground and room to flood fight.					
Inspector Comment					
Trees 4 inches in diamater or less at chest height should be removed from the waterside slope.

View of a small tree on the waterside slope. Fall 2020.

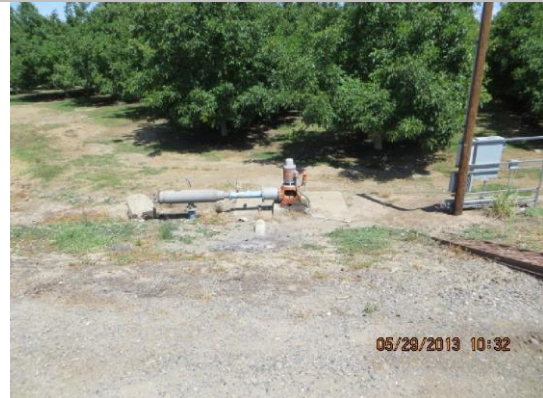
Photo 1 of 3 : UCIP\_SP\_2021\_14332\_23582.jpg

LM Start	2.22	Rating **	M	Issue No.	13	
LM End	2.22	Issue Type +	Ma	Location *		
Category	Supplemental			GPS Latitude/Longitude		
				Start	End	
Item	DWR UCIP LMA Responsibility			39.501690 °	39.501690 °	
				-122.006099 °	-122.006099 °	
DWR ID	22944					
Comment Code						
Inspector Comment						
FS_ID:14332						
DS_ID:22944						
EP_NO: N/A						
Repair Type: Non-Urgent						
Crossing Status: Found						
UCIP Comments: Appears abandoned and should be done so properly.						
FIELD_STRUCT_DESC: *ABANDONED* 8-inch drainage pipe of an						
unknown material sleeved through a 12-inch pipe of an unknown						
material through the levee, 9.5 feet below the crown. Flap gate located						
on the waterside (WS). Pipe open on the landside (LS). [Additional						
Reference(s): USACE Sacramento O&M Manual 140, May 1960, (HLM						
2.27)].						
FS Date: 5/29/2013

Pump at location of pipe on LS toe.

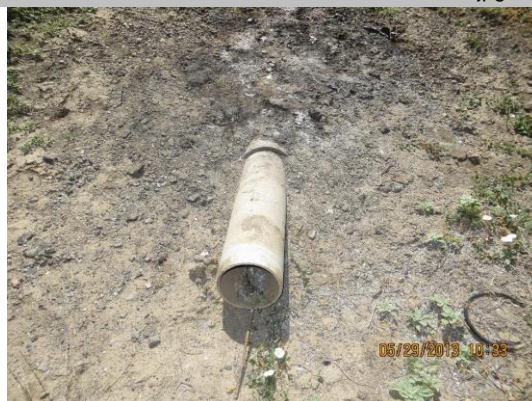
Photo 3 of 3 : UCIP\_SP\_2021\_14332\_23580.jpg

8-inch pipe sleeved through a 12-inch concrete pipe.

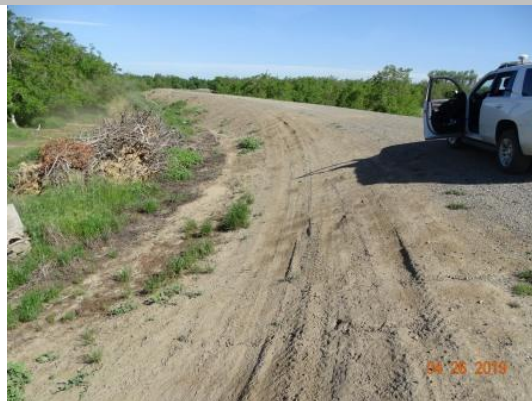
Photo 1 of 1 : SP\_2021\_LD0001G\_432\_77\_20210224\_00021.jpg

LM Start	3.04	Rating **	M	Issue No.	77
LM End	3.04	Issue Type +	Ma	Location *	LS
Category	Earthen Levee			GPS Latitude/Longitude	
				Start	End
Item	Slope Stability			39.512932 °	39.512932 °
				-122.009074 °	-122.009074 °
DWR ID	DWR_LD0001G_01_s_2019_77				
Comment Code					
S3 : Repair the levee slope damaged by vehicle traffic and prevent access where possible.					
Inspector Comment

View of the landside slope damaged by vehicle traffic. Spring 2019.

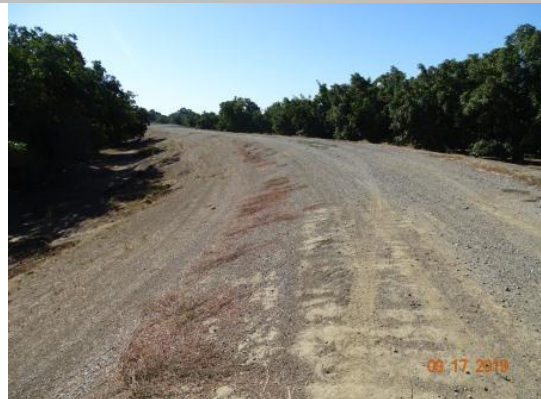
Photo 1 of 1 : SP\_2021\_LD0001G\_432\_68\_20210224\_00015.jpg

LM Start	<b>3.26</b>	Rating **	M	Issue No.	<b>68</b>
LM End	<b>3.26</b>	Issue Type +	Ma	Location *	WS
Category	Earthen Levee		GPS Latitude/Longitude		
			Start	End	
Item	Slope Stability		39.515595 °	39.515595 °	
			-122.011152 °	-122.011152 °	
DWR ID	DWR_LD0001G_01_f_2019_68				
Comment Code					
S3 : Repair the levee slope damaged by vehicle traffic and prevent access where possible.					
Inspector Comment

View of the waterside slope damaged by vehicle traffic. Fall 2019.

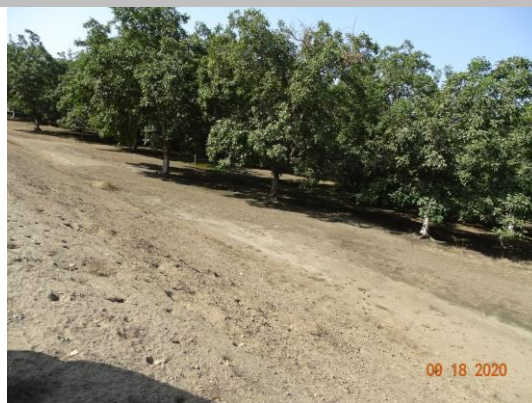
Photo 1 of 1 : SP\_2021\_LD0001G\_432\_52\_20210224\_00008.jpg

LM Start	4.82	Rating **	M	Issue No.	52
LM End	4.84	Issue Type +	Ma	Location *	LS
Category	Earthen Levee			GPS Latitude/Longitude	
				Start	End
Item	Animal Control			39.531214 °	39.531423 °
				-121.996388 °	-121.996306 °
DWR ID	DWR_LD0001G_01_s_2020_52				
Comment Code					
A3 : No rodents visible, but rodent burrows visible; need to backfill and compact or grout burrows.					
Inspector Comment

View of the rodent activity on the landside slope. Fall 2020.

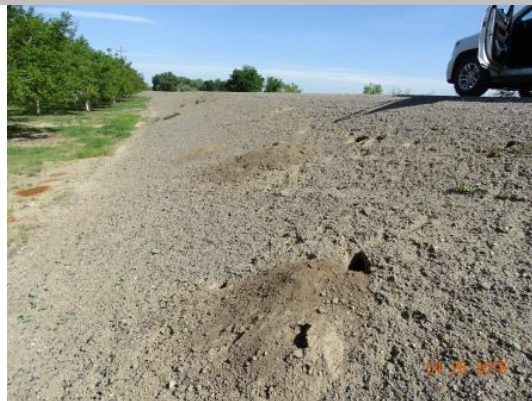
Photo 1 of 1 : SP\_2021\_LD0001G\_432\_82\_20210224\_00023.jpg

LM Start	5.34	Rating **	M	Issue No.	82
LM End	5.34	Issue Type +	Ma	Location *	LS
Category	Earthen Levee			GPS Latitude/Longitude	
				Start	End
Item	Animal Control			39.538363 °	39.538363 °
				-121.997805 °	-121.997805 °
DWR ID	DWR_LD0001G_01_s_2019_82				
Comment Code					
A3 : No rodents visible, but rodent burrows visible; need to backfill and compact or grout burrows.					
Inspector Comment

View of the rodent activity on the landside slope. Spring 2019.

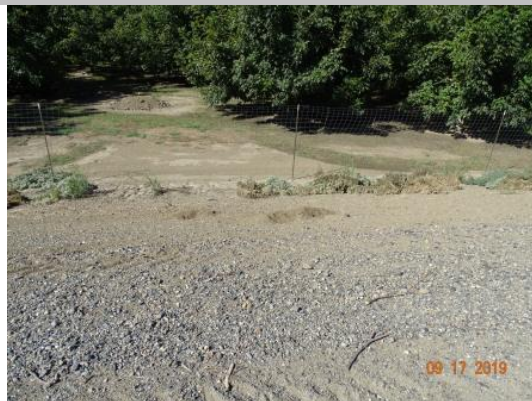
Photo 1 of 1 : SP\_2021\_LD0001G\_432\_84\_20210224\_00024.jpg

LM Start	<b>5.78</b>	Rating **	M	Issue No.	<b>84</b>
LM End	<b>5.81</b>	Issue Type +	Ma	Location *	LS
Category	Earthen Levee		GPS Latitude/Longitude		
			Start	End	
Item	Animal Control		39.544295 °	39.544590 °	
			-122.000934 °	-122.001047 °	
DWR ID	DWR_LD0001G_01_f_2020_84				
Comment Code					
A3 : No rodents visible, but rodent burrows visible; need to backfill and compact or grout burrows.					
Inspector Comment

View of the rodent activity on the landside slope. Fall 2019.

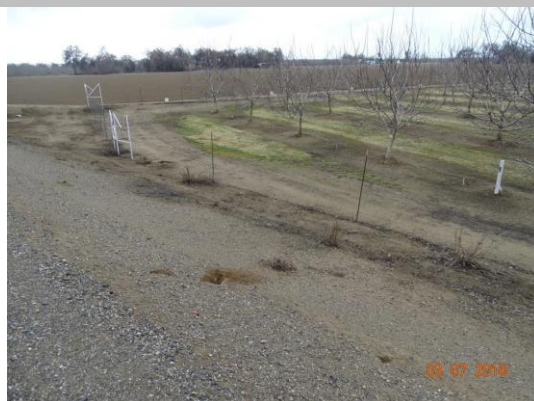
Photo 1 of 1 : SP\_2021\_LD0001G\_432\_70\_20210224\_00016.jpg

LM Start	5.83	Rating **	M	Issue No.	70
LM End	5.85	Issue Type +	Ma	Location *	LS
Category	Earthen Levee			GPS Latitude/Longitude	
				Start	End
Item	Animal Control			39.544894 °	39.545276 °
				-122.001077 °	-122.001126 °
DWR ID	DWR_LD0001G_01_s_2018_70				
Comment Code					
A3 : No rodents visible, but rodent burrows visible; need to backfill and compact or grout burrows.					
Inspector Comment

View of the rodent holes along the landside slope.

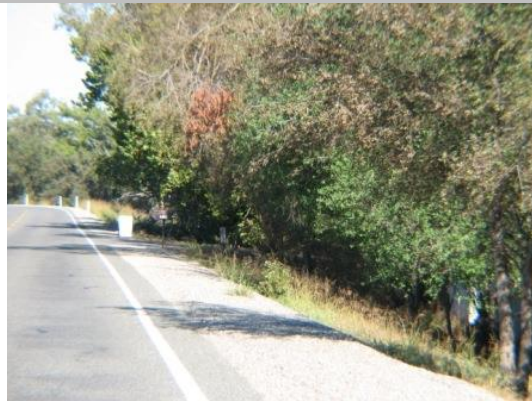
Photo 1 of 1 : SP\_2021\_LD0001G\_432\_20\_20210224\_00004.jpg

LM Start	8.05	Rating **	M	Issue No.	20
LM End	8.16	Issue Type +	Ma	Location *	WS
Category	Earthen Levee			GPS Latitude/Longitude	
				Start	End
Item	Trim / Thin Trees			39.576580 °	39.578187 °
				-122.004962 °	-122.005218 °
DWR ID	DWR_LD0001G_01_s_2012_20				
Comment Code					
T2 : Thin trees to allow visibility of the ground and room to flood fight.					
Inspector Comment					
Trees four inches in diamater or less at chest height should be removed from the waterside slope and toe.

View of the trees and vegetation along the waterside slope of the levee.

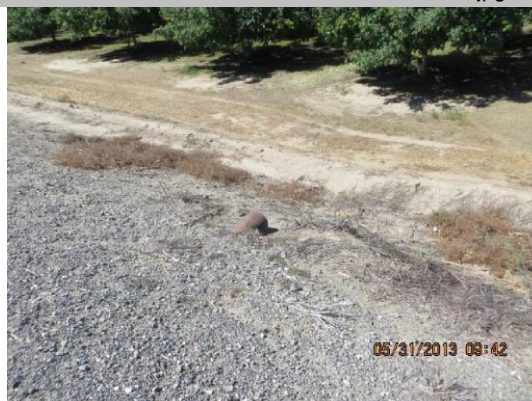
Photo 1 of 3 : UCIP\_SP\_2021\_53341\_23668.jpg

Comment Code					
Inspector Comment					
FS_ID:53341 DS_ID:22918 EP_NO: 9563 Repair Type: Non-Urgent Crossing Status: Found UCIP Comments: 10/9/2018 Pipe is open on both ends and damaged on WS. Recommended grouting in place. Crossing downgraded to "Non-Urgent" due to pipe location above floodplain. (O.Yakimov - DWR UCIP)12/21/2016 same as last inspection crossing is opened on both ends and damaged on WS slope is visible. According to LMA representative, Nick Henning, pipe appears to be abandoned. (O. Magana - DWR UCIP)05/31/2013 Pipe open on both ends and damaged on WS slope. Pipe should be abandoned properly if appropriate. (W. Wylie - DWR UCIP) FIELD_STRUCT_DESC: *ABANDONED* 12-inch steel drainage pipe through levee, 5 feet below crown. Pipe open on both waterside (WS) and landside (LS) ends. One corrugated metal cutoff wall. (12-inch pipe [HLM 8.6] authorized under Automatic Board Order (ABO) No. 9563, 1974 - County of Glenn). [Additional Reference(s): DWR Levee Log, 1992. USACE Sacramento O&M Manual Unit 140, May 1960, (HLM 8.60)]. FS Date: 10/9/2018 3:57:00 PM

Pipe on LS slope.

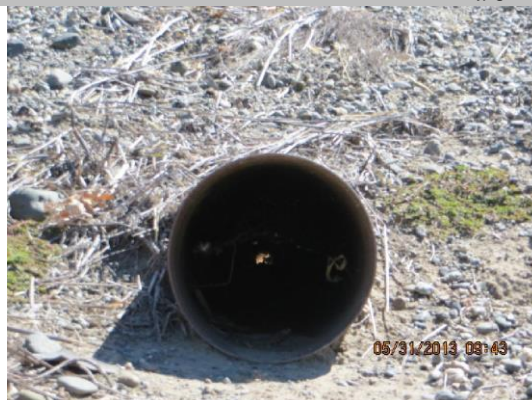
Photo 2 of 3 : UCIP\_SP\_2021\_53341\_23667.jpg

Pipe on LS slope.

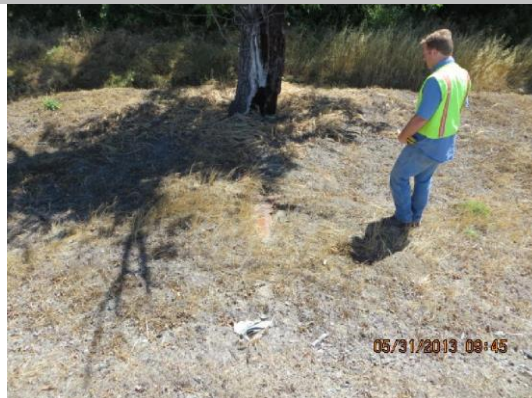
Photo 3 of 3 : UCIP\_SP\_2021\_53341\_23666.jpg

Pipe on WS slope.

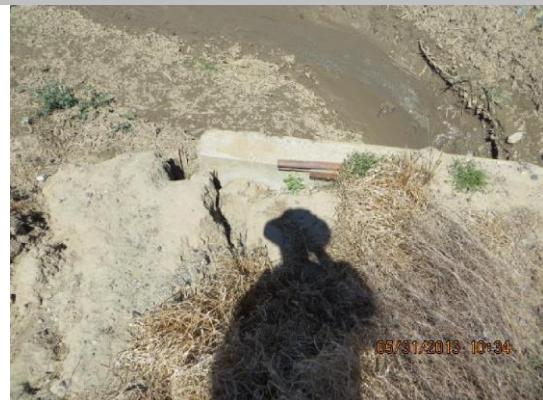
Photo 3 of 3 : UCIP\_SP\_2021\_14390\_23688.jpg

Erosion around headwall at LS toe.

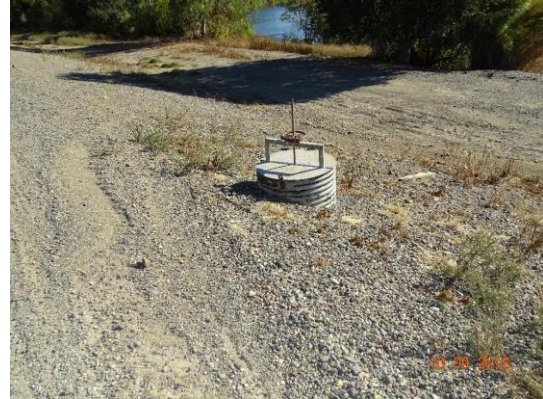
Photo 2 of 3 : UCIP\_SP\_2021\_53340\_78135.jpg

Water-Side

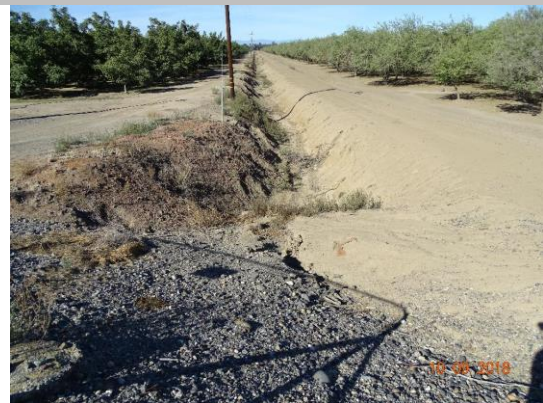
Photo 3 of 3 : UCIP\_SP\_2021\_53340\_78136.jpg

Drainage channel on LS.

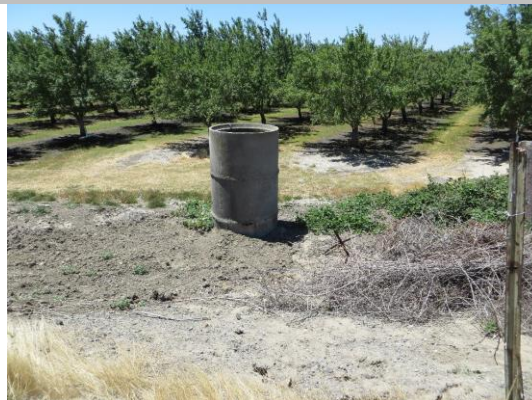
Photo 1 of 3 : UCIP\_SP\_2021\_14567\_24017.jpg

Comment Code					
Inspector Comment					
FS_ID:14567 DS_ID:22927 EP_NO: 9554 Repair Type: Non-Urgent Crossing Status: Found UCIP Comments: Erosion and sloughing on LS slope possibly due to rodent activity in area. FIELD_STRUCT_DESC: 24-inch corrugated metal drainage pipe through the levee, 11 feet below the crown. Slide gate in 36-inch corrugated metal riser unit on the waterside (WS) slope. 48-inch concrete standpipe on the landside (LS) toe. Two corrugated metal cutoff walls. (24-inch pipe [HLM 11.93] authorized under Automatic Board Order (ABO) issued as Permit No. 9554, 1974 - Thomas H. Reed). [Additional Reference(s): DWR Levee Log, 1992. USACE Sacramento O&M Manual 140, May 1960, (HLM 11.93)]. FS Date: 5/31/2013

Concrete standpipe on LS toe.
