**Flood Control Project Maintenance
Levee Inspections**

Maintenance Issue Types Only, Levee Inspection Report By Mile - Spring 2022

Levee District No. 0001 (Glenn County)

Waterway	Bank	Unit Miles	Inspection Start/End	Inspector
Unit No. 01 Sacramento River	Right	12.23	04/12/2022 04/12/2022	Makar Sokol

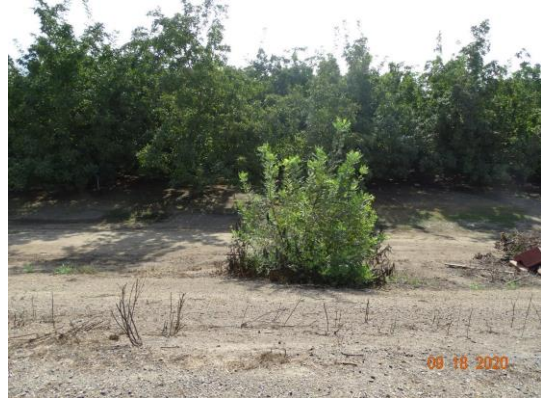
Photo 1 of 1 : SP_2022_LD0001G_432_59_20220307_00011.jpg

LM Start	1.08	Rating **	M	Issue No.	59
LM End	1.08	Issue Type +	Ma	Location *	WS
Category	Earthen Levee			GPS Latitude/Longitude	
				Start	End
Item	Trim / Thin Trees			39.492028 °	39.492028 °
				-122.020116 °	-122.020116 °
DWR ID	DWR_LD0001G_01_s_2019_59				
Comment Code					
T1 : Trim and thin trees to at least five feet above ground level to allow visibility of the ground and room to flood fight.					
Inspector Comment					
Trees 4 inches in diameter or less at chest height should be removed from the waterside slope.

View of a small tree on the waterside slope. Fall 2020.

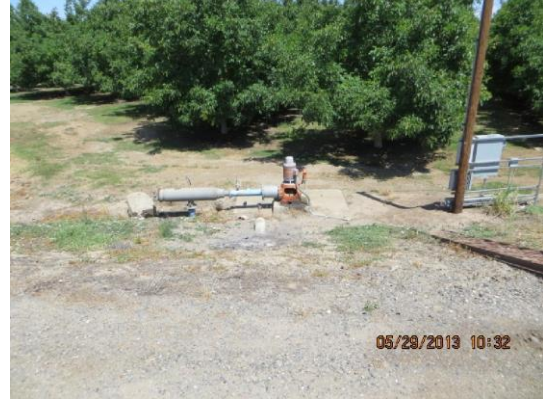
Photo 1 of 3 : UCIP_SP_2022_14332_23582.jpg

LM Start	2.22	Rating **	M	Issue No.	13	
LM End	2.22	Issue Type +	Ma	Location *		
Category	Supplemental			GPS Latitude/Longitude		
				Start	End	
Item	DWR UCIP LMA Responsibility			39.501690 °	39.501690 °	
				-122.006099 °	-122.006099 °	
DWR ID	22944					
Comment Code						
Inspector Comment						
FS_ID:14332						
DS_ID:22944						
EP_NO: N/A						
Repair Type: Non-Urgent						
Crossing Status: Found						
UCIP Comments: Appears abandoned and should be done so properly.						
FIELD_STRUCT_DESC: *ABANDONED* 8-inch drainage pipe of an						
unknown material sleeved through a 12-inch pipe of an unknown						
material through the levee, 9.5 feet below the crown. Flap gate located						
on the waterside (WS). Pipe open on the landside (LS). [Additional						
Reference(s): USACE Sacramento O&M Manual 140, May 1960, (HLM						
2.27)].						
FS Date: 5/29/2013

Pump at location of pipe on LS toe.

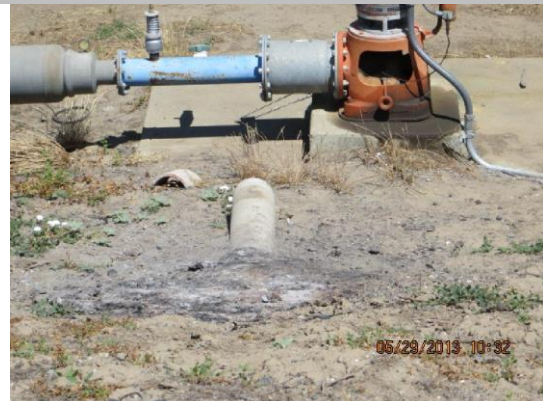
Photo 2 of 3 : UCIP_SP_2022_14332_23581.jpg

Pipe next to pump at LS toe.

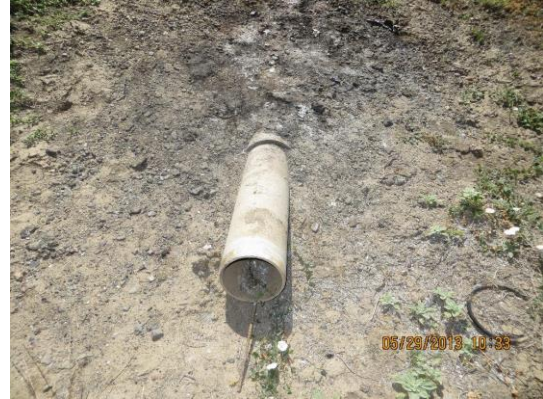
Photo 3 of 3 : UCIP_SP_2022_14332_23580.jpg

8-inch pipe sleeved through a 12-inch concrete pipe.

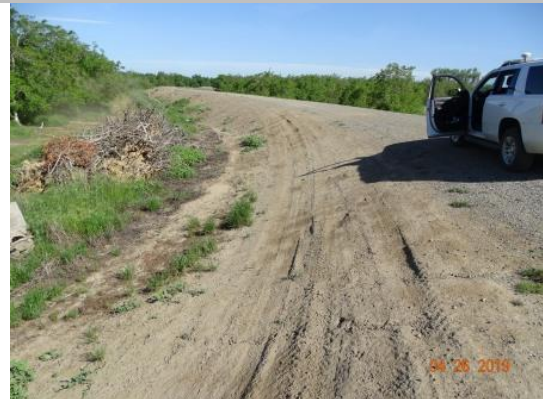
Photo 1 of 1 : SP_2022_LD0001G_432_77_20220307_00017.jpg

LM Start	3.04	Rating **	M	Issue No.	77
LM End	3.04	Issue Type +	Ma	Location *	LS
Category	Earthen Levee			GPS Latitude/Longitude	
				Start	End
Item	Erosion / Vehicle Traffic			39.512932 °	39.512932 °
				-122.009074 °	-122.009074 °
DWR ID	DWR_LD0001G_01_s_2019_77				
Comment Code					
E6 : Repair the levee slope damaged by vehicle traffic and prevent access where possible.					
Inspector Comment

View of the landside slope damaged by vehicle traffic. Spring 2019.

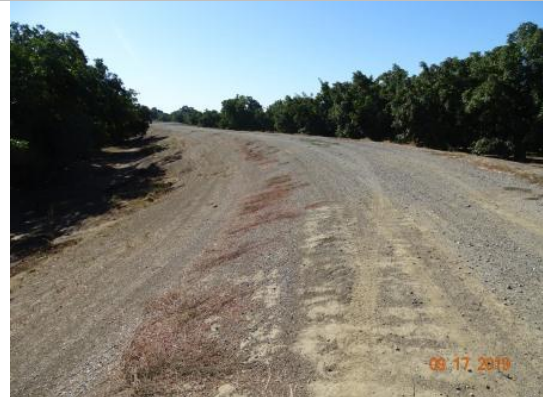
Photo 1 of 1 : SP_2022_LD0001G_432_68_20220307_00013.jpg

LM Start	3.26	Rating **	M	Issue No.	68
LM End	3.26	Issue Type +	Ma	Location *	WS
Category	Earthen Levee			GPS Latitude/Longitude	
				Start	End
Item	Erosion / Vehicle Traffic			39.515595 °	39.515595 °
				-122.011152 °	-122.011152 °
DWR ID	DWR_LD0001G_01_f_2019_68				
Comment Code					
E6 : Repair the levee slope damaged by vehicle traffic and prevent access where possible.					
Inspector Comment

View of the waterside slope damaged by vehicle traffic. Fall 2019.

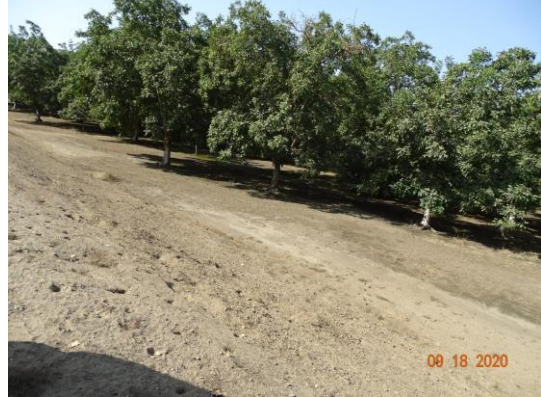
Photo 1 of 1 : SP_2022_LD0001G_432_52_20220307_00008.jpg

View of the rodent activity on the landside slope. Fall 2020.

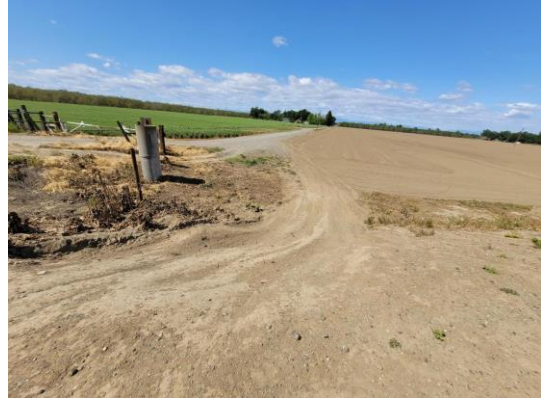
Photo 1 of 1 : SP_2022_LD0001G_432_61_20220417_00091.jpg

LM Start	5.06	Rating **	M	Issue No.	61
LM End	5.06	Issue Type +	Ma	Location *	LS
Category	Earthen Levee			GPS Latitude/Longitude	
				Start	End
Item	Erosion / Vehicle Traffic			39.534579 °	39.534579 °
				-121.995950 °	-121.995950 °
DWR ID	DWR_LD0001G_01_s_2022_61				
Comment Code					
E6 : Repair the levee slope damaged by vehicle traffic and prevent access where possible.					
Inspector Comment

View of erosion on the landside slope due to vehicle traffic. Spring 2022.

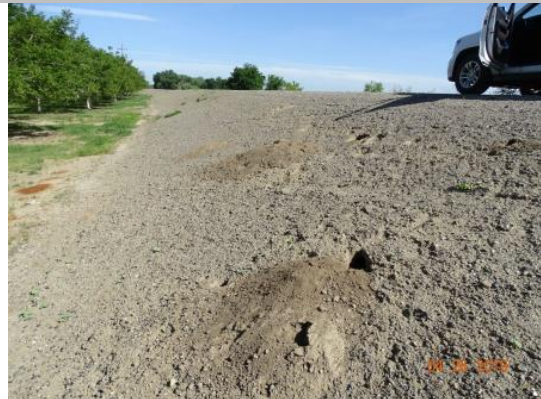
Photo 1 of 1 : SP_2022_LD0001G_432_82_20220307_00019.jpg

LM Start	5.34	Rating **	M	Issue No.	82
LM End	5.34	Issue Type +	Ma	Location *	LS
Category	Earthen Levee			GPS Latitude/Longitude	
				Start	End
Item	Animal Control			39.538363 °	39.538363 °
				-121.997805 °	-121.997805 °
DWR ID	DWR_LD0001G_01_s_2019_82				
Comment Code					
A3 : No rodents visible, but rodent burrows visible; need to backfill and compact or grout burrows.					
Inspector Comment

View of the rodent activity on the landside slope. Spring 2019.

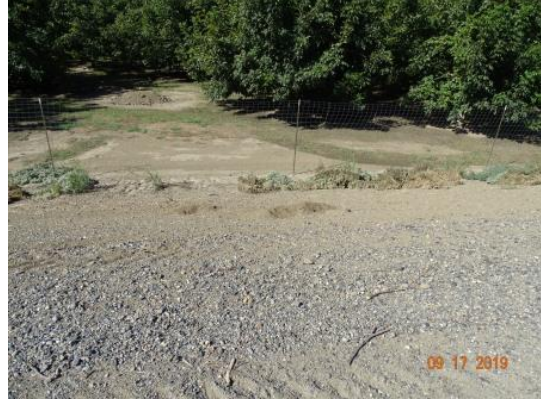
Photo 1 of 1 : SP_2022_LD0001G_432_84_20220307_00020.jpg

View of the rodent activity on the landside slope. Fall 2019.

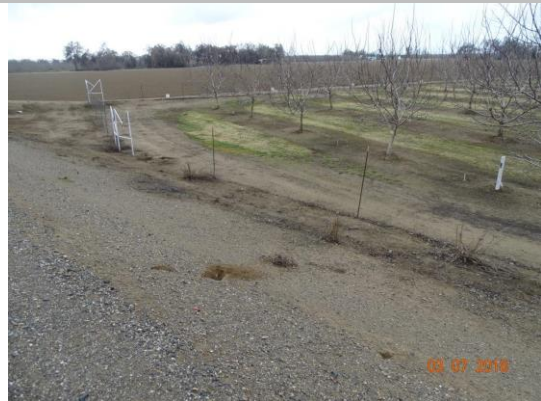
Photo 1 of 1 : SP_2022_LD0001G_432_70_20220307_00014.jpg

LM Start	5.83	Rating **	M	Issue No.	70
LM End	5.85	Issue Type +	Ma	Location *	LS
Category	Earthen Levee			GPS Latitude/Longitude	
				Start	End
Item	Animal Control			39.544894 °	39.545276 °
				-122.001077 °	-122.001126 °
DWR ID	DWR_LD0001G_01_s_2018_70				
Comment Code					
A3 : No rodents visible, but rodent burrows visible; need to backfill and compact or grout burrows.					
Inspector Comment

View of the rodent holes along the landside slope.

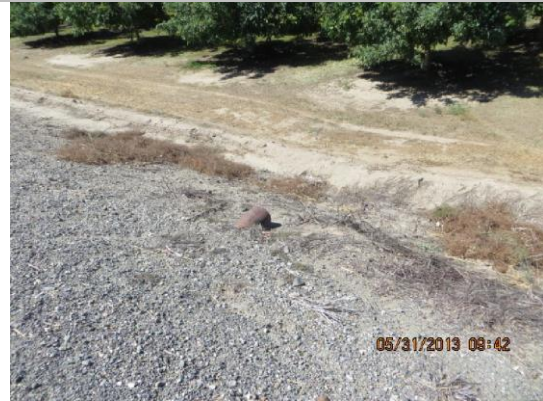
Photo 1 of 3 : UCIP_SP_2022_53341_23668.jpg

Comment Code					
Inspector Comment					
FS_ID:53341 DS_ID:22918 EP_NO: 9563 Repair Type: Urgent Crossing Status: Found UCIP Comments: 10/9/2018 Pipe is open on both ends and damaged on WS. Recommended grouting in place. Crossing downgraded to "Non-Urgent" due to pipe location above floodplain. (O.Yakimov - DWR UCIP)12/21/2016 same as last inspection crossing is opened on both ends and damaged on WS slope is visible. According to LMA representative, Nick Henning, pipe appears to be abandoned. (O. Magana - DWR UCIP)05/31/2013 Pipe open on both ends and damaged on WS slope. Pipe should be abandoned properly if appropriate. (W. Wylie - DWR UCIP) FIELD_STRUCT_DESC: *ABANDONED* 12-inch steel drainage pipe through levee, 5 feet below crown. Pipe open on both waterside (WS) and landside (LS) ends. One corrugated metal cutoff wall. (12-inch pipe [HLM 8.6] authorized under Automatic Board Order (ABO) No. 9563, 1974 - County of Glenn). [Additional Reference(s): DWR Levee Log, 1992. USACE Sacramento O&M Manual Unit 140, May 1960, (HLM 8.60)]. FS Date: 10/9/2018 3:57:00 PM

Pipe on LS slope.

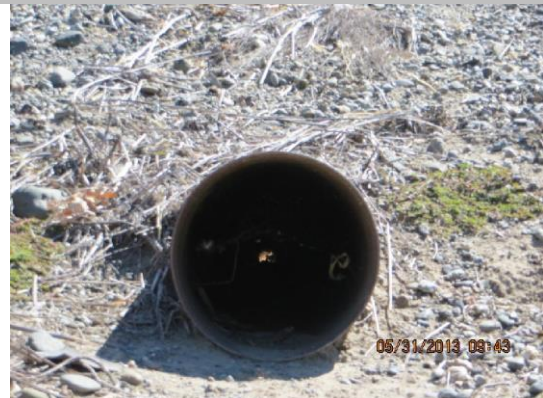
Photo 2 of 3 : UCIP_SP_2022_53341_23667.jpg

Pipe on LS slope.

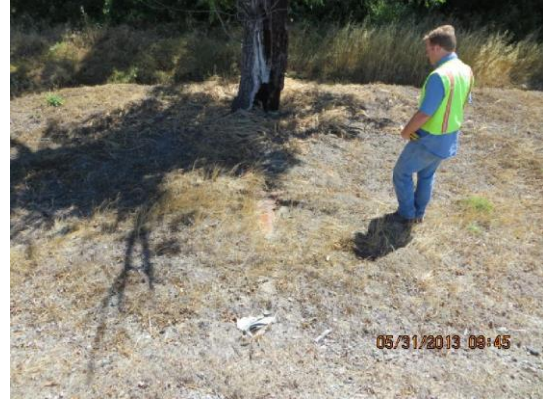
Photo 3 of 3 : UCIP_SP_2022_53341_23666.jpg

Pipe on WS slope.

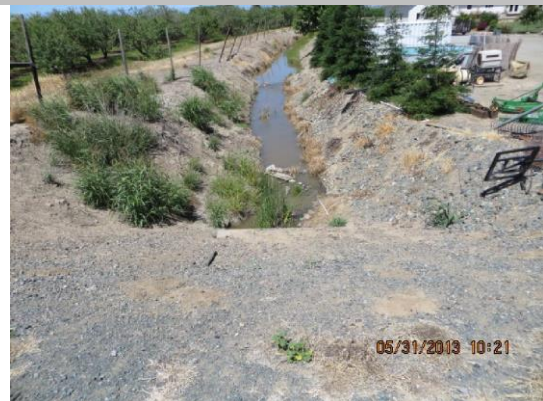
Photo 1 of 3 : UCIP_SP_2022_14389_23686.jpg

Comment Code						
Inspector Comment						
FS_ID:14389 DS_ID:22920 EP_NO: 9560 Repair Type: Non-Urgent Crossing Status: Found UCIP Comments: Heavy rust along springline of pipe. Pipe has slight deformation at centerline of levee, not noticable on crown. FIELD_STRUCT_DESC: 72-inch corrugated metal drainage pipe through the levee, 15 feet below the crown. Flap gate located on the waterside (WS) end. Slide gate in 8-inch corrugated metal riser unit on the WS slope. Concrete headwalls on both ends. Two corrugated metal cutoff walls. (72-inch pipe [HLM 9.64]authorized under Automatic Board Order (ABO) issued as Permit No. 9560, 1974 - John and Lena Friesen). [Additional Reference(s): DWR Levee Log, 1992. USACE Sacramento O&M Manual 140, May 1960, (HLM 9.64)]. FS Date: 5/31/2013

Pipe and headwall at LS toe.

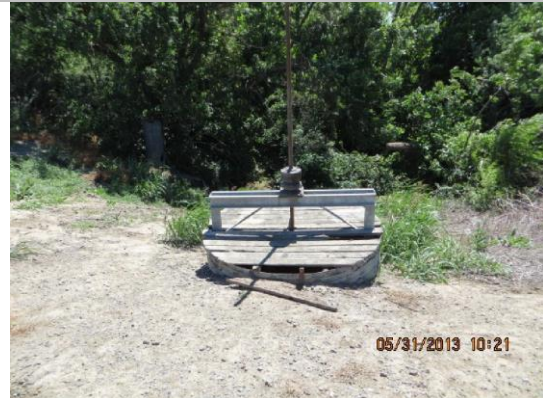
Photo 2 of 3 : UCIP_SP_2022_14389_23685.jpg

Slide gate in 8-foot diameter CMP riser on WS slope.

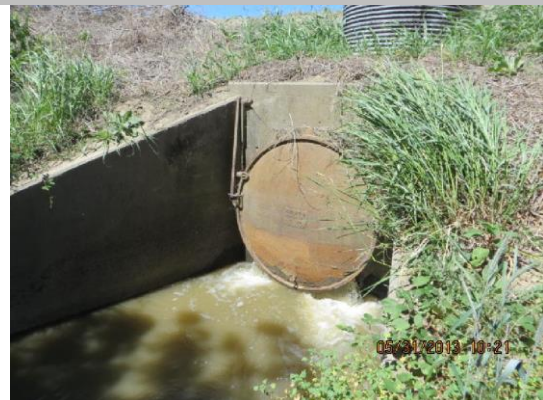
Photo 3 of 3 : UCIP_SP_2022_14389_23684.jpg

Flap gate and headwall on WS toe.

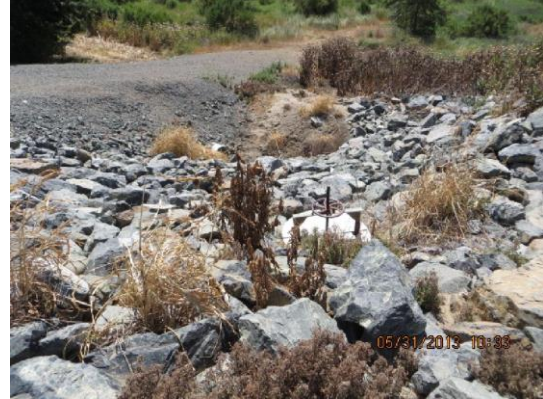
Photo 1 of 3 : UCIP_SP_2022_14390_23690.jpg

Comment Code						
Inspector Comment						
FS_ID:14390 DS_ID:22921 EP_NO: 9559 Repair Type: No Action Needed Crossing Status: Found UCIP Comments: FIELD_STRUCT_DESC: 24-inch corrugated metal drainage pipe through the levee, 11 feet below the crown. Flap gate located on the waterside (WS) end. Slide gate in 36-inch corrugated metal riser unit on the WS slope. Concrete headwalls on both ends. Two corrugated metal cutoff walls. (24-inch pipe [HLM 10.05] authorized under Automatic Board Order (ABO) issued as Permit No. 9559, 1974 - David and Mary Giesbrecht). [Additional Reference(s): DWR Levee Log, 1992. USACE Sacramento O&M Manual 140, May 1960, (HLM 10.05)]. FS Date: 5/31/2013

Slide gate in 36-inch CMP riser on WS slope.

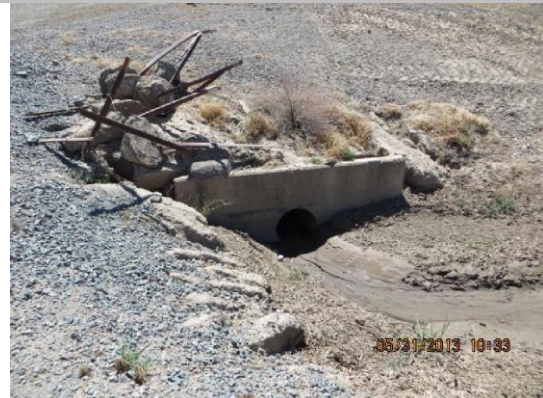
Photo 2 of 3 : UCIP_SP_2022_14390_23689.jpg

Concrete headwall and pipe at LS toe.

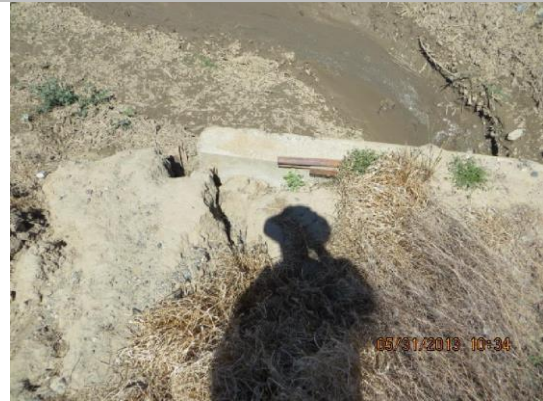
Photo 3 of 3 : UCIP_SP_2022_14390_23688.jpg

Erosion around headwall at LS toe.

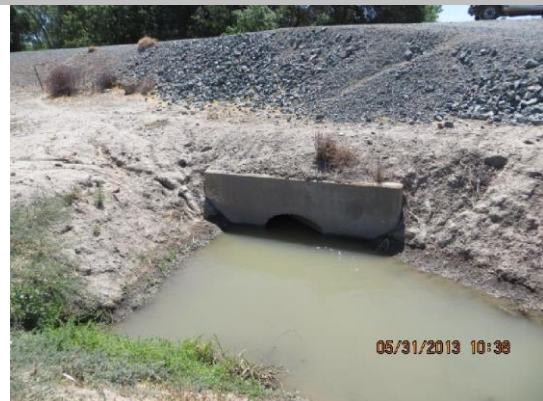
Photo 1 of 3 : UCIP_SP_2022_14559_23986.jpg

FS_ID:14559
DS_ID:22922
EP_NO: 9558
Repair Type: Urgent
Crossing Status: Found
UCIP Comments:
FIELD_STRUCT_DESC: 24-inch corrugated metal drainage pipe through the levee, 11 feet below the crown. Flap gate located on the waterside (WS) end. Slide gate in 36-inch corrugated metal pipe riser unit on the WS slope. Two corrugated metal cutoff walls. Concrete headwalls on both ends. (24-inch pipe [HLM 10.08] authorized under Automatic Board Order (ABO) issued as Permit No. 9558, 1974 - Duard Geis). [Additional Reference(s): DWR Levee Log, 1992. USACE Sacramento O&M Manual 140, May 1960, (HLM 10.08)].
FS Date: 5/31/2013 8:43:01 AM

Pipe and headwall on LS toe.

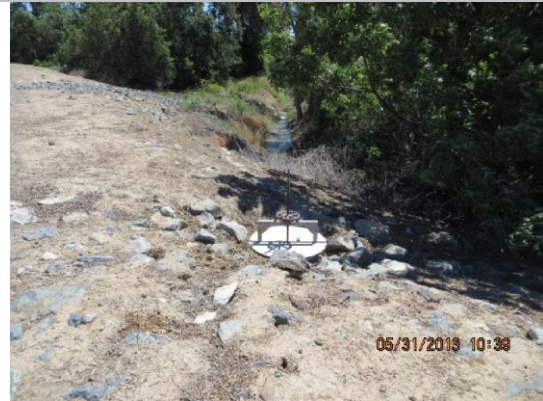
Photo 2 of 3 : UCIP_SP_2022_14559_23985.jpg

Slide gate in 36-inch CMP riser on WS slope.

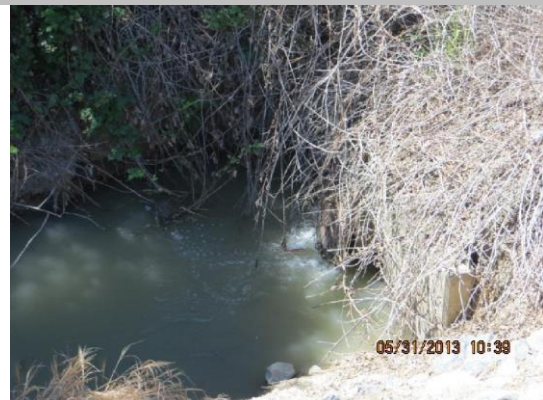
Photo 3 of 3 : UCIP_SP_2022_14559_23984.jpg

Pipe, flapgate, and headwall on WS toe.

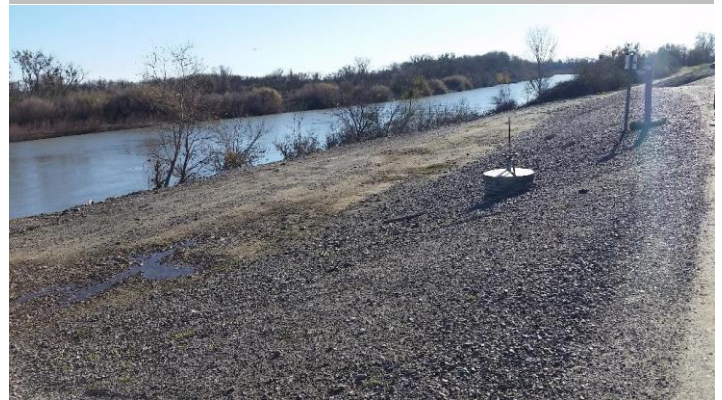
Photo 1 of 3 : UCIP_SP_2022_53340_76411.jpg

Comment Code						
Inspector Comment						
FS_ID:53340 DS_ID:22924 EP_NO: 9556 Repair Type: Urgent Crossing Status: Found UCIP Comments: 10/9/2018 Large rock at the bottom of CMP riser obstructs slide gate from completely closing. Pipe is rusted through at WS end. Recommend internal inspection to determine condition of pipe through levee, and to clean the inside of CMP riser for proper slide gate function. (O.Yakimov - DWR UCIP)12/21/2016 same as last inspection flap gate disabled in open position. Surface erosion observed on LS slope. Recommend repair on WS flap gate to be able to close flap gate. (O. Magana - DWR UCIP)05/31/2013 Flap gate dissabled in open position. Pipe rusted through at WS toe upstream of Flapgate. (W. Wylie - DWR UCIP) FIELD_STRUCT_DESC: 24-inch corrugated metal drainage pipe through levee, 15 feet below crown. Flap gate is located on the waterside (WS) end. Slide gate is inside a corrugated metal pipe (CMP) riser located on the WS slope. Two CM cutoff walls. Concrete headwall is located on LS and under outlet at the WS toe. (24-inch pipe [HLM 10.59] authorized under Automatic Board Order (ABO) issued as Permit No. 9556, 1974 - E. R & M. R. Cooper). [Additional Reference(s): DWR Levee Log, 1992. USACE Sacramento O&M Manual Unit 140, May 1960, (HLM 10.59)]. FS Date: 10/9/2018 4:05:00 PM

View of WS.

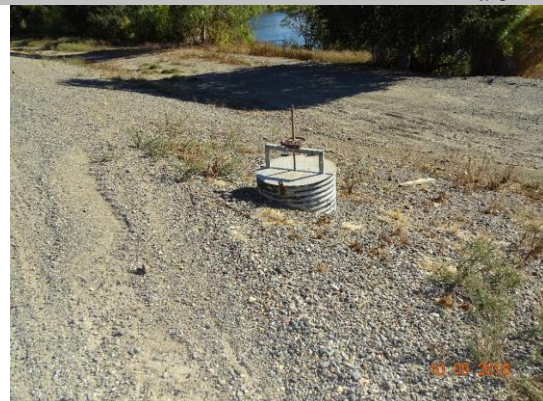
Photo 2 of 3 : UCIP_SP_2022_53340_78135.jpg

Water-Side

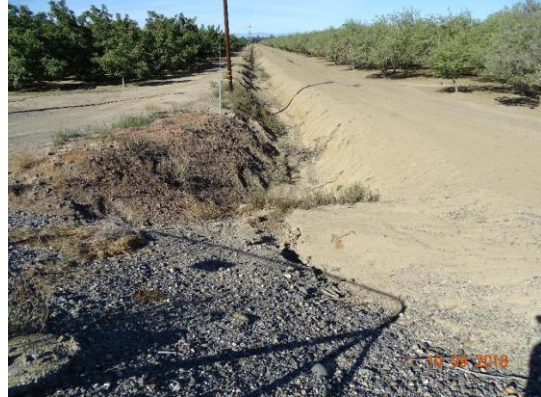
Photo 3 of 3 : UCIP_SP_2022_53340_78136.jpg

Drainage channel on LS.

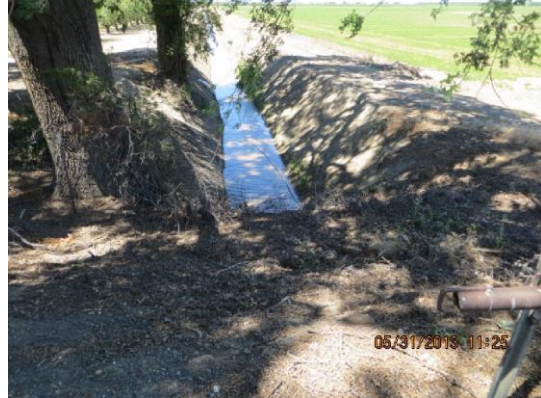
Photo 1 of 3 : UCIP_SP_2022_14565_24009.jpg

FS_ID:14565
 DS_ID:22925
 EP_NO: 9556
 Repair Type: Urgent
 Crossing Status: Found
 UCIP Comments:
 FIELD_STRUCT_DESC: 48-inch corrugated metal drainage pipe through the levee, 11 feet below the crown. Flap gate on the waterside (WS) end. Concrete headwall on both ends. Slide gate in 60-inch diameter corrugated metal riser unit on the WS slope (48-inch pipe [HLM 11.17] authorized under Automatic Board Order (ABO) issued as Permit No. 9556, 1974 - Earl R. and Merrit R. Cooper). [Additional Reference(s): DWR Levee Log, 1992. USACE Sacramento O&M Manual 140, May 1960, (HLM 11.17)].
 FS Date: 5/31/2013

Drainage ditch on LS toe.

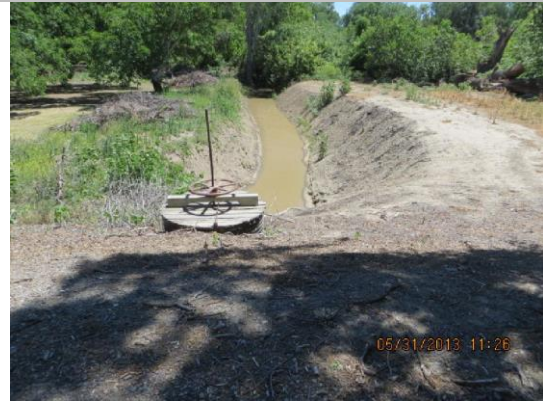
Photo 2 of 3 : UCIP_SP_2022_14565_24008.jpg

Slide gate in 60-inch CMP riser on WS slope.

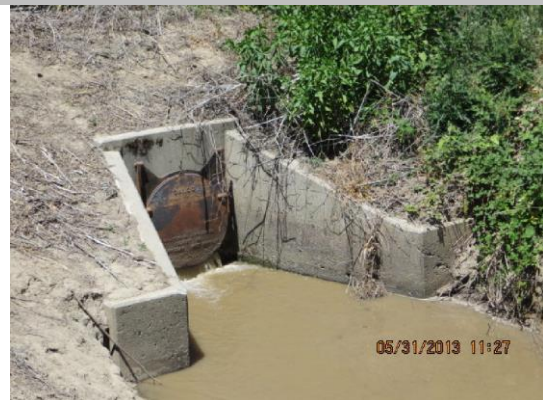
Photo 3 of 3 : UCIP_SP_2022_14565_24007.jpg

Flap gate and concrete headwall on WS toe.

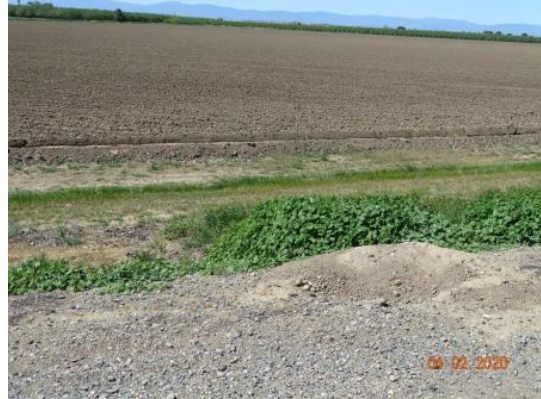
Photo 1 of 1 : SP_2022_LD0001G_432_66_20220307_00012.jpg

View of the rodent holes along the waterside slope. Spring 2020.

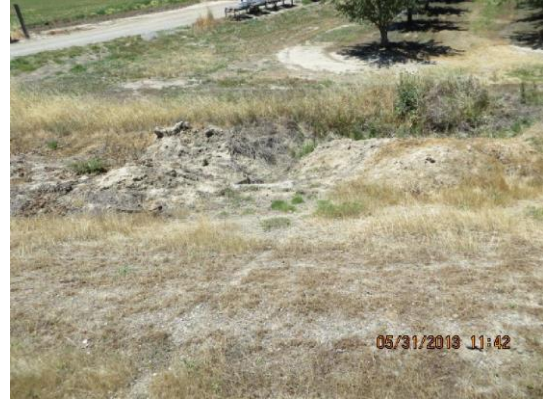
Photo 1 of 3 : UCIP_SP_2022_14566_24013.jpg

LM Start	11.64	Rating **	A/W	Issue No.	34	
LM End	11.64	Issue Type +	Ma	Location *		
Category	Supplemental			GPS Latitude/Longitude		
				Start	End	
Item	DWR UCIP LMA Responsibility			39.623874 °	39.623874 °	
				-121.999813 °	-121.999813 °	
DWR ID	22926					
Comment Code						
Inspector Comment						
FS_ID:14566 DS_ID:22926 EP_NO: 9555 Repair Type: No Action Needed Crossing Status: Found UCIP Comments: FIELD_STRUCT_DESC: 24-inch corrugated metal drainage pipe through the levee, 8.5 feet below the crown. Flap gate on the waterside (WS) slope. Concrete U-shaped headwalls on both ends. Two corrugated metal cutoff walls. (24-inch pipe [HLM 11.81] authorized under Automatic Board Order (ABO) issued as Permit No. 9555, 1974 - F. S. Reager). [Additional Reference(s): DWR Levee Log, 1992. USACE Sacramento O&M Manual 140, May 1960, (HLM 11.81)]. FS Date: 5/31/2013

Concrete headwall on LS toe.

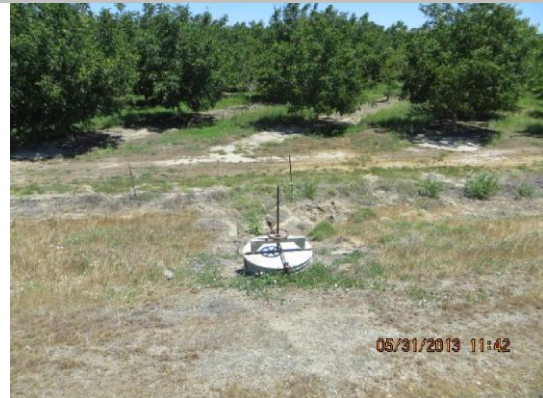
Photo 2 of 3 : UCIP_SP_2022_14566_24012.jpg

Slide gate in 36-inch CMP riser on WS slope.

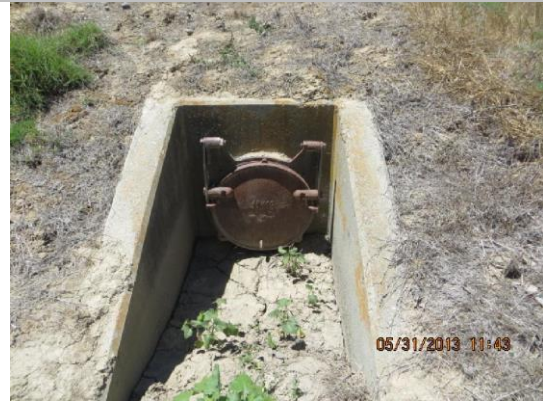
Photo 3 of 3 : UCIP_SP_2022_14566_24011.jpg

Concrete headwall and flapgate on WS toe

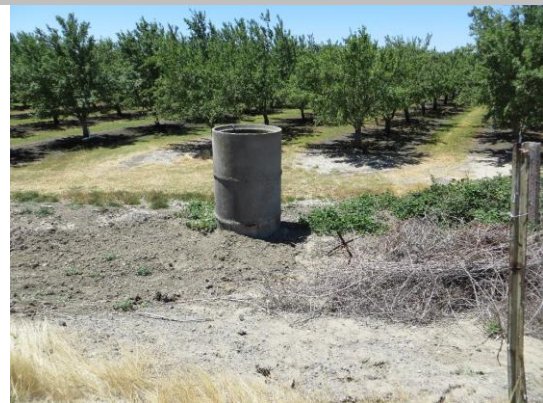
Photo 1 of 3 : UCIP_SP_2022_14567_24017.jpg

FS_ID:14567
 DS_ID:22927
 EP_NO: 9554
 Repair Type: Urgent
 Crossing Status: Found
 UCIP Comments: Erosion and sloughing on LS slope possibly due to rodent activity in area.
 FIELD_STRUCT_DESC: 24-inch corrugated metal drainage pipe through the levee, 11 feet below the crown. Slide gate in 36-inch corrugated metal riser unit on the waterside (WS) slope. 48-inch concrete standpipe on the landside (LS) toe. Two corrugated metal cutoff walls. (24-inch pipe [HLM 11.93] authorized under Automatic Board Order (ABO) issued as Permit No. 9554, 1974 - Thomas H. Reed). [Additional Reference(s): DWR Levee Log, 1992. USACE Sacramento O&M Manual 140, May 1960, (HLM 11.93)].
 FS Date: 5/31/2013

Concrete standpipe on LS toe.

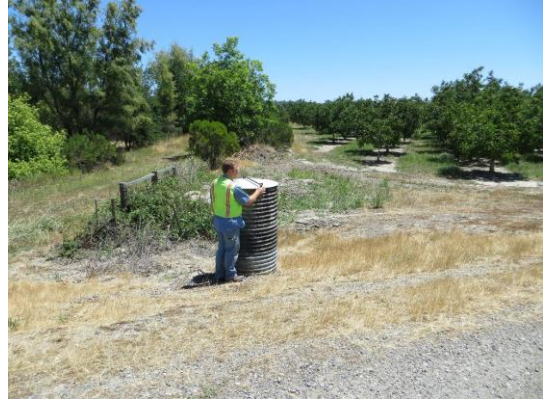
Photo 2 of 3 : UCIP_SP_2022_14567_24016.jpg

Slide gate in CMP riser on WS toe.

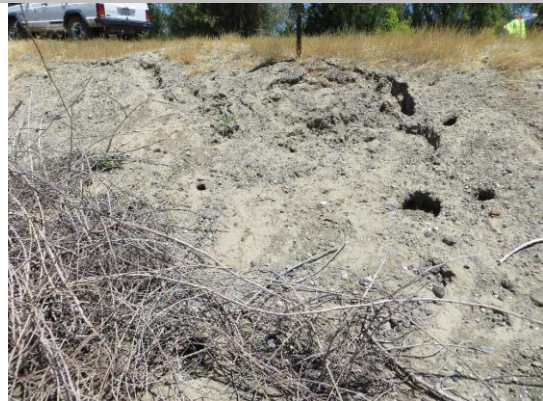
Photo 3 of 3 : UCIP_SP_2022_14567_24015.jpg

Erosion and sloughing on LS slope possibly due to rodent activity.

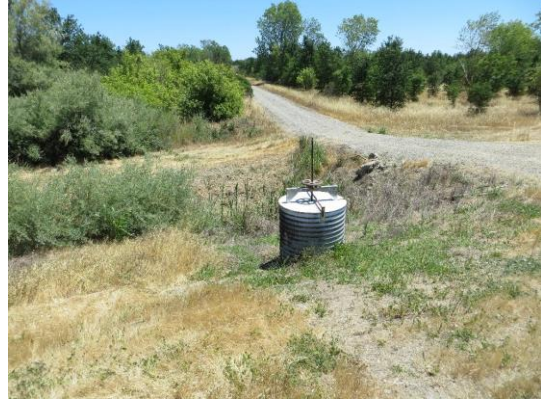
Photo 1 of 3 : UCIP_SP_2022_14569_24026.jpg

Comment Code					
Inspector Comment					
FS_ID:14569 DS_ID:22928 EP_NO: 9554 Repair Type: Urgent Crossing Status: Found UCIP Comments: Flap gate heavily corroded. Good candidate for video inspection. Vegetation interfering with inlet. FIELD_STRUCT_DESC: 24-inch corrugated metal drainage pipe through the levee, 7 feet below the crown. Flap gate on the waterside (WS) end. Slide gate in 36-inch corrugated metal pipe riser unit on the WS slope. Concrete headwalls on both ends. Two corrugated metal cutoff walls. (24-inch pipe [12.04] authorized under Automatic Board Order (ABO) issued as Permit No. 9554, 1974 - Thomas H. Reed). [Additional Reference(s): DWR Levee Log, 1992. USACE Sacramento O&M Manual 140, May 1960, (HLM 12.04)]. FS Date: 5/31/2013

Slidegate in 36-inch CMP riser on WS slope.

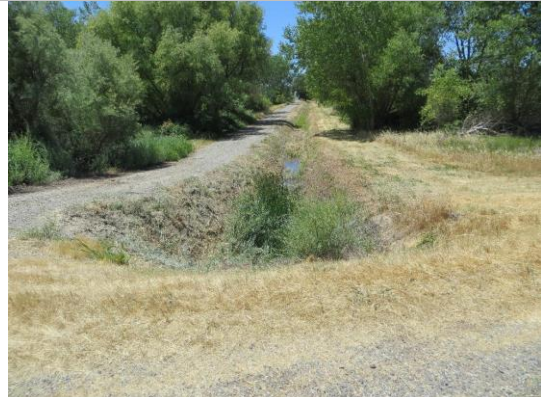
Photo 2 of 3 : UCIP_SP_2022_14569_24025.jpg

Drainage channel on LS toe.

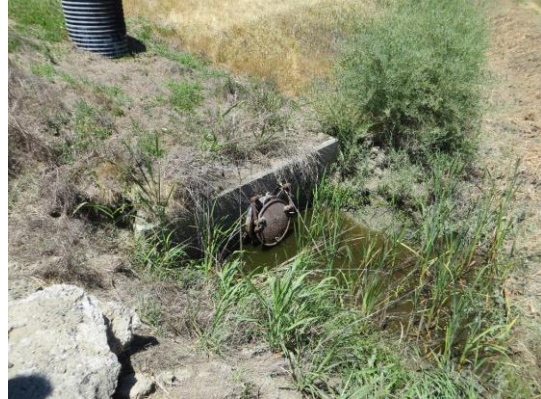
Photo 3 of 3 : UCIP_SP_2022_14569_24024.jpg

Headwall and flapgate on WS toe.

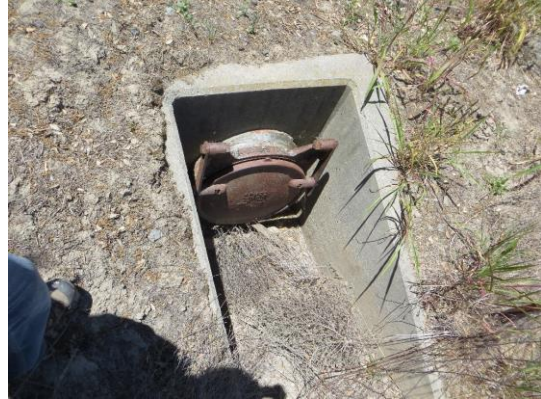
Photo 1 of 3 : UCIP_SP_2022_14570_24029.jpg

LM Start	12.13	Rating **	A/W	Issue No.	42
LM End	12.13	Issue Type +	Ma	Location *	
Category	Supplemental			GPS Latitude/Longitude	
				Start	End
Item	DWR UCIP LMA Responsibility			39.630451 °	39.630451 °
				-122.002737 °	-122.002737 °
DWR ID	22929				
Comment Code					
Inspector Comment					
FS_ID:14570 DS_ID:22929 EP_NO: 9554 Repair Type: No Action Needed Crossing Status: Found UCIP Comments: FIELD_STRUCT_DESC: 24-inch corrugated metal drainage pipe through the levee, 7 feet below the crown. Flap gate on the waterside (WS) end. Slide gate in 36-inch corrugated metal riser unit on the WS slope. Concrete U-shaped headwalls on both ends. (24-inch pipe [HLM 12.29] authorized under Automatic Board Order (ABO) issued as Permit No. 9554, 1974 - Thomas H. Reed). [Additional Reference(s): DWR Levee Log, 1992. USACE Sacramento O&M Manual 140, May 1960, (HLM 12.29)]. FS Date: 5/31/2013

Flapgate and U-shaped concrete headwall on WS toe.

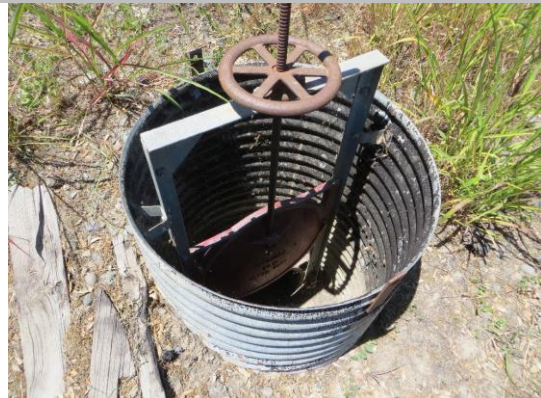
Photo 2 of 3 : UCIP_SP_2022_14570_24028.jpg

Slidegate in 36-inch CMP riser on WS slope.

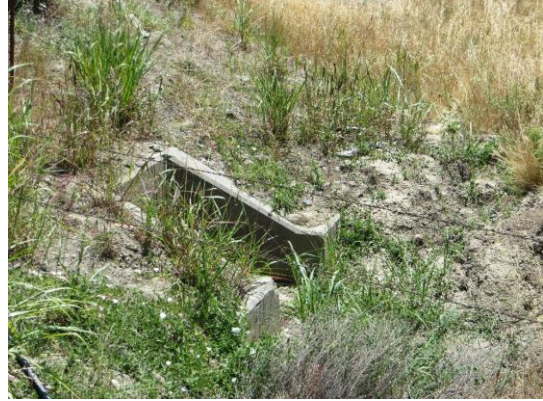
Photo 3 of 3 : UCIP_SP_2022_14570_24027.jpg

U-shaped concrete headwall on LS toe.
