**Flood Control Project Maintenance
Levee Inspections**

Maintenance Issue Types Only, Levee Inspection Report By Mile - Spring 2023

Levee District No. 0001 (Glenn County)

Waterway	Bank	Unit Miles	Inspection Start/End	Inspector
Unit No. 01 Sacramento River	Right	12.23	04/20/2023 04/20/2023	Makar Sokol

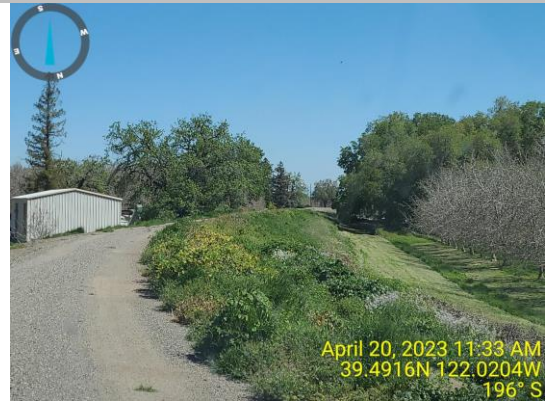
Photo 1 of 1 : SP_2023_LD0001G_432_27_20230510_00070.jpg

View of the vegetation along the waterside slope. Spring 2023.

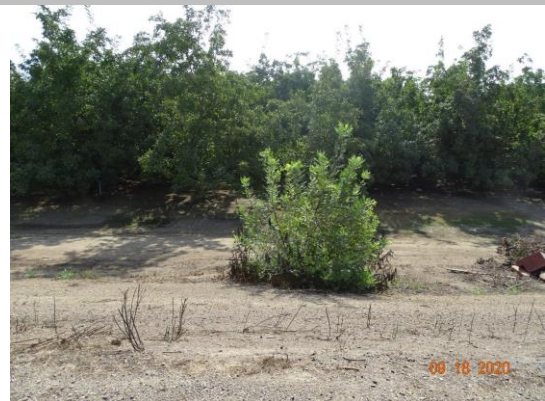
Photo 1 of 1 : SP_2023_LD0001G_432_59_20230417_00008.jpg

LM Start	1.08	Rating **	M	Issue No.	59
LM End	1.08	Issue Type +	Ma	Location *	WS
Category	Earthen Levee			GPS Latitude/Longitude	
				Start	End
Item	Trim / Thin Trees			39.492028°	39.492028°
				-122.020116°	-122.020116°
DWR ID	DWR_LD0001G_01_s_2019_59				
Comment Code					
T1 : Trim and thin trees to at least five feet above ground level to allow visibility of the ground and room to flood fight.					
Inspector Comment					
Trees 4 inches in diamater or less at chest height should be removed from the waterside slope.

View of a small tree on the waterside slope. Fall 2020.

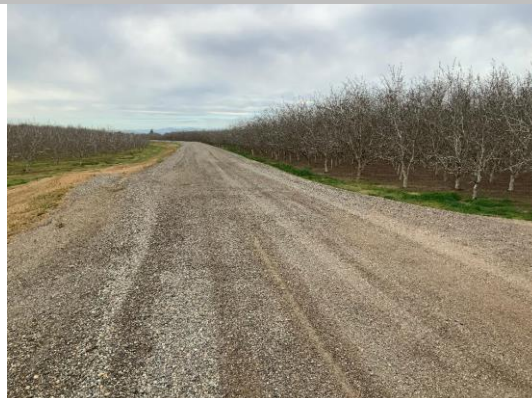
Photo 1 of 3 : UCIP_SP_2023_74765_108491.jpg

Comment Code						
Inspector Comment						
DS_ID:22944 FS_ID:74765 EP_NO: N/A Repair Type: Non-Urgent EVAL Issue: Crossing Status: Found UCIP Comments: 03/17/2022 The record remains Non-Urgent. Pipe damaged and open on LS and not visible on WS. Appears abandoned, owner will need to coordinate with the CVFPB to meet Title 23 requirements. Crossing doesn't appear to be a system feature, no permit has been identified authorizing pipe. DWR DMP internal inspection has not found pipe integrity issues. LOF of crossing is less or equal to 4.0. Recommend next video inspection in 5 years. The UCIP inspection was completed with GEI staff, H. Dunn. (A. Lau ? GEI)5/29/2013 Appears abandoned and should be done so properly. (G. Wylie ? DWR) FIELD_STRUCT_DESC: 8-inch drainage pipe of an unknown material sleeved through a 12-inch pipe of an unknown material through the levee, 9.5 feet below the crown. Flap gate located on the waterside (WS). Pipe open on the landside (LS). [Additional Reference(s): USACE Sacramento O&M Manual 140, May 1960, (HLM 2.27)]. FS Date: 3/17/2022 10:17:29 AM

Levee crest at crossing location.

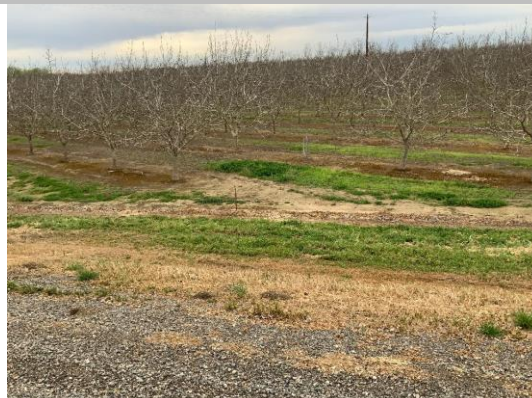
Photo 2 of 3 : UCIP_SP_2023_74765_108489.jpg

WS view: toe from crest; WS slope at crossing location.

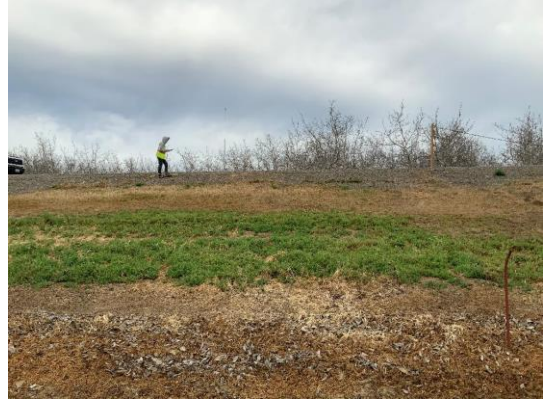
Photo 3 of 3 : UCIP_SP_2023_74765_108490.jpg

WS view: crest from toe; WS slope at crossing location.

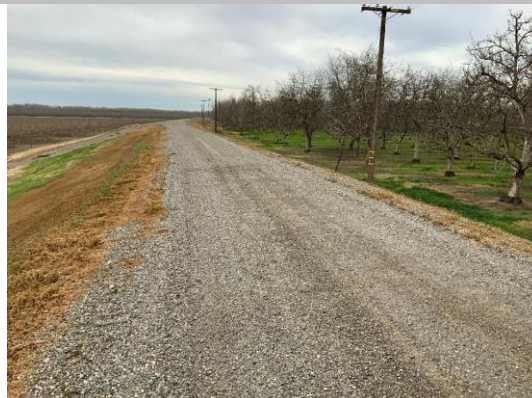
Photo 1 of 3 : UCIP_SP_2023_74766_108497.jpg

Comment Code						
Inspector Comment						
DS_ID:22899 FS_ID:74766 EP_NO: 9577 Repair Type: Non-Urgent EVAL Issue: Crossing Status: Indicator Found UCIP Comments: 03/17/2022 The record has been upgraded from No Action Needed to Non-Urgent. Pipe not found by visual inspection. DWR DMP Geophysical study indicates possible presence of pipe through levee. Owner needs to coordinate with the CVFPB to remove or abandon crossing according to Title 23 requirements. Coordinates of crossing have been updated. The UCIP inspection was completed with GEI staff, H. Dunn. (A. Lau ? GEI)5/29/2013 No pipe found. (G. Wylie ? DWR) FIELD_STRUCT_DESC: 14-inch drainage pipe of an unknown material through the levee, 11 feet below the crown. Flap gate is located on the waterside (WS) end on bank. Pump house, concrete distribution box, and 36-inch concrete standpipe are located at the toe of landside (LS) slope. (14-inch pipe [HLM 2.62] authorized under Automatic Board Order (ABO) issued as Permit No. 9577, 1974 - M. R. and M. E. Dias). [Additional Reference(s): DWR Levee Log, 1992. USACE Sacramento O&M Manual 140, May 1960, (HLM 2.62)]. FS Date: 3/17/2022 10:54:57 AM

Levee crown at crossing location on record.

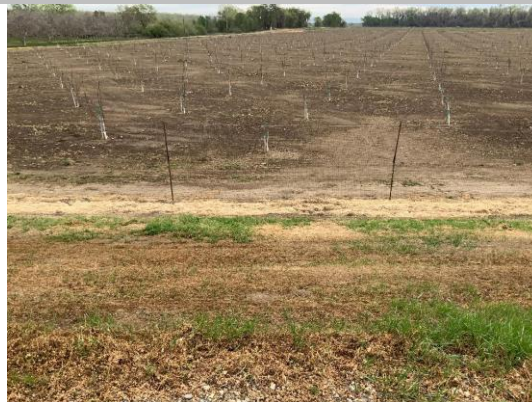
Photo 2 of 3 : UCIP_SP_2023_74766_108495.jpg

LS view: toe from crest; LS slope at crossing location on record, no pipe visible.

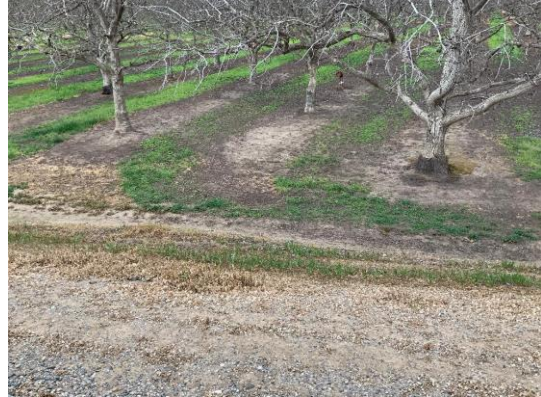
Photo 3 of 3 : UCIP_SP_2023_74766_108496.jpg

WS view: toe from crest; WS slope at crossing location on record, no pipe visible.

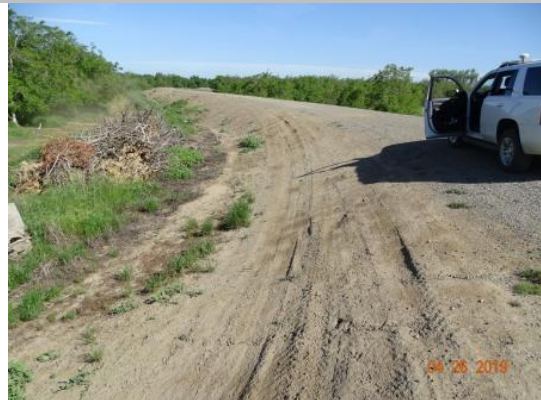
Photo 1 of 1 : SP_2023_LD0001G_432_77_20230417_00014.jpg

LM Start	3.04	Rating **	M	Issue No.	77
LM End	3.04	Issue Type +	Ma	Location *	LS
Category	Earthen Levee			GPS Latitude/Longitude	
				Start	End
Item	Erosion / Vehicle Traffic			39.512932°	39.512932°
				-122.009074°	-122.009074°
DWR ID	DWR_LD0001G_01_s_2019_77				
Comment Code					
E6 : Repair the levee slope damaged by vehicle traffic and prevent access where possible.					
Inspector Comment

View of the landside slope damaged by vehicle traffic. Spring 2019.

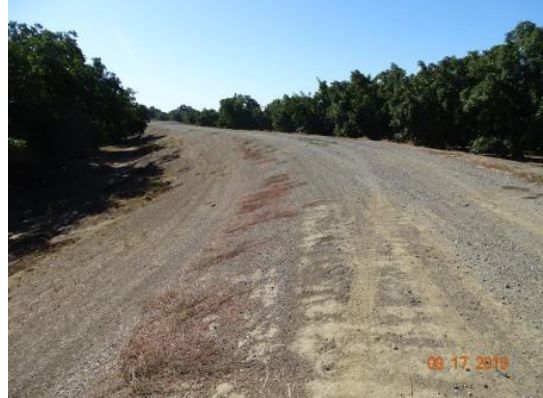
Photo 1 of 1 : SP_2023_LD0001G_432_68_20230417_00010.jpg

LM Start	3.26	Rating **	M	Issue No.	68
LM End	3.26	Issue Type +	Ma	Location *	WS
Category	Earthen Levee			GPS Latitude/Longitude	
				Start	End
Item	Erosion / Vehicle Traffic			39.515595°	39.515595°
				-122.011152°	-122.011152°
DWR ID	DWR_LD0001G_01_f _ 2019_68				
Comment Code					
E6 : Repair the levee slope damaged by vehicle traffic and prevent access where possible.					
Inspector Comment

View of the waterside slope damaged by vehicle traffic. Fall 2019.

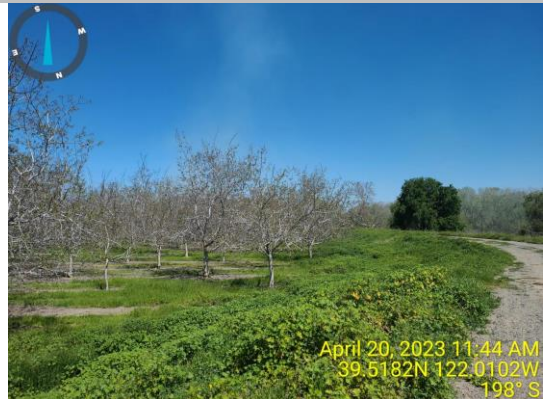
Photo 1 of 1 : SP_2023_LD0001G_432_31_20230510_00071.jpg

LM Start	3.45	Rating **	U	Issue No.	31
LM End	4.71	Issue Type +	Ma	Location *	LS
Category	Earthen Levee			GPS Latitude/Longitude	
				Start	End
Item	Vegetation			39.518209°	39.529991°
				-122.010117°	-121.997482°
DWR ID	DWR_LD0001G_01_s_2023_31				
Comment Code					
V1 : Control annual grass and weeds on the levee slopes and easements.					
Inspector Comment

View of the vegetation along the landside slope. Spring 2023.

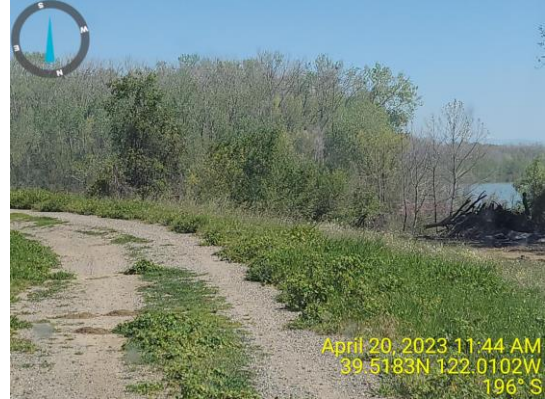
Photo 1 of 1 : SP_2023_LD0001G_432_33_20230510_00072.jpg

View of the vegetation along the waterside slope. Spring 2023.

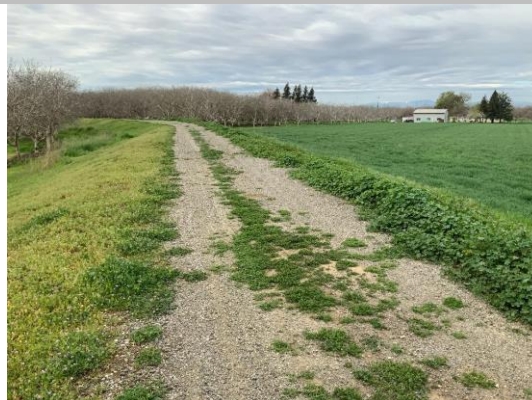
Photo 1 of 3 : UCIP_SP_2023_75562_108519.jpg

DS_ID:22904
FS_ID:75562
EP_NO: 9572
Repair Type: Urgent
EVAL Issue: 3a, Flood Risk
Crossing Status: Found
UCIP Comments: 3/17/2022 The record remains Urgent. Flap gate in concrete box on WS is not functioning correctly due to obstruction of a 3-inch metal pipe installed through the storm drainage pipe, resulting both WS and LS of the crossing open ended which would allow water to pass through the levee freely. Owner needs to remove obstruction in order to allow proper functionality of the flap gate and meet the compliance of Title 23. The UCIP inspection was completed with GEI staff, H. Dunn. (A. Lau ? GEI) 10/9/2018 No change to the crossing status. Flap gate on WS cannot be fully closed due to a 3-inch pipe through drainage pipe crossing the levee. Water is supplied from a well on LS via 3-inch pipe to the WS for irrigation/drinking purposes. Owner will need to remove obstruction to allow proper flap gate closure. (O. Yakimoving - DWR UCIP)12/21/2016 Flap gate on WS does not appear to be broken however, flap gate does not fully close due to a 3-inch aluminum pipe sleeve through larger pipe. Need to remove 3-inch pipe in order to have WS flap gate close and to be compliant with Title 23. (O. Magana - DWR UCIP)05/29/2013 Broken flap gate and Concrete headwall on LS toe possibly tilting. Also a 3-inch aluminum irrigation line through the pipe. (W. Wylie - DWR UCIP)

Levee crown at crossing location.

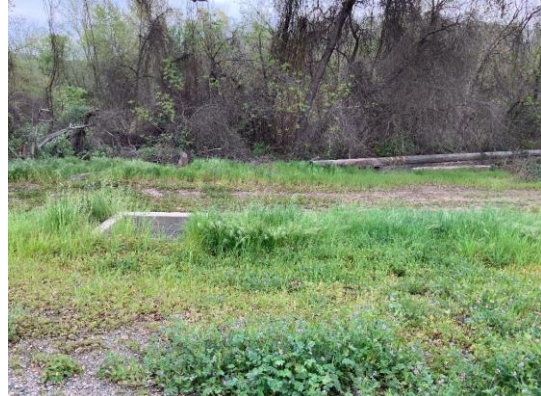
Photo 2 of 3 : UCIP_SP_2023_75562_108517.jpg

WS view: toe from crest; WS slope at crossing location..

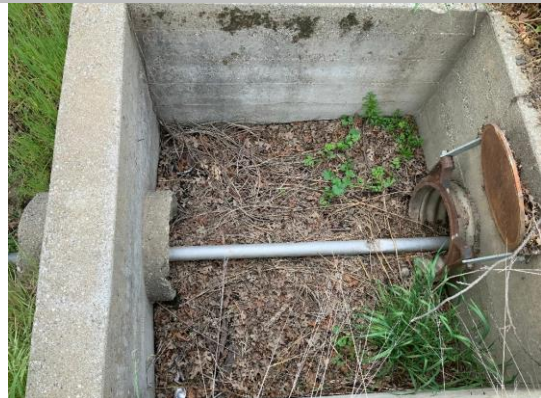
Photo 3 of 3 : UCIP_SP_2023_75562_108518.jpg

WS view: unauthorized 3-inch pipe installed through drainage pipe and preventing flap gate to function properly.

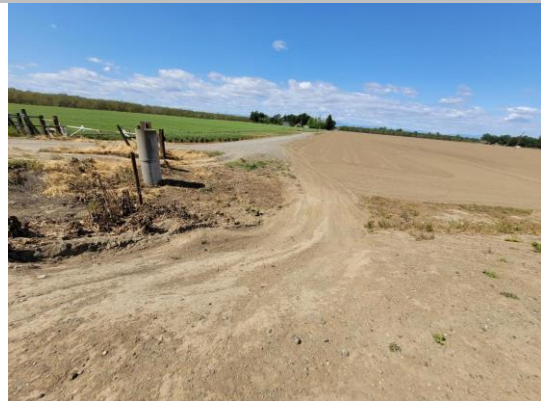
Photo 1 of 1 : SP_2023_LD0001G_432_61_20230417_00009.jpg

LM Start	5.06	Rating **	M	Issue No.	61
LM End	5.06	Issue Type +	Ma	Location *	LS
Category	Earthen Levee			GPS Latitude/Longitude	
				Start	End
Item	Erosion / Vehicle Traffic			39.534579°	39.534579°
				-121.995950°	-121.995950°
DWR ID	DWR_LD0001G_01_s_2022_61				
Comment Code					
E6 : Repair the levee slope damaged by vehicle traffic and prevent access where possible.					
Inspector Comment

View of erosion on the landside slope due to vehicle traffic. Spring 2022.

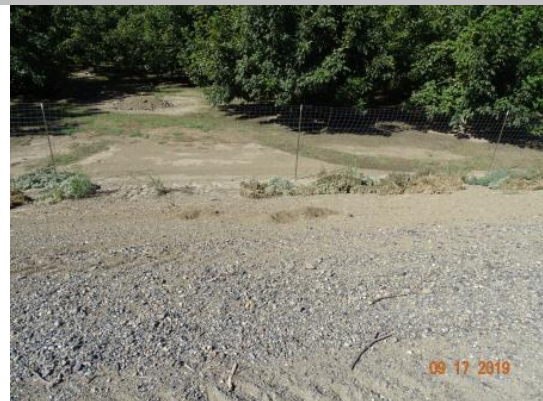
Photo 1 of 1 : SP_2023_LD0001G_432_84_20230417_00017.jpg

View of the rodent activity on the landside slope. Fall 2019.

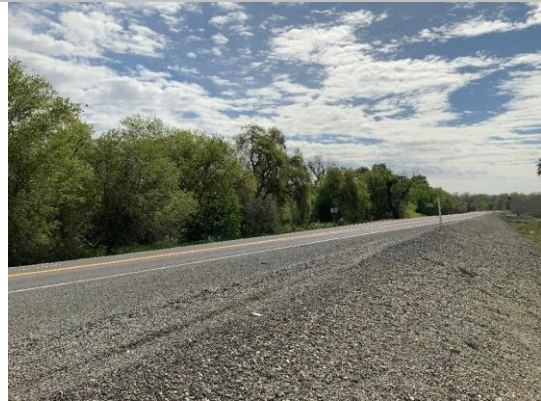
Photo 1 of 3 : UCIP_SP_2023_74471_108853.jpg

Comment Code					
Inspector Comment					
DS_ID:22918 FS_ID:74471 EP_NO: 9563 Repair Type: Urgent EVAL Issue: 1, Pipe Integrity Crossing Status: Found UCIP Comments: 03/17/2022 The record remains Urgent. DWR DMP internal inspection has found pipe integrity issues. LOF of crossing is between 5 and 6. Crossing will be monitored until funding becomes available to address the issues. WS outlet is damaged, and pipe is open on both ends, though it is above floodplain. The UCIP inspection was completed with GEI staff, A. Lau. (H. Dunn ? GEI)10/9/2018 Pipe is open on both ends and damaged on WS. Recommended grouting in place. Crossing downgraded to "Non-Urgent" due to pipe location above floodplain. (O.Yakimov - DWR UCIP)12/21/2016 same as last inspection crossing is opened on both ends and damaged on WS slope is visible. According to LMA representative, Nick Henning, pipe appears to be abandoned. (O. Magana - DWR UCIP)05/31/2013 Pipe open on both ends and damaged on WS slope. Pipe should be abandoned properly if appropriate. (W. Wylie - DWR UCIP) FIELD_STRUCT_DESC: 12-inch steel drainage pipe through levee, 5 feet below crown. Pipe open on both waterside (WS) and landside (LS) ends. One corrugated metal cutoff wall. (12-inch pipe [HLM 8.6] authorized under Automatic Board Order (ABO) No. 9563, 1974 - County of Glenn). [Additional Reference(s): DWR Levee Log, 1992. USACE Sacramento O&M Manual Unit 140, May 1960, (HLM 8.60)]. FS Date: 3/17/2022 7:51:10 AM

Levee crown at crossing location.

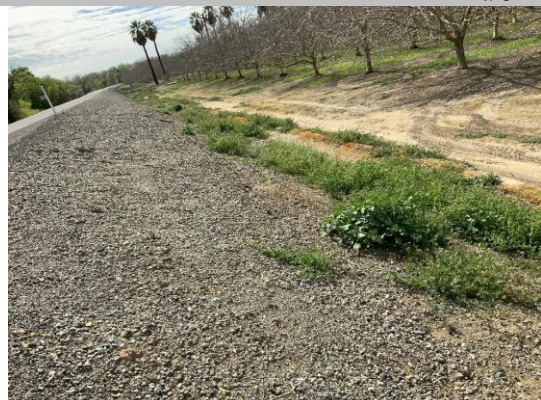
Photo 2 of 3 : UCIP_SP_2023_74471_108847.jpg

LS view: Toe from crown; LS slope at crossing location.

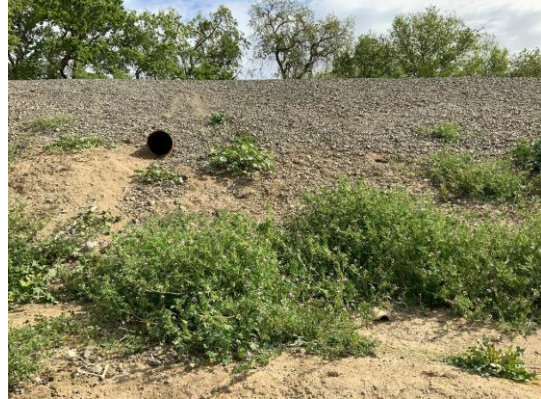
Photo 3 of 3 : UCIP_SP_2023_74471_108848.jpg

LS view: Slope from toe; pipe inlet on levee slope.

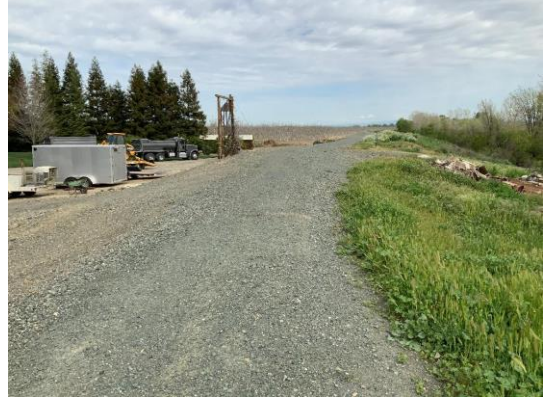
Photo 1 of 3 : UCIP_SP_2023_73667_108870.jpg

Comment Code						
Inspector Comment						
DS_ID:22920 FS_ID:73667 EP_NO: 9560 Repair Type: Non-Urgent EVAL Issue: 5, Pipe Damage Crossing Status: Found UCIP Comments: 03/17/2022 The record remains Non-Urgent. DWR DMP internal inspection has found pipe integrity issues. LOF of crossing is between 4.1 and 5. Crossing will be monitored until funding becomes available for rehabilitation. The UCIP inspection was completed with GEI staff, A. Lau. (H. Dunn ? GEI) 05/31/2013 Heavy rust along springline of pipe. Pipe has slight deformation at centerline of levee, not noticeable on crown. (G. Wylie - DWR) FIELD_STRUCT_DESC: 72-inch corrugated metal drainage pipe through the levee, 15 feet below the crown. Flap gate located on the waterside (WS) end. Slide gate in 8-inch corrugated metal riser unit on the WS slope. Concrete headwalls on both ends. Two corrugated metal cutoff walls. (72-inch pipe [HLM 9.64]authorized under Automatic Board Order (ABO) issued as Permit No. 9560, 1974 - John and Lena Friesen). [Additional Reference(s): DWR Levee Log, 1992. USACE Sacramento O&M Manual 140, May 1960, (HLM 9.64)]. FS Date: 3/17/2022 8:18:13 AM

Levee crown at crossing location.

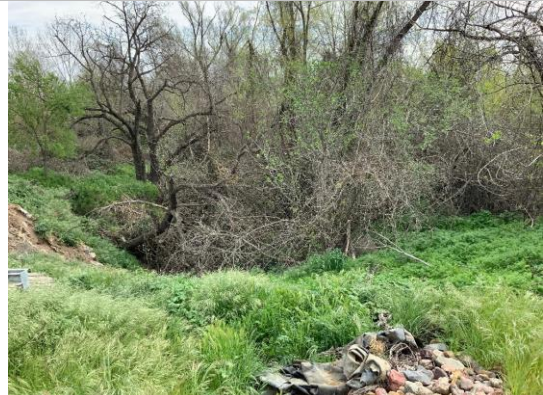
Photo 2 of 3 : UCIP_SP_2023_73667_108871.jpg

WS view: Toe from crown at crossing location; dense vegetation on WS slope.

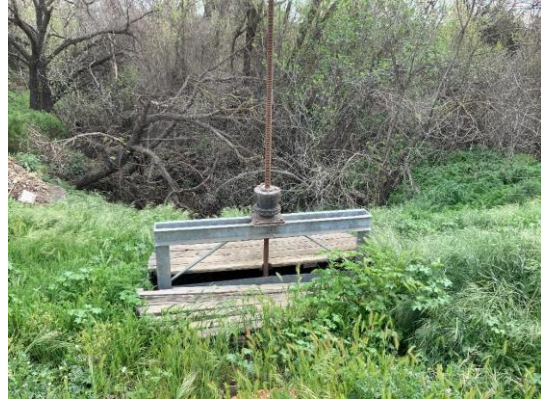
Photo 3 of 3 : UCIP_SP_2023_73667_108872.jpg

WS view: Slidegate on slope.

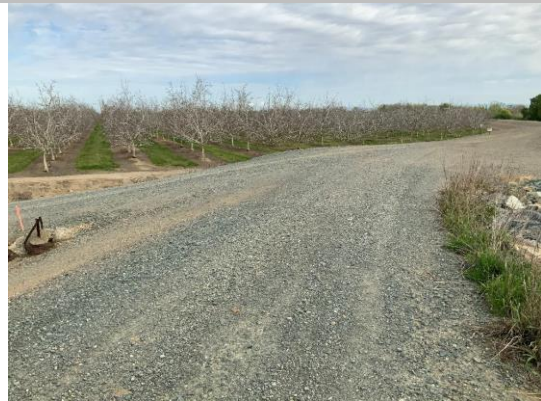
Photo 1 of 3 : UCIP_SP_2023_73668_108876.jpg

DS_ID:22921
 FS_ID:73668
 EP_NO: 9559
 Repair Type: Non-Urgent
 EVAL Issue: 5, Pipe Damage
 Crossing Status: Found
 UCIP Comments: 03/17/2022 The record has been upgraded from No Action Needed to Non-Urgent. DWR DMP internal inspection has found pipe integrity issues. LOF of crossing is between 4.1 and 5. Crossing will be monitored until funding becomes available for rehabilitation. WS flapgate has sediment buildup over it, limiting the ability to open, recommend digging out. The UCIP inspection was completed with GEI staff, A. Lau. (H. Dunn ? GEI)
 FIELD_STRUCT_DESC: 24-inch corrugated metal drainage pipe through the levee, 11 feet below the crown. Flap gate located on the waterside (WS) end. Slide gate in 36-inch corrugated metal riser unit on the WS slope. Concrete headwalls on both ends. Two corrugated metal cutoff walls. (24-inch pipe [HLM 10.05] authorized under Automatic Board Order (ABO) issued as Permit No. 9559, 1974 - David and Mary Giesbrecht). [Additional Reference(s): DWR Levee Log, 1992. USACE Sacramento O&M Manual 140, May 1960, (HLM 10.05)].

Levee crown at crossing location.

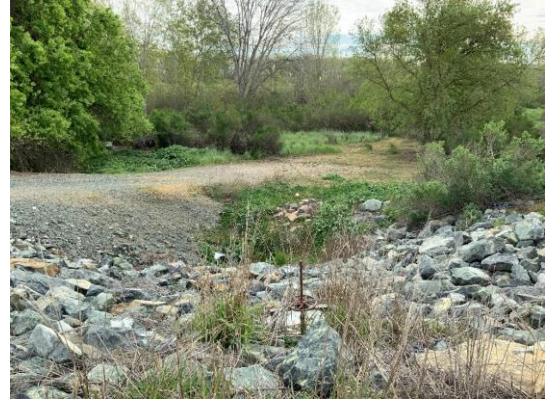
Photo 2 of 3 : UCIP_SP_2023_73668_108877.jpg

WS view: Toe from crown; riprap on WS slope.

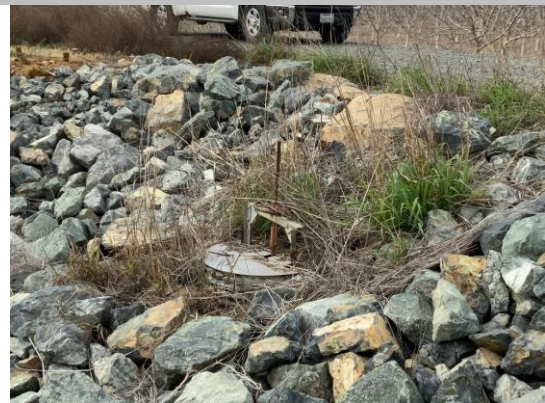
Photo 3 of 3 : UCIP_SP_2023_73668_108878.jpg

WS view: Slidegate and riser on WS slope.

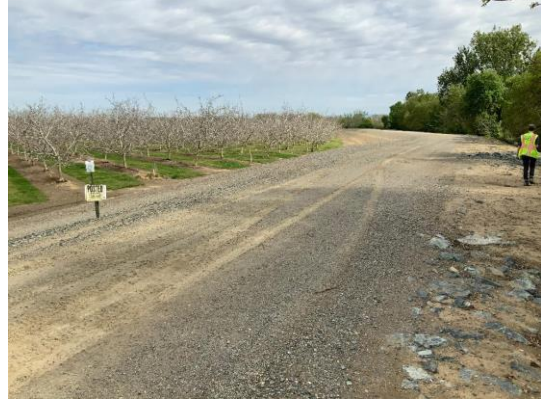
Photo 1 of 3 : UCIP_SP_2023_73670_108883.jpg

Comment Code					
Inspector Comment					
DS_ID:22922 FS_ID:73670 EP_NO: 9558 Repair Type: Urgent EVAL Issue: 1, Pipe Integrity Crossing Status: Found UCIP Comments: 03/17/2022 The record remains Urgent. DWR DMP internal inspection has found pipe integrity issues. LOF of crossing is between 5 and 6. Crossing will be monitored until funding becomes available to address the issues. The UCIP inspection was completed with GEI staff, A. Lau. (H. Dunn ? GEI) FIELD_STRUCT_DESC: 24-inch corrugated metal drainage pipe through the levee, 11 feet below the crown. Flap gate located on the waterside (WS) end. Slide gate in 36-inch corrugated metal pipe riser unit on the WS slope. Two corrugated metal cutoff walls. Concrete headwalls on both ends. (24-inch pipe [HLM 10.08] authorized under Automatic Board Order (ABO) issued as Permit No. 9558, 1974 - Duard Geis). [Additional Reference(s): DWR Levee Log, 1992. USACE Sacramento O&M Manual 140, May 1960, (HLM 10.08)]. FS Date: 3/17/2022 9:24:06 AM

Levee crown at crossing location.

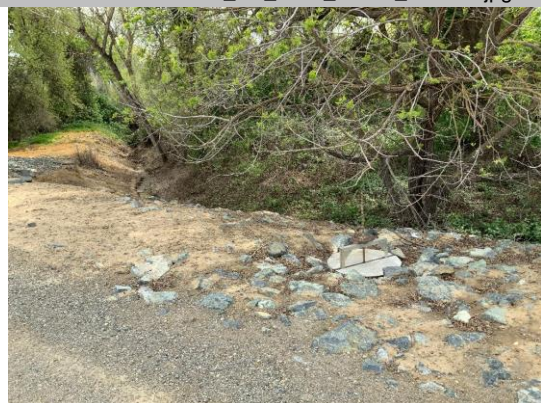
Photo 2 of 3 : UCIP_SP_2023_73670_108884.jpg

WS view: Toe from crown; riser on WS slope.

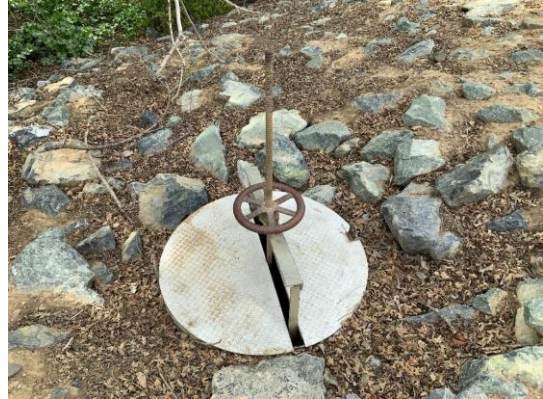
Photo 3 of 3 : UCIP_SP_2023_73670_108885.jpg

WS view: Slidegate and riser on slope.

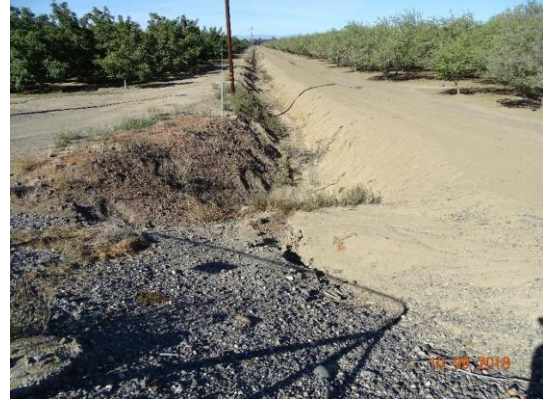
Photo 1 of 3 : UCIP_SP_2023_74777_78136.jpg

Comment Code					
Inspector Comment					
DS_ID:22924 FS_ID:74777 EP_NO: 9556 Repair Type: Urgent EVAL Issue: 1, Pipe Integrity Crossing Status: Found UCIP Comments: 03/17/2022 The record remains Urgent. DWR DMP internal inspection has found pipe integrity issues. LOF of crossing is between 5 and 6. Crossing will be monitored until funding becomes available to address the issues. Large rock at the bottom of CMP riser obstructs slide gate from completely closing. Debris covering LS inlet, recommend cleaning out. The UCIP inspection was completed with GEI staff, A. Lau. (H. Dunn ? GEI)10/9/2018 Large rock at the bottom of CMP riser obstructs slide gate from completely closing. Pipe is rusted through at WS end. Recommend internal inspection to determine condition of pipe through levee, and to clean the inside of CMP riser for proper slide gate function. (O.Yakimov - DWR UCIP)12/21/2016 same as last inspection flap gate disabled in open position. Surface erosion observed on LS slope. Recommend repair on WS flap gate to be able to close flap gate. (O. Magana - DWR UCIP)05/31/2013 Flap gate dissabled in open position. Pipe rusted through at WS toe upstream of Flapgate. (W. Wylie - DWR UCIP) FIELD_STRUCT_DESC: 24-inch corrugated metal drainage pipe through levee, 15 feet below crown. Flap gate is located on the waterside (WS) end. Slide gate is inside a corrugated metal pipe (CMP) riser located on the WS slope. Two CM cutoff walls. Concrete headwall is located on LS and under outlet at the WS toe. (24-inch pipe [HLM 10.59] authorized under Automatic Board Order (ABO) issued as Permit No. 9556, 1974 - E. R & M. R. Cooper). [Additional Reference(s): DWR Levee Log, 1992. USACE Sacramento O&M Manual Unit 140, May 1960, (HLM 10.59). USACE As-Built Drawing No. 50-04-3327, Sheet 3, 12, STA 106+76, 24 May 1960]. FS Date: 3/17/2022

Drainage channel on LS.

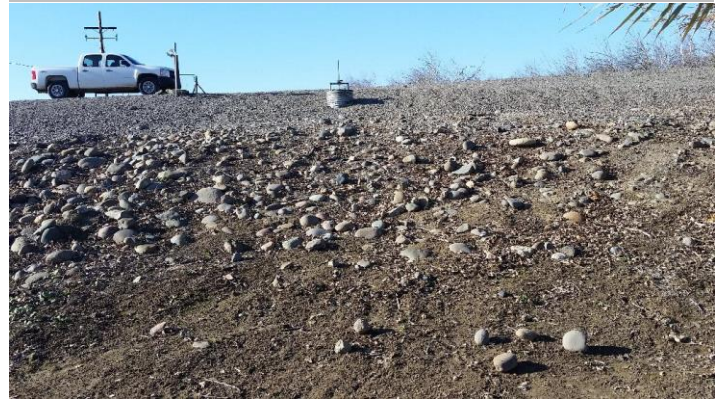
Photo 2 of 3 : UCIP_SP_2023_74777_76416.jpg

View of WS slope.

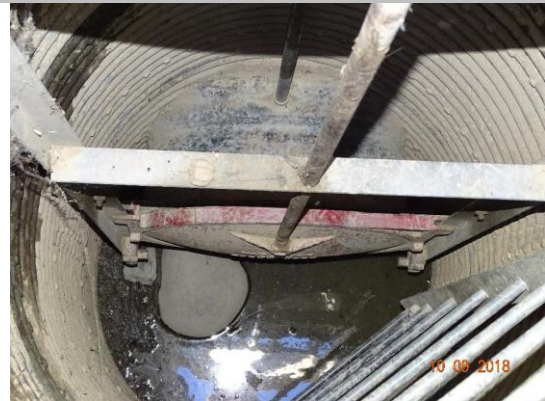
Photo 3 of 3 : UCIP_SP_2023_74777_78139.jpg

Large rock at the bottom of CMP riser obstructs slide gate from complete closing.

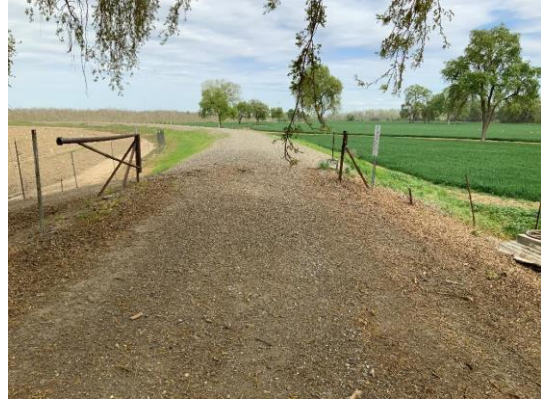
Photo 1 of 3 : UCIP_SP_2023_73674_109033.jpg

Comment Code						
Inspector Comment						
DS_ID:22925 FS_ID:73674 EP_NO: 9556 Repair Type: Urgent EVAL Issue: 1, Pipe Integrity Crossing Status: Found UCIP Comments: 03/17/2022 The record remains Urgent. DWR DMP internal inspection has found pipe integrity issues. LOF of crossing is between 5 and 6. Crossing will be monitored until funding becomes available to address the issues. The UCIP inspection was completed with GEI staff, A. Lau. (H. Dunn ? GEI) FIELD_STRUCT_DESC: 48-inch corrugated metal drainage pipe through the levee, 11 feet below the crown. Flap gate on the waterside (WS) end. Concrete headwall on both ends. Slide gate in 60-inch diameter corrugated metal riser unit on the WS slope (48-inch pipe [HLM 11.17] authorized under Automatic Board Order (ABO) issued as Permit No. 9556, 1974 - Earl R. and Merrit R. Cooper). [Additional Reference(s): DWR Levee Log, 1992. USACE Sacramento O&M Manual 140, May 1960, (HLM 11.17)]. FS Date: 3/17/2022

Levee crown at crossing location.

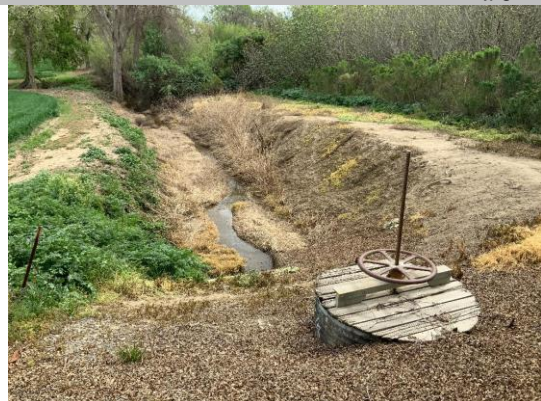
Photo 2 of 3 : UCIP_SP_2023_73674_109034.jpg

WS view: Riser on WS shoulder viewing from levee crown.

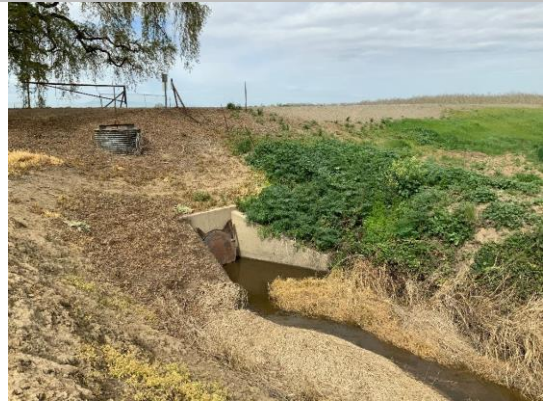
Photo 3 of 3 : UCIP_SP_2023_73674_109035.jpg

WS view: Slope from toe; concrete headwall and flapgate at WS toe.

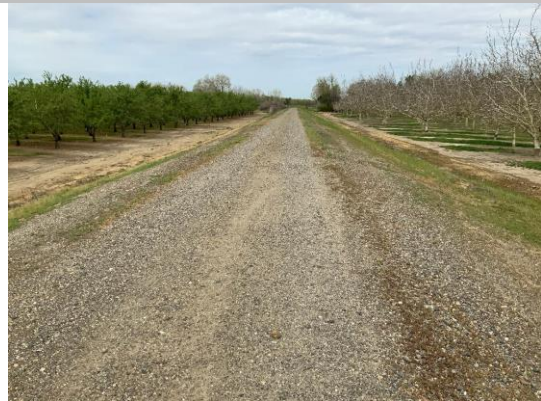
Photo 1 of 3 : UCIP_SP_2023_73675_109037.jpg

Comment Code					
Inspector Comment					
DS_ID:22926 FS_ID:73675 EP_NO: 9555 Repair Type: Non-Urgent EVAL Issue: 11, Maintenance Compliance Issue Crossing Status: Found UCIP Comments: 03/17/2022 The record has been upgraded from No Action Needed to Non-Urgent. Debris blocking landside pipe inlet, recommend removal of debris. DWR DMP internal inspection has not found pipe integrity issues. LOF of crossing is less or equal to 4.0. Recommend next video inspection in 5 years. Crossing appears to be in good condition. The UCIP inspection was completed with GEI staff, A. Lau. (H. Dunn ? GEI) FIELD_STRUCT_DESC: 24-inch corrugated metal drainage pipe through the levee, 8.5 feet below the crown. Flap gate on the waterside (WS) slope. Concrete U-shaped headwalls on both ends. Two corrugated metal cutoff walls. (24-inch pipe [HLM 11.81] authorized under Automatic Board Order (ABO) issued as Permit No. 9555, 1974 - F. S. Reager). [Additional Reference(s): DWR Levee Log, 1992. USACE Sacramento O&M Manual 140, May 1960, (HLM 11.81)]. FS Date: 3/17/2022 10:23:38 AM

Levee crown at crossing location.

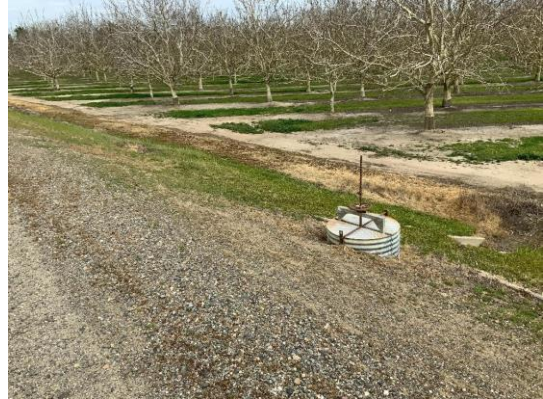
Photo 2 of 3 : UCIP_SP_2023_73675_109038.jpg

WS view: Toe from crown; corrugated riser on WS slope.

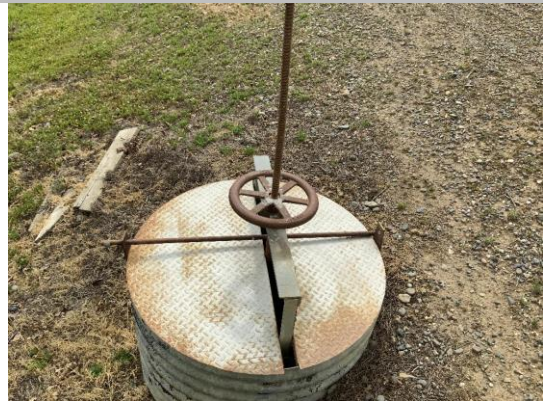
Photo 3 of 3 : UCIP_SP_2023_73675_109039.jpg

WS view: Riser and slidegate on slope.

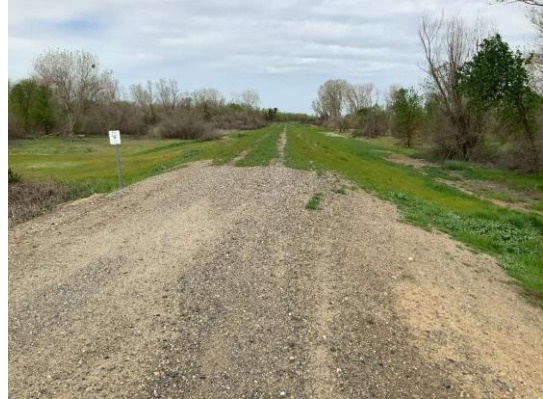
Photo 1 of 3 : UCIP_SP_2023_74778_109043.jpg

Comment Code					
Inspector Comment					
DS_ID:22927 FS_ID:74778 EP_NO: 9554 Repair Type: Urgent EVAL Issue: 1, Pipe Integrity Crossing Status: Found UCIP Comments: 03/17/2022 The record remains Urgent. DWR DMP internal inspection has found pipe integrity issues. LOF of crossing is between 5 and 6. Crossing will be monitored until funding becomes available to address the issues. WS inlet is not visible due to dense vegetation. The UCIP inspection was completed with GEI staff, A. Lau. (H. Dunn ? GEI)05/31/2013 Erosion and sloughing on LS slope possibly due to rodent activity in area. (G. Wylie - DWR) FIELD_STRUCT_DESC: 24-inch corrugated metal drainage pipe through the levee, 11 feet below the crown. Slide gate in 36-inch corrugated metal riser unit on the waterside (WS) slope. 48-inch concrete standpipe on the landside (LS) toe. Two corrugated metal cutoff walls. (24-inch pipe [HLM 11.93] authorized under Automatic Board Order (ABO) issued as Permit No. 9554, 1974 - Thomas H. Reed). [Additional Reference(s): DWR Levee Log, 1992. USACE Sacramento O&M Manual 140, May 1960, (HLM 11.93)]. FS Date: 3/17/2022 10:27:20 AM

Levee crown at crossing location.

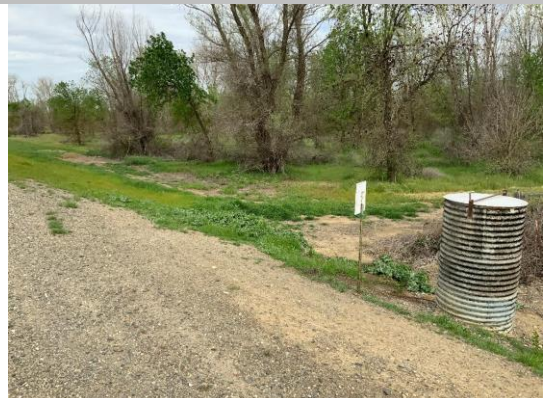
Photo 2 of 3 : UCIP_SP_2023_74778_109044.jpg

WS view: Toe from crown; corrugated metal riser at WS toe.

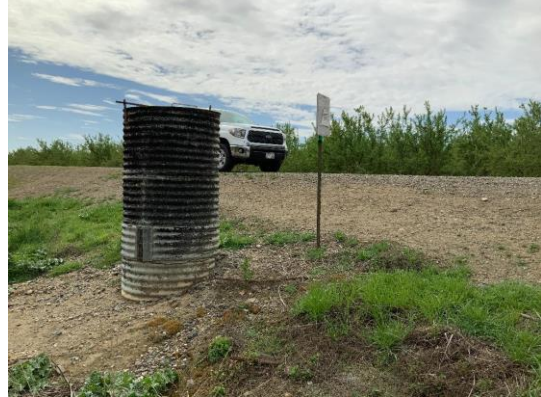
Photo 3 of 3 : UCIP_SP_2023_74778_109045.jpg

WS view: Riser and slope from toe.

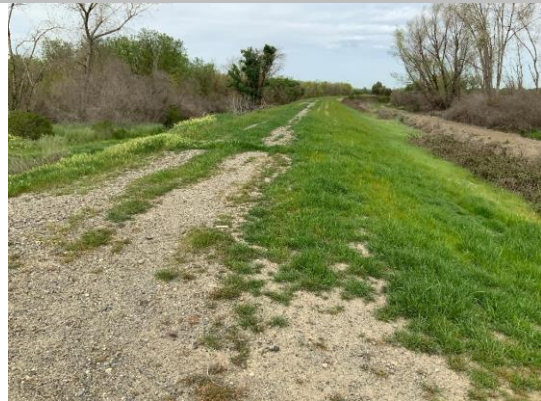
Photo 1 of 3 : UCIP_SP_2023_73677_109050.jpg

DS_ID:22928
FS_ID:73677
EP_NO: 9554
Repair Type: Urgent
EVAL Issue: 1, Pipe Integrity
Crossing Status: Found
UCIP Comments: 03/17/2022 The record remains Urgent. DWR DMP internal inspection has found pipe integrity issues. LOF of crossing is between 5 and 6. Crossing will be monitored until funding becomes available to address the issues. LS inlet is corroded. The UCIP inspection was completed with GEI staff, A. Lau. (H. Dunn ? GEI)05/29/2013 Flap gate heavily corroded. Good candidate for video inspection. Vegetation interfering with inlet. (G. Wylie - DWR)
FIELD_STRUCT_DESC: 24-inch corrugated metal drainage pipe through the levee, 7 feet below the crown. Flap gate on the waterside (WS) end. Slide gate in 36-inch corrugated metal pipe riser unit on the WS slope. Concrete headwalls on both ends. Two corrugated metal cutoff walls. (24-inch pipe [12.04] authorized under Automatic Board Order (ABO) issued as Permit No. 9554, 1974 - Thomas H. Reed).

Levee crown at crossing location.

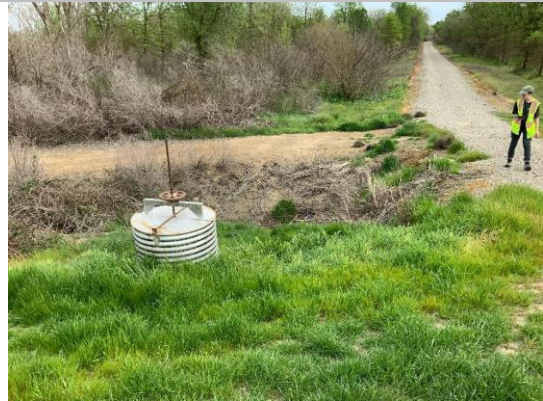
Photo 2 of 3 : UCIP_SP_2023_73677_109051.jpg

WS view: Toe from crown; corrugated metal riser on WS slope.

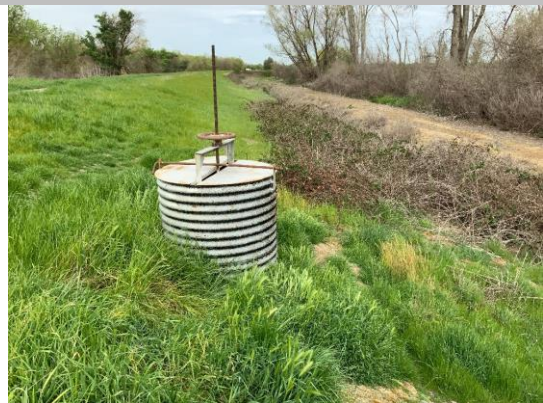
Photo 3 of 3 : UCIP_SP_2023_73677_109052.jpg

WS view: Riser and slidegate on WS slope.

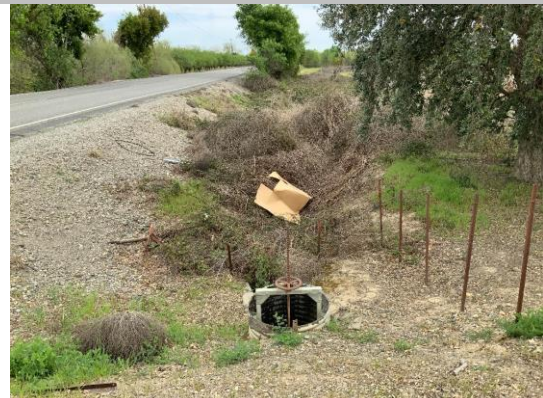
Photo 2 of 3 : UCIP_SP_2023_74779_109287.jpg

WS view: toe from crest; corrugated metal riser at WS levee toe.

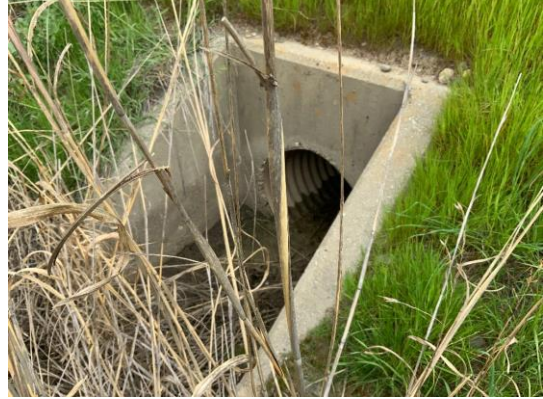
Photo 3 of 3 : UCIP_SP_2023_74779_109284.jpg

LS view: U-shaped concrete headwall and LS pipe opening at LS levee toe.
