**Flood Control Project Maintenance
Levee Inspections**

Maintenance Issue Types Only, Levee Inspection Report By Mile - Spring 2024

Levee District No. 0001 (Glenn County)

Waterway	Bank	Unit Miles	Inspection Start/End	Inspector
Unit No. 01 Sacramento River	Right	12.23	04/24/2024 04/24/2024	Makar Sokol

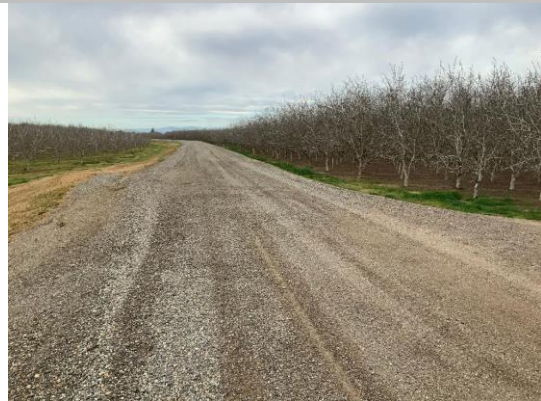
Photo 1 of 3 : UCIP_SP_2024_74765_108491.jpg

Comment Code						
Inspector Comment						
DS_ID:22944 FS_ID:74765 EP_NO: N/A Repair Type: Non-Urgent EVAL Issue: Crossing Status: Not Found UCIP Comments: 03/17/2022 The record remains Non-Urgent. Crossing not found. Appears that DWR DMP internal inspection was mistakenly completed for pipe DSID 22898 at this location. The UCIP inspection was completed with GEI staff, H. Dunn. (A. Lau - GEI)5/29/2013 Appears abandoned and should be done so properly. (G. Wylie - DWR) FIELD_STRUCT_DESC: 12-inch pipe of an unknown material through the levee, 9.5 feet below the crown. Flap gate located on the waterside (WS). Pipe open on the landside (LS). Application for Permit No. 5623 to sleeve 6-inch pipe through 12-inch drainage pipe was denied although the pipe was already sleeved. Photos are available in permit documents. [Additional Reference(s): DWR Levee Log, 1992 (HLM 2.27). USACE Sacramento O&M Manual, Unit 140, May 1960, Revised 29 December 2016, (HLM 2.27), listed as 12-inch pipe]. FS Date: 3/17/2022 10:17:29 AM

Levee crest at crossing location.

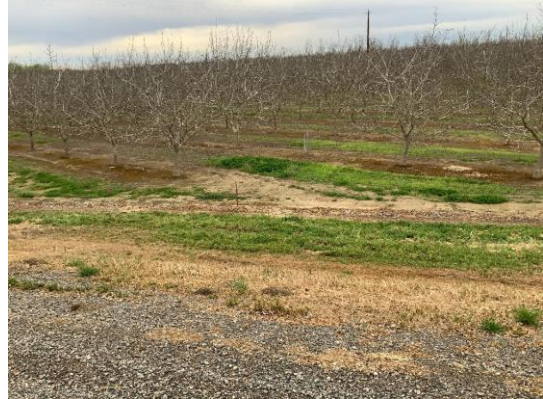
Photo 2 of 3 : UCIP_SP_2024_74765_108489.jpg

WS view: toe from crest; WS slope at crossing location.

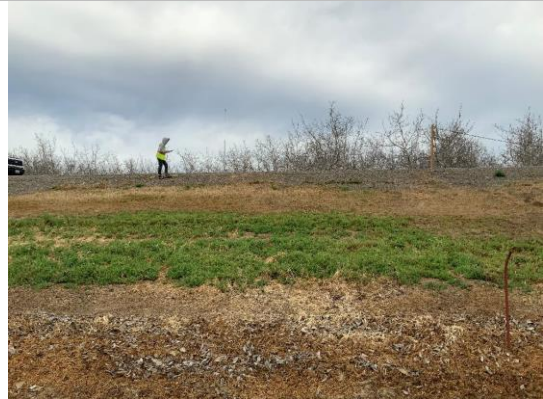
Photo 3 of 3 : UCIP_SP_2024_74765_108490.jpg

WS view: crest from toe; WS slope at crossing location.

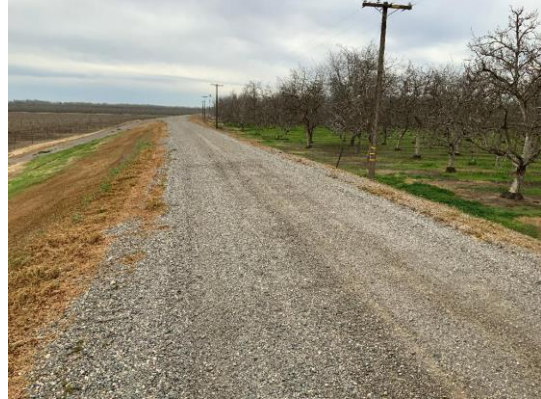
Photo 1 of 3 : UCIP_SP_2024_74766_108497.jpg

Comment Code						
Inspector Comment						
DS_ID:22899						
FS_ID:74766						
EP_NO: 9577						
Repair Type: Non-Urgent						
EVAL Issue:						
Crossing Status: Indicator Found						
UCIP Comments: 03/17/2022 The record has been upgraded from No						
Action Needed to Non-Urgent. Pipe not found by visual inspection.						
DWR DMP Geophysical study indicates possible presence of pipe						
through levee. Owner needs to coordinate with the CVFPB to remove or						
abandon crossing according to Title 23 requirements. Coordinates of						
crossing have been updated. The UCIP inspection was completed with						
GEI staff, H. Dunn. (A. Lau – GEI)5/29/2013 No pipe found. (G. Wylie						
– DWR)						
FIELD_STRUCT_DESC: 14-inch drainage pipe of an unknown material						
through the levee, 11 feet below the crown. Flap gate is located on the						
waterside (WS) end on bank. Pump house, concrete distribution box,

Levee crown at crossing location on record.

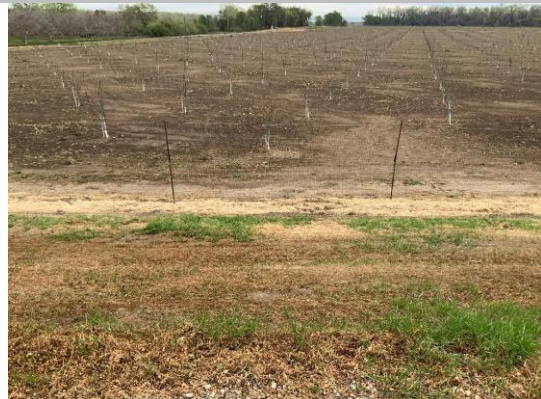
Photo 2 of 3 : UCIP_SP_2024_74766_108495.jpg

LS view: toe from crest; LS slope at crossing location on record, no pipe visible.

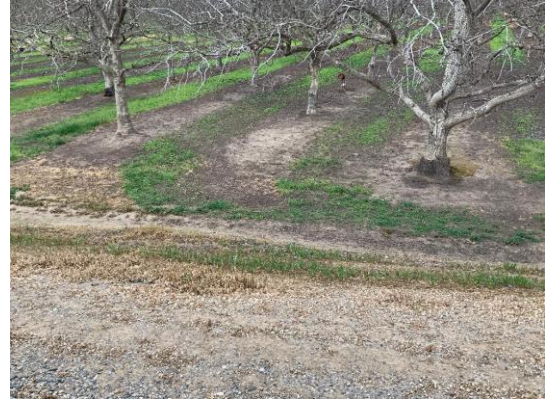
Photo 3 of 3 : UCIP_SP_2024_74766_108496.jpg

WS view: toe from crest; WS slope at crossing location on record, no pipe visible.

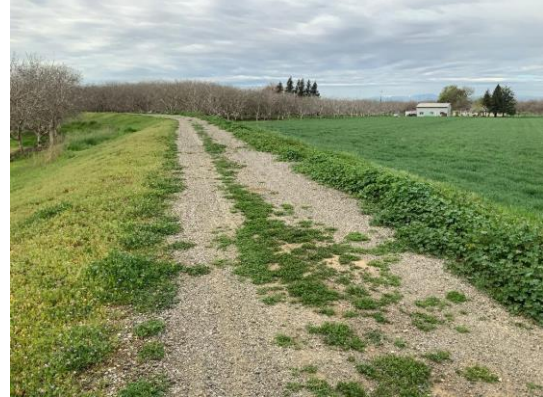
Photo 1 of 3 : UCIP_SP_2024_75562_108519.jpg

Comment Code					
Inspector Comment					
DS_ID:22904 FS_ID:75562 EP_NO: 9572 Repair Type: Urgent EVAL Issue: 3a, Flood Risk Crossing Status: Found UCIP Comments: 3/17/2022 The record remains Urgent. Flap gate in concrete box on WS is not functioning correctly due to obstruction of a 3-inch metal pipe installed through the storm drainage pipe, resulting both WS and LS of the crossing open ended which would allow water to pass through the levee freely. Owner needs to remove obstruction in order to allow proper functionality of the flap gate and meet the compliance of Title 23. The UCIP inspection was completed with GEI staff, H. Dunn. (A. Lau – GEI) 10/9/2018 No change to the crossing status. Flap gate on WS cannot be fully closed due to a 3-inch pipe through drainage pipe crossing the levee. Water is supplied from a well on LS via 3-inch pipe to the WS for irrigation/drinking purposes. Owner will need to remove obstruction to allow proper flap gate closure. (O.Yakimoving - DWR UCIP)12/21/2016 Flap gate on WS does not appear to be broken however, flap gate does not fully close due to a 3-inch aluminum pipe sleeve through larger pipe. Need to remove 3-inch pipe in order to have WS flap gate close and to be compliant with Title 23. (O. Magana - DWR UCIP)05/29/2013 Broken flap gate and Concrete headwall on LS toe possibly tilting. Also a 3-inch aluminum irrigation line through the pipe. (W. Wylie - DWR UCIP) FIELD_STRUCT_DESC: 18-inch steel drainage pipe through the levee, 7.3 feet below the crown. Flap gate in 6-inch by 6-inch concrete box located on the waterside (WS) end. Concrete headwall located on the landside (LS) toe. (18-inch pipe [HLM 4.05] authorized under Automatic Board Order (ABO) issued as Permit No. 9572, 1974 - Henry and Annabel B. Smith). [Additional Reference(s): DWR Levee Log, 1992 (HLM 4.05). USACE Sacramento O&M Manual, Unit 140, May 1960, Revised 29 December 2016, (HLM 4.05), listed as 18-inch pipe]. FS Date: 3/17/2022 2:21:10 PM

Levee crown at crossing location.

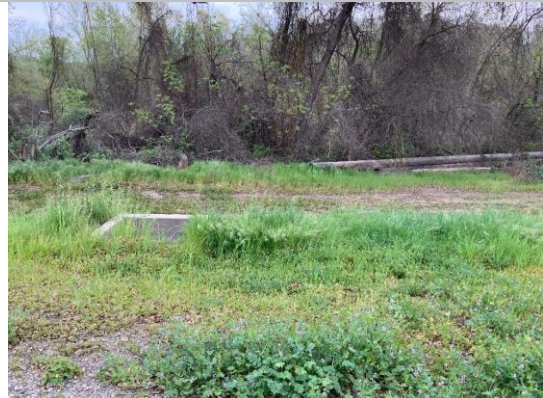
Photo 2 of 3 : UCIP_SP_2024_75562_108517.jpg

WS view: toe from crest; WS slope at crossing location..

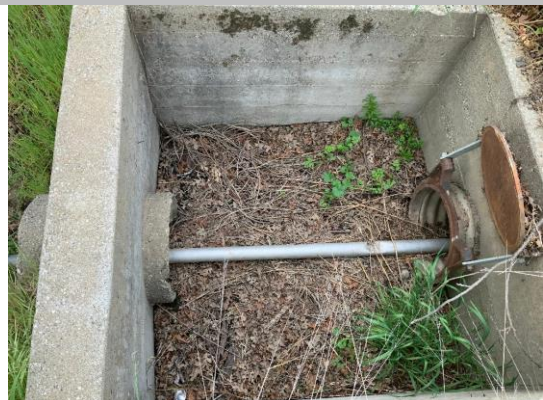
Photo 3 of 3 : UCIP_SP_2024_75562_108518.jpg

WS view: unauthorized 3-inch pipe installed through drainage pipe and preventing flap gate to function properly.

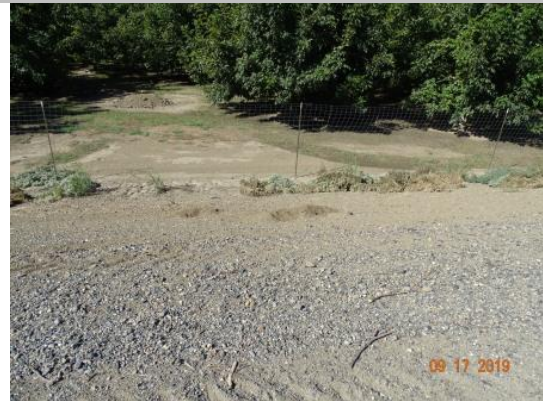
Photo 1 of 1 : SP_2024_LD0001G_432_84_20240212_00013.jpg

View of the rodent activity on the landside slope. Fall 2019.

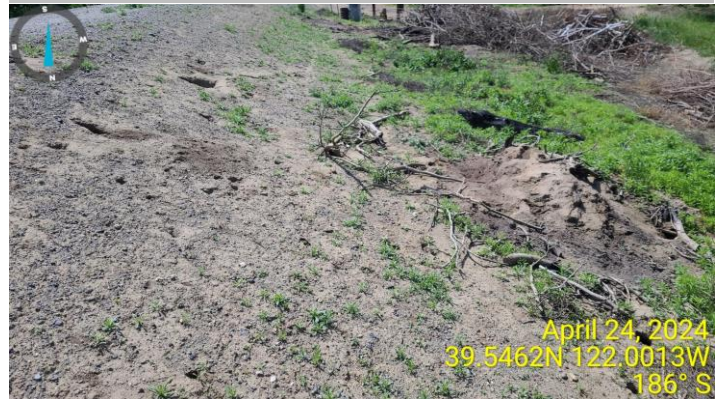
Photo 1 of 1 : SP_2024_LD0001G_432_52_20240425_00066.jpg

LM Start	5.91	Rating **	U	Issue No.	52
LM End	5.91	Issue Type +	Ma	Location *	LS
Category	Earthen Levee			GPS Latitude/Longitude	
				Start	End
Item	Animal Control			39.546143°	39.546143°
				-122.001198°	-122.001198°
DWR ID	DWR_LD0001G_01_s_2024_52				
Comment Code					
A3 : No rodents visible, but rodent burrows visible; need to backfill and compact or grout burrows.					
Inspector Comment

View of rodent activity on the landside slope. Spring 2024.

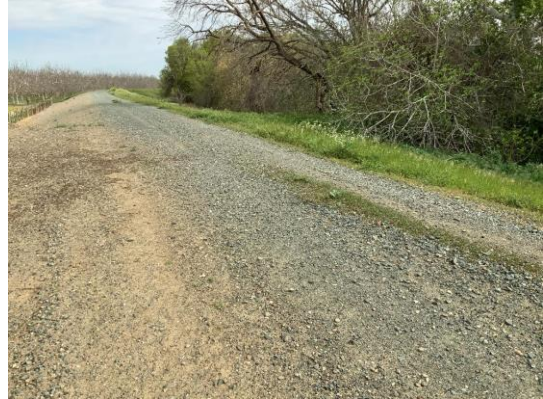
Photo 1 of 3 : UCIP_SP_2024_74472_108862.jpg

Comment Code						
Inspector Comment						
DS_ID:22919 FS_ID:74472 EP_NO: 9562-1 Repair Type: Urgent EVAL Issue: 1, Pipe Integrity Crossing Status: Found UCIP Comments: 03/17/2022 The record remains Urgent. Unable to find a permit for sleeving 24-inch pipe. DWR DMP internal inspection has found pipe integrity issues. LOF of crossing is between 5 and 6. Crossing will be monitored until funding becomes available to address the issues. No permit has been identified authorizing pipe. Need to have CVFPB review ABO and determine current owner. (H. Dunn - GEI) FIELD_STRUCT_DESC: 24-inch corrugated metal drainage pipe with 0.375-inch wall epoxy coated steel sleeved through existing 30-inch corrugated metal pipe through the levee, 15 feet below the crown. Flap gate located on the waterside (WS) end. Slide gate in 44-inch corrugated metal riser unit on the WS slope. Concrete headwalls on both ends. Two corrugated metal cutoff walls. (30-inch pipe [HLM 8.98] authorized under Automatic Board Order (ABO) issued as Permit No. 9562, 1974 - L. R. Henrich). [Additional Reference(s): DWR Levee Log, 1992 (HLM 8.98). USACE Sacramento O&M Manual, Unit 140, May 1960, Revised 29 December 2016, (HLM 8.98), listed as 30-inch pipe. USACE As-Built Drawing No. 50-04-3327, 24 May 1960, Sheets 4 and 13, STA 190+89, listed as 30-inch pipe]. FS Date: 3/17/2022 8:08:19 AM

Levee crown at crossing location.

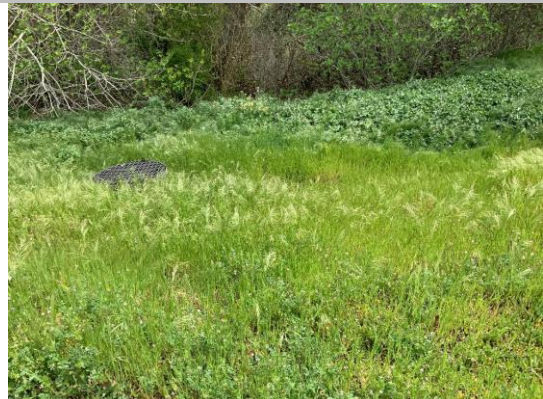
Photo 2 of 3 : UCIP_SP_2024_74472_108863.jpg

WS view: Toe from crown at crossing location.

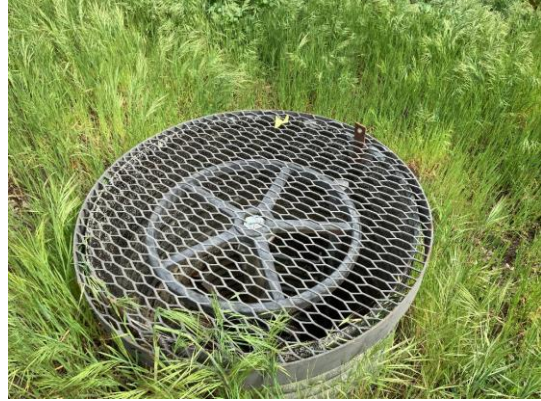
Photo 3 of 3 : UCIP_SP_2024_74472_108864.jpg

WS view: Closeup of valve and riser with metal mesh cover on WS slope.

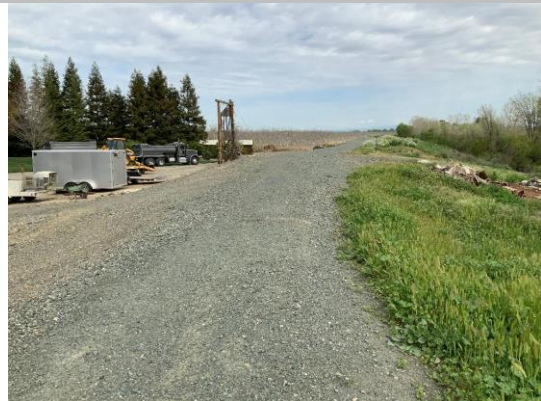
Photo 1 of 3 : UCIP_SP_2024_73667_108870.jpg

DS_ID:22920
FS_ID:73667
EP_NO: 9560
Repair Type: Non-Urgent
EVAL Issue: 5, Pipe Damage
Crossing Status: Found
UCIP Comments: 03/17/2022 The record remains Non-Urgent. DWR DMP internal inspection has found pipe integrity issues. LOF of crossing is between 4.1 and 5. Crossing will be monitored until funding becomes available for rehabilitation. The UCIP inspection was completed with GEI staff, A. Lau. (H. Dunn – GEI) 05/31/2013 Heavy rust along springline of pipe. Pipe has slight deformation at centerline of levee, not noticeable on crown. (G. Wylie - DWR)
FIELD_STRUCT_DESC: 72-inch corrugated metal drainage pipe through the levee, 15 feet below the crown. Flap gate located on the waterside (WS) end. Slide gate in 8-inch corrugated metal riser unit on the WS slope. Concrete headwalls on both ends. Two corrugated metal cutoff walls. (72-inch pipe [HLM 9.64] authorized under Automatic Board Order (ABO) issued as Permit No. 9560, 1974 - John and Lena Friesen). [Additional Reference(s): DWR Levee Log, 1992 (HLM 9.64). USACE Sacramento O&M Manual, Unit 140, May 1960, Revised 29 December 2016, (HLM 9.64), listed as 72-inch pipe. USACE As-Built Drawing No. 50-04-3327, 24 May 1960, Sheets 4 and 13, STA 156+23]. FS Date: 3/17/2022 8:18:13 AM

Levee crown at crossing location.

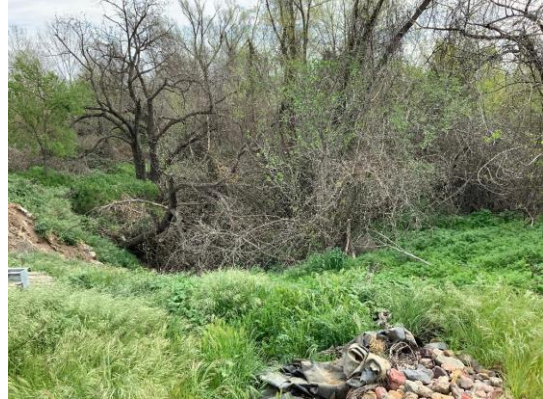
Photo 2 of 3 : UCIP_SP_2024_73667_108871.jpg

WS view: Toe from crown at crossing location; dense vegetation on WS slope.

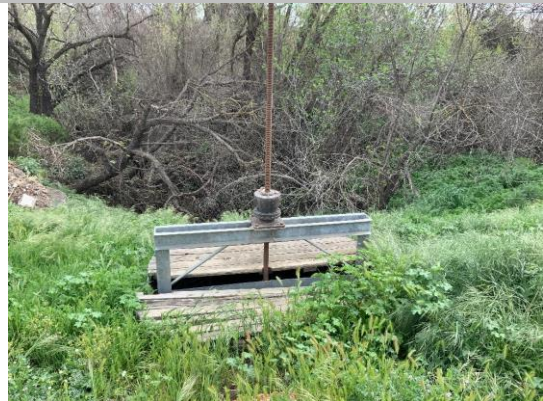
Photo 3 of 3 : UCIP_SP_2024_73667_108872.jpg

WS view: Slidegate on slope.

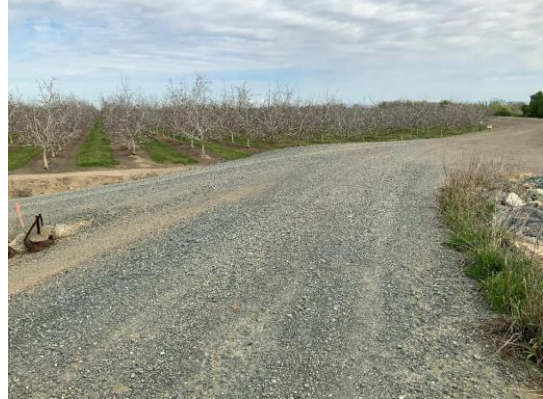
Photo 1 of 3 : UCIP_SP_2024_73668_108876.jpg

Comment Code					
Inspector Comment					
DS_ID:22921 FS_ID:73668 EP_NO: 9559 Repair Type: Non-Urgent EVAL Issue: 5, Pipe Damage Crossing Status: Found UCIP Comments: 03/17/2022 The record has been upgraded from No Action Needed to Non-Urgent. DWR DMP internal inspection has found pipe integrity issues. LOF of crossing is between 4.1 and 5. Crossing will be monitored until funding becomes available for rehabilitation. WS flapgate has sediment buildup over it, limiting the ability to open, recommend digging out. The UCIP inspection was completed with GEI staff, A. Lau. (H. Dunn – GEI) FIELD_STRUCT_DESC: 24-inch corrugated metal drainage pipe through the levee, 11 feet below the crown. Flap gate located on the waterside (WS) end. Slide gate in 36-inch corrugated metal riser unit on the WS slope. Concrete headwalls on both ends. Two corrugated metal cutoff walls. (24-inch pipe [HLM 10.05] authorized under Automatic Board Order (ABO) issued as Permit No. 9559, 1974 - David and Mary Giesbrecht). [Additional Reference(s): DWR Levee Log, 1992 (HLM 10.05). USACE Sacramento O&M Manual, Unit 140, May 1960, Revised 29 December 2016, (HLM 10.05), listed as 24-inch pipe. USACE As-Built Drawing No. 50-04-3327, 24 May 1960, Sheets 3 and 12, STA 134+40]. FS Date: 3/17/2022 8:28:30 AM

Levee crown at crossing location.

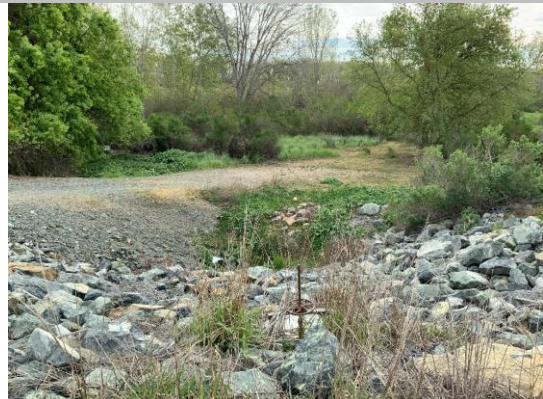
Photo 2 of 3 : UCIP_SP_2024_73668_108877.jpg

WS view: Toe from crown; riprap on WS slope.

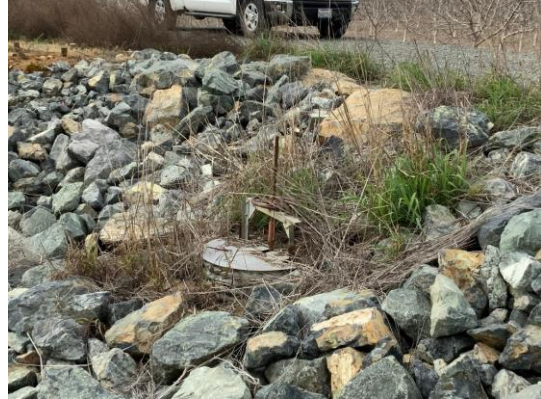
Photo 3 of 3 : UCIP_SP_2024_73668_108878.jpg

WS view: Slidegate and riser on WS slope.

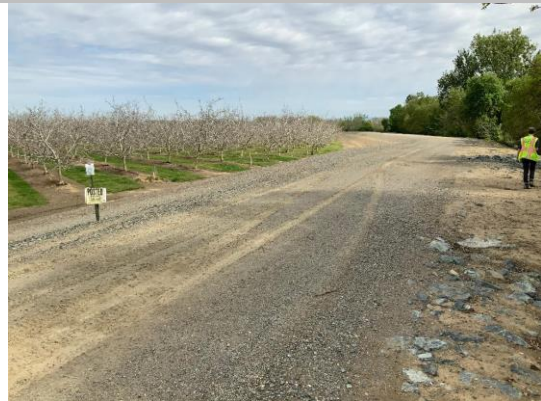
Photo 1 of 3 : UCIP_SP_2024_73670_108883.jpg

DS_ID:22922
FS_ID:73670
EP_NO: 9558
Repair Type: Urgent
EVAL Issue: 1, Pipe Integrity
Crossing Status: Found
UCIP Comments: 03/17/2022 The record remains Urgent. DWR DMP internal inspection has found pipe integrity issues. LOF of crossing is between 5 and 6. Crossing will be monitored until funding becomes available to address the issues. The UCIP inspection was completed with GEI staff, A. Lau. (H. Dunn – GEI)
FIELD_STRUCT_DESC: 24-inch corrugated metal drainage pipe through the levee, 11 feet below the crown. Flap gate located on the waterside (WS) end. Slide gate in 36-inch corrugated metal pipe riser unit on the WS slope. Two corrugated metal cutoff walls. Concrete headwalls on both ends. (24-inch pipe [HLM 10.08] authorized under Automatic Board Order (ABO) issued as Permit No. 9558, 1974 - Duard Geis). [Additional Reference(s): DWR Levee Log, 1992 (HLM 10.08). USACE Sacramento O&M Manual, Unit 140, May 1960, Revised 29 December 2016, (HLM 10.08), listed as 24-inch pipe. USACE As-Built Drawing No. 50-04-3327, 24 May 1960, Sheets 3 and 12, STA 133+39].

Levee crown at crossing location.

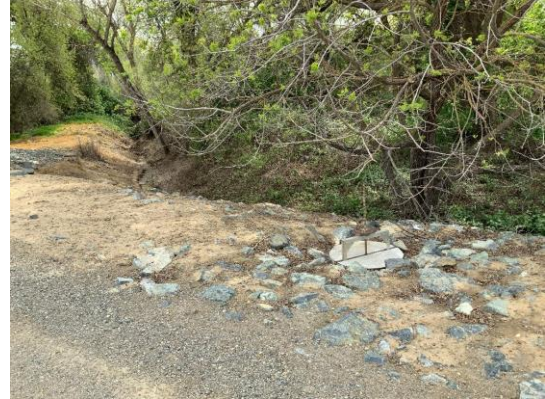
Photo 2 of 3 : UCIP_SP_2024_73670_108884.jpg

WS view: Toe from crown; riser on WS slope.

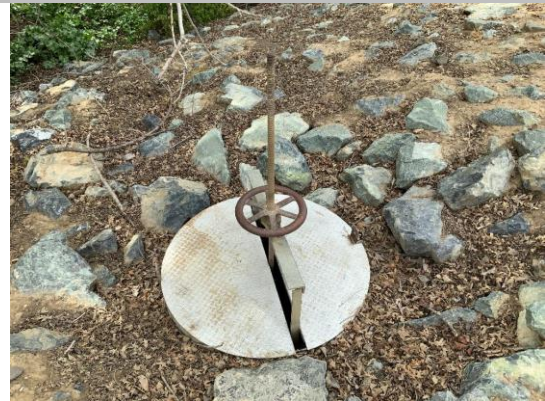
Photo 3 of 3 : UCIP_SP_2024_73670_108885.jpg

WS view: Slidegate and riser on slope.

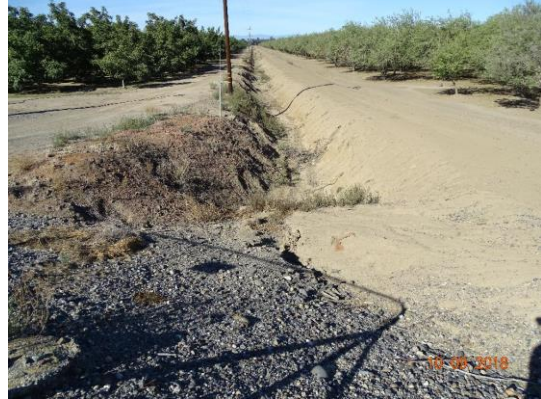
Photo 1 of 3 : UCIP_SP_2024_74777_78136.jpg

Comment Code					
Inspector Comment					
DS_ID:22924 FS_ID:74777 EP_NO: 9556 Repair Type: Urgent EVAL Issue: 1, Pipe Integrity Crossing Status: Found UCIP Comments: 03/17/2022 The record remains Urgent. DWR DMP internal inspection has found pipe integrity issues. LOF of crossing is between 5 and 6. Crossing will be monitored until funding becomes available to address the issues. Large rock at the bottom of CMP riser obstructs slide gate from completely closing. Debris covering LS inlet, recommend cleaning out. The UCIP inspection was completed with GEI staff, A. Lau. (H. Dunn – GEI)10/9/2018 Large rock at the bottom of CMP riser obstructs slide gate from completely closing. Pipe is rusted through at WS end. Recommend internal inspection to determine condition of pipe through levee, and to clean the inside of CMP riser for proper slide gate function. (O.Yakimov - DWR UCIP)12/21/2016 same as last inspection flap gate disabled in open position. Surface erosion observed on LS slope. Recommend repair on WS flap gate to be able to close flap gate. (O. Magana - DWR UCIP)05/31/2013 Flap gate dissabled in open position. Pipe rusted through at WS toe upstream of Flapgate. (W. Wylie - DWR UCIP) FIELD_STRUCT_DESC: 24-inch corrugated metal drainage pipe through levee, 15 feet below crown. Flap gate is located on the waterside (WS) end. Slide gate is inside a corrugated metal pipe (CMP) riser located on the WS slope. Two CM cutoff walls. Concrete headwall is located on LS and under outlet at the WS toe. (24-inch pipe [HLM 10.59] authorized under Automatic Board Order (ABO) issued as Permit No. 9556, 1974 - E. R & M. R. Cooper). [Additional Reference(s): DWR Levee Log, 1992 (HLM 10.59). USACE Sacramento O&M Manual, Unit 140, May 1960, Revised 29 December 2016, (HLM 10.59), listed as 24-inch pipe. USACE As-Built Drawing No. 50-04-3327, 24 May 1960, Sheets 3 and 12, STA 106+76]. FS Date: 3/17/2022

Drainage channel on LS.

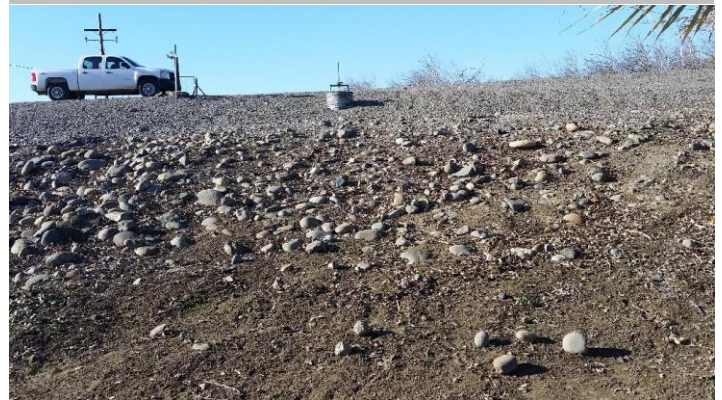
Photo 2 of 3 : UCIP_SP_2024_74777_76416.jpg

View of WS slope.

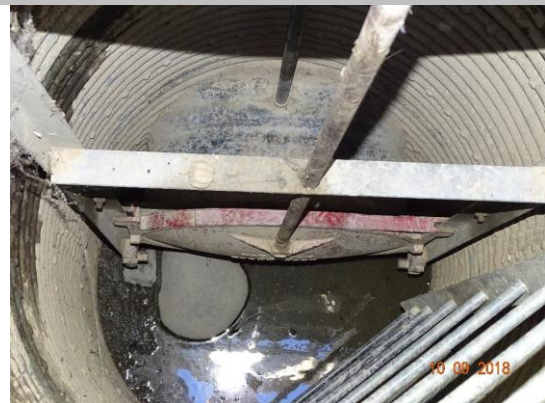
Photo 3 of 3 : UCIP_SP_2024_74777_78139.jpg

Large rock at the bottom of CMP riser obstructs slide gate from complete closing.

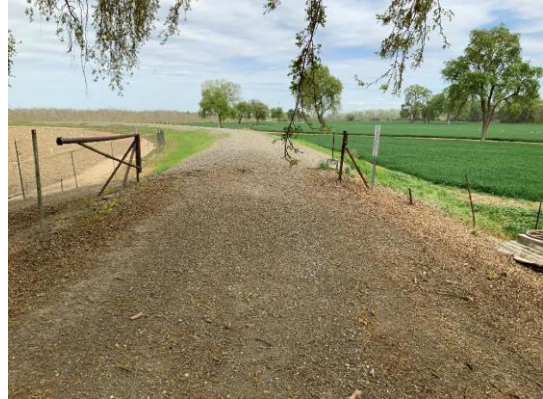
Photo 1 of 3 : UCIP_SP_2024_73674_109033.jpg

Comment Code					
Inspector Comment					
DS_ID:22925 FS_ID:73674 EP_NO: 9556 Repair Type: Urgent EVAL Issue: 1, Pipe Integrity Crossing Status: Found UCIP Comments: 03/17/2022 The record remains Urgent. DWR DMP internal inspection has found pipe integrity issues. LOF of crossing is between 5 and 6. Crossing will be monitored until funding becomes available to address the issues. The UCIP inspection was completed with GEI staff, A. Lau. (H. Dunn – GEI) FIELD_STRUCT_DESC: 48-inch corrugated metal drainage pipe through the levee, 11 feet below the crown. Flap gate on the waterside (WS) end. Concrete headwall on both ends. Slide gate in 60-inch diameter corrugated metal riser unit on the WS slope (48-inch pipe [HLM 11.17] authorized under Automatic Board Order (ABO) issued as Permit No. 9556, 1974 - Earl R. and Merrit R. Cooper). [Additional Reference(s): DWR Levee Log, 1992 (HLM 11.17). USACE Sacramento O&M Manual, Unit 140, May 1960, Revised 29 December 2016, (HLM 11.17), listed as 48-inch pipe. USACE As-Built Drawing No. 50-04-3327, 24 May 1960, Sheets 3 and 12, STA 76+94]. FS Date: 3/17/2022

Levee crown at crossing location.

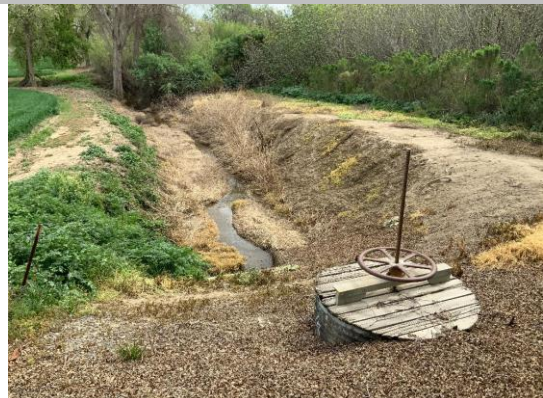
Photo 2 of 3 : UCIP_SP_2024_73674_109034.jpg

WS view: Riser on WS shoulder viewing from levee crown.

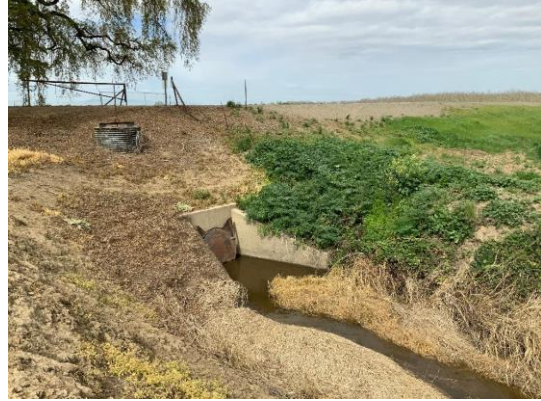
Photo 3 of 3 : UCIP_SP_2024_73674_109035.jpg

WS view: Slope from toe; concrete headwall and flapgate at WS toe.

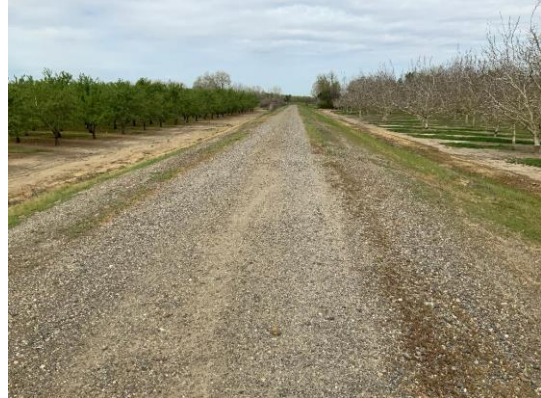
Photo 1 of 3 : UCIP_SP_2024_73675_109037.jpg

Comment Code						
Inspector Comment						
DS_ID:22926 FS_ID:73675 EP_NO: 9555 Repair Type: Non-Urgent EVAL Issue: 11, Maintenance Compliance Issue Crossing Status: Found UCIP Comments: 03/17/2022 The record has been upgraded from No Action Needed to Non-Urgent. Debris blocking landside pipe inlet, recommend removal of debris. DWR DMP internal inspection has not found pipe integrity issues. LOF of crossing is less or equal to 4.0. Recommend next video inspection in 5 years. Crossing appears to be in good condition. The UCIP inspection was completed with GEI staff, A. Lau. (H. Dunn – GEI) FIELD_STRUCT_DESC: 24-inch corrugated metal drainage pipe through the levee, 8.5 feet below the crown. Flap gate on the waterside (WS) slope. Concrete U-shaped headwalls on both ends. Two corrugated metal cutoff walls. (24-inch pipe [HLM 11.81] authorized under Automatic Board Order (ABO) issued as Permit No. 9555, 1974 - F. S. Reager). [Additional Reference(s): DWR Levee Log, 1992 (HLM 11.81). USACE Sacramento O&M Manual, Unit 140, May 1960, Revised 29 December 2016, (HLM 11.81), listed as 24-inch pipe. USACE As-Built Drawing No. 50-04-3327, 24 May 1960, Sheets 2 and 13, STA 43+50]. FS Date: 3/17/2022 10:23:38 AM

Levee crown at crossing location.

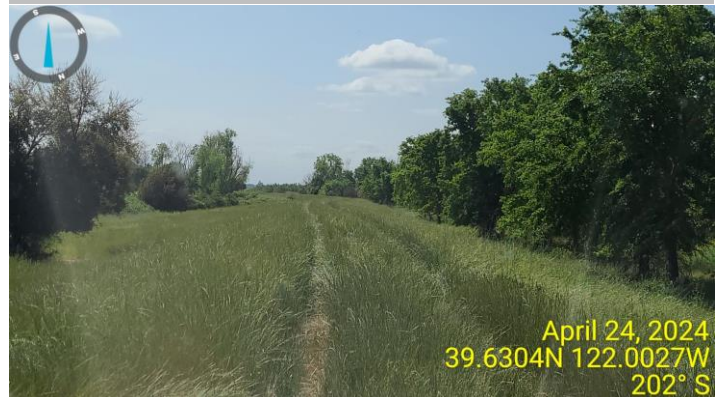
Photo 1 of 1 : SP_2024_LD0001G_432_32_20240425_00068.jpg

LM Start	11.76	Rating **	U	Issue No.	32
LM End	12.12	Issue Type +	Ma	Location *	CR
Category	Earthen Levee			GPS Latitude/Longitude	
				Start	End
Item	Vegetation			39.625487°	39.630398°
				-122.000661°	-122.002719°
DWR ID	DWR_LD0001G_01_s_2024_32				
Comment Code					
V1 : Control annual grass and weeds on the levee slopes and easements.					
Inspector Comment

View of vegetation along the crown of the levee. Spring 2024.

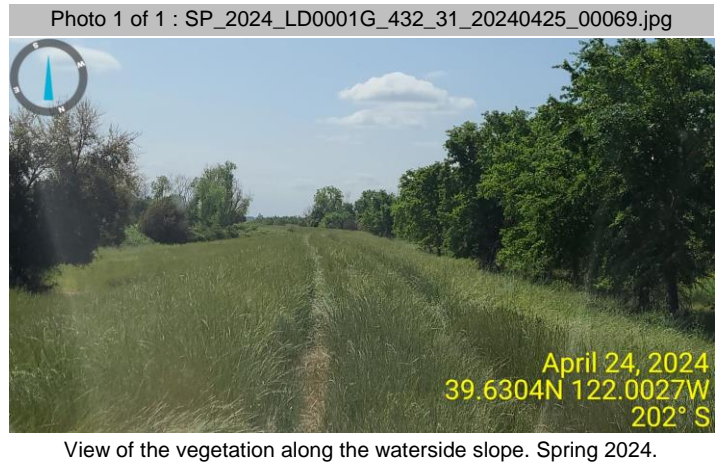
LM Start	11.76	Rating **	U	Issue No.	31
LM End	12.12	Issue Type +	Ma	Location *	WS
Category	Earthen Levee			GPS Latitude/Longitude	
				Start	End
Item	Vegetation			39.625487°	39.630399°
				-122.000661°	-122.002723°
DWR ID	DWR_LD0001G_01_s_2024_31				
Comment Code					
V1 : Control annual grass and weeds on the levee slopes and easements.					
Inspector Comment

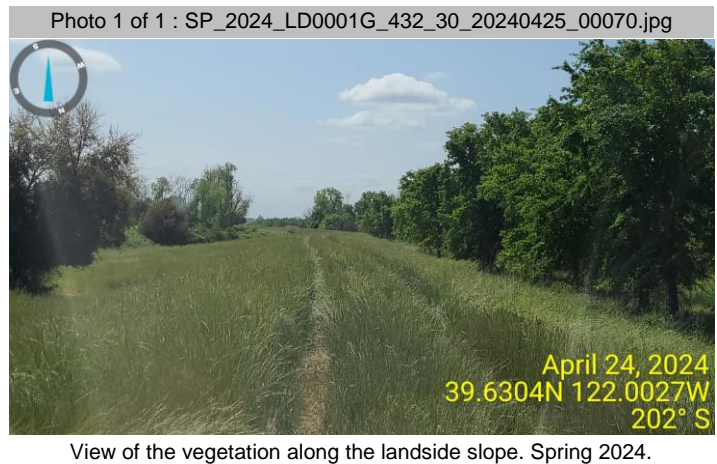
LM Start	11.76	Rating **	U	Issue No.	30
LM End	12.12	Issue Type +	Ma	Location *	LS
Category	Earthen Levee			GPS Latitude/Longitude	
				Start	End
Item	Vegetation			39.625488°	39.630396°
				-122.000662°	-122.002724°
DWR ID	DWR_LD0001G_01_s_2024_30				
Comment Code					
V1 : Control annual grass and weeds on the levee slopes and easements.					
Inspector Comment

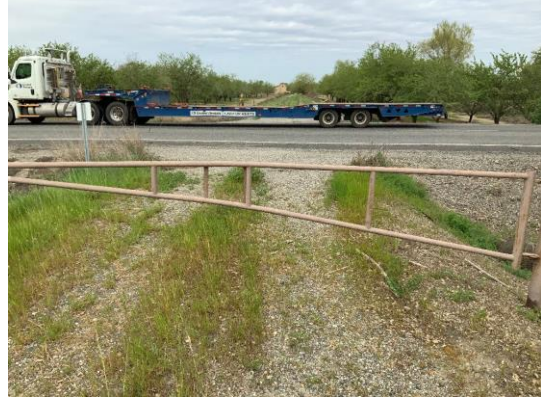
Photo 1 of 3 : UCIP_SP_2024_74779_109286.jpg

Comment Code					
Inspector Comment					
DS_ID:22929 FS_ID:74779 EP_NO: 9554 Repair Type: Non-Urgent EVAL Issue: 4b, Safety Issue Crossing Status: Found UCIP Comments: 03/17/2022 The record has been upgraded from No Action Needed to Non-Urgent. DWR DMP internal inspection has found pipe integrity issues. LOF of crossing is between 4.1 and 5. Crossing will be monitored until funding becomes available for rehabilitation. No lid over low lying WS riser causing fall concern. The UCIP inspection was completed with GEI staff, A. Lau. (A. Lau – GEI) FIELD_STRUCT_DESC: 24-inch corrugated metal drainage pipe through the levee, 7 feet below the crown. Flap gate on the waterside (WS) end. Slide gate in 36-inch corrugated metal riser unit on the WS slope. Concrete U-shaped headwalls on both ends. (24-inch pipe [HLM 12.29] authorized under Automatic Board Order (ABO) issued as Permit No. 9554, 1974 - Thomas H. Reed). [Additional Reference(s): DWR Levee Log, 1992 (HLM 12.29). USACE Sacramento O&M Manual, Unit 140, May 1960, Revised 29 December 2016, (HLM 12.29), listed as 24-inch pipe. USACE As-Built Drawing No. 50-04-3327, 24 May 1960, Sheets 2 and 20, STA 18+18]. FS Date: 3/17/2022 3:36:24 PM

Levee crown at crossing location.

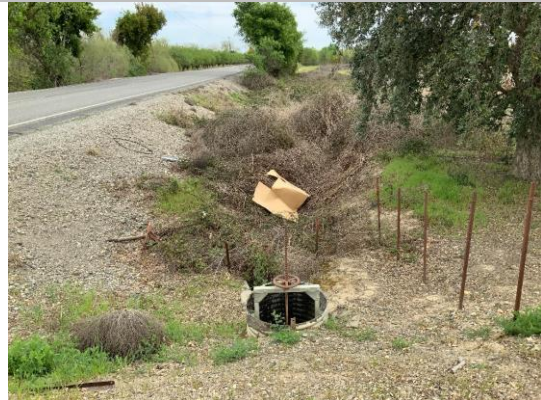
Photo 2 of 3 : UCIP_SP_2024_74779_109287.jpg

WS view: toe from crest; corrugated metal riser at WS levee toe.

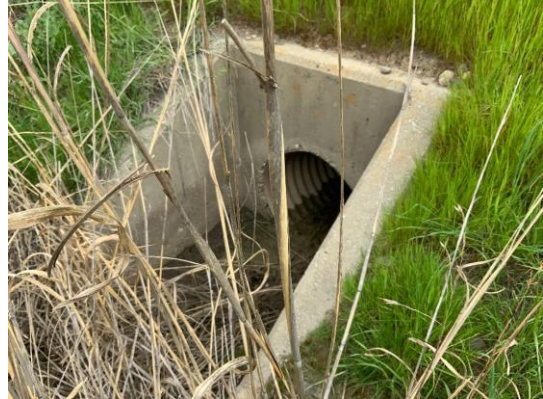
Photo 3 of 3 : UCIP_SP_2024_74779_109284.jpg

LS view: U-shaped concrete headwall and LS pipe opening at LS levee toe.
