**Flood Control Project Maintenance
Levee Inspections**

Fall 2011 Levee Maintenance Deficiency Summary Report

Levee District No. 0001 (Sutter County)

Levee Inspection Report By Mile - Fall 2011

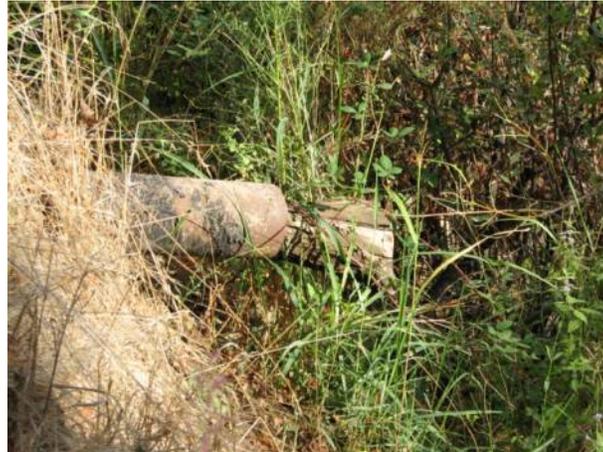
cathom_f_20111019_948.jpg

Levee Mile Report Line	2
Start Levee Mile	1.84
End Levee Mile	1.84
Location	Land Side
Category	Interior Drainage & Piping Systems
Item	Metal Pipes

This photo shows the abandoned pipe on the waterside berm, note the piece of wood stuck in the pipe.
