**Flood Control Project Maintenance
Levee Inspections**

Fall 2013 Levee Maintenance Deficiency Summary Report

Levee District No. 0001 (Sutter County)

Waterway	Bank	Unit Miles
Unit No. 01 Feather River	Right	16.65

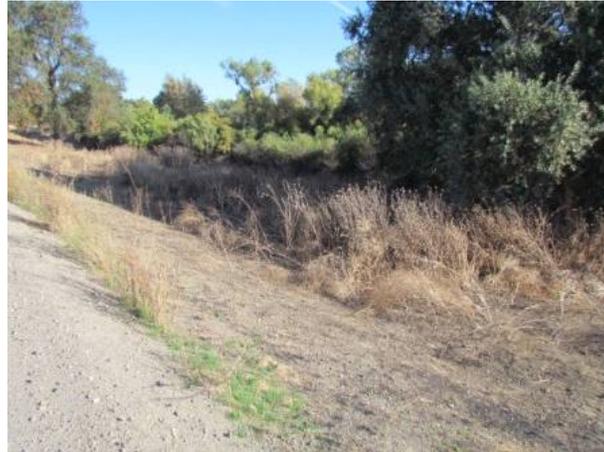
Levee Mile Report Line	8
Start Levee Mile	1.59
End Levee Mile	1.59
Location	Water Side
Category	Earthen Levee
Item	Vegetation
<p>Photo taken from levee crown looking east at vegetation on the waterward slope.</p>	
<p>mhoffman_f_20131002_639.JPG</p>

DWR ID: DWR_LD0001S_01_f_2012_10		
7	1.19	1.19	Earthen Levee	Encroachments	LS	M En	DE : Debris	38.968022 ° -121.587509 °	38.968022 ° -121.587509 °	7
								DWR ID: DWR_LD0001S_01_s_2012_7		
8	1.59	1.59	Earthen Levee	Vegetation	WS	M Ma	V2 : Remove the wild growth other than native grasses from the levee slopes.	38.973515 ° -121.589765 °	38.973515 ° -121.589765 °	18 Y
								DWR ID: DWR_LD0001S_01_f_2013_18		
9	1.84	1.84	Interior Drainage & Piping Systems	Metal Pipes	LS	M Ma	Inspector Comments: Abandoned pipe. This pipe is listed in our levee log as an abandoned pipe, no date listed. No permit number. Corp pipe.	38.976927 ° -121.591210 °	38.976927 ° -121.591210 °	487 Y
								DWR ID: DWR_LD0001S_01_s_2012_487		
10	2.20	2.20	Supplemental	DWR UCIP Field Study	LS	M En	Inspector Comments: FS_ID:11383 EP_NO: N/A Repair Type: Non-Urgent Crossing Status: Found UCIP Comments: Siphon breaker cap missing. Sump pump and gate valve at landward toe not found may be due to dense vegetation. FIELD_STRUCT_DESC: A 8-inch steel pipe through levee, 4.6-feet below the crown. Siphon breaker in corrugated metal riser on landward slope.O&M Manual Sac 144, August 1955, Revision Year 2011. FS Date: 4/12/2013	38.982135 ° 38.982135 °	-121.591974 ° -121.591974 °	1 Y

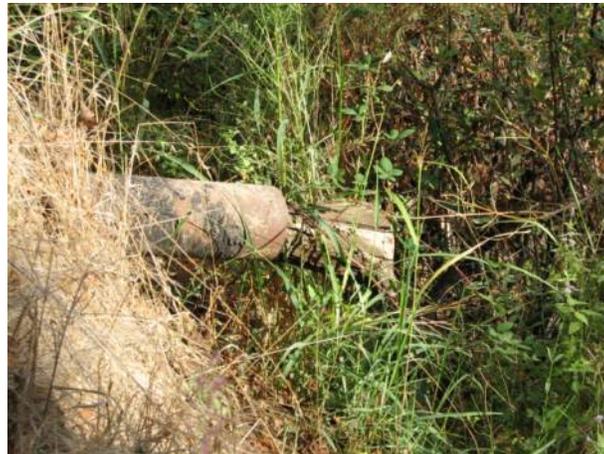
Levee Mile Report Line	9
Start Levee Mile	1.84
End Levee Mile	1.84
Location	Land Side
Category	Interior Drainage & Piping Systems
Item	Metal Pipes
<p>This photo shows the abandoned pipe on the waterside berm, note the piece of wood stuck in the pipe.</p>	
<p>mhoffman_f_20130917_001.jpg</p>

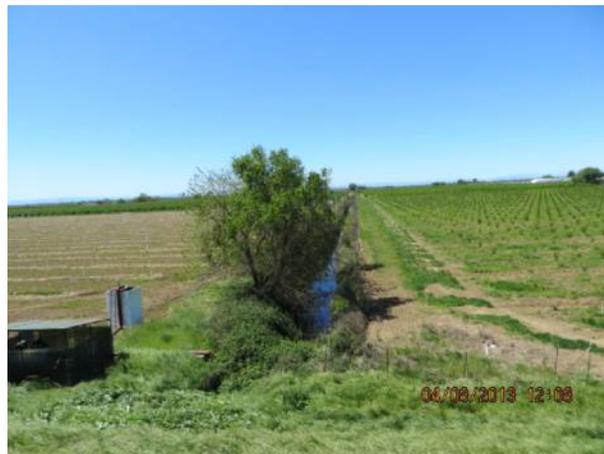
Levee Mile Report Line	10
Start Levee Mile	2.20
End Levee Mile	2.20
Location	Land Side
Category	Supplemental
Item	DWR UCIP Field Study
<p>LS- overview of levee slope with dense vegetation and drainage ditch in background</p>	
<p>UCIP_6292.jpg</p>

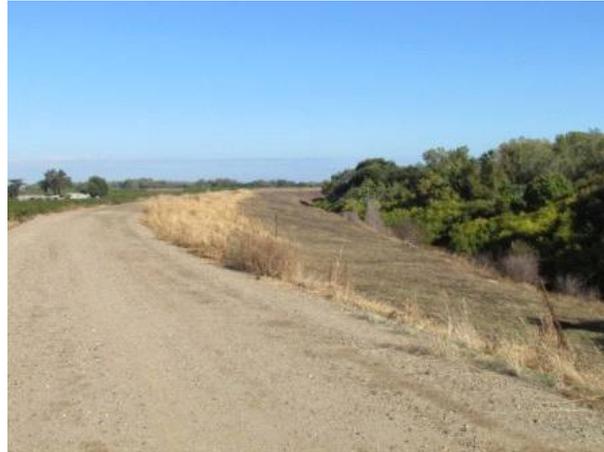
Levee Mile Report Line	11
Start Levee Mile	3.22
End Levee Mile	3.22
Location	Water Side
Category	Earthen Levee
Item	Vegetation
Photo taken from levee crown looking north at vegetation on the waterward slope.	
mhoffman_f_20131002_640.JPG

DWR ID: DWR_LD0001S_01_f_2013_1		
11	3.22	3.22	Earthen Levee	Vegetation	WSA/W	Ma	V2 : Remove the wild growth other than native grasses from the levee slopes.	38.996261 ° -121.595939 °	38.996261 ° -121.595939 °	19 Y
								DWR ID: DWR_LD0001S_01_f_2013_19

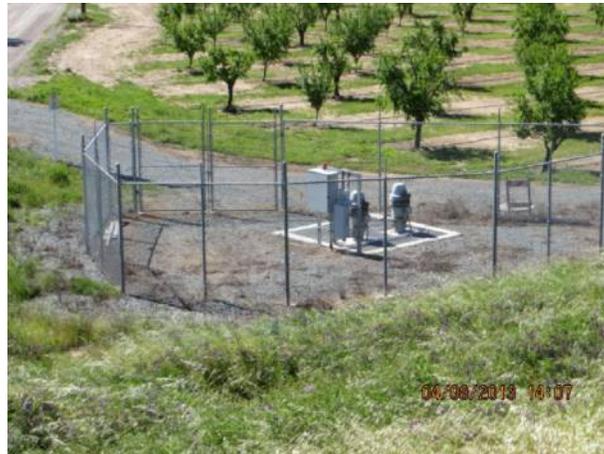
LMIR No.	Levee Mile		Category	Item	* Location	** Rating	Action/Comment	GPS Latitude/Longitude		Issue No. Photo
	Start	End						Start	End	
12	4.58	4.58	Supplemental	DWR UCIP Field Study	CR	M En	Inspector Comments: FS_ID:11505 EP_NO: 18438 Repair Type: Non-Urgent Crossing Status: Found UCIP Comments: Needs removal of blockage by riprap rubbles. FIELD_STRUCT_DESC: 1 of 2. 2- 16-inch steel drainage pipe. Riprap discharge structure on WS. Flap gate not properly closed. Pump station on LS concrete sump. FS Date: 4/8/2013	39.011340 °	-121.603474 °	2 Y
								DWR ID: DWR_LD0001S_01_f_2013_2		
13	4.58	4.58	Supplemental	DWR UCIP Field Study	CR	M En	Inspector Comments: FS_ID:11844 EP_NO: 18438 Repair Type: Non-Urgent Crossing Status: Found UCIP Comments: FIELD_STRUCT_DESC: 2 of 2. 2- 16-inch steel drainage pipe. Riprap discharge structure on WS. Flap gate not properly closed. Pump station on LS concrete sump. FS Date: 4/8/2013	39.011354 °	-121.603488 °	11

Levee Mile Report Line	12
Start Levee Mile	4.58
End Levee Mile	4.58
Location	Water Side
Category	Supplemental
Item	DWR UCIP Field Study
LS- two pumps in concrete sump.	
UCIP_6306.jpg

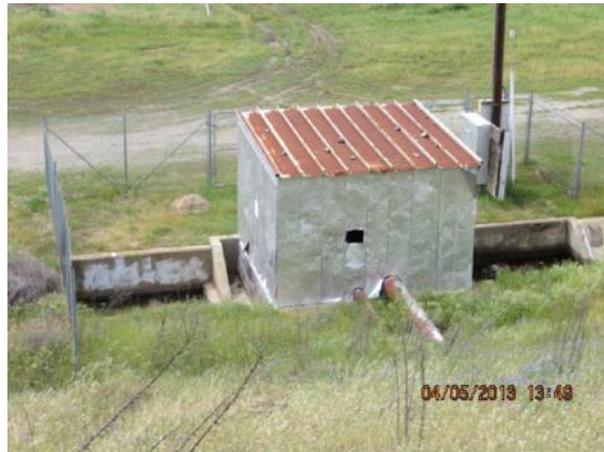
Levee Mile Report Line	17
Start Levee Mile	11.89
End Levee Mile	11.89
Location	Water Side
Category	Supplemental
Item	DWR UCIP Field Study
LS- pipes and pump house on concrete base.	
UCIP_6412.jpg

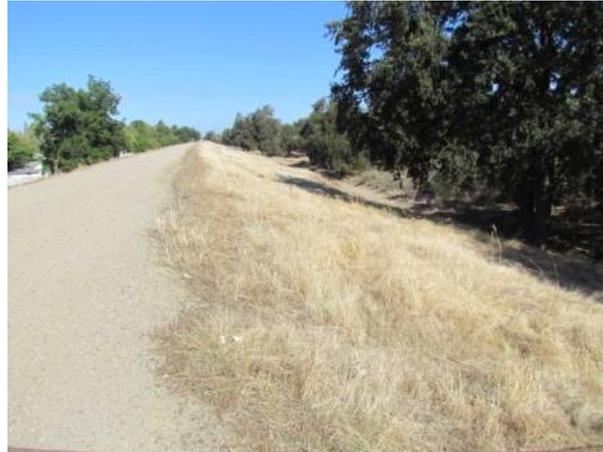
DWR ID: DWR_LD0001S_01_f_2013_15											
20	13.64	14.26	Earthen Levee	Encroachments	LS	M En	BU : Building	39.130197 °	39.138262 °	3	
									-121.602453 °	-121.607007 °	
DWR ID: DWR_LD0001S_01_s_2012_3											
21	13.65	14.04	Earthen Levee	Vegetation	WS	M Ma	V2 : Remove the wild growth other than native grasses from the levee slopes. Inspector Comments: Due to fires in the valley the district was unable to burn this section. District stated that they will drag the area to control vegetation.	39.130209 °	39.135551 °	21	
									-121.602451 °	-121.604932 °	Y
DWR ID: DWR_LD0001S_01_f_2013_21											
22	13.65	14.04	Earthen Levee	Vegetation	LS	M Ma	V2 : Remove the wild growth other than native grasses from the levee slopes. Inspector Comments: Due to fires in the valley the district was unable to burn this section. District stated that they will drag the area to control vegetation.	39.130209 °	39.135551 °	22

Levee Mile Report Line	21
Start Levee Mile	13.65
End Levee Mile	14.04
Location	Water Side
Category	Earthen Levee
Item	Vegetation
Photo taken from levee crown looking north at vegetation on the waterward slope.	
mhoffman_f_20131002_641.JPG

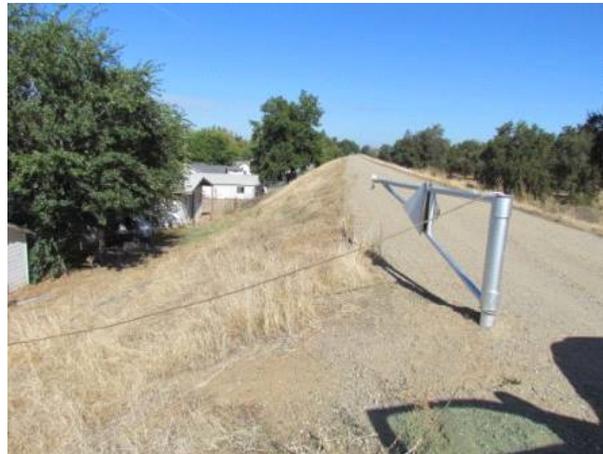
Levee Mile Report Line	22
Start Levee Mile	13.65
End Levee Mile	14.04
Location	Land Side
Category	Earthen Levee
Item	Vegetation
Photo taken from levee crown looking north at vegetation on the landward slope.	
mhoffman_f_20131002_642.JPG

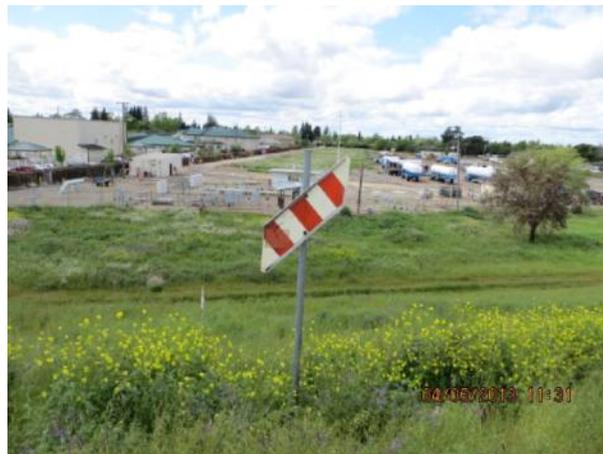
-121.602451 °	-121.604932 °	Y
DWR ID: DWR_LD0001S_01_f_2013_22											
23	15.56	15.56	Supplemental	DWR UCIP Field Study	LS	M En	Inspector Comments: FS_ID:12092 EP_NO: N/A Repair Type: Non-Urgent Crossing Status: Indicator Found UCIP Comments: Only a gasoline indicator found on LS.Needs gasoline marker also on WS. FIELD_STRUCT_DESC: A 16-inch gas line through levee, 3.5 feet below the crown. FS Date: 4/5/2013	39.154970 °	-121.615617 °	16

Levee Mile Report Line	23
Start Levee Mile	15.56
End Levee Mile	15.56
Location	Land Side
Category	Supplemental
Item	DWR UCIP Field Study
LS- gasoline marker on levee slope	
UCIP_6422.jpg

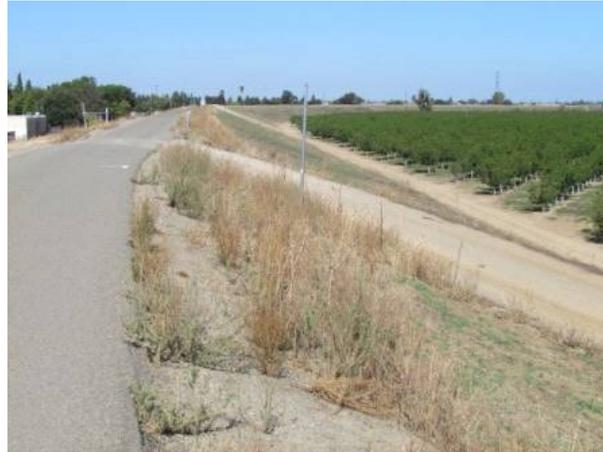
Levee Mile Report Line	25
Start Levee Mile	15.66
End Levee Mile	15.97
Location	Water Side
Category	Earthen Levee
Item	Vegetation

Photo taken from levee crown looking north at vegetation on the waterward slope.

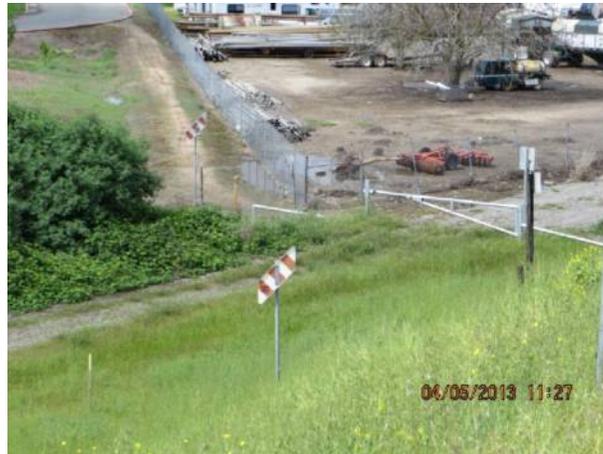
Levee Mile Report Line	26
Start Levee Mile	15.68
End Levee Mile	15.68
Location	Water Side
Category	Supplemental
Item	DWR UCIP Field Study

LS- gasoline indicators on levee slope and across.
