**Flood Control Project Maintenance
Levee Inspections**

Fall 2012 Levee Maintenance Deficiency Summary Report

Levee District No. 0001 (Sutter County)

Levee Inspection Report By Mile - Fall 2012

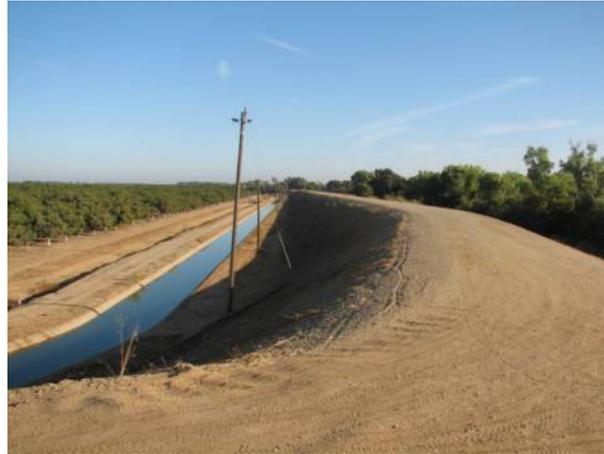
Levee Mile Report Line	4
Start Levee Mile	0.00
End Levee Mile	16.63
Location	Land Side
Category	Earthen Levee
Item	Vegetation

This photo shows the landside levee slope.

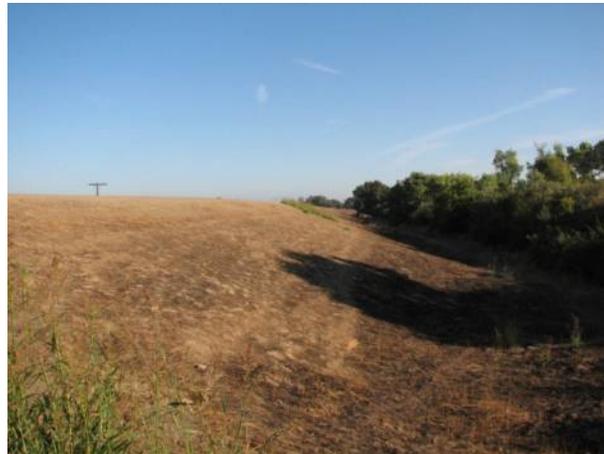
Levee Mile Report Line	5
Start Levee Mile	0.00
End Levee Mile	16.63
Location	Water Side
Category	Earthen Levee
Item	Vegetation

5	0.00	16.63	Earthen Levee	Vegetation	WS	A Ma	V2 : Remove the wild growth other than native grasses from the levee slopes.	38.951046 ° -121.585738 °	39.168604 ° -121.622726 °	5 Y
DWR ID: DWR_LD0001S_01_f_2012_5										
6	0.33	0.33	Earthen Levee	Encroachments	LS	M En	PO : Pole	38.955946 ° -121.585517 °	38.955946 ° -121.585517 °	8
DWR ID: DWR_LD0001S_01_f_2012_8										
7	0.82	0.82	Earthen Levee	Encroachments	LS	M En	DE : Debris	38.963081 ° -121.586217 °	38.963081 ° -121.586217 °	9
DWR ID: DWR_LD0001S_01_f_2012_9										
8	0.94	1.02	Earthen Levee	Encroachments	LS	M En	AT : Agricultural tilling Inspector Comments: Occuring at the levee toe.	38.964768 ° -121.586681 °	38.965668 ° -121.587392 °	10
DWR ID: DWR_LD0001S_01_f_2012_10										
9	1.19	1.19	Earthen Levee	Encroachments	LS	M En	DE : Debris	38.968022 ° -121.587509 °	38.968022 ° -121.587509 °	7
DWR ID: DWR_LD0001S_01_s_2012_7										
10	1.84	1.84	Interior Drainage & Piping Systems	Metal Pipes	LS	M Ma	Inspector Comments: Abandoned pipe. This pipe is listed in our levee log as an abandoned pipe, no date listed. No permit number. Corp pipe.	38.976927 ° -121.591210 °	38.976927 ° -121.591210 °	487 Y

This photo shows the waterside levee slope.

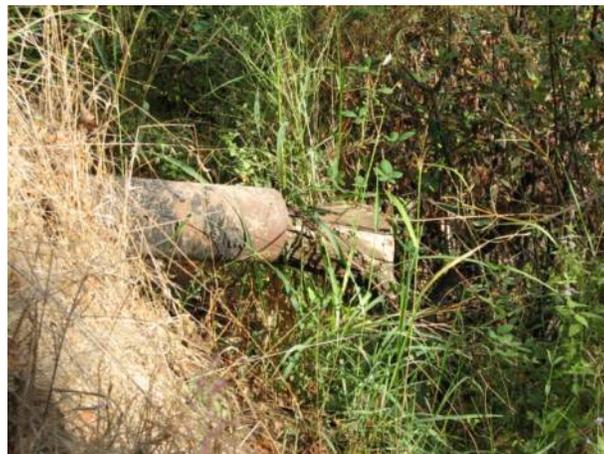
Levee Mile Report Line	10
Start Levee Mile	1.84
End Levee Mile	1.84
Location	Land Side
Category	Interior Drainage & Piping Systems
Item	Metal Pipes

This photo shows the abandoned pipe on the waterside berm, note the piece of wood stuck in the pipe.
