**Flood Control Project Maintenance
Levee Inspections**

Maintenance Issue Types Only, Levee Inspection Report By Mile - Fall 2014

Levee District No. 0001 (Sutter County)

Waterway	Bank	Unit Miles	Inspection Start/End	Inspector
Unit No. 01 Feather River	Right	16.11	11/12/2014 11/12/2014	Matthew Hoffman

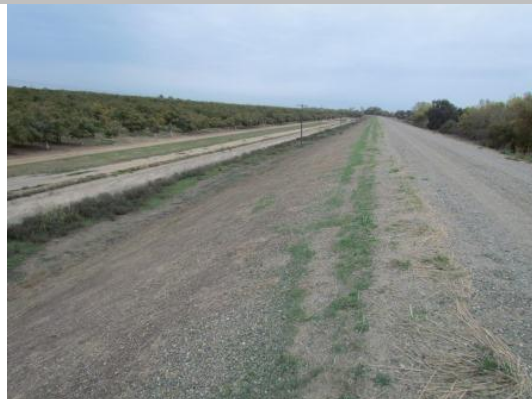
Photo 1 of 1 : FA_2014_LD0001S_433_13_20141124_00011.jpg

LM Start	0.05	Rating **	A	Issue No.	13
LM End	0.05	Issue Type +	Ma	Location *	LS
Category	Earthen Levee			GPS Latitude/Longitude	
				Start	End
Item	Vegetation			38.951881 °	38.951881 °
				-121.585589 °	-121.585589 °
DWR ID	DWR_LD0001S_01_f _ 2014_13				
Action/Comments					
Control annual grass and weeds on the levee slopes and easements.

This photo was taken from the crown facing north looking down the landward levee slope at acceptable vegetation maintenance. Fall 2014.
