**Flood Control Project Maintenance
Levee Inspections**

Maintenance Issue Types Only, Levee Inspection Report By Mile - Fall 2015

Levee District No. 0001 (Sutter County)

Waterway	Bank	Unit Miles	Inspection Start/End	Inspector
Unit No. 01 Feather River	Right	16.11	11/12/2015 11/12/2015	Keith Millard

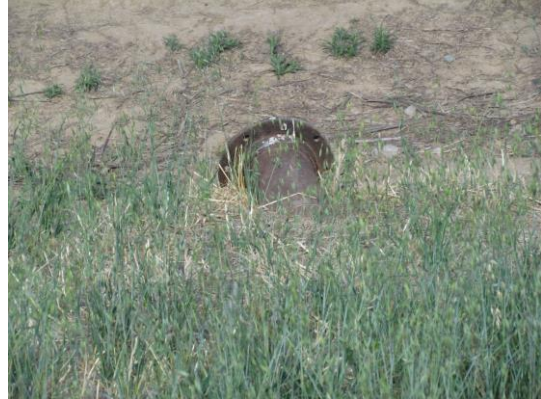
Photo 1 of 2 : FA_2015_LD0001S_433_487_20151106_00003.jpg

LM Start	1.85	Rating **	M	Issue No.	487
LM End	1.85	Issue Type +	Ma	Location *	LS
Category	Interior Drainage & Piping Systems			GPS Latitude/Longitude	
				Start	End
Item	Metal Pipes			38.976927 °	38.976927 °
				-121.591210 °	-121.591210 °
DWR ID	DWR_LD0001S_01_s_2012_487				
Action/Comments					
Inspector Comments: Abandoned pipe. This pipe is listed in our levee log as an abandoned pipe, no date listed. No permit number. Corp pipe.

View of the pipe on the landside of the levee from the crown.

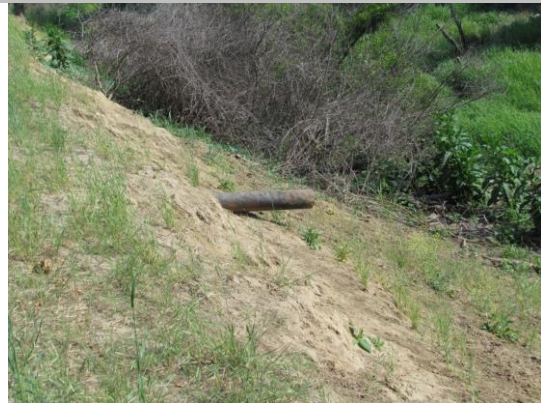
Photo 2 of 2 : FA_2015_LD0001S_433_487_20151106_00004.jpg

View of the pipe on the waterside of the levee from the crown facing upstream.

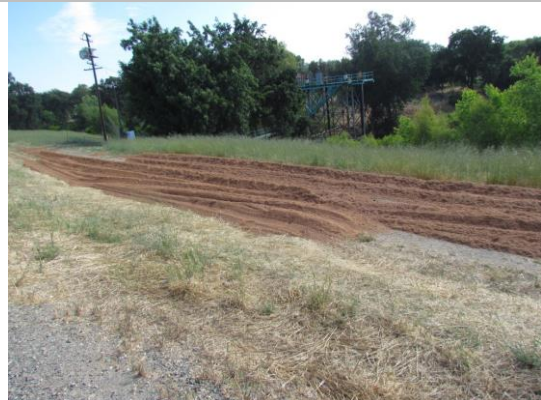
Photo 1 of 1 : FA_2015_LD0001S_433_16_20151106_00002.jpg

LM Start	2.44	Rating **	M	Issue No.	16
LM End	2.44	Issue Type +	Ma	Location *	WS
Category	Earthen Levee			GPS Latitude/Longitude	
				Start	End
Item	Encroachments			38.985446 °	38.985446 °
				-121.591930 °	-121.591930 °
DWR ID	DWR_LD0001S_01_s_2015_16				
Action/Comments					
Material					
Inspector Comments: Walnut holes left on waterside of the levee.

View of the material on the waterside of the levee facing upstream.

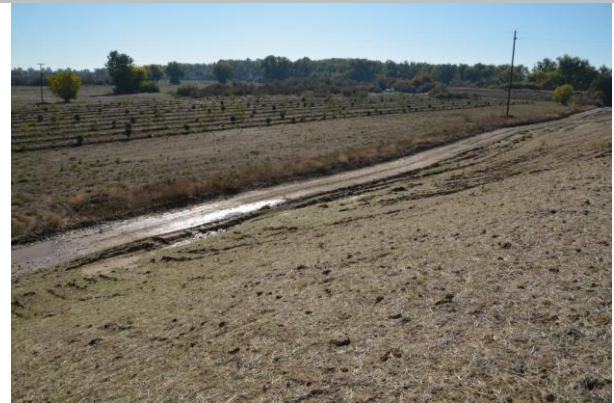
Photo 1 of 1 : FA_2015_LD0001S_433_21_20151117_00013.jpg

LM Start	6.00	Rating **	M	Issue No.	21
LM End	6.00	Issue Type +	Ma	Location *	WS
Category	Earthen Levee			GPS Latitude/Longitude	
				Start	End
Item	Slope Stability			39.031780 °	39.031780 °
				-121.611811 °	-121.611811 °
DWR ID	DWR_LD0001S_01_s_2015_21				
Action/Comments					
Repair the levee slope damaged by vehicle traffic and prevent access where possible.					
Inspector Comments: track-walking on slope and tire ruts at toe

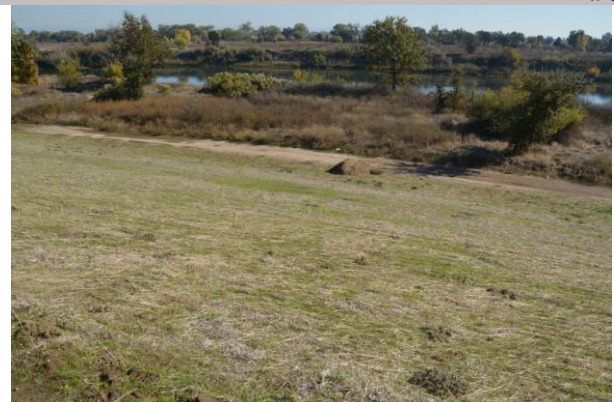
Photo 1 of 1 : FA_2015_LD0001S_433_19_20151117_00019.jpg

LM Start	8.31	Rating **	M	Issue No.	19
LM End	8.31	Issue Type +	Ma	Location *	WS
Category	Earthen Levee			GPS Latitude/Longitude	
				Start	End
Item	Encroachments			39.064799 °	39.064799 °
				-121.609865 °	-121.609865 °
DWR ID	DWR_LD0001S_01_f_2015_19				
Action/Comments					
Tree or limb					
Inspector Comments: debris pile of wood trimmings/shavings

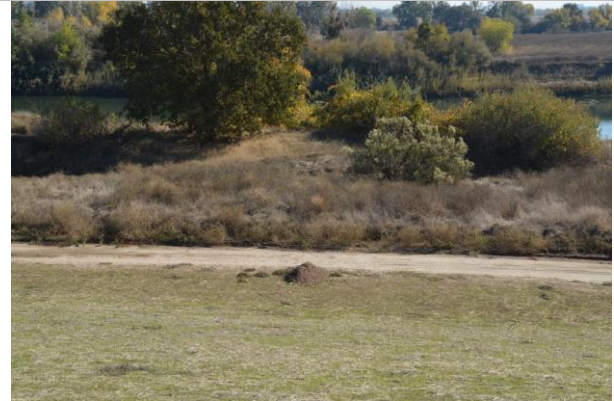
Photo 1 of 1 : FA_2015_LD0001S_433_20_20151117_00020.jpg

LM Start	8.44	Rating **	M	Issue No.	20
LM End	8.44	Issue Type +	Ma	Location *	WS
Category	Earthen Levee			GPS Latitude/Longitude	
				Start	End
Item	Encroachments			39.066486 °	39.066486 °
				-121.608794 °	-121.608794 °
DWR ID	DWR_LD0001S_01_f_2015_20				
Action/Comments					
Tree or limb					
Inspector Comments: Debris pile of wood shavings at waterside toe.

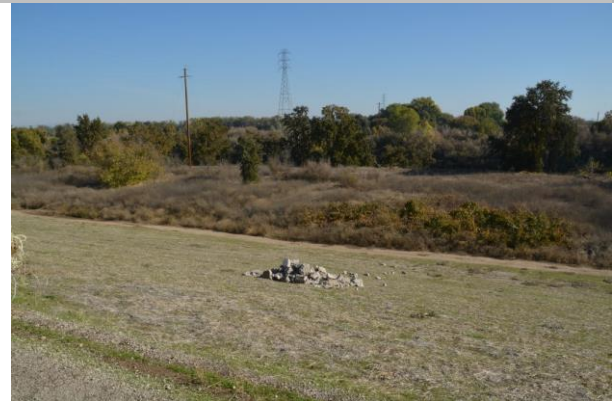
Photo 1 of 1 : FA_2015_LD0001S_433_22_20151117_00021.jpg

LM Start	8.87	Rating **	M	Issue No.	22
LM End	8.87	Issue Type +	Ma	Location *	WS
Category	Earthen Levee			GPS Latitude/Longitude	
				Start	End
Item	Encroachments			39.072503 °	39.072503 °
				-121.606710 °	-121.606710 °
DWR ID	DWR_LD0001S_01_f_2015_22				
Action/Comments					
Debris					
Inspector Comments: Concrete debris piled up on waterside slope.

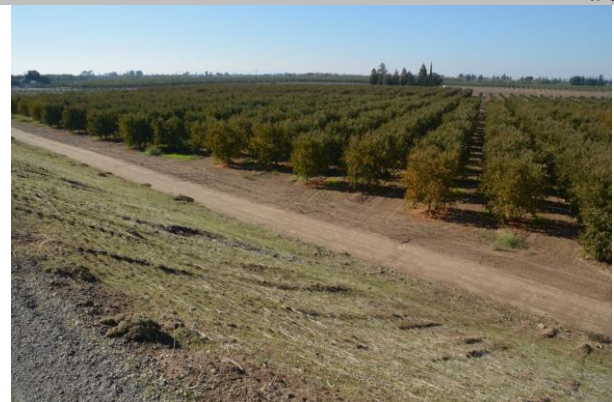
Photo 1 of 1 : FA_2015_LD0001S_433_25_20151117_00023.jpg

LM Start	9.84	Rating **	M	Issue No.	25
LM End	9.84	Issue Type +	Ma	Location *	LS
Category	Earthen Levee			GPS Latitude/Longitude	
				Start	End
Item	Slope Stability			39.085915 °	39.085915 °
				-121.603733 °	-121.603733 °
DWR ID	DWR_LD0001S_01_f_2015_25				
Action/Comments					
Repair the levee slope damaged by vehicle traffic and prevent access where possible.					
Inspector Comments: Track walking rutts on landside slope.

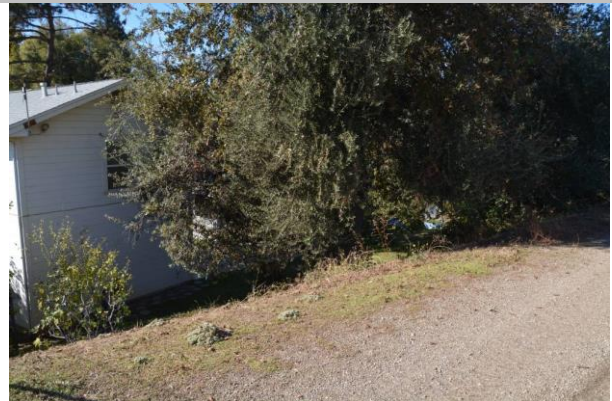
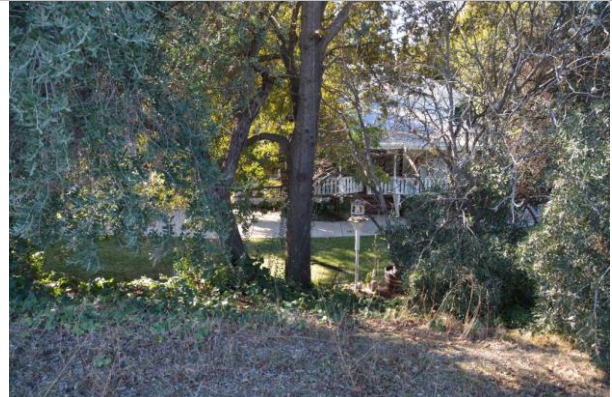
LM Start	13.34	Rating **	U	Issue No.	18
LM End	13.34	Issue Type +	Ma	Location *	LS
Category	Earthen Levee			GPS Latitude/Longitude	
				Start	End
Item	Vegetation			39.133050 °	39.133050 °
				-121.603813 °	-121.603813 °
DWR ID	DWR_LD0001S_01_f_2015_18				
Action/Comments					
Trees / Woody Vegetation					
Inspector Comments: Overgrown olive trees (6), buckeye (1) and oak trees (2) on slope of levee, branches touching and obscuring levee. Ivy obscuring slope.

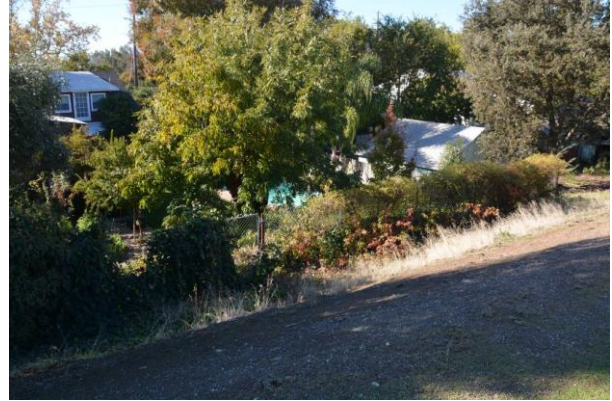
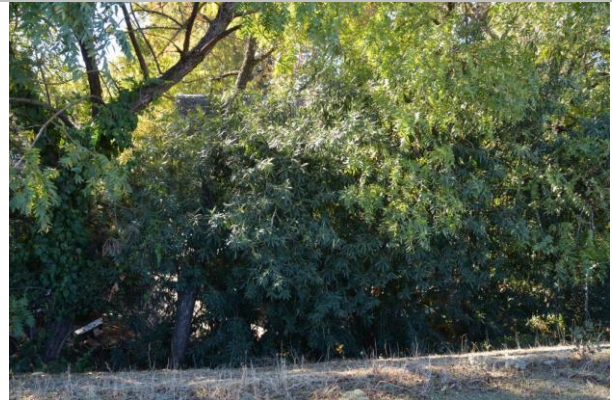
LM Start	13.42	Rating **	U	Issue No.	24
LM End	13.42	Issue Type +	Ma	Location *	LS
Category	Earthen Levee			GPS Latitude/Longitude	
				Start	End
Item	Vegetation			39.134119 °	39.134119 °
				-121.604213 °	-121.604213 °
DWR ID	DWR_LD0001S_01_f_2015_24				
Action/Comments					
Trees / Woody Vegetation					
Inspector Comments: Vegetation on chainlink fence obscuring visibility. Oleander touchning levee.
