**Flood Control Project Maintenance
Levee Inspections**

Maintenance Issue Types Only, Levee Inspection Report By Mile - Fall 2017

Levee District No. 0001 (Sutter County)

Waterway	Bank	Unit Miles	Inspection Start/End	Inspector
Unit No. 01 Feather River	Right	16.11	10/27/2017 10/27/2017	Sterling York

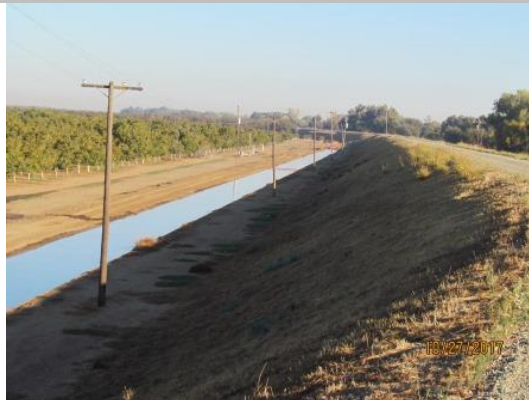
Photo 1 of 3 : FA_2017_LD0001S_433_26_20171106_00067.jpg

LM Start	0.00	Rating **	A	Issue No.	26
LM End	8.06	Issue Type +	Ma	Location *	LS
Category	Earthen Levee			GPS Latitude/Longitude	
				Start	End
Item	Vegetation			38.950984 °	39.061383 °
				-121.585747 °	-121.611328 °
DWR ID	DWR_LD0001S_01_f_2017_26				
Comment Code					
V1 : Control annual grass and weeds on the levee slopes and easements.					
Inspector Comment					
Annual vegetation is well maintained, Fall 2017.

View looking upstream landside levee mile 0.04 of the well maintained annual vegetation, Fall 2017.

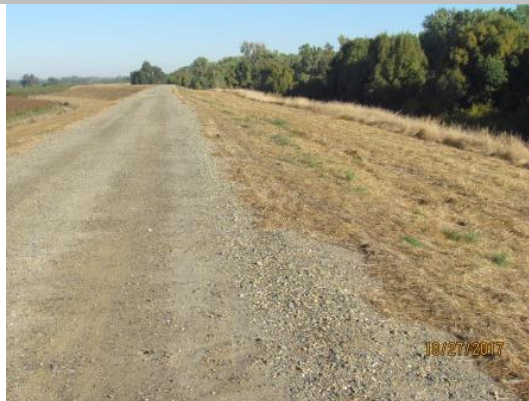
Photo 1 of 3 : FA_2017_LD0001S_433_28_20171106_00073.jpg

LM Start	0.00	Rating **	A	Issue No.	28
LM End	8.06	Issue Type +	Ma	Location *	WS
Category	Earthen Levee			GPS Latitude/Longitude	
				Start	End
Item	Vegetation			38.950984 °	39.061383 °
				-121.585747 °	-121.611328 °
DWR ID	DWR_LD0001S_01_f_2017_28				
Comment Code					
V1 : Control annual grass and weeds on the levee slopes and easements.					
Inspector Comment					
Annual vegetation is well maintained, Fall 2017.

View looking upstream waterside levee mile 0.14 of the well maintained annual vegetation, Fall 2017.

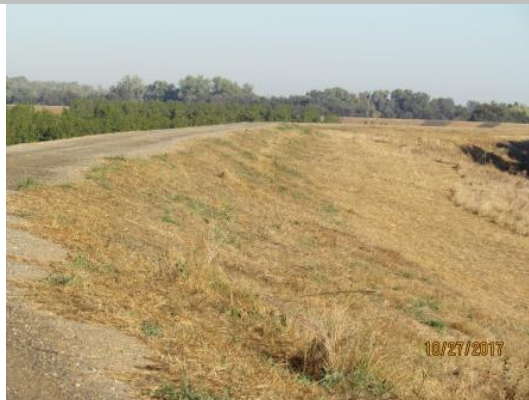
Photo 2 of 3 : FA_2017_LD0001S_433_28_20171106_00074.jpg

View looking upstream waterside levee mile 3.24 of the well maintained annual vegetation, Fall 2017.

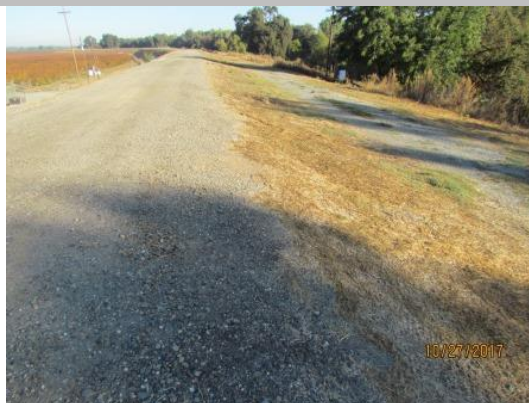
Photo 3 of 3 : FA_2017_LD0001S_433_28_20171106_00072.jpg

View looking upstream waterside levee mile 6.96 of the well maintained annual vegetation, Fall 2017.

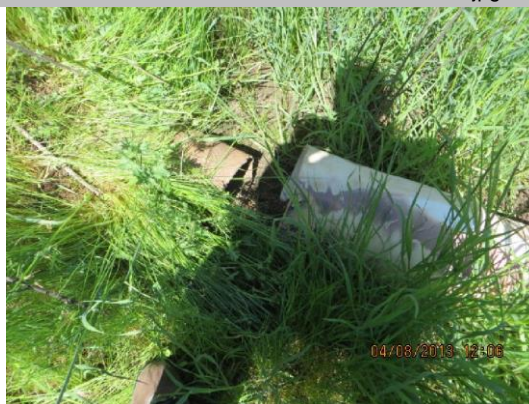
Photo 1 of 3 : UCIP_FA_2017_11383_18782.jpg

LM Start	2.21	Rating **	M	Issue No.	45
LM End	2.21	Issue Type +	Ma	Location *	
Category	Supplemental			GPS Latitude/Longitude	
				Start	End
Item	DWR UCIP LMA Responsibility			38.982135 °	38.982135 °
				-121.591974 °	-121.591974 °
DWR ID					
Comment Code					
Inspector Comment					
FS_ID:11383 DS_ID:17915 EP_NO: N/A Repair Type: Non-Urgent Crossing Status: Found UCIP Comments: Siphon breaker cap missing. Sump pump and gate valve at landward toe not found may be due to dense vegetation. FIELD_STRUCT_DESC: A 8-inch steel pipe of unknown purpose through levee, 4.6-feet below the crown. Siphon breaker in corrugated metal riser on landward slope.O&M Manual Sac 144, August 1955, Revision Year 2011. FS Date: 4/12/2013

WS- 8-inch steel pipe and disconnected pvc pipe on levee slope

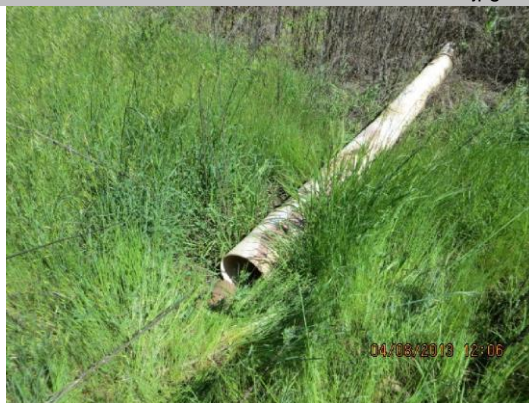
Photo 2 of 3 : UCIP_FA_2017_11383_18781.jpg

WS-a disconnected pvc pipe on levee slope

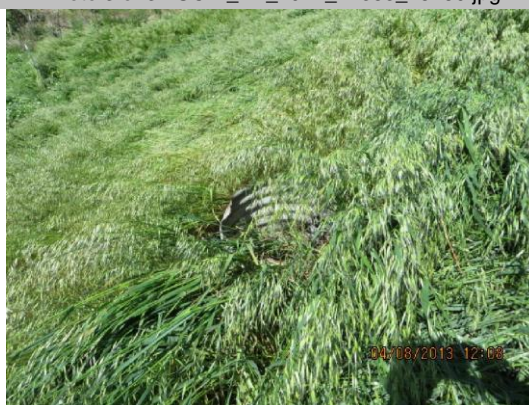
Photo 3 of 3 : UCIP_FA_2017_11383_18780.jpg

LS- CMP riser on levee slope with dense vegetation.

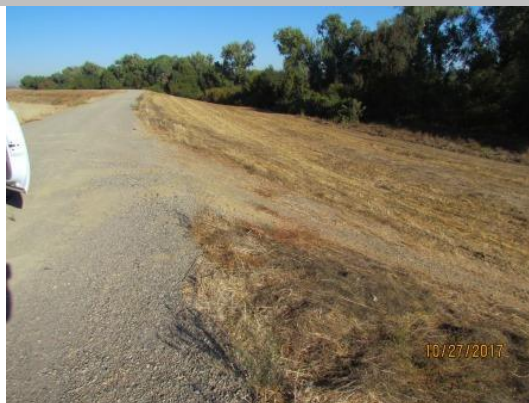
Photo 1 of 2 : FA_2017_LD0001S_433_36_20171106_00076.jpg

LM Start	4.41	Rating **	A/W	Issue No.	36
LM End	4.41	Issue Type +	Ma	Location *	WS
Category	Earthen Levee			GPS Latitude/Longitude	
				Start	End
Item	Slope Stability			39.011493 °	39.011493 °
				-121.603624 °	-121.603624 °
DWR ID	DWR_LD0001S_01_f _ 2016_36				
Comment Code					
S3 : Repair the levee slope damaged by vehicle traffic and prevent access where possible.					
Inspector Comment					
No erosion or separation on slope, continue to monitor, Fall 2017.

View of waterside slope where vehicles have been driving up and down to go around gate. Fall 2017.

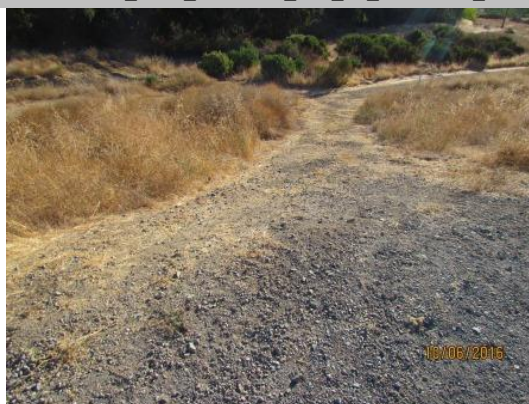
Photo 2 of 2 : FA_2017_LD0001S_433_36_20170911_00017.jpg

View of waterside slope where vehicles have been driving up and down to go around gate. Fall 2016.

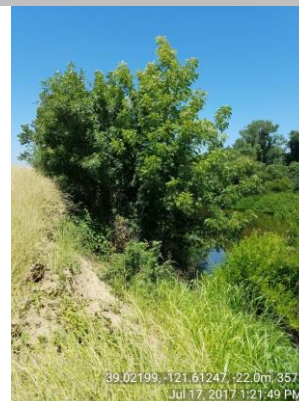
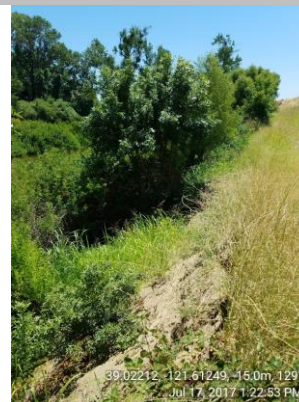
LM Start	5.02	Rating **	A/W	Issue No.	25	
LM End	5.02	Issue Type +	Ma	Location *		
Category	Supplemental			GPS Latitude/Longitude		
				Start		End
Item	2017 Storm Damage			39.018322 °	39.018322 °	
				-121.610275 °	-121.610275 °	
DWR ID	DWR_LD0001S_01_f_2017_25					
Comment Code						
Inspector Comment						
Levee Evaluation Comments						
Description:						
Site ID No:145						
Site Designation:LD1-S-02						
Repair Type: Erosion						
Rating:Critical						
Field Date:7/17/2017						
Notes:

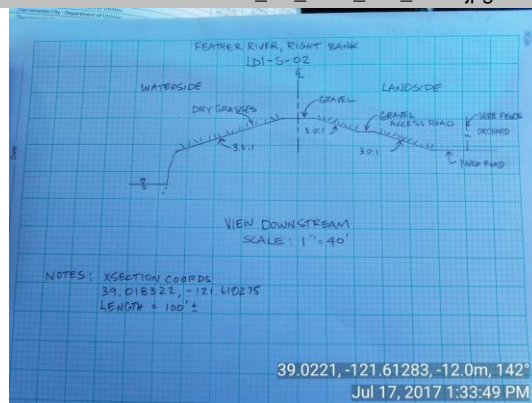
Photo 3 of 3 : LEVAL_FA_2017_145_1769.jpg

LM Start	5.02	Rating **	A/W	Issue No.	25 (cont)	
LM End	5.02	Issue Type +	Ma	Location *		
Category	Supplemental			GPS Latitude/Longitude		
				Start	End	
Item	2017 Storm Damage			39.018322 °	39.018322 °	
				-121.610275 °	-121.610275 °	
DWR ID	DWR_LD0001S_01_f_2017_25					
Comment Code						
Inspector Comment						
Levee Evaluation Comments						
Description:						
Site ID No:145						
Site Designation:LD1-S-02						
Repair Type: Erosion						
Rating:Critical						
Field Date:7/17/2017						
Notes:

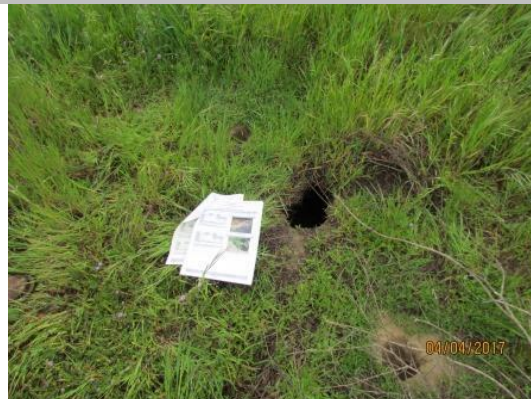
Photo 1 of 3 : FA_2017_LD0001S_433_20_20170911_00007.jpg

LM Start	6.81	Rating **	A/W	Issue No.	20
LM End	6.81	Issue Type +	Ma	Location *	LS
Category	Earthen Levee			GPS Latitude/Longitude	
				Start	End
Item	Animal Control			39.043262 °	39.043262 °
				-121.611527 °	-121.611527 °
DWR ID	DWR_LD0001S_01_s_2017_20				
Comment Code					
A3 : No rodents visible, but rodent burrows visible; need to backfill and compact or grout burrows.					
Inspector Comment					
Large animal burrows on slope has been repaired from Spring 2017. Drew at LMA had this repaired in May, no signs of animal activity but should be monitored, Fall 2016.

View of highest point on waterside slope of large animal burrow that needs to be repaired, Spring 2017.

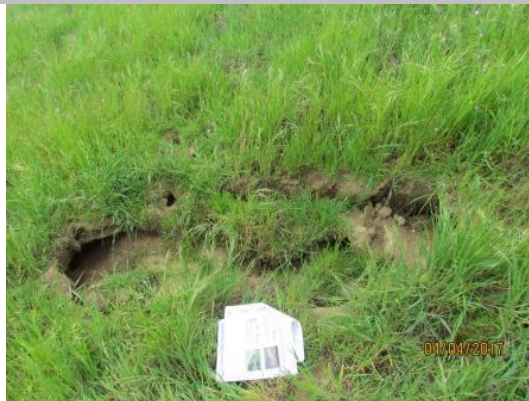
Photo 2 of 3 : FA_2017_LD0001S_433_20_20170911_00008.jpg

View of mid point on waterside slope of the same large animal burrow that needs to be repaired, Spring 2017.

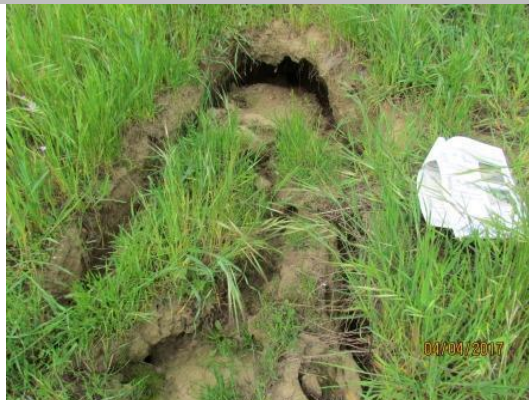
Photo 3 of 3 : FA_2017_LD0001S_433_20_20170911_00009.jpg

View looking up from bottom of waterside slope at the same large animal burrow that needs to be repaired, Spring 2017.

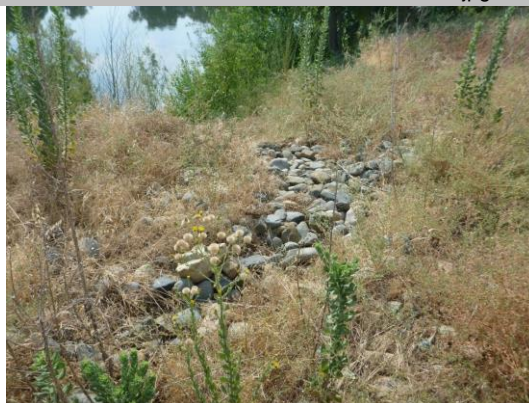
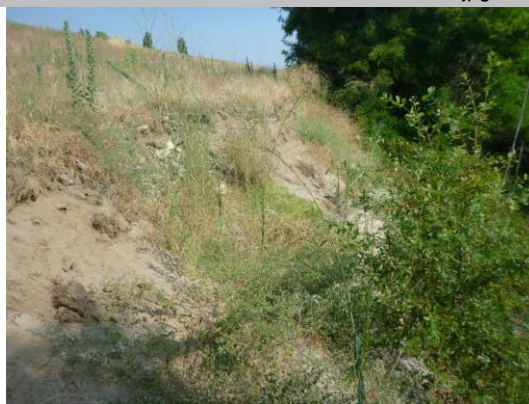
LM Start	7.74	Rating **	A/W	Issue No.	19
LM End	7.69	Issue Type +	Ma	Location *	
Category	Supplemental			GPS Latitude/Longitude	
				Start	End
Item	2017 Storm Damage			39.056710 °	39.055986 °
				-121.611331 °	-121.611301 °
DWR ID	DWR_LD0001S_01_f_2017_19				
Comment Code					
Inspector Comment					
Levee Evaluation Comments					
Description:					
Site ID No:146					
Site Designation:LD1-S-03					
Repair Type: Erosion					
Rating:Area of Concern					
Field Date:8/3/2017					
Notes:

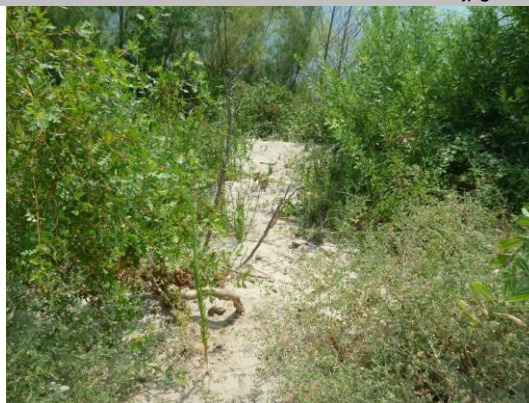
Photo 3 of 3 : LEVAL_FA_2017_146_4054.jpg

LM Start	7.74	Rating **	A/W	Issue No.	19 (cont)	
LM End	7.69	Issue Type +	Ma	Location *		
Category	Supplemental			GPS Latitude/Longitude		
				Start	End	
Item	2017 Storm Damage			39.056710 °	39.055986 °	
				-121.611331 °	-121.611301 °	
DWR ID	DWR_LD0001S_01_f_2017_19					
Comment Code						
Inspector Comment						
Levee Evaluation Comments						
Description:						
Site ID No:146						
Site Designation:LD1-S-03						
Repair Type: Erosion						
Rating:Area of Concern						
Field Date:8/3/2017						
Notes:

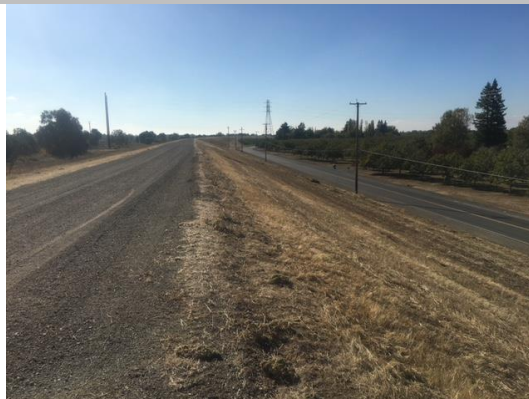
Photo 1 of 3 : FA_2017_LD0001S_433_29_20171115_00091.jpg

LM Start	8.06	Rating **	A	Issue No.	29	
LM End	10.25	Issue Type +	Ma	Location *	LS	
Category	Earthen Levee			GPS Latitude/Longitude		
				Start	End	
Item	Vegetation			39.061383 °	39.091455 °	
				-121.611328 °	-121.600913 °	
DWR ID	DWR_LD0001S_01_f_2017_29					
Comment Code						
V1 : Control annual grass and weeds on the levee slopes and easements.						
Inspector Comment						
The LD was in the process of mowing this section, they finished after the Fall 2017 inspection.

View looking downstream landside. The LD was in the process of mowing this section, they finished after the Fall 2017 inspection.

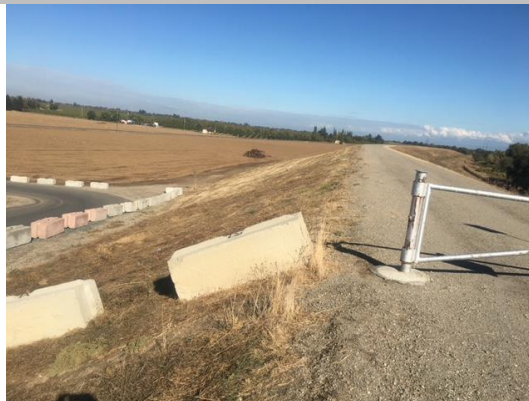
Photo 2 of 3 : FA_2017_LD0001S_433_29_20171115_00092.jpg

View looking upstream landside. The LD was in the process of mowing this section, they finished after the Fall 2017 inspection.

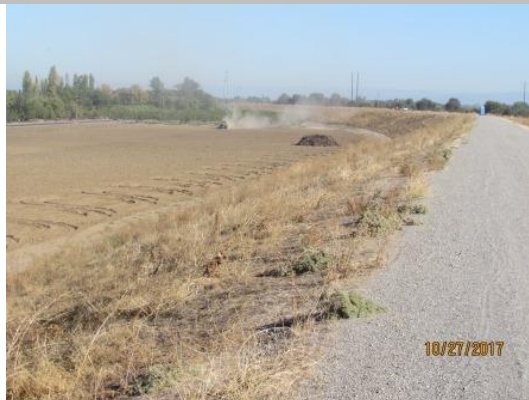
Photo 3 of 3 : FA_2017_LD0001S_433_29_20171107_00077.jpg

View looking upstream landside of annual vegetation that needs to be maintained, Fall 2017.

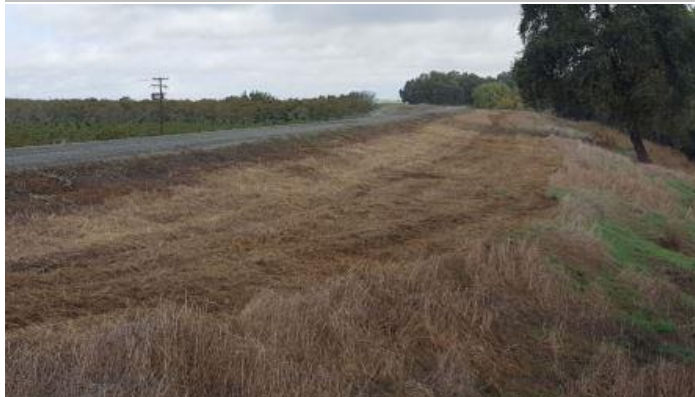
Photo 1 of 2 : FA_2017_LD0001S_433_30_20171115_00089.jpg

LM Start	8.06	Rating **	A	Issue No.	30
LM End	10.25	Issue Type +	Ma	Location *	WS
Category	Earthen Levee			GPS Latitude/Longitude	
				Start	End
Item	Vegetation			39.061383 °	39.091455 °
				-121.611328 °	-121.600913 °
DWR ID	DWR_LD0001S_01_f _ 2017_30				
Comment Code					
V1 : Control annual grass and weeds on the levee slopes and easements.					
Inspector Comment					
The LD is in the process of mowing this section, they finished after the Fall 2017 Inspection.

The LD was in the process of mowing this section, they finished after the Fall 2017 Inspection.

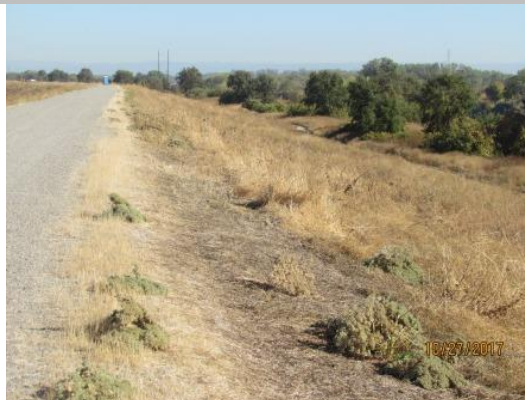
Photo 2 of 2 : FA_2017_LD0001S_433_30_20171107_00078.jpg

View looking upstream waterside of annual vegetation that needs to be maintained, Fall 2017.

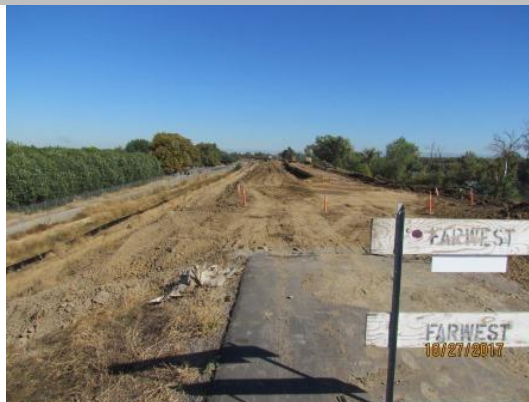
Photo 1 of 4 : FA_2017_LD0001S_433_31_20171107_00083.jpg

LM Start	12.15	Rating **	A/W	Issue No.	31
LM End	15.09	Issue Type +	Ma	Location *	CR
Category	Earthen Levee			GPS Latitude/Longitude	
				Start	End
Item	Crown Surface / Depressions / Rutting			39.116846 °	39.155672 °
				-121.604524 °	-121.616478 °
DWR ID	DWR_LD0001S_01_f _ 2017_31				
Comment Code					
Inspector Comment					
This section of levee is under construction, Fall 2017.

View looking upstream at the start point of the new construction of the levee, Fall 2017.

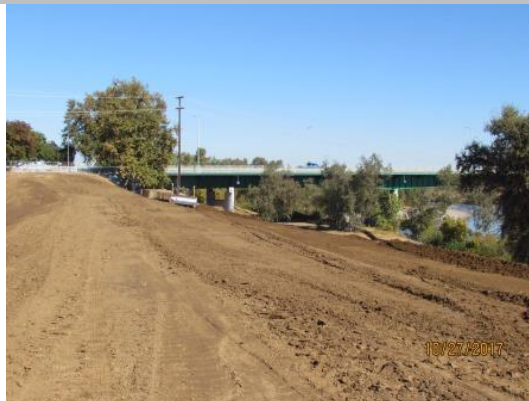
Photo 2 of 4 : FA_2017_LD0001S_433_31_20171107_00084.jpg

View looking upstream at the 10th Street Bridge of the new construction of the levee, Fall 2017.

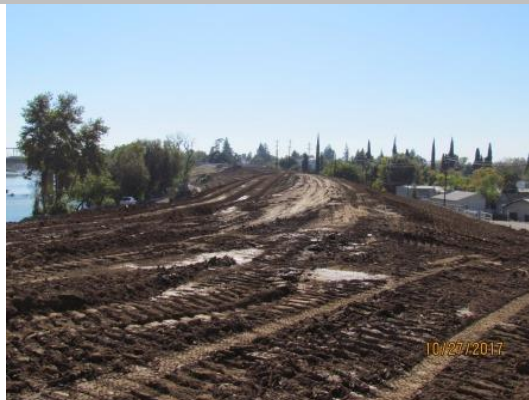
Photo 3 of 4 : FA_2017_LD0001S_433_31_20171107_00085.jpg

View looking downstream from the 10th Street Bridge of the new construction of the levee, Fall 2017.

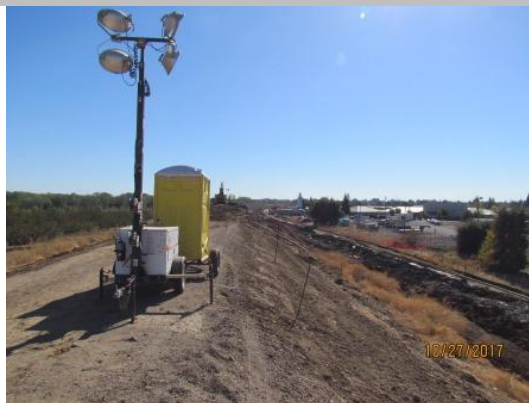
Photo 4 of 4 : FA_2017_LD0001S_433_31_20171107_00086.jpg

View looking downstream at the end point of the new construction of the levee, Fall 2017.
