**Flood Control Project Maintenance  
Levee Inspections**

**Maintenance Issue Types Only, Levee Inspection Report By Mile - Fall 2018**

**Levee District No. 0001 (Sutter County)**

Waterway	Bank	Unit Miles	Inspection Start/End	Inspector
Unit No. 01 Feather River	Right	16.11	10/18/2018 10/18/2018	Sterling York

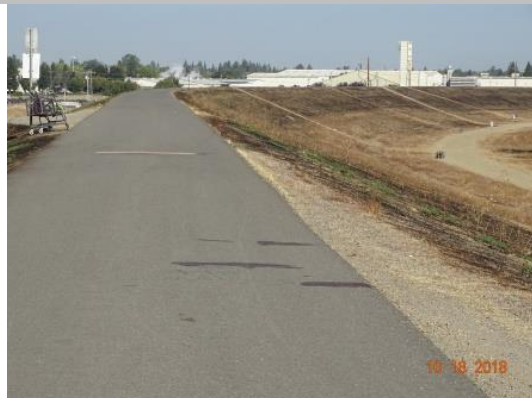
Photo 2 of 2 : FA\_2018\_LD0001S\_433\_17\_20181108\_00054.jpg

LM Start	0.20	Rating **	A	Issue No.	17 (cont)	
LM End	16.09	Issue Type +	Ma	Location *	WS	
Category	Earthen Levee			GPS Latitude/Longitude		
				Start		End
Item	Vegetation			38.953824 °		39.168587 °
				-121.585551 °		-121.622683 °
DWR ID	DWR_LD0001S_01_f_2018_17					
Comment Code						
V1 : Control annual grass and weeds on the levee slopes and easements.						
Inspector Comment						
The annual vegetation is well maintained, Fall 2018.

View looking upstream waterside LM 10.8 of the well maintained vegetation, Fall 2018.

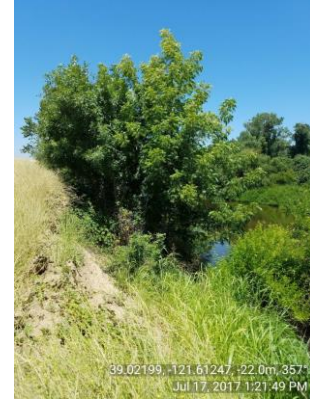
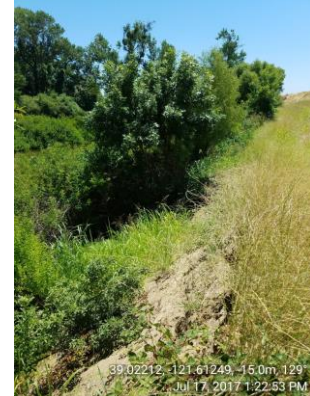
LM Start	5.02	Rating **	A/W	Issue No.	25
LM End	5.02	Issue Type +	Ma	Location *	
Category	Supplemental			GPS Latitude/Longitude	
				Start	End
Item	2017 Storm Damage			39.018322°	39.018322°
				-121.610275°	-121.610275°
DWR ID	DWR_LD0001S_01_f_2017_25				
Comment Code					
Inspector Comment					
Levee Evaluation Comments					
Description:					
Site ID No:145					
Site Designation:LD1-S-02					
Repair Type: Erosion					
Rating:Critical					
Field Date:7/17/2017					
Notes:

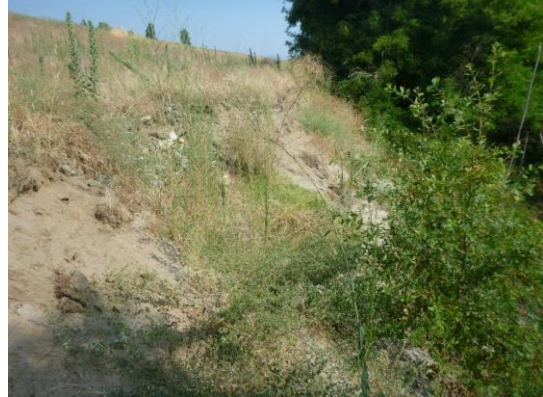
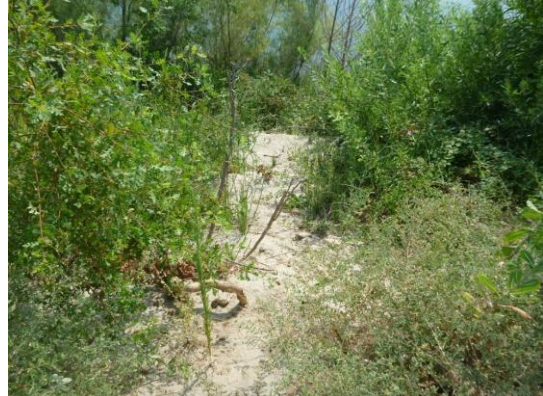
LM Start	7.69	Rating **	A/W	Issue No.	19 (cont)	
LM End	7.74	Issue Type +	Ma	Location *		
Category	Supplemental			GPS Latitude/Longitude		
				Start	End	
Item	2017 Storm Damage			39.055986 °	39.056710 °	
				-121.611301 °	-121.611331 °	
DWR ID	DWR_LD0001S_01_f_2017_19					
Comment Code						
Inspector Comment						
Levee Evaluation Comments						
Description:						
Site ID No:146						
Site Designation:LD1-S-03						
Repair Type: Erosion						
Rating:Area of Concern						
Field Date:8/3/2017						
Notes:

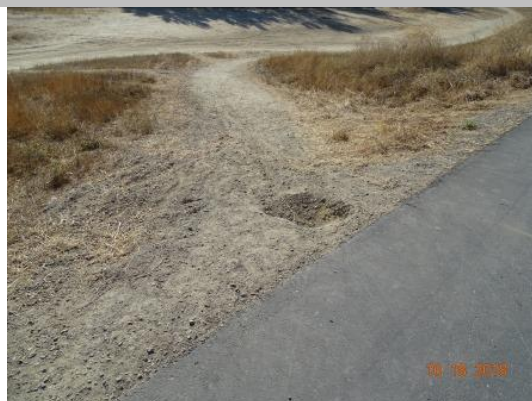
Photo 1 of 1 : FA\_2018\_LD0001S\_433\_24\_20181108\_00060.jpg

LM Start	12.00	Rating **	A/W	Issue No.	24
LM End	12.00	Issue Type +	Ma	Location *	WS
Category	Earthen Levee			GPS Latitude/Longitude	
				Start	End
Item	Slope Stability			39.114994 °	39.114994 °
				-121.605726 °	-121.605726 °
DWR ID	DWR_LD0001S_01_f_2018_24				
Comment Code					
S2 : Repair the levee slope damaged by foot traffic and prevent access where possible.					
Inspector Comment					
Foot path shows no sign of soil separation or erosion, but should be monitored, Fall 2018.

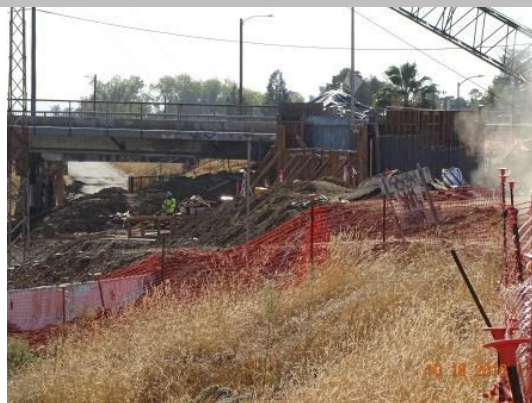
Photo 1 of 2 : FA\_2018\_LD0001S\_433\_26\_20181108\_00058.jpg

LM Start	13.87	Rating **	A/W	Issue No.	26
LM End	13.87	Issue Type +	Ma	Location *	CR
Category	Earthen Levee			GPS Latitude/Longitude	
				Start	End
Item	Crown Surface / Depressions / Rutting			39.139734 °	39.139734 °
				-121.608477 °	-121.608477 °
DWR ID	DWR_LD0001S_01_f_2018_26				
Comment Code					
C2 : Repair depressions or ruts in the crown or slope.					
Inspector Comment					
Fifth Street Bridge Construction, Fall 2018.

View looking downstream waterside of the 5th Street bridge construction, Fall 2018.

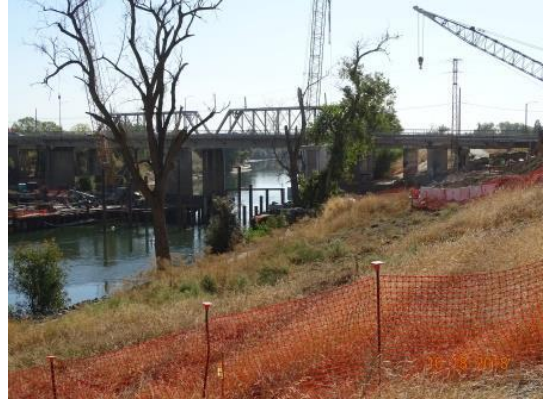
Photo 2 of 2 : FA\_2018\_LD0001S\_433\_26\_20181108\_00059.jpg

LM Start	13.87	Rating **	A/W	Issue No.	26 (cont)
LM End	13.87	Issue Type +	Ma	Location *	CR
Category	Earthen Levee			GPS Latitude/Longitude	
				Start	End
Item	Crown Surface / Depressions / Rutting			39.139734 °	39.139734 °
				-121.608477 °	-121.608477 °
DWR ID	DWR_LD0001S_01_f_2018_26				
Comment Code					
C2 : Repair depressions or ruts in the crown or slope.					
Inspector Comment					
Fifth Street Bridge Construction, Fall 2018.

View looking downstream waterside of the 5th Street bridge construction, Fall 2018.
