**Flood Control Project Maintenance
Levee Inspections**

Maintenance Issue Types Only, Levee Inspection Report By Mile - Fall 2019

Levee District No. 0001 (Sutter County)

Waterway	Bank	Unit Miles	Inspection Start/End	Inspector
Unit No. 01 Feather River	Right	16.11	10/25/2019 10/25/2019	Sterling York

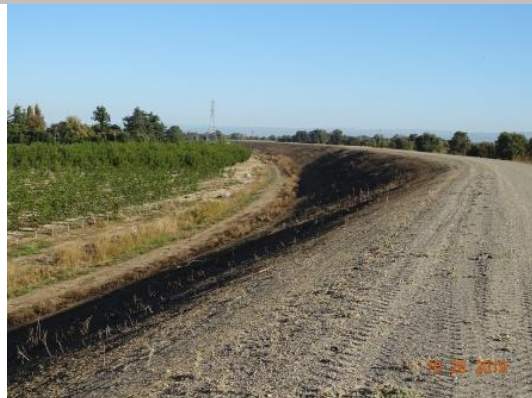
Photo 1 of 1 : FA_2019_LD0001S_433_15_20191030_00044.jpg

LM Start	4.41	Rating **	A	Issue No.	15
LM End	16.11	Issue Type +	Ma	Location *	LS
Category	Earthen Levee			GPS Latitude/Longitude	
				Start	End
Item	Vegetation			39.011497°	39.169221°
				-121.603630°	-121.622951°
DWR ID	DWR_LD0001S_01_f_2019_15				
Comment Code					
V1 : Control annual grass and weeds on the levee slopes and easements.					
Inspector Comment					
The annual vegetation is well maintained, Fall 2019.

View looking upstream landside at the well maintained annual vegetation, Fall 2019.

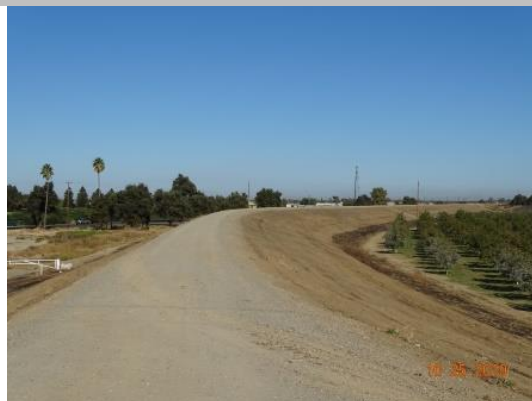
Photo 1 of 1 : FA_2019_LD0001S_433_16_20191030_00046.jpg

LM Start	4.41	Rating **	A	Issue No.	16
LM End	16.11	Issue Type +	Ma	Location *	WS
Category	Earthen Levee			GPS Latitude/Longitude	
				Start	End
Item	Vegetation			39.011497 °	39.169221 °
				-121.603630 °	-121.622951 °
DWR ID	DWR_LD0001S_01_f_2019_16				
Comment Code					
V1 : Control annual grass and weeds on the levee slopes and easements.					
Inspector Comment					
The annual vegetation is well maintained, Fall 2019.

View looking upstream waterside at the well maintained annual vegetation, Fall 2019.

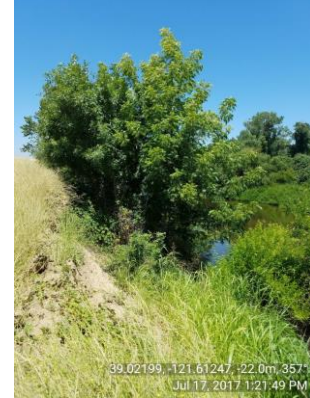
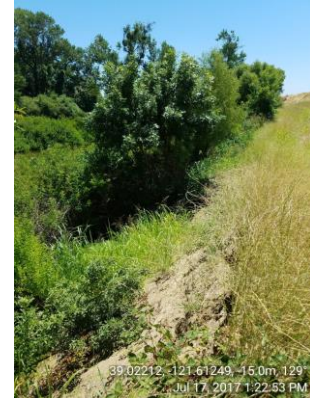
LM Start	5.02	Rating **	A/W	Issue No.	25	
LM End	5.02	Issue Type +	Ma	Location *		
Category	Supplemental			GPS Latitude/Longitude		
				Start		End
Item	2017 Storm Damage			39.018322 °		39.018322 °
				-121.610275 °		-121.610275 °
DWR ID	LD1-S-02					
Comment Code						
Inspector Comment						
Levee Evaluation Comments						
Description:						
Site ID No:145						
Site Designation:LD1-S-02						
Repair Type: Erosion						
Rating:Critical						
Field Date:7/17/2017						
Notes:

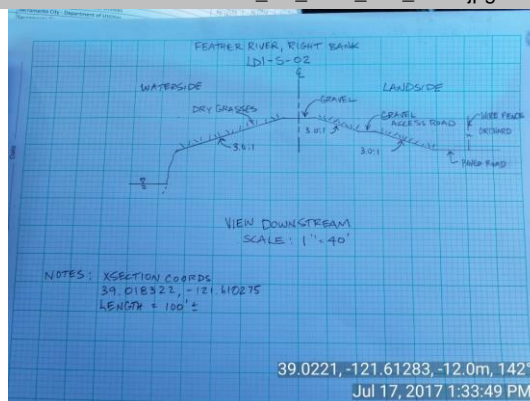
Photo 3 of 3 : LEVAL_FA_2019_145_1769.jpg

LM Start	5.02	Rating **	A/W	Issue No.	25 (cont)	
LM End	5.02	Issue Type +	Ma	Location *		
Category	Supplemental			GPS Latitude/Longitude		
				Start	End	
Item	2017 Storm Damage			39.018322 °	39.018322 °	
				-121.610275 °	-121.610275 °	
DWR ID	LD1-S-02					
Comment Code						
Inspector Comment						
Levee Evaluation Comments						
Description:						
Site ID No:145						
Site Designation:LD1-S-02						
Repair Type: Erosion						
Rating:Critical						
Field Date:7/17/2017						
Notes:

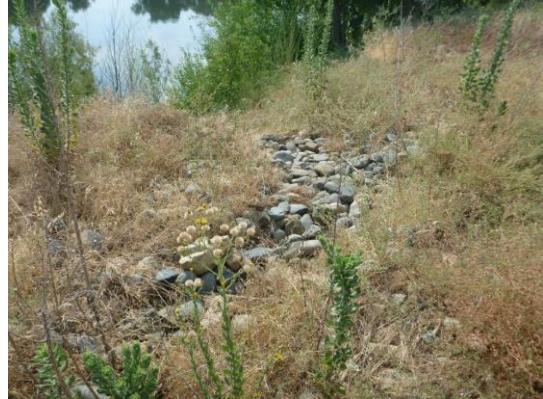
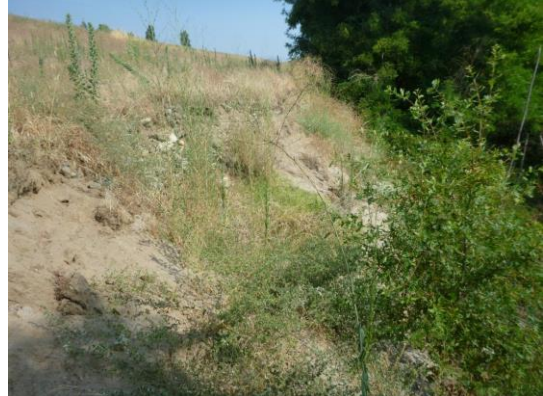
LM Start	7.69	Rating **	A/W	Issue No.	19	
LM End	7.74	Issue Type +	Ma	Location *		
Category	Supplemental			GPS Latitude/Longitude		
				Start	End	
Item	2017 Storm Damage			39.055986 °	39.056710 °	
				-121.611301 °	-121.611331 °	
DWR ID	LD1-S-03					
Comment Code						
Inspector Comment						
Levee Evaluation Comments						
Description:						
Site ID No:146						
Site Designation:LD1-S-03						
Repair Type: Erosion						
Rating:Area of Concern						
Field Date:8/3/2017						
Notes:

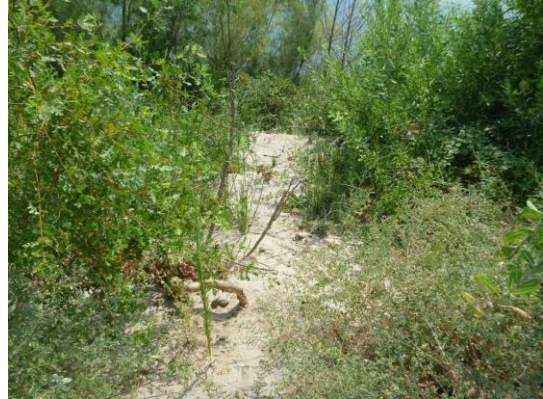
Photo 3 of 3 : LEVAL_FA_2019_146_4054.jpg

LM Start	7.69	Rating **	A/W	Issue No.	19 (cont)	
LM End	7.74	Issue Type +	Ma	Location *		
Category	Supplemental			GPS Latitude/Longitude		
				Start	End	
Item	2017 Storm Damage			39.055986 °	39.056710 °	
				-121.611301 °	-121.611331 °	
DWR ID	LD1-S-03					
Comment Code						
Inspector Comment						
Levee Evaluation Comments						
Description:						
Site ID No:146						
Site Designation:LD1-S-03						
Repair Type: Erosion						
Rating:Area of Concern						
Field Date:8/3/2017						
Notes:
