**Flood Control Project Maintenance
Levee Inspections**

Maintenance Issue Types Only, Levee Inspection Report By Mile - Fall 2020

Levee District No. 0001 (Sutter County)

| Waterway | Bank | Unit Miles | Inspection Start/End | Inspector |
|---|---|---|---|---|
| Unit No. 01 Feather River | Right | 16.11 | 10/13/2020 10/13/2020 | Brooks Weisser |

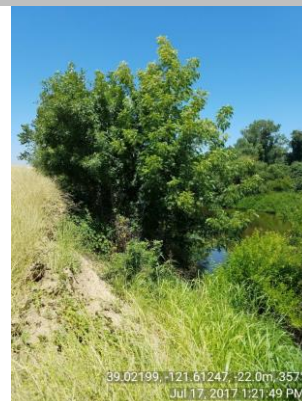
Photo 1 of 3 : LEVAL_FA_2020_145_1767.jpg

| Item | 2017 Storm Damage | | | 39.018322 ° | | 39.023753 ° |
| Rating: Critical | | | | | | |

The erosion site is planned for PL 84-99 Repair in 2020.

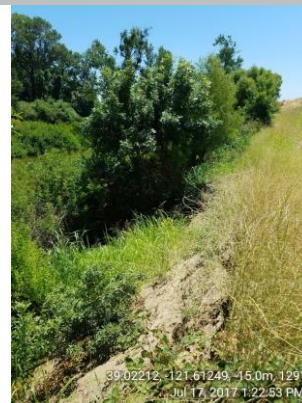
Photo 2 of 3 : LEVAL_FA_2020_145_1768.jpg

The erosion site is planned for PL 84-99 Repair in 2020.

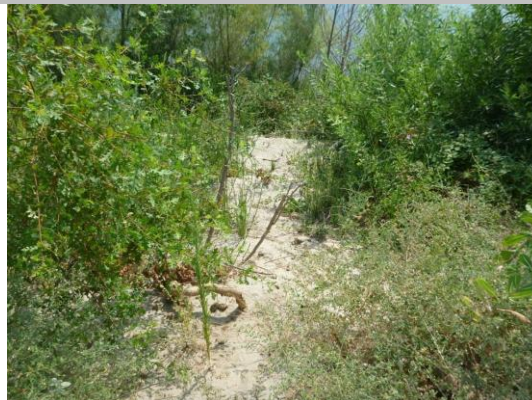
Photo 3 of 3 : LEVAL_FA_2020_146_4054.jpg

| Item | Erosion / Bank Caving | | | 39.055986 ° | 39.056710 ° |

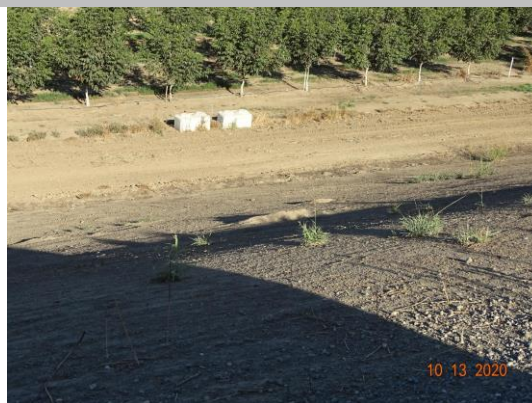
Photo 1 of 1 : FA_2020_LD0001S_433_17_20201019_00043.jpg

| Item | Animal Control | | | 39.058591 ° | 39.058591 ° |

No rodent activity noted, but holes need to be backfilled, Fall 2020

View of rodent holes on land side slope, Fall 2020.

A3 : No rodents visible, but rodent burrows visible; need to backfill and compact or grout burrows.
