**Flood Control Project Maintenance
Levee Inspections**

Maintenance Issue Types Only, Levee Inspection Report By Mile - Fall 2021

Levee District No. 0001 (Sutter County)

Waterway	Bank	Unit Miles	Inspection Start/End	Inspector
Unit No. 01 Feather River	Right	16.11	10/27/2021 10/27/2021	Sterling York

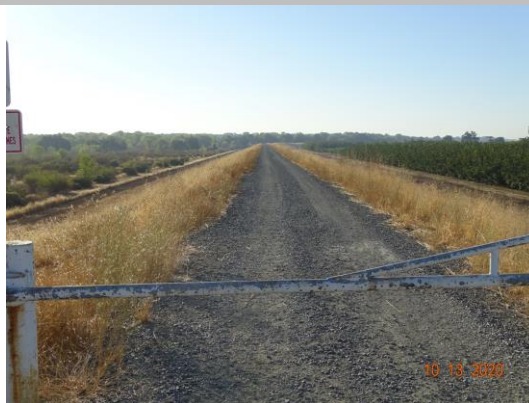
Photo 1 of 1 : FA_2021_LD0001S_433_15_20211026_00001.jpg

LM Start	0.00	Rating **	A/W	Issue No.	15
LM End	4.34	Issue Type +	Ma	Location *	CR
Category	Earthen Levee			GPS Latitude/Longitude	
				Start	End
Item	Crown Surface / Depressions / Rutting			38.950976 °	39.010657 °
				-121.585753 °	-121.602887 °
DWR ID	DWR_LD0001S_01_s_2020_15				
Comment Code					
C1 : Add appropriate material and re-grade the levee to bring the crown above the design elevation.					
Inspector Comment					
USACE Project completed, O&M manual and levee have not been turned over to LMA. This section is not maintained yet, Fall 2021.

View looking downstream of completed construction, but levee has not been turned over to LMA, Fall 2020.

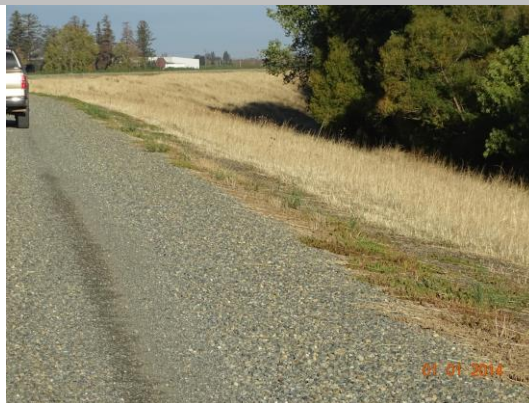
Photo 1 of 1 : FA_2021_LD0001S_433_17_20211028_00041.jpg

LM Start	4.49	Rating **	M	Issue No.	17
LM End	4.71	Issue Type +	Ma	Location *	WS
Category	Earthen Levee			GPS Latitude/Longitude	
				Start	End
Item	Vegetation			39.012413 °	39.014384 °
				-121.604325 °	-121.607665 °
DWR ID	DWR_LD0001S_01_f _ 2021_17				
Comment Code					
V1 : Control annual grass and weeds on the levee slopes and easements.					
Inspector Comment					
Control the annual vegetation, Fall 2021.

Control the annual vegetation, Fall 2021.

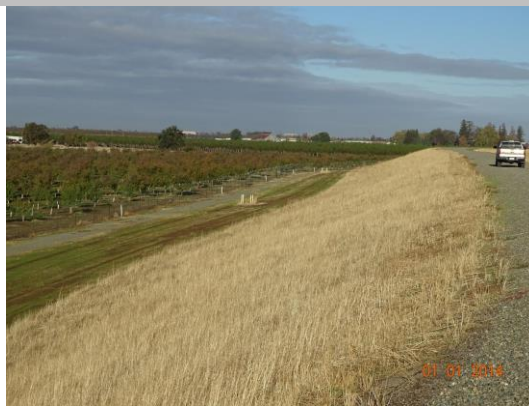
Photo 1 of 1 : FA_2021_LD0001S_433_16_20211028_00040.jpg

LM Start	4.49	Rating **	M	Issue No.	16
LM End	4.71	Issue Type +	Ma	Location *	LS
Category	Earthen Levee			GPS Latitude/Longitude	
				Start	End
Item	Vegetation			39.012414 °	39.014383 °
				-121.604330 °	-121.607667 °
DWR ID	DWR_LD0001S_01_f _ 2021_16				
Comment Code					
V1 : Control annual grass and weeds on the levee slopes and easements.					
Inspector Comment					
Control the annual vegetation, Fall 2021.

Control the annual vegetation, Fall 2021.

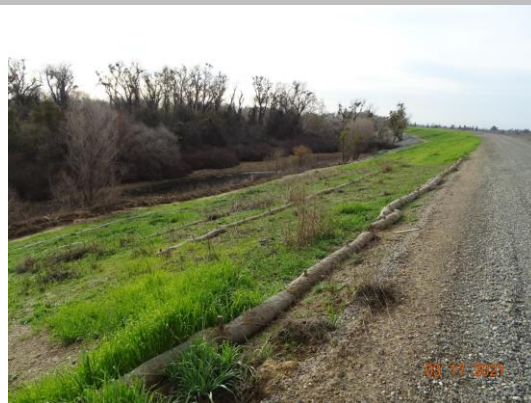
Photo 1 of 1 : FA_2021_LD0001S_433_26_20211026_00007.jpg

LM Start	5.43	Rating **	A/W	Issue No.	26
LM End	5.43	Issue Type +	Ma	Location *	WS
Category	Earthen Levee			GPS Latitude/Longitude	
				Start	End
Item	Slope Stability			39.023753 °	39.023753 °
				-121.613171 °	-121.613171 °
DWR ID	DWR_LD0001S_01_s_2021_26				
Comment Code					
S1 : Repair slope instability.					
Inspector Comment					
This site should be monitored as the wattles deteriorate to confirm the v ditches are no longer present. Contractor should removed wattles. Fall 2021.

View of wattles on waterside slope that should be monitored to ensure v-ditches are removed when wattles are removed or deteriorate, Spring 2021.

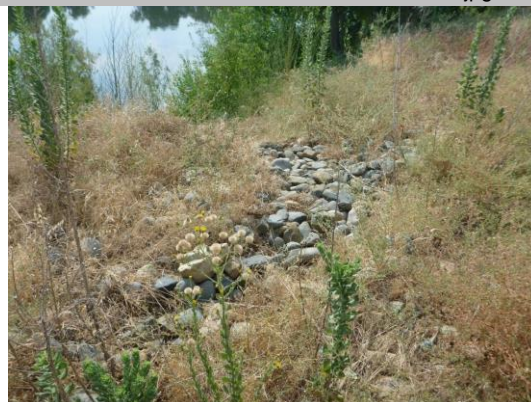
Photo 1 of 1 : LEVAL_FA_2021_146_4051.jpg

LM Start	7.69	Rating **	A/W	Issue No.	19
LM End	7.74	Issue Type +	Ma	Location *	WS
Category	Earthen Levee			GPS Latitude/Longitude	
				Start	End
Item	Slope Stability			39.055986 °	39.056710 °
				-121.611301 °	-121.611331 °
DWR ID	LD1-S-03				
Comment Code					
S1 : Repair slope instability.					
Inspector Comment					
This was a 2017 Storm Damage site for erosion.					
Site ID No:146					
Site Designation:LD1-S-03
