**Flood Control Project Maintenance
Levee Inspections**

Maintenance Issue Types Only, Levee Inspection Report By Mile - Fall 2022

Levee District No. 0001 (Sutter County)

Waterway	Bank	Unit Miles	Inspection Start/End	Inspector
Unit No. 01 Feather River	Right	16.11	10/27/2022 10/27/2022	Brooks Weisser

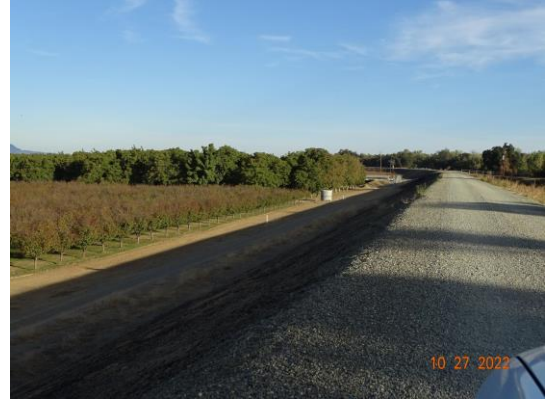
Photo 1 of 1 : FA_2022_LD0001S_433_69_20221028_00004.jpg

LM Start	0.20	Rating **	A	Issue No.	69
LM End	16.10	Issue Type +	Ma	Location *	LS
Category	Earthen Levee			GPS Latitude/Longitude	
				Start	End
Item	Vegetation			38.953742 °	39.168732 °
				-121.585547 °	-121.622687 °
DWR ID	DWR_LD0001S_01_f_2022_69				
Comment Code					
V1 : Control annual grass and weeds on the levee slopes and easements.					
Inspector Comment					
Annual vegetation is well maintained, Fall 2022.

View of well maintained vegetation on the landside slope, Fall 2022.

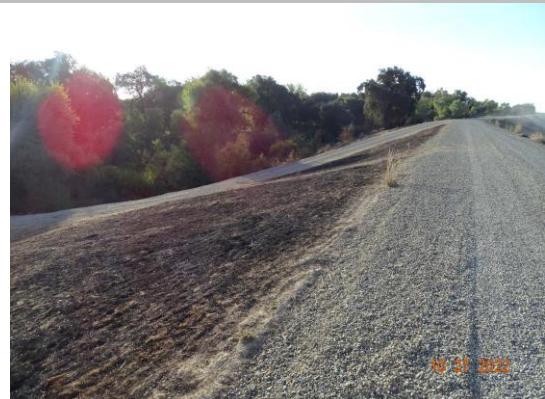
Photo 1 of 1 : FA_2022_LD0001S_433_70_20221028_00005.jpg

LM Start	0.20	Rating **	A	Issue No.	70
LM End	16.10	Issue Type +	Ma	Location *	WS
Category	Earthen Levee			GPS Latitude/Longitude	
				Start	End
Item	Vegetation			38.953743 °	39.168732 °
				-121.585545 °	-121.622687 °
DWR ID	DWR_LD0001S_01_f _ 2022_70				
Comment Code					
V1 : Control annual grass and weeds on the levee slopes and easements.					
Inspector Comment					
Annual Vegetation is well maintained, Fall 2022.

View of annual vegetation on the waterside slope, Fall 2022.

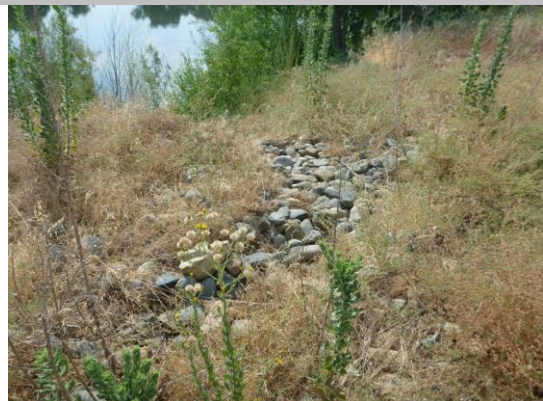
Photo 1 of 1 : LEVAL_FA_2022_146_4051.jpg

LM Start	7.69	Rating **	A/W	Issue No.	19
LM End	7.74	Issue Type +	Ma	Location *	WS
Category	Earthen Levee			GPS Latitude/Longitude	
				Start	End
Item	Slope Stability			39.055986 °	39.056710 °
				-121.611301 °	-121.611331 °
DWR ID	LD1-S-03				
Comment Code					
S1 : Repair slope instability.					
Inspector Comment					
This was a 2017 Storm Damage site for erosion.					
Site ID No:146					
Site Designation:LD1-S-03
