**Flood Control Project Maintenance
Levee Inspections**

Maintenance Issue Types Only, Levee Inspection Report By Mile - Fall 2023

Levee District No. 0001 (Sutter County)

Waterway	Bank	Unit Miles	Inspection Start/End	Inspector
Unit No. 01 Feather River	Right	16.11	10/05/2023 10/05/2023	Brooks Weisser

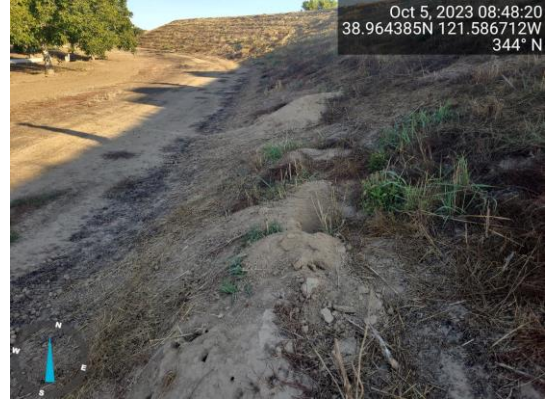
Photo 1 of 1 : FA_2023_LD0001S_433_14_20231010_00022.jpg

LM Start	0.94	Rating **	M	Issue No.	14
LM End	0.94	Issue Type +	Ma	Location *	LS
Category	Earthen Levee			GPS Latitude/Longitude	
				Start	End
Item	Animal Control			38.964534°	38.964534°
				-121.586570°	-121.586570°
DWR ID	DWR_LD0001S_01_f_2023_14				
Comment Code					
A3 : No rodents visible, but rodent burrows visible; need to backfill and compact or grout burrows.					
Inspector Comment					
No rodent activity observed, but rodent holes need to be backfilled and compacted.

View of rodent holes on the landside slope, Fall 2023.

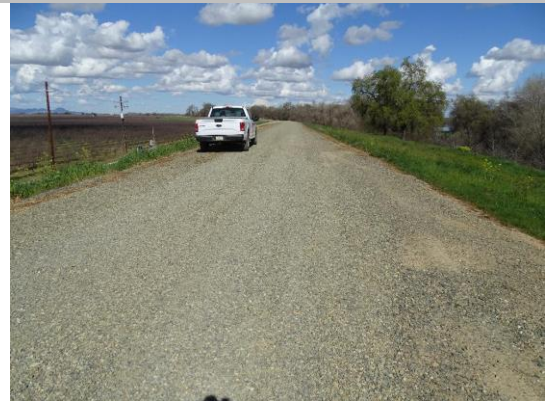
Photo 1 of 3 : UCIP_FA_2023_77099_113766.jpg

Comment Code						
Inspector Comment						
DS_ID:18668 FS_ID:77099 EP_NO: N/A Repair Type: Non-Urgent EVAL Issue: Crossing Status: Not Found UCIP Comments: 02/22/2022 Record has been updated to Non-Urgent. No drainage culvert located on the LS. Based on USACE As-Built Drawing No. 04-04-0205-1, pipe is described as crossing LS approach and does not indicate through the levee. Need to obtain recent Feather River West Levee Project as-built drawings to verify if pipe actually crosses the levee at this location. (M. Thao - DWR UCIP) FIELD_STRUCT_DESC: 8-inch corrugated iron gravity drainage culvert under the landside (LS) approach, at an unknown depth. [Additional Reference(s): USACE As-Built Drawing No. 04-04-0205-1, Station 627+00, July 1939]. FS Date: 2/22/2022

Levee crown looking upstream.

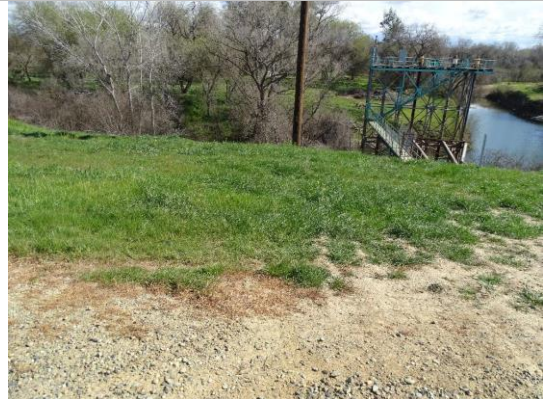
Photo 3 of 3 : UCIP_FA_2023_77099_113767.jpg

WS view: Looking from levee; general overview. Pole and pump station not associated with this record.

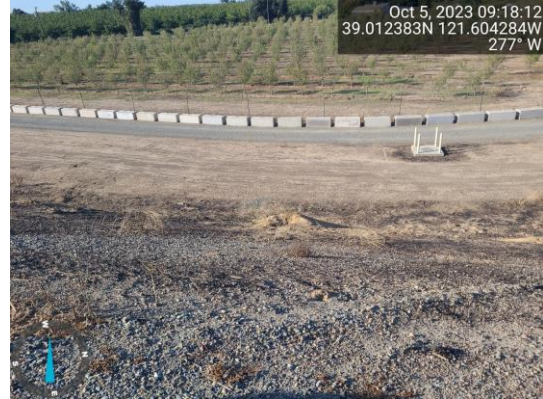
Photo 1 of 1 : FA_2023_LD0001S_433_15_20231010_00023.jpg

LM Start	4.48	Rating **	M	Issue No.	15
LM End	4.73	Issue Type +	Ma	Location *	LS
Category	Earthen Levee			GPS Latitude/Longitude	
				Start	End
Item	Animal Control			39.012365°	39.014601°
				-121.604267°	-121.607921°
DWR ID	DWR_LD0001S_01_f_2023_15				
Comment Code					
A1 : Exterminate rodents and backfill and compact or grout burrows.					
Inspector Comment					
Rodent activity observed, area needs to be baited, and holes backfilled and compacted, Fall 2023.

View of rodent holes on the landside slope, Fall 2023.

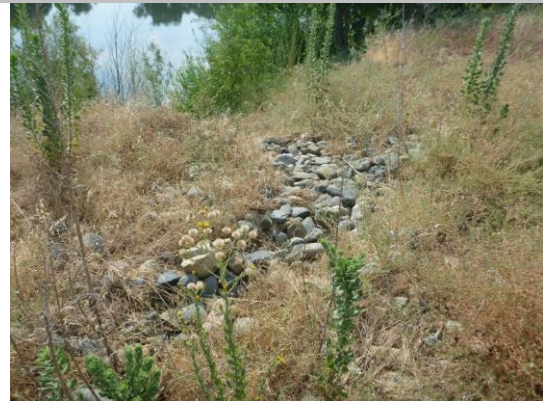
Photo 1 of 1 : LEVAL_FA_2023_146_4051.jpg

LM Start	7.69	Rating **	A/W	Issue No.	19
LM End	7.74	Issue Type +	Ma	Location *	WS
Category	Earthen Levee			GPS Latitude/Longitude	
				Start	End
Item	Erosion / Bank Caving			39.055986°	39.056710°
				-121.611301°	-121.611331°
DWR ID	LD1-S-03				
Comment Code					
E1 : Note and monitor erosion site.					
Inspector Comment					
This was a 2017 Storm Damage site for erosion.					
Site ID No:146					
Site Designation:LD1-S-03

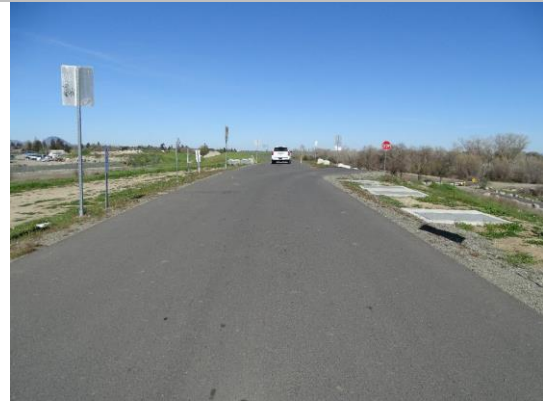
Photo 1 of 3 : UCIP_FA_2023_80013_114549.jpg

Comment Code						
Inspector Comment						
DS_ID:17924 FS_ID:80013 EP_NO: N/A Repair Type: Non-Urgent EVAL Issue: Crossing Status: Not Found UCIP Comments: 02/24/2022 Need to verify if pipe was grouted in place or removed. Permit application proposed pipe removal but a Reclamation Board suggests that abandonment might be safely and more economically accomplished by filling with concrete rather than opening a cut some 200 feet long and 40 feet deep in the levee. Sutter Butte Flood Control Agency As-Built Drawing No. 04-04-0648, Sheet 59, May 2013, at approximately Station 1043+40 does not indicate there is a 36-inch pipe, 30 feet below the crown. (M. Thao - DWR UCIP) 04/09/2013 Need verification pipe was grouted in place. (P. Amatya) FIELD_STRUCT_DESC: 36-inch corrugated metal gravity drainage pipe through the levee, 30 feet below the crown. Slide gate in a corrugated metal pipe (CMP) riser on the waterside (WS) slope. (36-inch pipe removed under Permit 1066, 1945 - Levee District No. 1 of Sutter County). [Additional Reference(s): DWR Levee Log, 2005 (HLM 14.98). USACE Sacramento O&M Manual, Unit No. 144, August 1955, (Station 1468+79), listed as 36-inch pipe. USACE As-Built Drawing No. 04-04-0172-1, Station 1468+79, August 1938]. FS Date: 2/24/2022

Levee crown looking upstream.

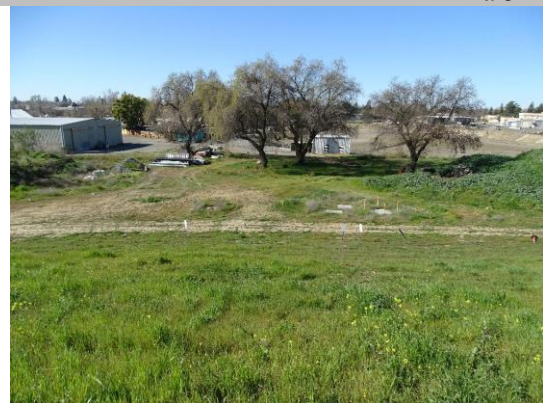
Photo 2 of 3 : UCIP_FA_2023_80013_114550.jpg

LS view: Looking from levee; general overview.

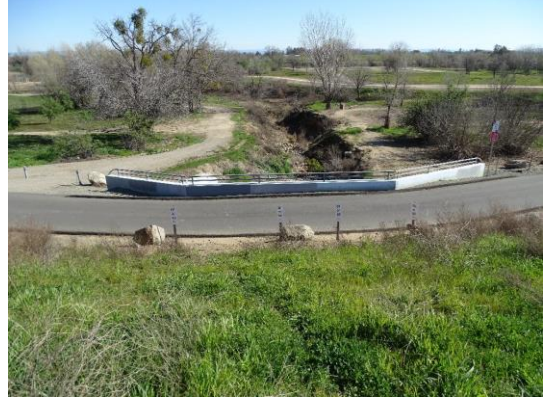
Photo 3 of 3 : UCIP_FA_2023_80013_114551.jpg

WS view: Looking from levee; general overview.
