**Flood Control Project Maintenance  
Levee Inspections****Maintenance Issue Types Only, Levee Inspection Report By Mile - Fall 2024****Levee District No. 0001 (Sutter County)**

Waterway	Bank	Unit Miles	Inspection Start/End	Inspector
Unit No. 01 Feather River	Right	16.11	10/30/2024 10/30/2024	Brooks Weisser

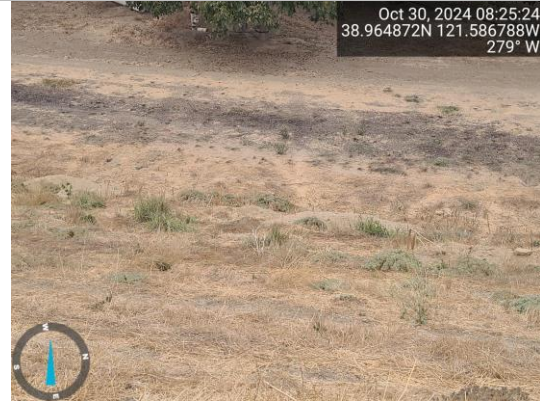
Photo 1 of 1 : FA\_2024\_LD0001S\_433\_14\_20241031\_00024.jpg

LM Start	0.94	Rating **	A/W	Issue No.	14
LM End	0.94	Issue Type +	Ma	Location *	LS
Category	Earthen Levee			GPS Latitude/Longitude	
				Start	End
Item	Animal Control			38.964534°	38.964534°
				-121.586570°	-121.586570°
DWR ID	DWR_LD0001S_01_f_2023_14				
Comment Code					
A3 : No rodents visible, but rodent burrows visible; need to backfill and compact or grout burrows.					
Inspector Comment					
No rodents visible, and LMA is actively baiting and backfilling. Monitor area for further activity, Fall 2024.

View of rodent holes on the landside slope, Fall 2024.

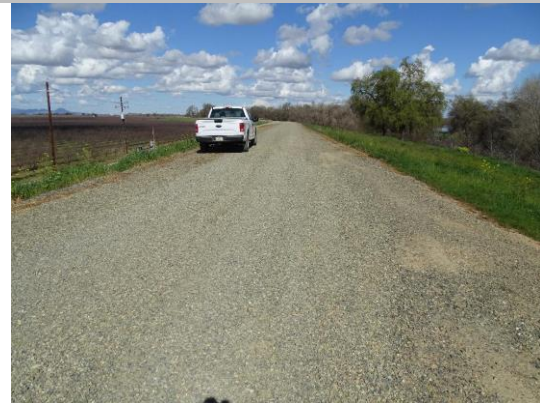
Photo 1 of 3 : UCIP\_FA\_2024\_77099\_113766.jpg

Comment Code					
Inspector Comment					
DS_ID:18668 FS_ID:77099 EP_NO: N/A Repair Type: Non-Urgent EVAL Issue: Crossing Status: Not Found UCIP Comments: 02/22/2022 Record has been updated to Non-Urgent. No drainage culvert located on the LS. Based on USACE As-Built Drawing No. 04-04-0205-1, pipe is described as crossing LS approach and does not indicate through the levee. Need to obtain recent Feather River West Levee Project as-built drawings to verify if pipe actually crosses the levee at this location. (M. Thao - DWR UCIP) FIELD_STRUCT_DESC: 8-inch corrugated iron gravity drainage culvert under the landside (LS) approach, at an unknown depth. [Additional Reference(s): USACE As-Built Drawing No. 04-04-0205-1, Station 627+00, July 1939]. FS Date: 2/22/2022

Levee crown looking upstream.

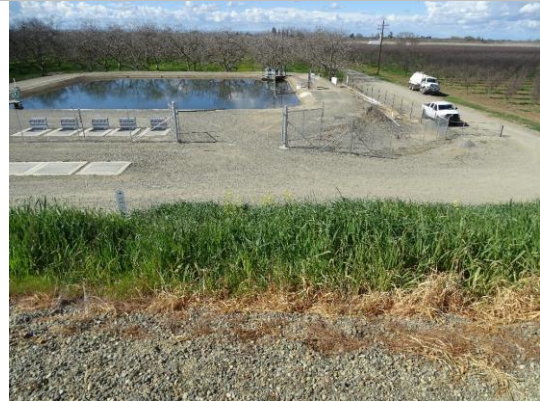
Photo 2 of 3 : UCIP\_FA\_2024\_77099\_113768.jpg

LS view: Looking from crown; general overview. Sump and vaults are not associated this record.

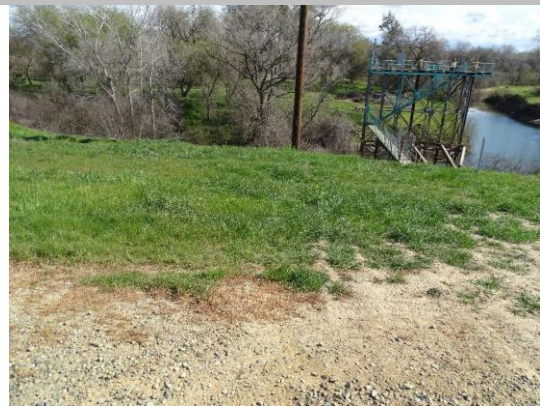
Photo 3 of 3 : UCIP\_FA\_2024\_77099\_113767.jpg

WS view: Looking from levee; general overview. Pole and pump station not associated with this record.

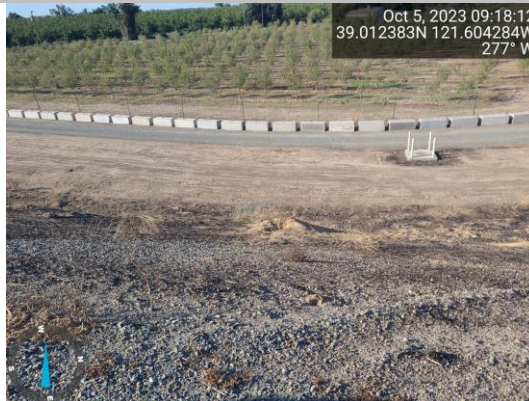
Photo 1 of 1 : FA\_2024\_LD0001S\_433\_15\_20240829\_00002.jpg

LM Start	4.48	Rating **	A/W	Issue No.	15
LM End	4.73	Issue Type +	Ma	Location *	LS
Category	Earthen Levee			GPS Latitude/Longitude	
				Start	End
Item	Animal Control			39.012365°	39.014601°
				-121.604267°	-121.607921°
DWR ID	DWR_LD0001S_01_f_2023_15				
Comment Code					
A3 : No rodents visible, but rodent burrows visible; need to backfill and compact or grout burrows.					
Inspector Comment					
No rodents visible, and LMA is actively baiting and backfilling. Monitor area for further activity, Fall 2024.

View of rodent holes on the landside slope, Fall 2023.

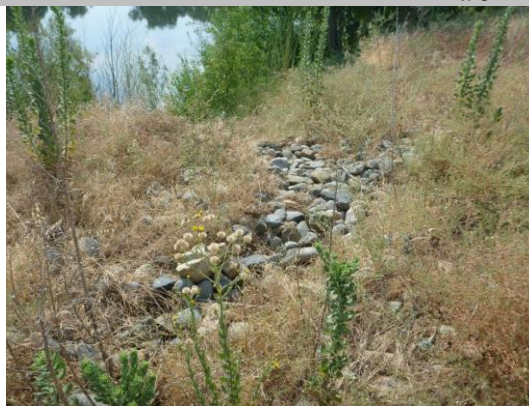
Photo 1 of 1 : LEVAL\_FA\_2024\_146\_4051.jpg

LM Start	7.69	Rating **	A/W	Issue No.	19
LM End	7.74	Issue Type +	Ma	Location *	WS
Category	Earthen Levee			GPS Latitude/Longitude	
				Start	End
Item	Erosion / Bank Caving			39.055986°	39.056710°
				-121.611301°	-121.611331°
DWR ID	LD1-S-03				
Comment Code					
E1 : Note and monitor erosion site.					
Inspector Comment					
This was a 2017 Storm Damage site for erosion.					
Site ID No:146					
Site Designation:LD1-S-03

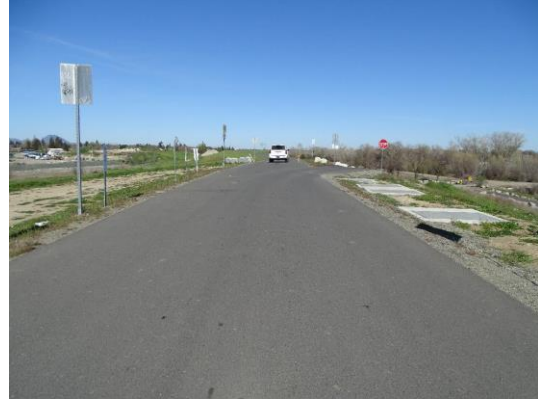
Photo 1 of 3 : UCIP\_FA\_2024\_80013\_114549.jpg

Comment Code					
Inspector Comment					
DS_ID:17924 FS_ID:80013 EP_NO: N/A Repair Type: Non-Urgent EVAL Issue: Crossing Status: Not Found UCIP Comments: 02/24/2022 Need to verify if pipe was grouted in place or removed. Permit application proposed pipe removal but a Reclamation Board suggests that abandonment might be safely and more economically accomplished by filling with concrete rather than opening a cut some 200 feet long and 40 feet deep in the levee. Sutter Butte Flood Control Agency As-Built Drawing No. 04-04-0648, Sheet 59, May 2013, at approximately Station 1043+40 does not indicate there is a 36-inch pipe, 30 feet below the crown. (M. Thao - DWR UCIP) 04/09/2013 Need verification pipe was grouted in place. (P. Amatya) FIELD_STRUCT_DESC: 36-inch corrugated metal gravity drainage pipe through the levee, 30 feet below the crown. Slide gate in a corrugated metal pipe (CMP) riser on the waterside (WS) slope. (36-inch pipe removed under Permit 1066, 1945 - Levee District No. 1 of Sutter County). [Additional Reference(s): DWR Levee Log, 2005 (HLM 14.98). USACE Sacramento O&M Manual, Unit No. 144, August 1955, (Station 1468+79), listed as 36-inch pipe. USACE As-Built Drawing No. 04-04-0172-1, Station 1468+79, August 1938]. FS Date: 2/24/2022

Levee crown looking upstream.

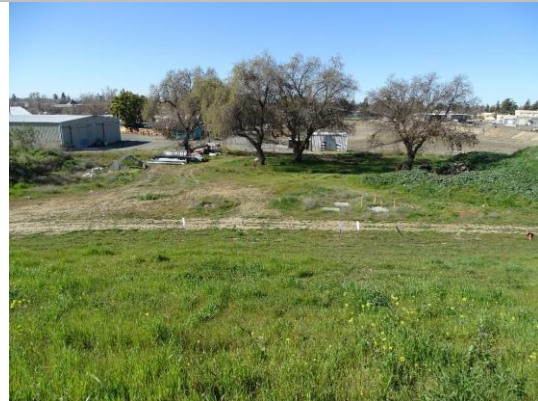
Photo 2 of 3 : UCIP\_FA\_2024\_80013\_114550.jpg

LS view: Looking from levee; general overview.

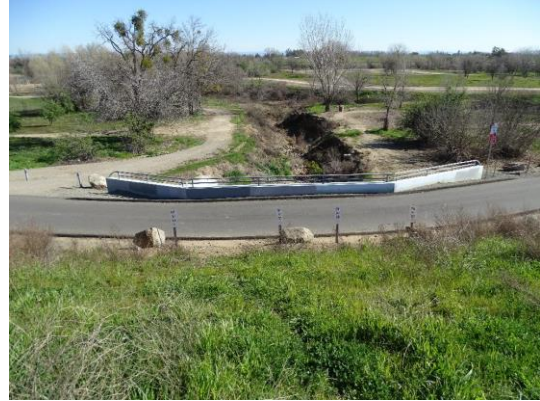
Photo 3 of 3 : UCIP\_FA\_2024\_80013\_114551.jpg

WS view: Looking from levee; general overview.

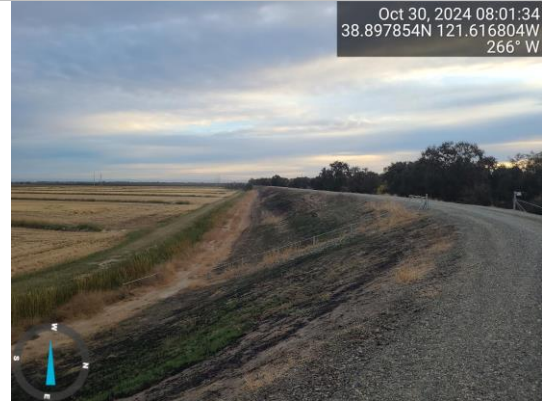
Photo 1 of 1 : FA\_2024\_LD0001S\_195\_1\_20241031\_00001.jpg

LM Start	0.09	Rating **	A	Issue No.	1	
LM End	5.10	Issue Type +	Ma	Location *	LS	
Category	Earthen Levee			GPS Latitude/Longitude		
				Start	End	
Item	Vegetation			38.897900°	38.950796°	
				-121.616417°	-121.585792°	
DWR ID	DWR_LD0001S_02_f_2024_1					
Comment Code						
V1 : Control annual grass and weeds on the levee slopes and easements.						
Inspector Comment						
Vegetation is well maintained, Fall 2024.

View of maintained vegetation on the landside slope, Fall 2024.

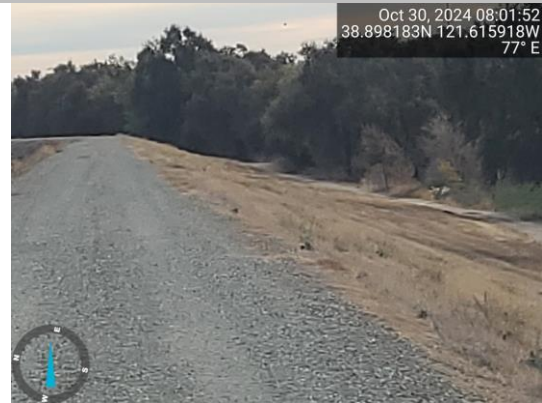
Photo 1 of 1 : FA\_2024\_LD0001S\_195\_2\_20241031\_00002.jpg

LM Start	0.09	Rating **	A	Issue No.	2
LM End	5.10	Issue Type +	Ma	Location *	WS
Category	Earthen Levee			GPS Latitude/Longitude	
				Start	End
Item	Vegetation			38.897900°	38.950796°
				-121.616417°	-121.585792°
DWR ID	DWR_LD0001S_02_f _ 2024_2				
Comment Code					
V1 : Control annual grass and weeds on the levee slopes and easements.					
Inspector Comment					
Vegetation is well maintained, Fall 2024.

View of maintained vegetation on the waterside slope, Fall 2024.

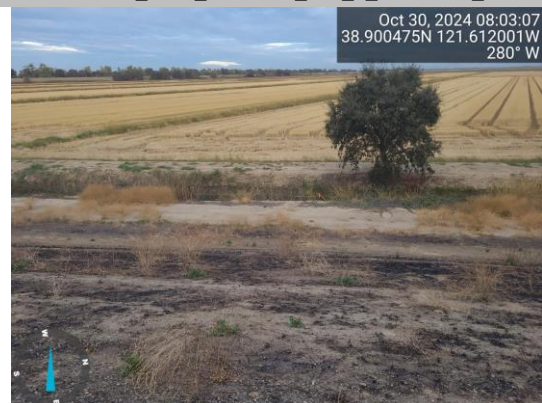
Photo 1 of 1 : FA\_2024\_LD0001S\_195\_3\_20241031\_00003.jpg

LM Start	0.11	Rating **	A/W	Issue No.	3
LM End	0.51	Issue Type +	Ma	Location *	LS
Category	Earthen Levee			GPS Latitude/Longitude	
				Start	End
Item	Erosion / Bank Caving			38.898064°	38.901752°
				-121.616111°	-121.610406°
DWR ID	DWR_LD0001S_02_f_2024_3				
Comment Code					
E1 : Note and monitor erosion site.					
Inspector Comment					
Erosion on the landside toe road needs to be monitored and plans for repair need to be made, Fall 2024.

View of erosion on the landside toe road, Fall 2024.

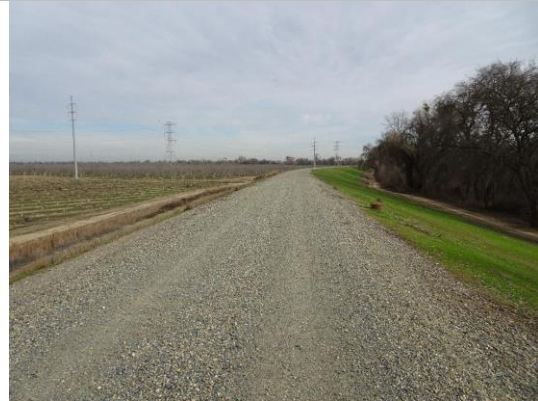
Photo 1 of 3 : UCIP\_FA\_2024\_85226\_97990.jpg

DS\_ID:17092  
FS\_ID:85226  
EP\_NO: N/A  
Repair Type: Non-Urgent  
EVAL Issue: 6, Levee Damage or Threat for Levee Damage  
Crossing Status: Found  
UCIP Comments: 10/21/2024 Record updated from Urgent to Non-Urgent. Depression on LS behind headwall is located approximately 20 feet from levee toe and does not appear to be within levee prism. Unable to inspect flap gate on WS due to being under water. Unsure if pipe is actually abandoned; unable to locate a permit and confirm proper pipe abandonment. Recommend owner to contact CVFPB to abandon or remove pipe from levee if pipe is actually abandoned. (M. Thao - DWR UCIP)  
01/21/2021 Record remains Urgent. Potential levee integrity issues still remain at this location. This section of the levee under Feather River West Levee Project has not been completed yet. Will need to continue coordinating with DWR Sutter Yard Pipe Inspector, Andy Freitag, to obtain progress update. Need to request construction plans to review levee modifications at this location. The site inspection was completed with DWR Sutter Yard staff, Bob Duffey and Cory Hutton. (O. Magana - DWR UCIP)

Overview of levee crown looking upstream towards crossing.

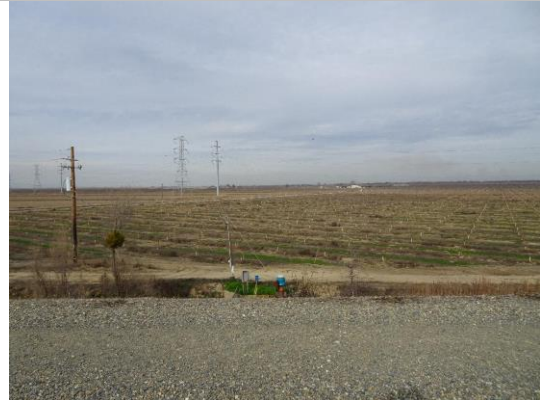
Photo 2 of 3 : UCIP\_FA\_2024\_85226\_97991.jpg

LS view: overview of LS

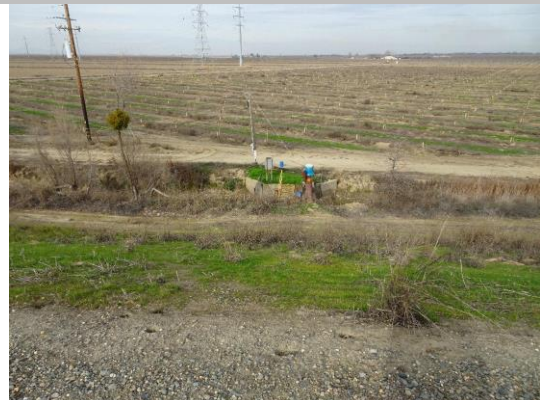
Photo 3 of 3 : UCIP\_FA\_2024\_85226\_97992.jpg

LS view: view of LS slope and pump located on the LS toe

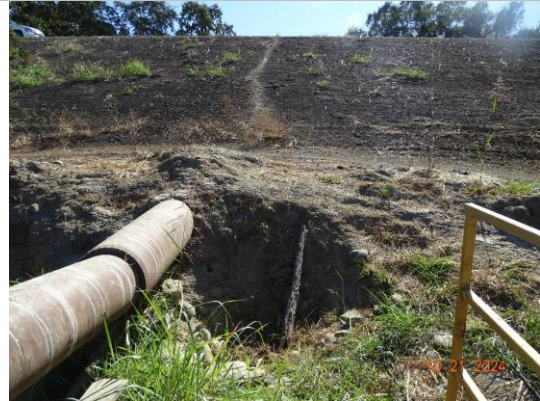
Photo 1 of 1 : UCIP\_FA\_2024\_85230\_126269.jpg

UCIP Comments: 10/21/2024 Record updated from Urgent to Non-Urgent. Depression on LS behind headwall is located approximately 20 feet from levee toe and does not appear to be within levee prism. Unable to inspect flap gate on WS due to being under water. Crossing appears abandoned; slide gate wheel on LS is missing. Unable to locate a permit and confirm proper pipe abandonment. Recommend owner to contact CVFPB to abandon or remove pipe from levee. (M. Thao - DWR UCIP)

05/01/2019 Same as last inspection, record remains Urgent due to the potential of levee integrity issues on the LS. Dense vegetation on both the WS and LS limits the inspection to determine if sink hole or erosion behind headwall on LS has progressed. No permit has been identified for this structure. Structure has been abandoned. (O. Magana - DWR UCIP)

04/2018 Sink hole observed between the dual 18-inch pipes located on the LS near the concrete headwall. Erosion was also observed behind the concrete headwall located on the LS. Inlet of dual 18-inch pipes was still covered by filled sandbags. Crossing remains Urgent due to the sink hole and erosion visible on the LS. These crossings were recommended for replacement under the SBFCA project; however, no work has been done to date. Recommend monitoring site and coordinating with SBFCA to determine the status of the project. (O. Magana - DWR UCIP)

LS view: Depression located behind the concrete headwall approximately 20 feet from toe; looking toward levee.
