**Flood Control Project Maintenance
Levee Inspections**

Maintenance Issue Types Only, Levee Inspection Report By Mile - Spring 2015

Levee District No. 0001 (Sutter County)

Waterway	Bank	Unit Miles	Inspection Start/End	Inspector
Unit No. 01 Feather River	Right	16.11	05/20/2015 05/20/2015	Michael Pitta

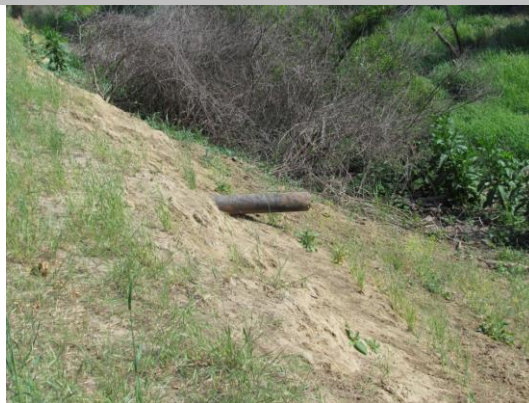
Photo 1 of 2 : SP_2015_LD0001S_433_487_20150521_00010.jpg

LM Start	1.85	Rating **	M	Issue No.	487
LM End	1.85	Issue Type +	Ma	Location *	LS
Category	Interior Drainage & Piping Systems			GPS Latitude/Longitude	
				Start	End
Item	Metal Pipes			38.976927 °	38.976927 °
				-121.591210 °	-121.591210 °
DWR ID	DWR_LD0001S_01_s_2012_487				
Action/Comments					
Inspector Comments: Abandoned pipe. This pipe is listed in our levee log as an abandoned pipe, no date listed. No permit number. Corp pipe.

View of the pipe on the waterside of the levee from the crown facing upstream.

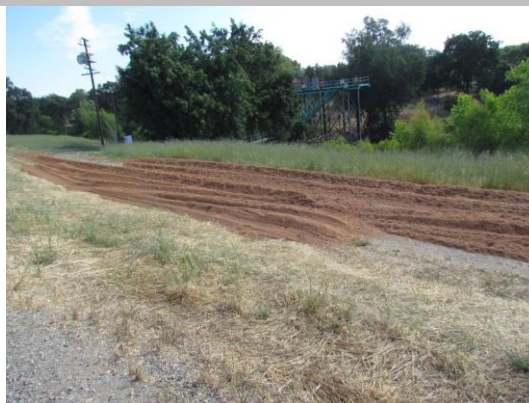
Photo 1 of 1 : SP_2015_LD0001S_433_16_20150521_00012.jpg

LM Start	2.44	Rating **	M	Issue No.	16
LM End	2.44	Issue Type +	Ma	Location *	WS
Category	Earthen Levee			GPS Latitude/Longitude	
				Start	End
Item	Encroachments			38.985446 °	38.985446 °
				-121.591930 °	-121.591930 °
DWR ID	DWR_LD0001S_01_s_2015_16				
Action/Comments					
Material					
Inspector Comments: Walnut holes left on waterside of the levee.

View of the material on the waterside of the levee facing upstream.
