**Flood Control Project Maintenance
Levee Inspections**

Maintenance Issue Types Only, Levee Inspection Report By Mile - Spring 2016

Levee District No. 0001 (Sutter County)

Waterway	Bank	Unit Miles	Inspection Start/End	Inspector
Unit No. 01 Feather River	Right	16.11	03/24/2016 03/24/2016	Sterling York

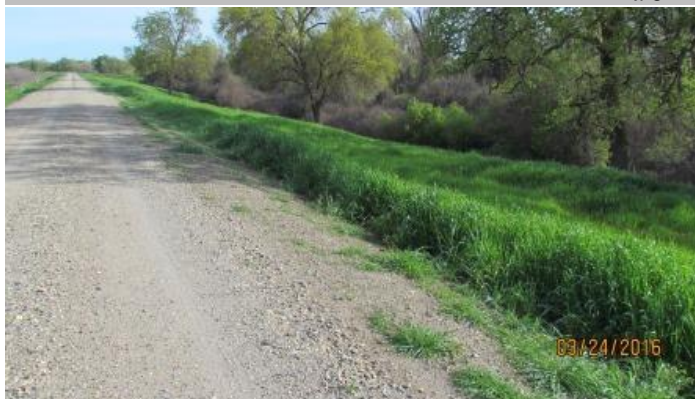
Photo 1 of 1 : SP_2016_LD0001S_433_36_20160328_00060.jpg

LM Start	2.17	Rating **	M	Issue No.	36
LM End	3.49	Issue Type +	Ma	Location *	WS
Category	Earthen Levee			GPS Latitude/Longitude	
				Start	End
Item	Vegetation			38.981559 °	38.999973 °
				-121.591996 °	-121.597019 °
DWR ID	DWR_LD0001S_01_s_2016_36				
Comment Code					
V2 : Remove the wild growth other than native grasses from the levee slopes.					
Inspector Comment

View of waterside vegetation looking upstream.

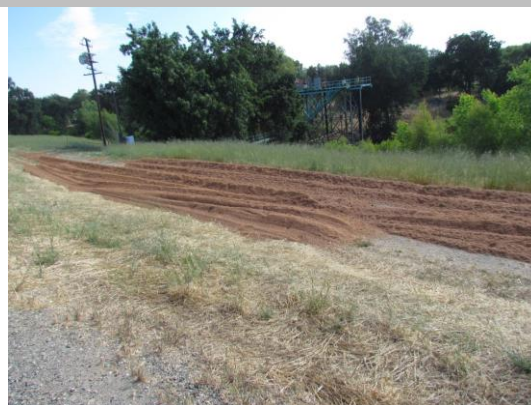
Photo 1 of 1 : SP_2016_LD0001S_433_16_20160307_00005.jpg

LM Start	2.44	Rating **	M	Issue No.	16
LM End	2.44	Issue Type +	Ma	Location *	WS
Category	Earthen Levee			GPS Latitude/Longitude	
				Start	End
Item	Encroachments			38.985446 °	38.985446 °
				-121.591930 °	-121.591930 °
DWR ID	DWR_LD0001S_01_s_2015_16				
Comment Code					
MA : Material					
Inspector Comment					
Walnut holes left on waterside of the levee.

View of the material on the waterside of the levee facing upstream.

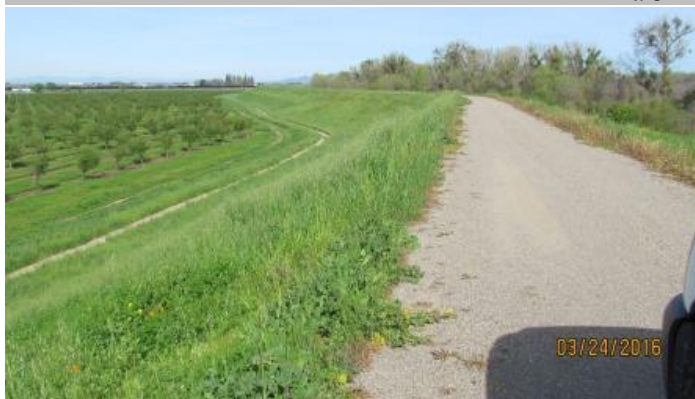
Photo 1 of 1 : SP_2016_LD0001S_433_37_20160328_00061.jpg

LM Start	4.42	Rating **	M	Issue No.	37
LM End	6.10	Issue Type +	Ma	Location *	LS
Category	Earthen Levee			GPS Latitude/Longitude	
				Start	End
Item	Vegetation			39.011638 °	39.033070 °
				-121.603729 °	-121.610990 °
DWR ID	DWR_LD0001S_01_s_2016_37				
Comment Code					
V1 : Control annual grass and weeds on the levee slopes and easements.					
Inspector Comment

View of landside vegetation looking upstream.

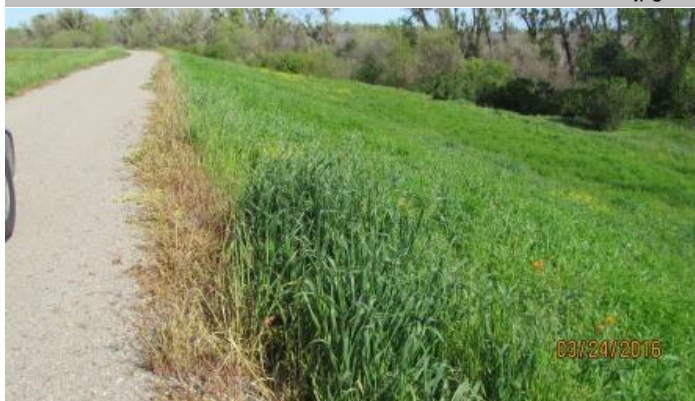
Photo 1 of 1 : SP_2016_LD0001S_433_38_20160328_00062.jpg

LM Start	4.42	Rating **	M	Issue No.	38
LM End	6.10	Issue Type +	Ma	Location *	WS
Category	Earthen Levee			GPS Latitude/Longitude	
				Start	End
Item	Vegetation			39.011639 °	39.033070 °
				-121.603729 °	-121.610990 °
DWR ID	DWR_LD0001S_01_s_2016_38				
Comment Code					
V1 : Control annual grass and weeds on the levee slopes and easements.					
Inspector Comment

View of waterside vegetation looking upstream.

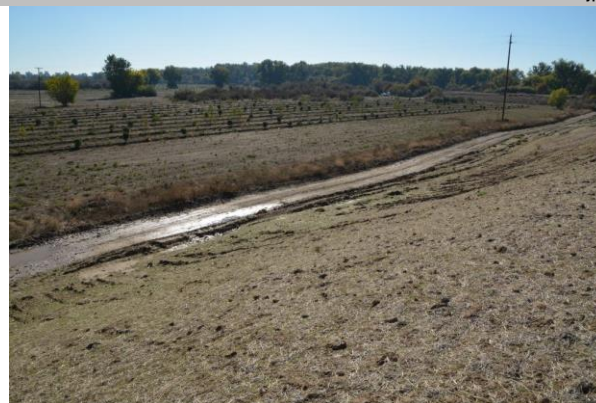
Photo 1 of 1 : SP_2016_LD0001S_433_21_20160307_00010.jpg

LM Start	6.00	Rating **	M	Issue No.	21
LM End	6.00	Issue Type +	Ma	Location *	WS
Category	Earthen Levee			GPS Latitude/Longitude	
				Start	End
Item	Slope Stability			39.031780 °	39.031780 °
				-121.611811 °	-121.611811 °
DWR ID	DWR_LD0001S_01_s_2015_21				
Comment Code					
S3 : Repair the levee slope damaged by vehicle traffic and prevent access where possible.					
Inspector Comment					
Track-walking on slope and tire ruts at waterside toe.

Slope instability was found on the waterside slope of the levee during fall 2015 inspection.

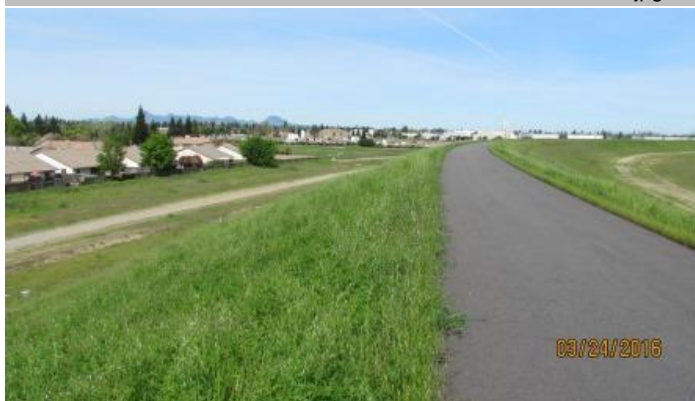
Photo 1 of 1 : SP_2016_LD0001S_433_41_20160328_00063.jpg

LM Start	11.18	Rating **	M	Issue No.	41
LM End	12.30	Issue Type +	Ma	Location *	LS
Category	Earthen Levee			GPS Latitude/Longitude	
				Start	End
Item	Vegetation			39.103298 °	39.118812 °
				-121.606473 °	-121.603287 °
DWR ID	DWR_LD0001S_01_s_2016_41				
Comment Code					
V1 : Control annual grass and weeds on the levee slopes and easements.					
Inspector Comment

View of vegetation on landside looking upstream. Spring 2016.

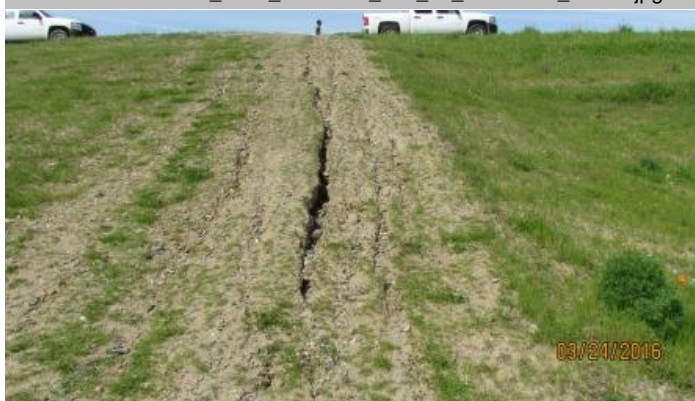
Photo 1 of 1 : SP_2016_LD0001S_433_42_20160328_00064.jpg

LM Start	11.63	Rating **	U	Issue No.	42
LM End	11.63	Issue Type +	Ma	Location *	WS
Category	Earthen Levee			GPS Latitude/Longitude	
				Start	End
Item	Slope Stability			39.109692 °	39.109692 °
				-121.607142 °	-121.607142 °
DWR ID	DWR_LD0001S_01_s_2016_42				
Comment Code					
S1 : Repair slope instability.					
Inspector Comment					
Erosion on the waterside slope caused by rain.

Slope erosion due to rain on the waterside.

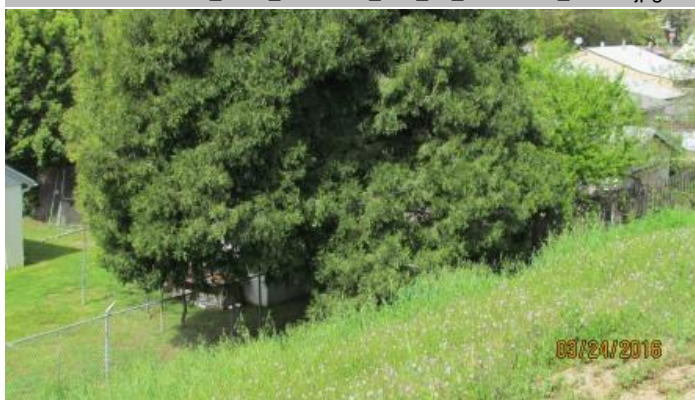
Photo 1 of 1 : SP_2016_LD0001S_433_27_20160328_00068.jpg

LM Start	13.25	Rating **	M	Issue No.	27
LM End	13.25	Issue Type +	Ma	Location *	LS
Category	Earthen Levee			GPS Latitude/Longitude	
				Start	End
Item	Trim / Thin Trees			39.131827 °	39.131827 °
				-121.603233 °	-121.603233 °
DWR ID	DWR_LD0001S_01_f _ 2015_27				
Comment Code					
T3 : Trim and thin trees to allow visibility of the ground and room to flood fight.					
Inspector Comment					
Tree foliage hiding levee face/toe.

Tree at landside levee toe obstructing visibility. Spring 2016.

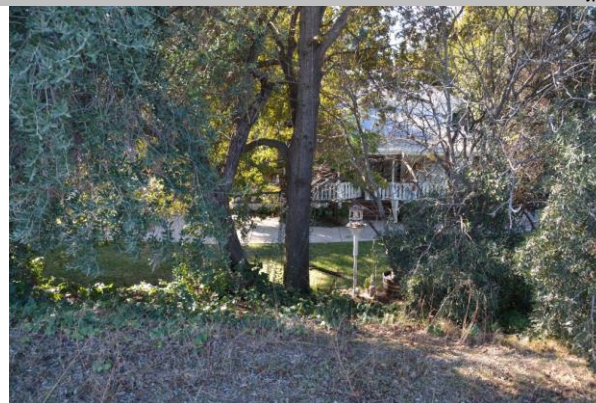
Photo 1 of 2 : SP_2016_LD0001S_433_18_20160307_00006.jpg

LM Start	13.34	Rating **	U	Issue No.	18
LM End	13.34	Issue Type +	Ma	Location *	LS
Category	Earthen Levee			GPS Latitude/Longitude	
				Start	End
Item	Vegetation			39.133050 °	39.133050 °
				-121.603813 °	-121.603813 °
DWR ID	DWR_LD0001S_01_f_2015_18				
Comment Code					
V7 : Trees / Woody Vegetation					
Inspector Comment					
Overgrown olive trees (6), buckeye (1) and oak trees (2) on slope of levee, branches touching and obscuring levee. Ivy obscuring slope.

Trees and vegetation blocking visibility on the landside slope of the levee. Spring 2016.

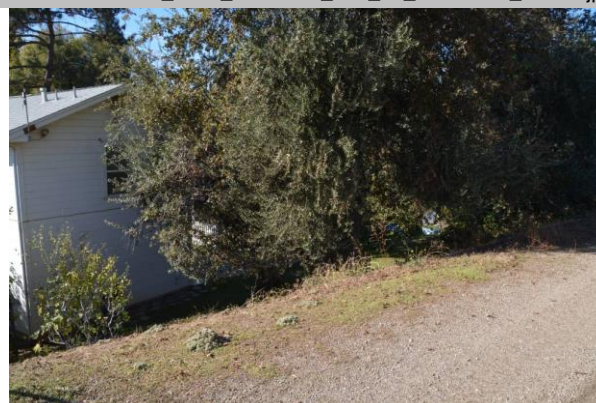
Photo 2 of 2 : SP_2016_LD0001S_433_18_20160307_00007.jpg

LM Start	13.34	Rating **	U	Issue No.	18 (cont)
LM End	13.34	Issue Type +	Ma	Location *	LS

Trees and vegetation blocking visibility. Spring 2016.

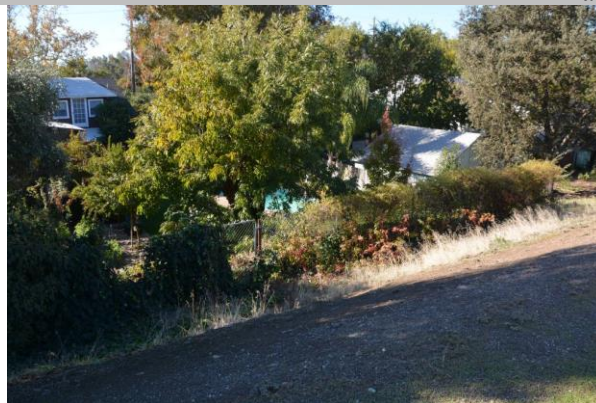
Photo 1 of 2 : SP_2016_LD0001S_433_24_20160307_00013.jpg

LM Start	13.42	Rating **	U	Issue No.	24
LM End	13.42	Issue Type +	Ma	Location *	LS
Category	Earthen Levee			GPS Latitude/Longitude	
				Start	End
Item	Vegetation			39.134119 °	39.134119 °
				-121.604213 °	-121.604213 °
DWR ID	DWR_LD0001S_01_f_2015_24				
Comment Code					
V7 : Trees / Woody Vegetation					
Inspector Comment					
Vegetation on the chainlink fence obscuring visibility. Oleander on the levee.

Trees and vegetation blocking visibility on the landside toe of the levee. Spring 2016.

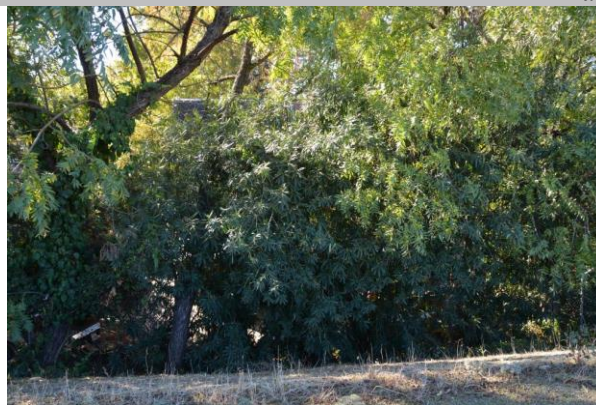
Photo 2 of 2 : SP_2016_LD0001S_433_24_20160307_00014.jpg

LM Start	13.42	Rating **	U	Issue No.	24 (cont)
LM End	13.42	Issue Type +	Ma	Location *	LS

Trees and vegetation blocking visibility. Spring 2016.

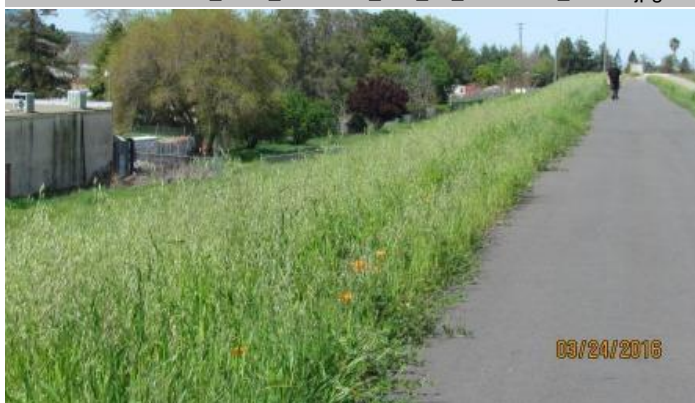
Photo 1 of 1 : SP_2016_LD0001S_433_43_20160328_00069.jpg

LM Start	15.21	Rating **	M	Issue No.	43
LM End	16.11	Issue Type +	Ma	Location *	LS
Category	Earthen Levee			GPS Latitude/Longitude	
				Start	End
Item	Vegetation			39.156922 °	39.168830 °
				-121.617960 °	-121.622630 °
DWR ID	DWR_LD0001S_01_s_2016_43				
Comment Code					
V1 : Control annual grass and weeds on the levee slopes and easements.					
Inspector Comment

View of landside vegetation looking upstream.

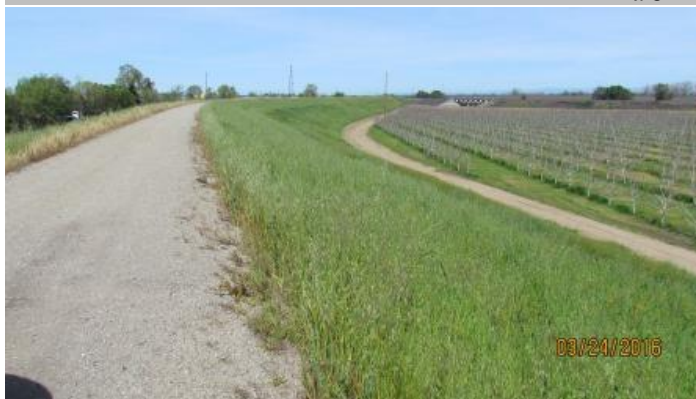
Photo 1 of 1 : SP_2016_LD0001S_433_44_20160328_00070.jpg

LM Start	15.53	Rating **	M	Issue No.	44
LM End	16.11	Issue Type +	Ma	Location *	WS
Category	Earthen Levee			GPS Latitude/Longitude	
				Start	End
Item	Vegetation			39.160594 °	°
				-121.621573 °	°
DWR ID	DWR_LD0001S_01_s_2016_44				
Comment Code					
V1 : Control annual grass and weeds on the levee slopes and easements.					
Inspector Comment

View of waterside vegetation looking upstream.
