**Flood Control Project Maintenance
Levee Inspections**

Maintenance Issue Types Only, Levee Inspection Report By Mile - Spring 2017

Levee District No. 0001 (Sutter County)

Waterway	Bank	Unit Miles	Inspection Start/End	Inspector
Unit No. 01 Feather River	Right	16.11	04/04/2017 04/04/2017	Sterling York

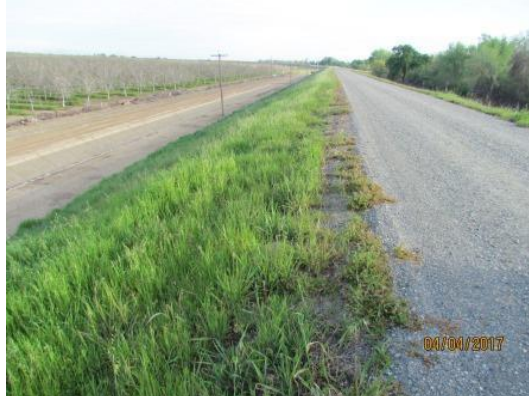
Photo 1 of 1 : SP_2017_LD0001S_433_30_20170404_00061.jpg

LM Start	0.01	Rating **	M	Issue No.	30
LM End	16.09	Issue Type +	Ma	Location *	LS
Category	Earthen Levee			GPS Latitude/Longitude	
				Start	End
Item	Vegetation			38.951109 °	39.168577 °
				-121.585711 °	-121.622691 °
DWR ID	DWR_LD0001S_01_f _ 2016_30				
Comment Code					
V1 : Control annual grass and weeds on the levee slopes and easements.					
Inspector Comment					
Annual grasses need to be maintained. Spring 2017.

View of annual grasses that need to be maintained. Spring 2017.

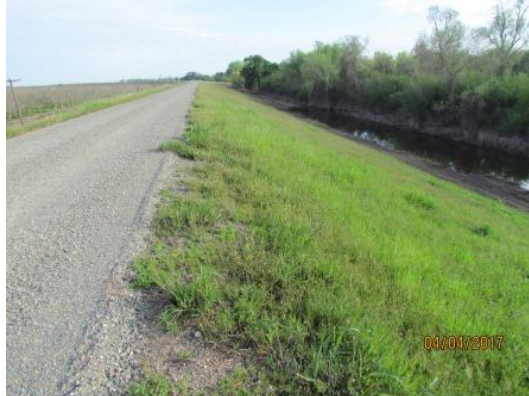
Photo 1 of 1 : SP_2017_LD0001S_433_31_20170404_00060.jpg

LM Start	0.01	Rating **	M	Issue No.	31
LM End	16.09	Issue Type +	Ma	Location *	WS
Category	Earthen Levee			GPS Latitude/Longitude	
				Start	End
Item	Vegetation			38.951109 °	39.168577 °
				-121.585711 °	-121.622691 °
DWR ID	DWR_LD0001S_01_f _ 2016_31				
Comment Code					
V1 : Control annual grass and weeds on the levee slopes and easements.					
Inspector Comment					
Annual grasses need to be maintained. Spring 2017.

View of annual grasses that need to be maintained. Fall 2016.

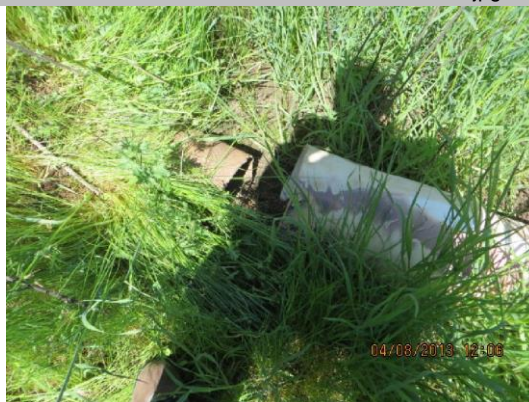
Photo 1 of 3 : UCIP_SP_2017_11383_18782.jpg

LM Start	2.21	Rating **	M	Issue No.	492
LM End	2.21	Issue Type +	Ma	Location *	WS
Category	Supplemental			GPS Latitude/Longitude	
				Start	End
Item	DWR UCIP LMA Responsibility			38.982135 °	38.982135 °
				-121.591974 °	-121.591974 °
DWR ID					
Comment Code					
Inspector Comment					
FS_ID:11383 DS_ID:17915 EP_NO: N/A Repair Type: Non-Urgent Crossing Status: Found UCIP Comments: Siphon breaker cap missing. Sump pump and gate valve at landward toe not found may be due to dense vegetation. FIELD_STRUCT_DESC: A 8-inch steel drainage pipe through levee, 4.6-feet below the crown. Siphon breaker in corrugated metal riser on landward slope.O&M Manual Sac 144, August 1955, Revision Year 2011. FS Date: 4/12/2013

WS- 8-inch steel pipe and disconnected pvc pipe on levee slope

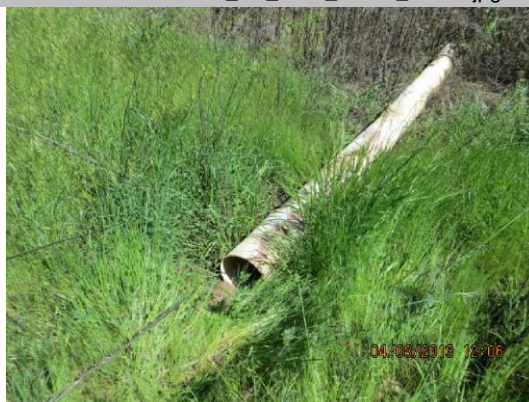
Photo 2 of 3 : UCIP_SP_2017_11383_18781.jpg

WS-a disconnected pvc pipe on levee slope

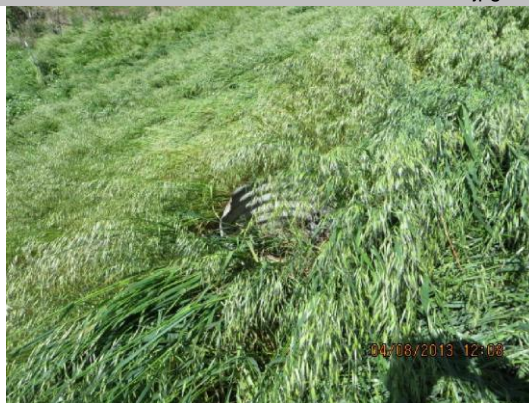
Photo 3 of 3 : UCIP_SP_2017_11383_18780.jpg

LM Start	2.21	Rating **	M	Issue No.	492 (cont)
LM End	2.21	Issue Type +	Ma	Location *	WS
Category	Supplemental			GPS Latitude/Longitude	
				Start	End
Item	DWR UCIP LMA Responsibility			38.982135 °	38.982135 °
				-121.591974 °	-121.591974 °
DWR ID					
Comment Code					
Inspector Comment					
FS_ID:11383 DS_ID:17915 EP_NO: N/A Repair Type: Non-Urgent Crossing Status: Found UCIP Comments: Siphon breaker cap missing. Sump pump and gate valve at landward toe not found may be due to dense vegetation. FIELD_STRUCT_DESC: A 8-inch steel drainage pipe through levee, 4.6-feet below the crown. Siphon breaker in corrugated metal riser on landward slope.O&M Manual Sac 144, August 1955, Revision Year 2011. FS Date: 4/12/2013

LS- CMP riser on levee slope with dense vegetation.

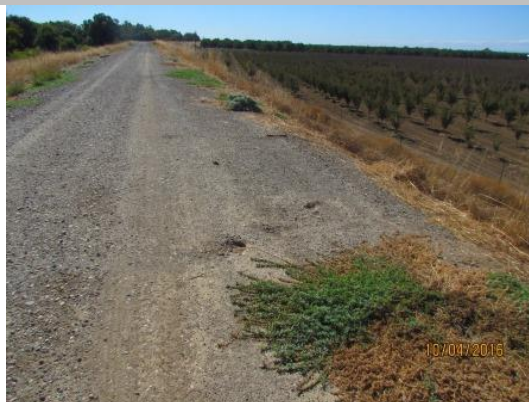
Photo 1 of 2 : SP_2017_LD0001S_433_17_20170316_00005.jpg

LM Start	2.72	Rating **	A/W	Issue No.	17
LM End	2.72	Issue Type +	Ma	Location *	CR
Category	Earthen Levee			GPS Latitude/Longitude	
				Start	End
Item	Animal Control			38.989470 °	38.989470 °
				-121.592502 °	-121.592502 °
DWR ID	DWR_LD0001S_01_s_ 2015_17				
Comment Code					
A3 : No rodents visible, but rodent burrows visible; need to backfill and compact or grout burrows.					
Inspector Comment					
Animal activity is determined to be goffer not ground squirrel, continue to monitor. Spring 2017.

View of rodent holes on the landside crown and slope. Fall 2016.

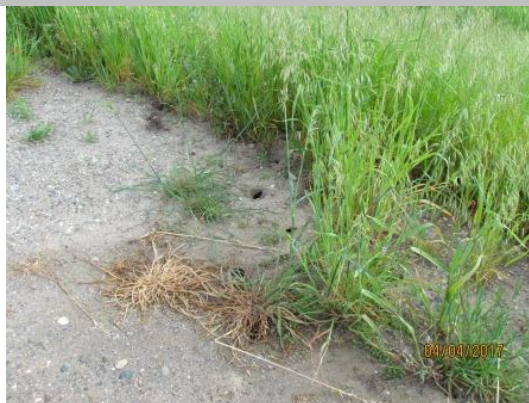
Photo 2 of 2 : SP_2017_LD0001S_433_17_20170404_00066.jpg

LM Start	2.72	Rating **	A/W	Issue No.	17 (cont)	
LM End	2.72	Issue Type +	Ma	Location *	CR	
Category	Earthen Levee			GPS Latitude/Longitude		
				Start		End
Item	Animal Control			38.989470 °		38.989470 °
				-121.592502 °		-121.592502 °
DWR ID	DWR_LD0001S_01_s_2015_17					
Comment Code						
A3 : No rodents visible, but rodent burrows visible; need to backfill and compact or grout burrows.						
Inspector Comment						
Animal activity is determined to be goffer not ground squirrel, continue to monitor. Spring 2017.

Animal activity is determined to be gopher not ground squirrel, continue to monitor. Spring 2017.

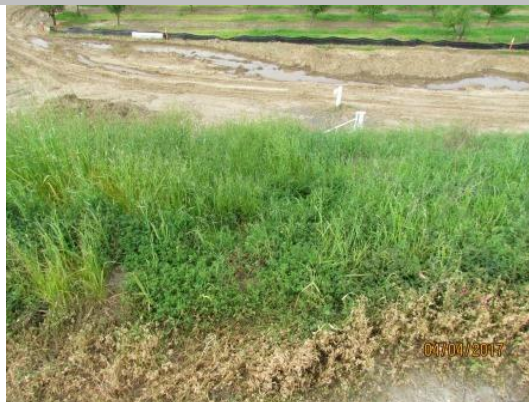
Photo 1 of 2 : SP_2017_LD0001S_433_21_20170404_00065.jpg

LM Start	4.41	Rating **	A/W	Issue No.	21
LM End	4.41	Issue Type +	Ma	Location *	LS
Category	Earthen Levee			GPS Latitude/Longitude	
				Start	End
Item	Slope Stability			39.011493 °	39.011493 °
				-121.603623 °	-121.603623 °
DWR ID	DWR_LD0001S_01_f_2016_21				
Comment Code					
S3 : Repair the levee slope damaged by vehicle traffic and prevent access where possible.					
Inspector Comment					
No erosion or separation on slope, continue to monitor, Spring 2017.

No erosion or separation on the landside slope, continue to monitor, Spring 2017.

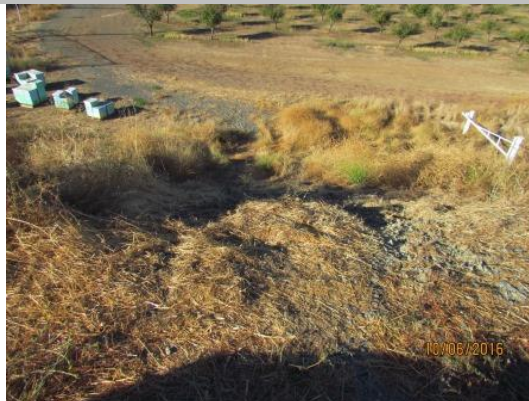
Photo 2 of 2 : SP_2017_LD0001S_433_21_20170316_00008.jpg

LM Start	4.41	Rating **	A/W	Issue No.	21 (cont)	
LM End	4.41	Issue Type +	Ma	Location *	LS	
Category	Earthen Levee			GPS Latitude/Longitude		
				Start		End
Item	Slope Stability			39.011493 °		39.011493 °
				-121.603623 °		-121.603623 °
DWR ID	DWR_LD0001S_01_f _ 2016_21					
Comment Code						
S3 : Repair the levee slope damaged by vehicle traffic and prevent access where possible.						
Inspector Comment						
No erosion or separation on slope, continue to monitor, Spring 2017.

View of landside slope where vehicles have been driving up and down to go around gate. Fall 2016.

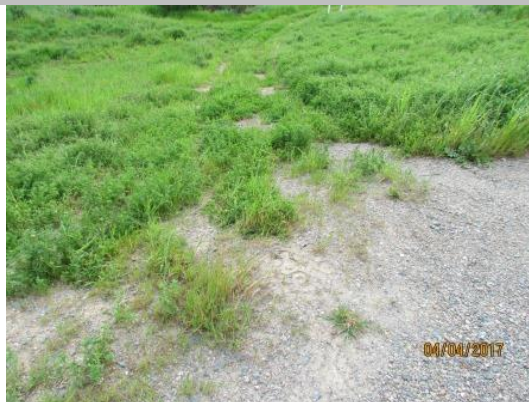
Photo 1 of 2 : SP_2017_LD0001S_433_36_20170404_00067.jpg

LM Start	4.41	Rating **	A/W	Issue No.	36
LM End	4.41	Issue Type +	Ma	Location *	WS
Category	Earthen Levee			GPS Latitude/Longitude	
				Start	End
Item	Slope Stability			39.011493 °	39.011493 °
				-121.603624 °	-121.603624 °
DWR ID	DWR_LD0001S_01_f_2016_36				
Comment Code					
S3 : Repair the levee slope damaged by vehicle traffic and prevent access where possible.					
Inspector Comment					
No erosion or separation on slope, continue to monitor, Spring 2017.

View of waterside slope where vehicles in the past have used to access the crown. No erosion or separation on slope, continue to monitor, Spring 2017.

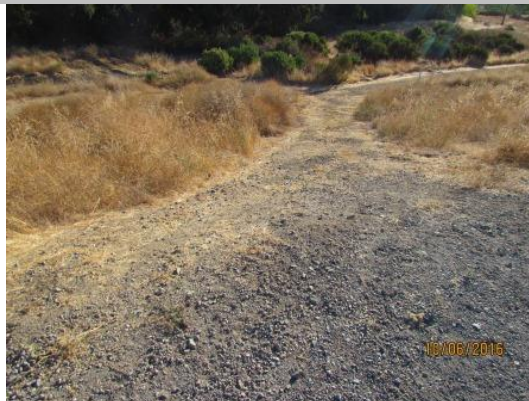
Photo 2 of 2 : SP_2017_LD0001S_433_36_20170316_00018.jpg

LM Start	4.41	Rating **	A/W	Issue No.	36 (cont)	
LM End	4.41	Issue Type +	Ma	Location *	WS	
Category	Earthen Levee			GPS Latitude/Longitude		
				Start		End
Item	Slope Stability			39.011493 °		39.011493 °
				-121.603624 °		-121.603624 °
DWR ID	DWR_LD0001S_01_f _ 2016_36					
Comment Code						
S3 : Repair the levee slope damaged by vehicle traffic and prevent access where possible.						
Inspector Comment						
No erosion or separation on slope, continue to monitor, Spring 2017.

View of waterside slope where vehicles have been driving up and down to go around gate. Fall 2016.

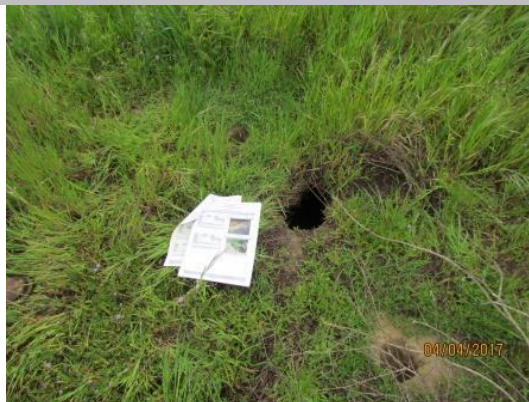
Photo 1 of 3 : SP_2017_LD0001S_433_20_20170404_00068.jpg

LM Start	6.81	Rating **	M	Issue No.	20
LM End	6.81	Issue Type +	Ma	Location *	LS
Category	Earthen Levee			GPS Latitude/Longitude	
				Start	End
Item	Animal Control			39.043262 °	39.043262 °
				-121.611527 °	-121.611527 °
DWR ID	DWR_LD0001S_01_s_2017_20				
Comment Code					
A2 : Repair the levee slope damaged by livestock and prevent large animal access.					
Inspector Comment					
Large animal burrows on slope need to be repaired, Spring 2017.

View of highest point on waterside slope of large animal burrow that needs to be repaired, Spring 2017.

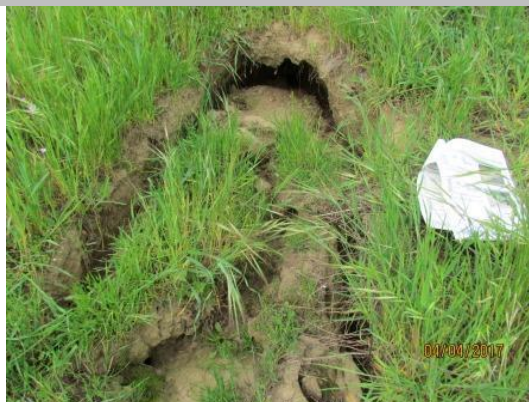
Photo 3 of 3 : SP_2017_LD0001S_433_20_20170404_00071.jpg

View looking up from bottom of waterside slope at the same large animal burrow that needs to be repaired, Spring 2017.

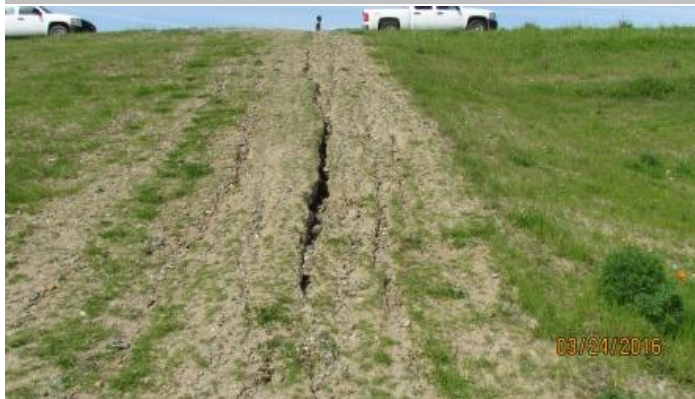
Photo 1 of 2 : SP_2017_LD0001S_433_42_20170316_00023.jpg

LM Start	11.63	Rating **	M	Issue No.	42
LM End	11.63	Issue Type +	Ma	Location *	WS
Category	Earthen Levee			GPS Latitude/Longitude	
				Start	End
Item	Slope Stability			39.109692 °	39.109692 °
				-121.607142 °	-121.607142 °
DWR ID	DWR_LD0001S_01_s_2016_42				
Comment Code					
S1 : Repair slope instability.					
Inspector Comment					
Erosion on the waterside slope caused by rain and foot traffic needs to be monitored. Fall 2016.

Slope erosion due to rain on the waterside. Spring 2016.

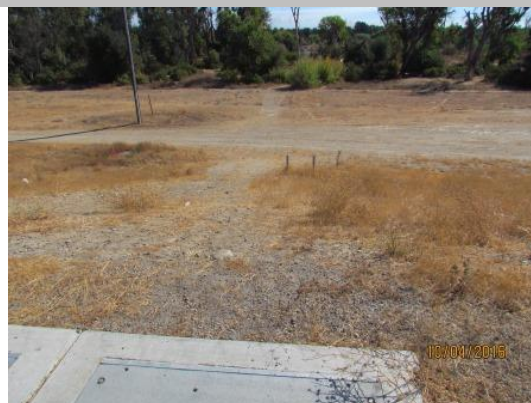
Photo 2 of 2 : SP_2017_LD0001S_433_42_20170316_00024.jpg

View of where slope erosion due has occurred due to rain and foot traffic on the waterside. Fall 2016.

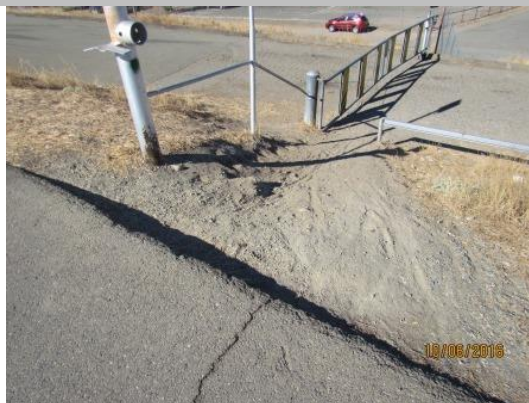
Photo 1 of 1 : SP_2017_LD0001S_433_40_20170316_00021.jpg

LM Start	12.28	Rating **	M	Issue No.	40
LM End	12.28	Issue Type +	Ma	Location *	LS
Category	Earthen Levee			GPS Latitude/Longitude	
				Start	End
Item	Slope Stability			39.118530 °	39.118530 °
				-121.603455 °	-121.603455 °
DWR ID	DWR_LD0001S_01_f _2016_40				
Comment Code					
S2 : Repair the levee slope damaged by foot traffic and prevent access where possible.					
Inspector Comment

View of landside slope at access gate that has been cut into by foot traffic. Fall 2016.

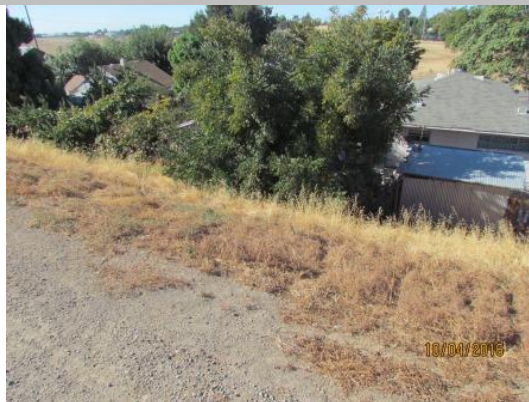
Photo 1 of 1 : SP_2017_LD0001S_433_27_20170316_00012.jpg

LM Start	13.25	Rating **	M	Issue No.	27
LM End	13.25	Issue Type +	Ma	Location *	LS
Category	Earthen Levee			GPS Latitude/Longitude	
				Start	End
Item	Trim / Thin Trees			39.131827 °	39.131827 °
				-121.603233 °	-121.603233 °
DWR ID	DWR_LD0001S_01_f_2015_27				
Comment Code					
T3 : Trim and thin trees to allow visibility of the ground and room to flood fight.					
Inspector Comment					
Tree foliage hiding levee face/toe. Fall 2016.

Tree at landside levee toe obstructing visibility. Fall 2016.

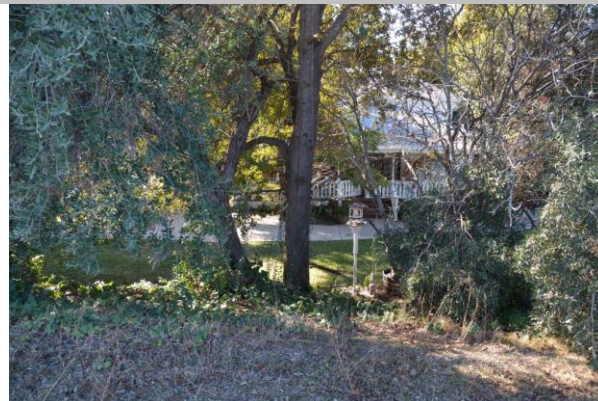
Photo 1 of 2 : SP_2017_LD0001S_433_18_20170316_00006.jpg

LM Start	13.34	Rating **	U	Issue No.	18
LM End	13.34	Issue Type +	Ma	Location *	LS
Category	Earthen Levee			GPS Latitude/Longitude	
				Start	End
Item	Vegetation			39.133050 °	39.133050 °
				-121.603813 °	-121.603813 °
DWR ID	DWR_LD0001S_01_f_ 2015_18				
Comment Code					
V7 : Trees / Woody Vegetation					
Inspector Comment					
Overgrown olive trees (6), buckeye (1) and oak trees (2) on slope of levee, branches touching and obscuring levee. Ivy obscuring slope.

Trees and vegetation blocking visibility on the landside slope of the levee. Spring 2016.

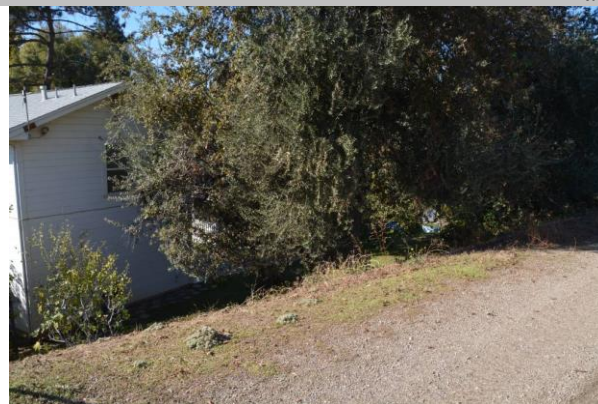
Photo 2 of 2 : SP_2017_LD0001S_433_18_20170316_00007.jpg

Trees and vegetation blocking visibility. Spring 2016.
