**Flood Control Project Maintenance  
Levee Inspections**

## Maintenance Issue Types Only, Levee Inspection Report By Mile - Spring 2018

### Levee District No. 0001 (Sutter County)

Waterway	Bank	Unit Miles	Inspection Start/End	Inspector
Unit No. 01 Feather River	Right	16.11	03/13/2018 03/13/2018	Sterling York

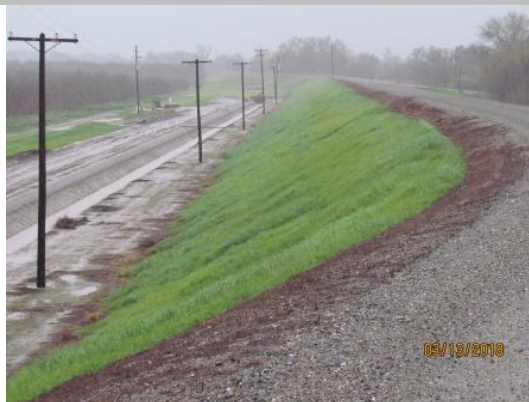
Photo 1 of 3 : SP\_2018\_LD0001S\_433\_16\_20180319\_00055.jpg

LM Start	0.02	Rating **	A	Issue No.	16
LM End	16.10	Issue Type +	Ma	Location *	LS
Category	Earthen Levee			GPS Latitude/Longitude	
				Start	End
Item	Vegetation			38.951182 °	39.168748 °
				-121.585689 °	-121.622711 °
DWR ID	DWR_LD0001S_01_s_2018_16				
Comment Code					
V1 : Control annual grass and weeds on the levee slopes and easements.					
Inspector Comment					
Annual Vegetation is well maintained the entire length of the levee, Spring 2018.

View looking upstream landside of the well maintained annual vegetation at Levee Mile 0.02, Spring 2018.

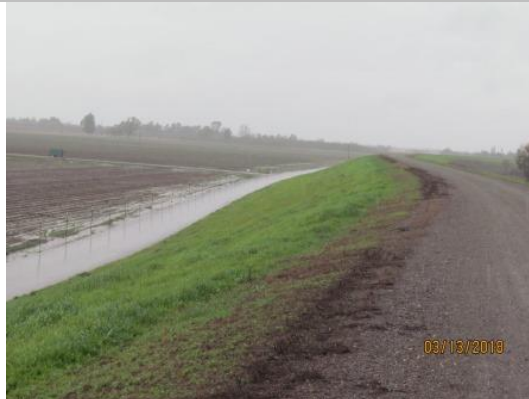
Photo 2 of 3 : SP\_2018\_LD0001S\_433\_16\_20180319\_00056.jpg

View looking upstream landside of the well maintained annual vegetation at Levee Mile 6.16, Spring 2018.

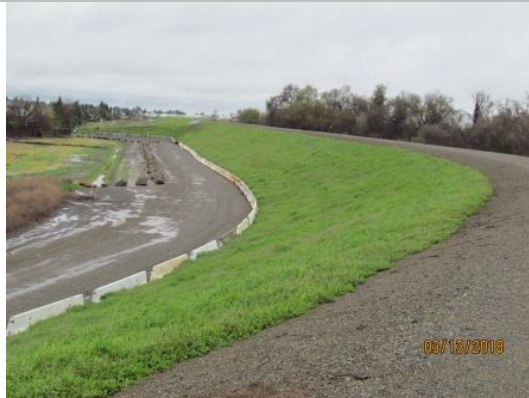
Photo 3 of 3 : SP\_2018\_LD0001S\_433\_16\_20180319\_00057.jpg

View looking upstream landside of the well maintained annual vegetation at Levee Mile 10.48, Spring 2018.

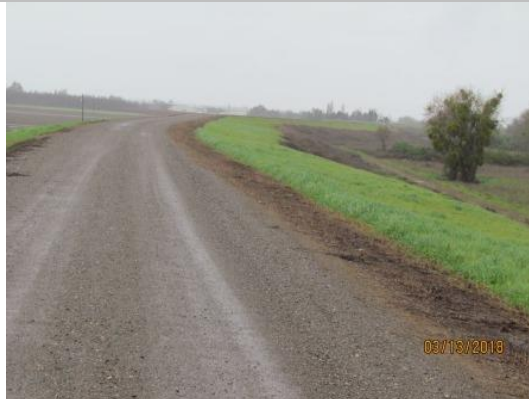
Photo 1 of 3 : SP\_2018\_LD0001S\_433\_17\_20180319\_00059.jpg

LM Start	0.02	Rating **	A	Issue No.	17
LM End	16.10	Issue Type +	Ma	Location *	WS
Category	Earthen Levee			GPS Latitude/Longitude	
				Start	End
Item	Vegetation			38.951182 °	39.168748 °
				-121.585689 °	-121.622711 °
DWR ID	DWR_LD0001S_01_s_2018_17				
Comment Code					
V1 : Control annual grass and weeds on the levee slopes and easements.					
Inspector Comment					
Annual Vegetation is well maintained the entire length of the levee, Spring 2018.

View looking upstream waterside of the well maintained annual vegetation at Levee Mile 0.02, Spring 2018.

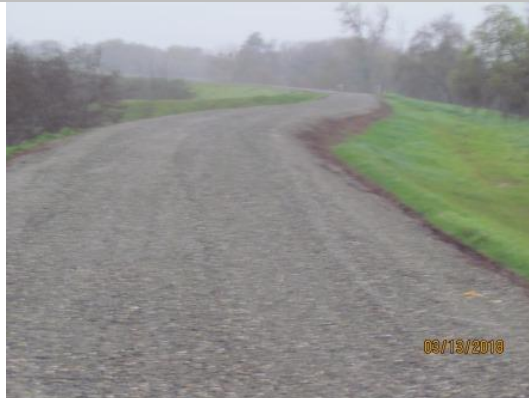
Photo 2 of 3 : SP\_2018\_LD0001S\_433\_17\_20180319\_00058.jpg

View looking upstream waterside of the well maintained annual vegetation at Levee Mile 6.24, Spring 2018.

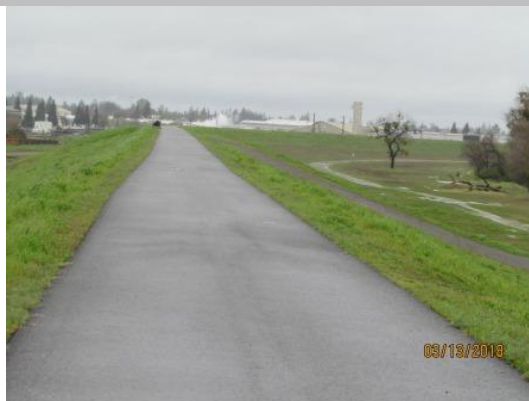
Photo 3 of 3 : SP\_2018\_LD0001S\_433\_17\_20180319\_00060.jpg

View looking upstream waterside of the well maintained annual vegetation at Levee Mile 10.92, Spring 2018.

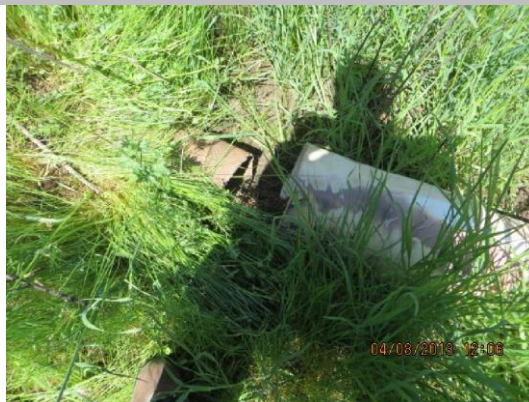
Photo 1 of 3 : UCIP\_SP\_2018\_11383\_18782.jpg

LM Start	2.21	Rating **	M	Issue No.	39
LM End	2.21	Issue Type +	Ma	Location *	
Category	Supplemental			GPS Latitude/Longitude	
				Start	End
Item	DWR UCIP LMA Responsibility			38.982135 °	38.982135 °
				-121.591974 °	-121.591974 °
DWR ID					
Comment Code					
Inspector Comment					
FS_ID:11383					
DS_ID:17915					
EP_NO: N/A					
Repair Type: Non-Urgent					
Crossing Status: Found					
UCIP Comments: Siphon breaker cap missing. Sump pump and gate valve at landward toe not found may be due to dense vegetation.					
FIELD_STRUCT_DESC: 8-inch coated steel pipe of an unknown purpose through the levee, 4.6 feet below the crown. Siphon breaker in a corrugated metal pipe (CMP) riser on the landside (LS) slope.					
[Additional Reference(s): DWR Levee Log, 2005. USACE Sacramento O&M Manual 144, August 1955, (Station 638+07)].					
FS Date: 4/12/2013

WS- 8-inch steel pipe and disconnected pvc pipe on levee slope

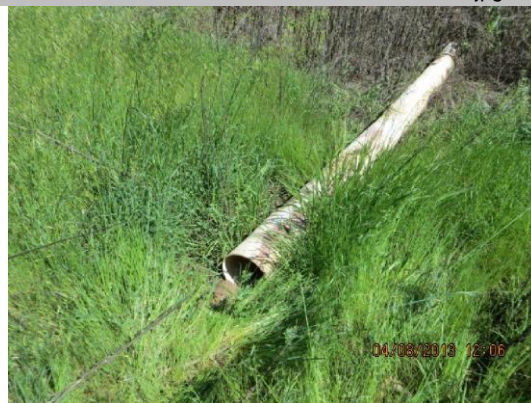
Photo 2 of 3 : UCIP\_SP\_2018\_11383\_18781.jpg

WS-a disconnected pvc pipe on levee slope

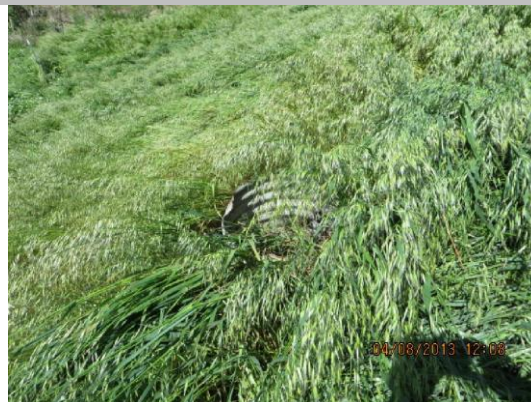
Photo 3 of 3 : UCIP\_SP\_2018\_11383\_18780.jpg

LS- CMP riser on levee slope with dense vegetation.

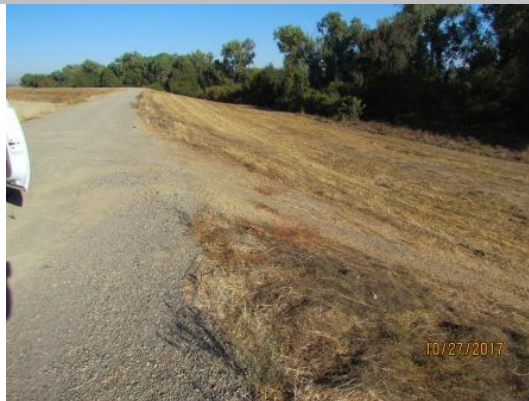
Photo 1 of 2 : SP\_2018\_LD0001S\_433\_36\_20180302\_00015.jpg

LM Start	4.41	Rating **	A/W	Issue No.	36
LM End	4.41	Issue Type +	Ma	Location *	WS
Category	Earthen Levee			GPS Latitude/Longitude	
				Start	End
Item	Slope Stability			39.011493 °	39.011493 °
				-121.603624 °	-121.603624 °
DWR ID	DWR_LD0001S_01_f_2016_36				
Comment Code					
S3 : Repair the levee slope damaged by vehicle traffic and prevent access where possible.					
Inspector Comment					
No erosion or separation on slope, continue to monitor, Fall 2017.

View of waterside slope where vehicles have been driving up and down to go around gate. Fall 2017.

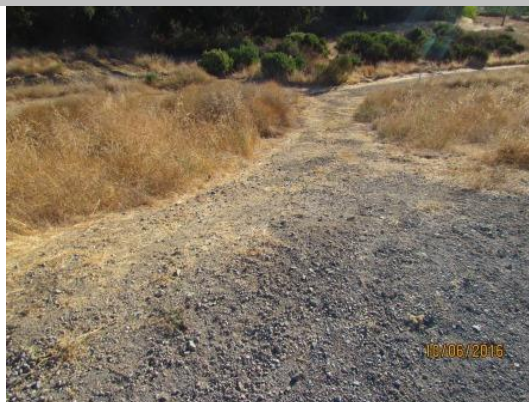
Photo 2 of 2 : SP\_2018\_LD0001S\_433\_36\_20180302\_00016.jpg

View of waterside slope where vehicles have been driving up and down to go around gate. Fall 2016.

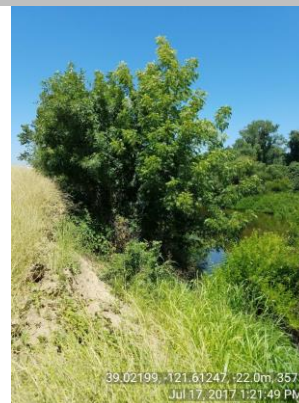
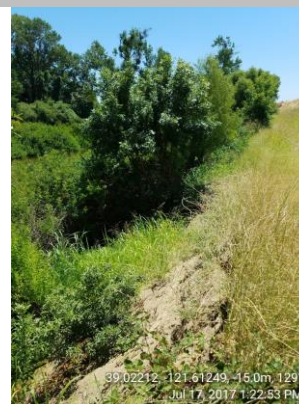
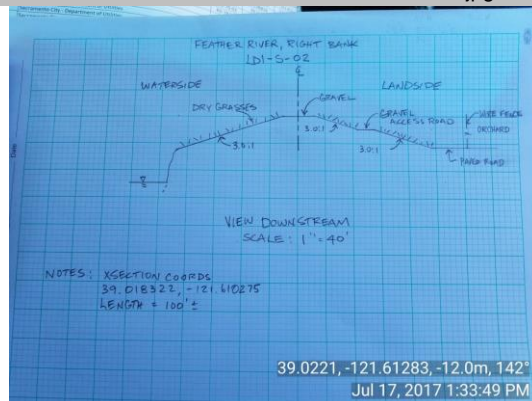
LM Start	5.02	Rating **	A/W	Issue No.	25	
LM End	5.02	Issue Type +	Ma	Location *		
Category	Supplemental			GPS Latitude/Longitude		
				Start		End
Item	2017 Storm Damage			39.018322 °	39.018322 °	
				-121.610275 °	-121.610275 °	
DWR ID	DWR_LD0001S_01_f_2017_25					
Comment Code						
Inspector Comment						
Levee Evaluation Comments						
Description:						
Site ID No:145						
Site Designation:LD1-S-02						
Repair Type: Erosion						
Rating:Critical						
Field Date:7/17/2017						
Notes:

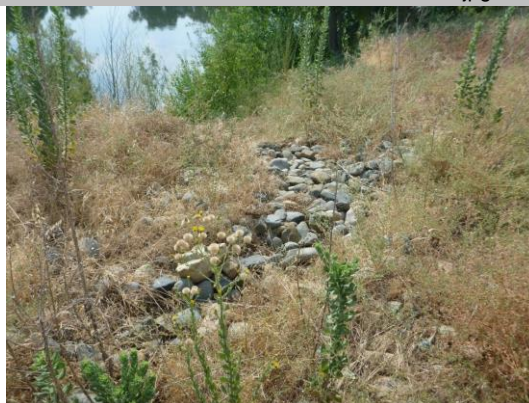
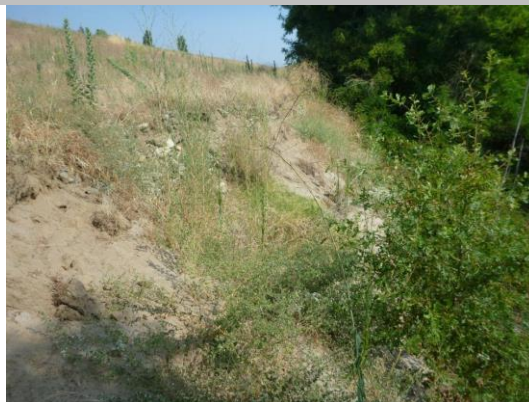
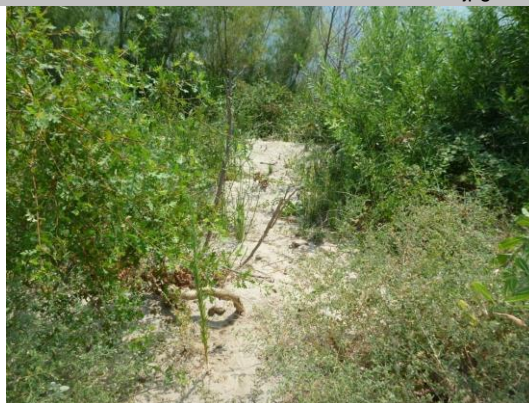
LM Start	7.69	Rating **	A/W	Issue No.	19	
LM End	7.74	Issue Type +	Ma	Location *		
Category	Supplemental			GPS Latitude/Longitude		
				Start	End	
Item	2017 Storm Damage			39.055986 °	39.056710 °	
				-121.611301 °	-121.611331 °	
DWR ID	DWR_LD0001S_01_f_2017_19					
Comment Code						
Inspector Comment						
Levee Evaluation Comments						
Description:						
Site ID No:146						
Site Designation:LD1-S-03						
Repair Type: Erosion						
Rating:Area of Concern						
Field Date:8/3/2017						
Notes:

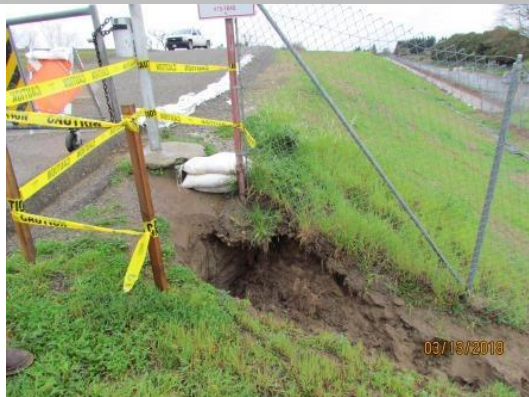
Photo 1 of 4 : SP\_2018\_LD0001S\_433\_31\_20180319\_00066.jpg

LM Start	12.15	Rating **	A/W	Issue No.	31
LM End	15.09	Issue Type +	Ma	Location *	CR
Category	Earthen Levee			GPS Latitude/Longitude	
				Start	End
Item	Crown Surface / Depressions / Rutting			39.116846 °	39.155672 °
				-121.604524 °	-121.616478 °
DWR ID	DWR_LD0001S_01_f_2017_31				
Comment Code					
Inspector Comment					
This section of levee is still under construction, It has been brought up to grade and the bike path needs to be paved a few more punch list item finished up before it is turned over to the LMA, Spring 2018.

View of erosion from run off at a ramp. This will be repaired with the punch list for the completion of the project, Spring 2018.

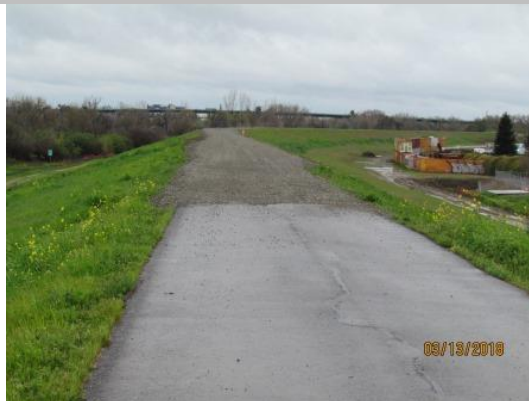
Photo 2 of 4 : SP\_2018\_LD0001S\_433\_31\_20180319\_00067.jpg

View looking downstream. This section of levee is still under construction, It has been brought up to grade and the bike path needs to be paved, also a few more punch list item finished up before it is turned over to the LMA, Spring 2018.

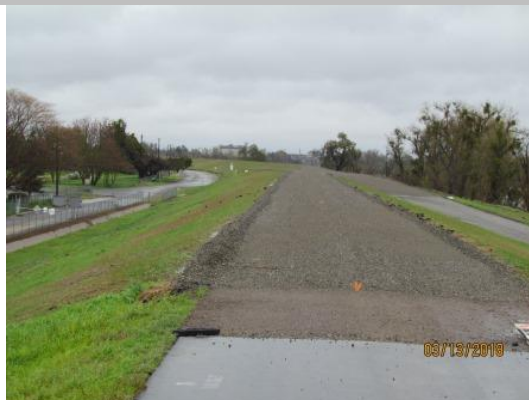
Photo 3 of 4 : SP\_2018\_LD0001S\_433\_31\_20180319\_00068.jpg

View looking upstream. This section of levee is still under construction, It has been brought up to grade and the bike path needs to be paved, also a few more punch list item finished up before it is turned over to the LMA, Spring 2018.

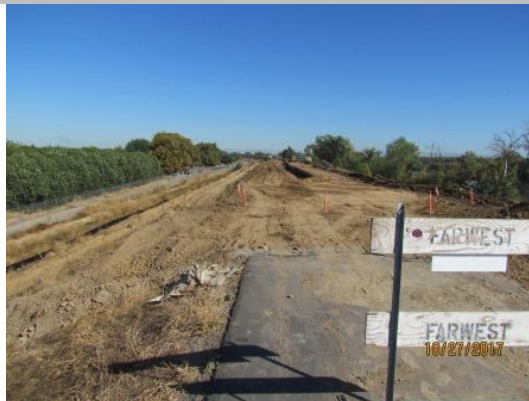
Photo 4 of 4 : SP\_2018\_LD0001S\_433\_31\_20180302\_00011.jpg

View looking upstream at the start point of the new construction of the levee, Fall 2017.
