**Flood Control Project Maintenance
Levee Inspections**

Maintenance Issue Types Only, Levee Inspection Report By Mile - Spring 2019

Levee District No. 0001 (Sutter County)

Waterway	Bank	Unit Miles	Inspection Start/End	Inspector
Unit No. 01 Feather River	Right	16.11	04/12/2019 04/12/2019	Sterling York

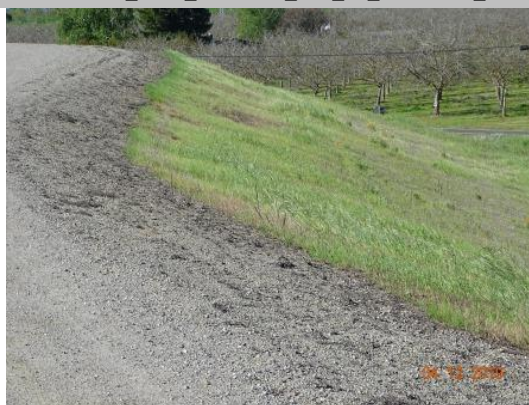
Photo 1 of 1 : SP_2019_LD0001S_433_15_20190415_00045.jpg

LM Start	3.72	Rating **	A	Issue No.	15
LM End	16.10	Issue Type +	Ma	Location *	LS
Category	Earthen Levee			GPS Latitude/Longitude	
				Start	End
Item	Vegetation			39.003134 °	39.168732 °
				-121.596628 °	-121.622687 °
DWR ID	DWR_LD0001S_01_s_2019_15				
Comment Code					
V1 : Control annual grass and weeds on the levee slopes and easements.					
Inspector Comment					
The annual vegetation is well maintained through this section of levee, Spring 2019.

View looking downstream landside at the well maintained annual vegetation, Spring 2019.

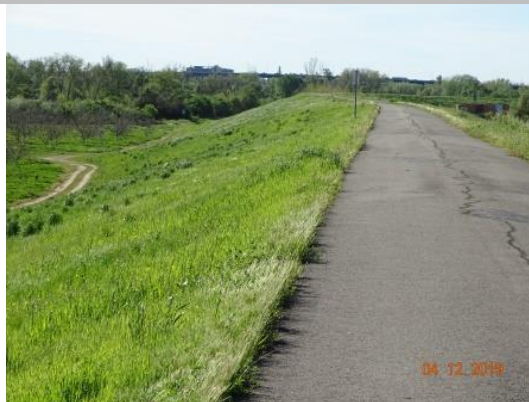
Photo 1 of 1 : SP_2019_LD0001S_433_16_20190415_00046.jpg

LM Start	3.72	Rating **	A	Issue No.	16
LM End	16.10	Issue Type +	Ma	Location *	WS
Category	Earthen Levee			GPS Latitude/Longitude	
				Start	End
Item	Vegetation			39.003134 °	39.168732 °
				-121.596628 °	-121.622687 °
DWR ID	DWR_LD0001S_01_s_2019_16				
Comment Code					
V1 : Control annual grass and weeds on the levee slopes and easements.					
Inspector Comment					
The annual vegetation is well maintained through this section of levee, Spring 2019.

View looking downstream waterside at the well maintained annual vegetation, Spring 2019.

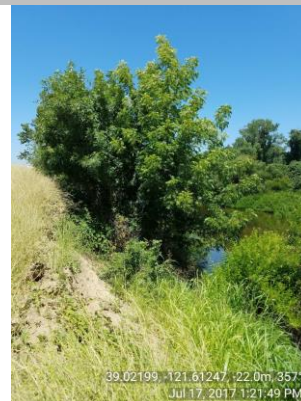
Photo 1 of 3 : LEVAL_SP_2019_145_1767.jpg

LM Start	5.02	Rating **	A/W	Issue No.	25
LM End	5.02	Issue Type +	Ma	Location *	
Category	Supplemental			GPS Latitude/Longitude	
				Start	End
Item	2017 Storm Damage			39.018322 °	39.018322 °
				-121.610275 °	-121.610275 °
DWR ID	DWR_LD0001S_01_f_2017_25				
Comment Code					
Inspector Comment					
Levee Evaluation Comments					
Description:					
Site ID No:145					
Site Designation:LD1-S-02					
Repair Type: Erosion					
Rating:Critical					
Field Date:7/17/2017					
Notes:

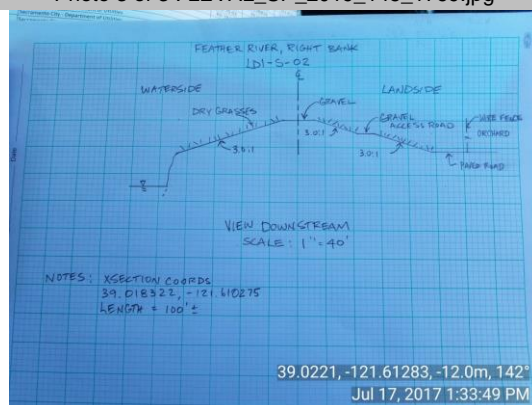
Photo 3 of 3 : LEVAL_SP_2019_145_1769.jpg

LM Start	5.02	Rating **	A/W	Issue No.	25 (cont)	
LM End	5.02	Issue Type +	Ma	Location *		
Category	Supplemental			GPS Latitude/Longitude		
				Start		End
Item	2017 Storm Damage			39.018322 °	39.018322 °	
				-121.610275 °	-121.610275 °	
DWR ID	DWR_LD0001S_01_f_2017_25					
Comment Code						
Inspector Comment						
Levee Evaluation Comments						
Description:						
Site ID No:145						
Site Designation:LD1-S-02						
Repair Type: Erosion						
Rating:Critical						
Field Date:7/17/2017						
Notes:

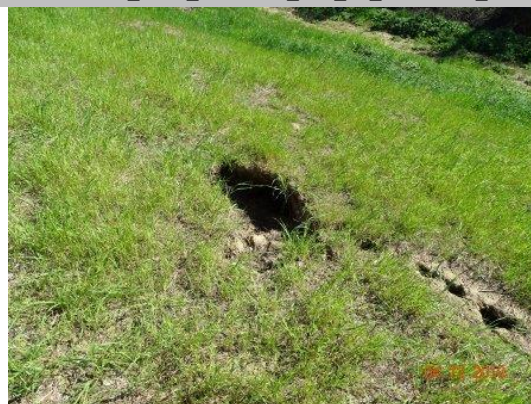
Photo 1 of 1 : SP_2019_LD0001S_433_18_20190415_00044.jpg

LM Start	5.65	Rating **	U	Issue No.	18
LM End	5.65	Issue Type +	Ma	Location *	WS
Category	Earthen Levee			GPS Latitude/Longitude	
				Start	End
Item	Animal Control			39.026940 °	39.026940 °
				-121.613100 °	-121.613100 °
DWR ID	DWR_LD0001S_01_s_2019_18				
Comment Code					
A3 : No rodents visible, but rodent burrows visible; need to backfill and compact or grout burrows.					
Inspector Comment					
Repair rodent hole in levee slope, Spring 2019.

View looking at waterside levee slope of a large rodent/animal hole, Spring 2019.

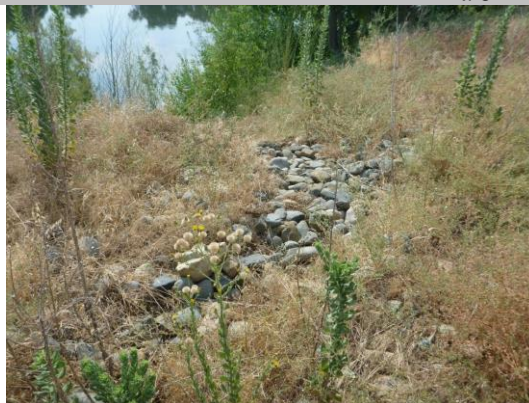
Photo 1 of 3 : LEVAL_SP_2019_146_4051.jpg

LM Start	7.69	Rating **	A/W	Issue No.	19	
LM End	7.74	Issue Type +	Ma	Location *		
Category	Supplemental			GPS Latitude/Longitude		
				Start	End	
Item	2017 Storm Damage			39.055986 °	39.056710 °	
				-121.611301 °	-121.611331 °	
DWR ID	DWR_LD0001S_01_f_2017_19					
Comment Code						
Inspector Comment						
Levee Evaluation Comments						
Description:						
Site ID No:146						
Site Designation:LD1-S-03						
Repair Type: Erosion						
Rating:Area of Concern						
Field Date:8/3/2017						
Notes:

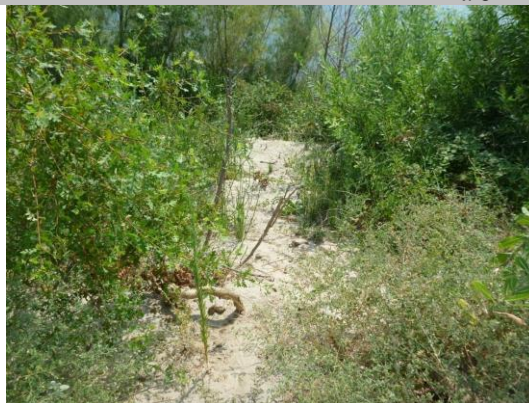
Photo 3 of 3 : LEVAL_SP_2019_146_4054.jpg

LM Start	7.69	Rating **	A/W	Issue No.	19 (cont)	
LM End	7.74	Issue Type +	Ma	Location *		
Category	Supplemental			GPS Latitude/Longitude		
				Start		End
Item	2017 Storm Damage			39.055986 °		39.056710 °
				-121.611301 °		-121.611331 °
DWR ID	DWR_LD0001S_01_f_2017_19					
Comment Code						
Inspector Comment						
Levee Evaluation Comments						
Description:						
Site ID No:146						
Site Designation:LD1-S-03						
Repair Type: Erosion						
Rating:Area of Concern						
Field Date:8/3/2017						
Notes:

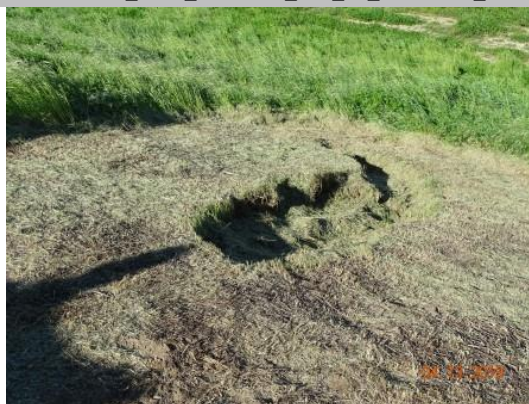
Photo 1 of 1 : SP_2019_LD0001S_433_17_20190415_00043.jpg

LM Start	8.55	Rating **	M	Issue No.	17
LM End	8.55	Issue Type +	Ma	Location *	LS
Category	Earthen Levee			GPS Latitude/Longitude	
				Start	End
Item	Animal Control			39.067929 °	39.067929 °
				-121.608064 °	-121.608064 °
DWR ID	DWR_LD0001S_01_s_2019_17				
Comment Code					
A3 : No rodents visible, but rodent burrows visible; need to backfill and compact or grout burrows.					
Inspector Comment					
There are large depressions in the levee slope that appear to be caused by some type of burrowing animals that needs to be repaired, Spring 2019.

View looking at the landside levee slope at large depressions in the levee that appear to be caused by some type of burrowing animals that need to be repaired, Spring 2019.

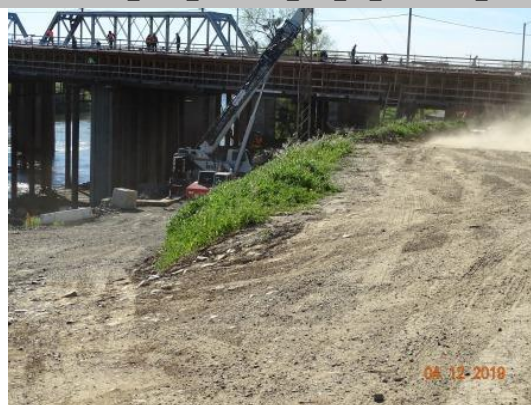
Photo 1 of 2 : SP_2019_LD0001S_433_26_20190415_00047.jpg

LM Start	13.87	Rating **	A/W	Issue No.	26
LM End	13.87	Issue Type +	Ma	Location *	CR
Category	Earthen Levee			GPS Latitude/Longitude	
				Start	End
Item	Crown Surface / Depressions / Rutting			39.139734 °	39.139734 °
				-121.608477 °	-121.608477 °
DWR ID	DWR_LD0001S_01_f _ 2018_26				
Comment Code					
C2 : Repair depressions or ruts in the crown or slope.					
Inspector Comment					
There is ongoing construction at the 5th Street Bridge, Fall 2018.

View looking downstream waterside of the 5th Street bridge construction, Spring 2019.

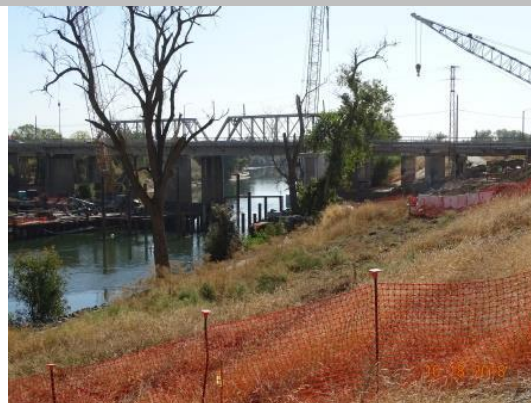
Photo 2 of 2 : SP_2019_LD0001S_433_26_20190305_00011.jpg

View looking downstream waterside of the 5th Street bridge construction, Fall 2018.
