**Flood Control Project Maintenance
Levee Inspections**

Maintenance Issue Types Only, Levee Inspection Report By Mile - Spring 2020

Levee District No. 0001 (Sutter County)

Waterway	Bank	Unit Miles	Inspection Start/End	Inspector
Unit No. 01 Feather River	Right	16.11	03/17/2020 03/17/2020	Sterling York

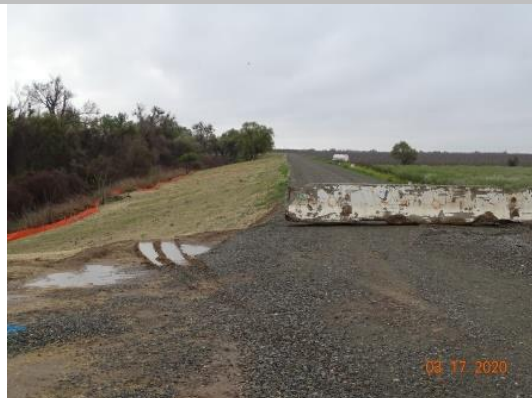
Photo 1 of 1 : SP_2020_LD0001S_433_15_20200324_00040.jpg

LM Start	0.00	Rating **	A/W	Issue No.	15
LM End	4.34	Issue Type +	Ma	Location *	CR
Category	Earthen Levee			GPS Latitude/Longitude	
				Start	End
Item	Crown Surface / Depressions / Rutting			38.950976 °	39.010657 °
				-121.585753 °	-121.602887 °
DWR ID	DWR_LD0001S_01_s_2020_15				
Comment Code					
C1 : Add appropriate material and re-grade the levee to bring the crown above the design elevation.					
Inspector Comment					
USACE Project still under construction with pipe installation, Spring 2020.

View looking downstream at the section of levee that is still under construction with the pipe installation, Spring 2020.

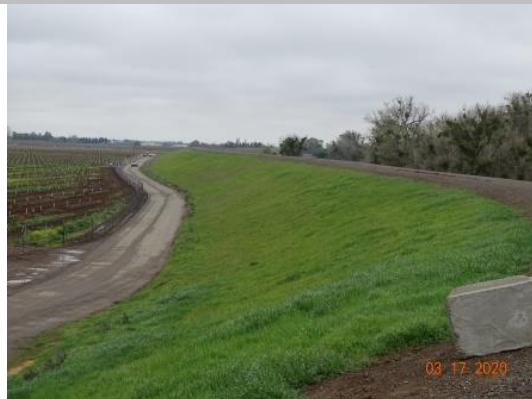
Photo 1 of 1 : SP_2020_LD0001S_433_16_20200324_00041.jpg

LM Start	4.40	Rating **	A	Issue No.	16
LM End	16.09	Issue Type +	Ma	Location *	LS
Category	Earthen Levee			GPS Latitude/Longitude	
				Start	End
Item	Vegetation			39.011370 °	39.168533 °
				-121.603526 °	-121.622706 °
DWR ID	DWR_LD0001S_01_s_2020_16				
Comment Code					
V1 : Control annual grass and weeds on the levee slopes and easements.					
Inspector Comment					
The annual vegetation is well maintained, Spring 2020.

View looking upstream landside at the well maintained annual vegetation, Spring 2020.

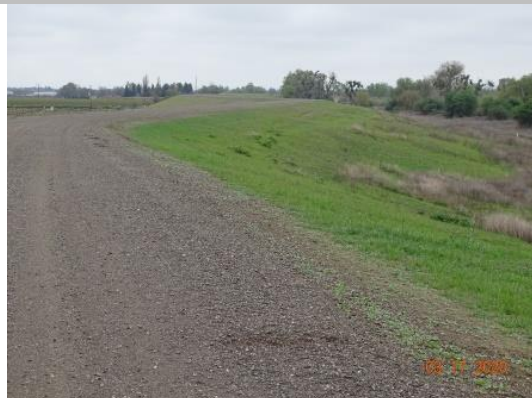
Photo 1 of 1 : SP_2020_LD0001S_433_17_20200324_00042.jpg

LM Start	4.40	Rating **	A	Issue No.	17
LM End	16.09	Issue Type +	Ma	Location *	WS
Category	Earthen Levee			GPS Latitude/Longitude	
				Start	End
Item	Vegetation			39.011370 °	39.168533 °
				-121.603527 °	-121.622706 °
DWR ID	DWR_LD0001S_01_s_2020_17				
Comment Code					
V1 : Control annual grass and weeds on the levee slopes and easements.					
Inspector Comment					
The annual vegetation is well maintained, Spring 2020.

View looking upstream waterside at the well maintained annual vegetation, Spring 2020.

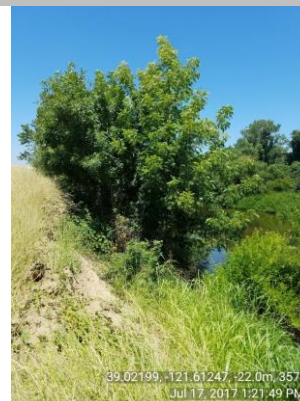
Photo 1 of 3 : LEVAL_SP_2020_145_1767.jpg

LM Start	5.02	Rating **	A/W	Issue No.	25	
LM End	5.43	Issue Type +	Ma	Location *		
Category	Supplemental			GPS Latitude/Longitude		
				Start		End
Item	2017 Storm Damage			39.018322 °		39.023753 °
				-121.610275 °		-121.613171 °
DWR ID	LD1-S-02					
Comment Code						
Inspector Comment						
The erosion site is planned for PL 84-99 Repair in 2020.						
Site ID No:145						
Site Designation:LD1-S-02						
Rating: Critical

The erosion site is planned for PL 84-99 Repair in 2020.

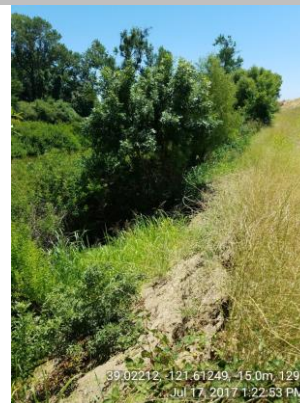
Photo 2 of 3 : LEVAL_SP_2020_145_1768.jpg

The erosion site is planned for PL 84-99 Repair in 2020.
