**Flood Control Project Maintenance
Levee Inspections**

Maintenance Issue Types Only, Levee Inspection Report By Mile - Spring 2021

Levee District No. 0001 (Sutter County)

Waterway	Bank	Unit Miles	Inspection Start/End	Inspector
Unit No. 01 Feather River	Right	16.11	03/17/2021 03/17/2021	Brooks Weisser

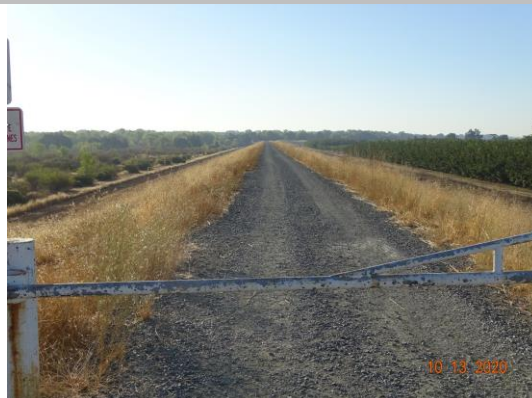
Photo 1 of 1 : SP_2021_LD0001S_433_15_20210301_00001.jpg

LM Start	0.00	Rating **	A/W	Issue No.	15
LM End	4.34	Issue Type +	Ma	Location *	CR
Category	Earthen Levee			GPS Latitude/Longitude	
				Start	End
Item	Crown Surface / Depressions / Rutting			38.950976 °	39.010657 °
				-121.585753 °	-121.602887 °
DWR ID	DWR_LD0001S_01_s_2020_15				
Comment Code					
C1 : Add appropriate material and re-grade the levee to bring the crown above the design elevation.					
Inspector Comment					
USACE Project completed, O&M manual and levee have not been turned over to LMA. This section is not maintained yet, Fall 2020.

View looking downstream of completed construction, but levee has not been turned over to LMA, Fall 2020.

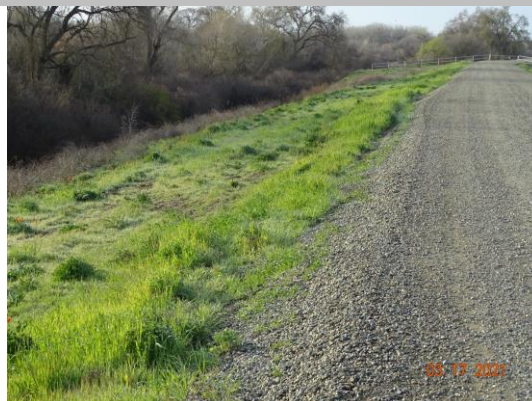
Photo 1 of 1 : SP_2021_LD0001S_433_20_20210318_00052.jpg

LM Start	0.05	Rating **	M	Issue No.	20
LM End	0.43	Issue Type +	Ma	Location *	WS
Category	Earthen Levee			GPS Latitude/Longitude	
				Start	End
Item	Vegetation			38.951701 °	38.957098 °
				-121.585576 °	-121.585484 °
DWR ID	DWR_LD0001S_01_s_2021_20				
Comment Code					
V1 : Control annual grass and weeds on the levee slopes and easements.					
Inspector Comment					
Annual vegetation on waterside slope should be maintained, Spring 2021.

View of annual vegetation on waterside slope that should be maintained, Spring 2021.

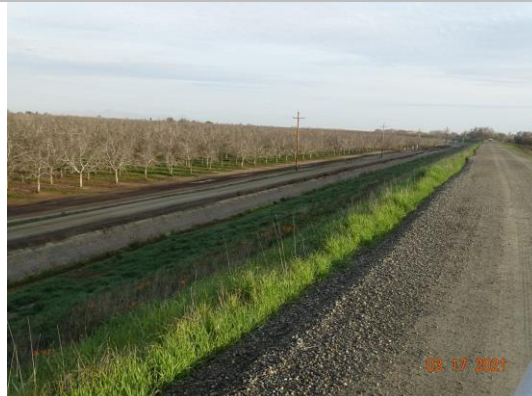
Photo 1 of 1 : SP_2021_LD0001S_433_18_20210318_00041.jpg

LM Start	0.05	Rating **	M	Issue No.	18
LM End	0.43	Issue Type +	Ma	Location *	LS
Category	Earthen Levee			GPS Latitude/Longitude	
				Start	End
Item	Vegetation			38.951706 °	38.957093 °
				-121.585581 °	-121.585482 °
DWR ID	DWR_LD0001S_01_s_2021_18				
Comment Code					
V1 : Control annual grass and weeds on the levee slopes and easements.					
Inspector Comment					
Annual vegetation on landside slope should be maintained, Spring 2021

View of annual vegetation on land side slope that should be maintained, Spring 2021.

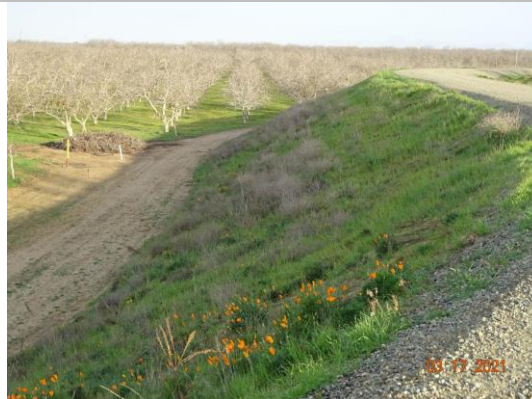
Photo 1 of 1 : SP_2021_LD0001S_433_21_20210318_00043.jpg

LM Start	0.95	Rating **	M	Issue No.	21
LM End	4.34	Issue Type +	Ma	Location *	LS
Category	Earthen Levee			GPS Latitude/Longitude	
				Start	End
Item	Vegetation			38.964652 °	39.010662 °
				-121.586587 °	-121.602882 °
DWR ID	DWR_LD0001S_01_s_2021_21				
Comment Code					
V1 : Control annual grass and weeds on the levee slopes and easements.					
Inspector Comment					
Annual vegetation should be maintained, Spring 2021.

View of annual vegetation on landside slope that should be maintained, Spring 2021.

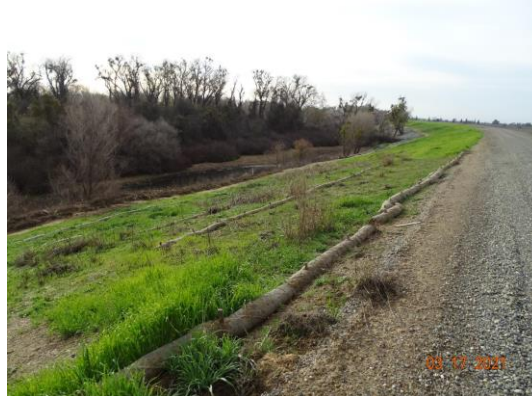
Photo 1 of 1 : SP_2021_LD0001S_433_26_20210318_00049.jpg

LM Start	5.43	Rating **	A/W	Issue No.	26
LM End	5.43	Issue Type +	Ma	Location *	WS
Category	Earthen Levee			GPS Latitude/Longitude	
				Start	End
Item	Erosion / Bank Caving			39.023753 °	39.023753 °
				-121.613171 °	-121.613171 °
DWR ID	DWR_LD0001S_01_s_2021_26				
Comment Code					
E1 : Note and monitor erosion site.					
Inspector Comment					
Wattles have been placed on the waterside slope. This site should be monitored as the wattles deteriorate to confirm the v ditches are no longer present. Contractor should removed wattles. Spring 2021.

View of wattles on waterside slope that should be monitored to ensure v-ditches are removed when wattles are removed or deteriorate, Spring 2021.

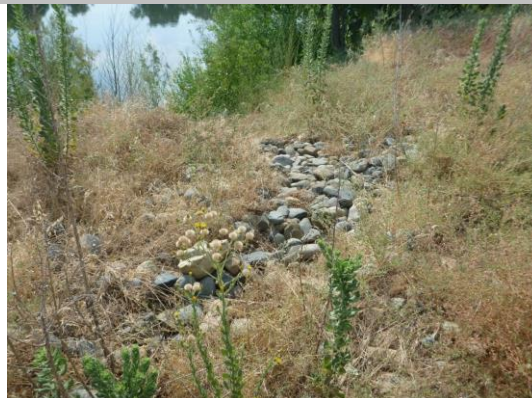
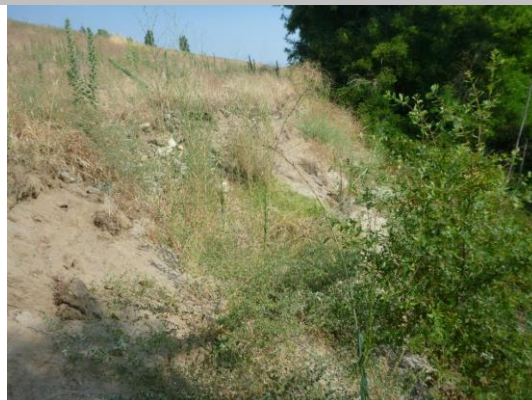
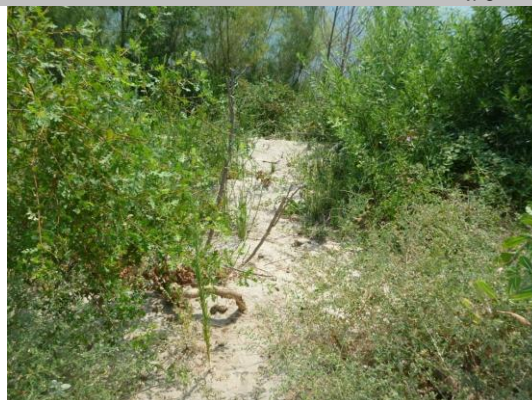
LM Start	7.69	Rating **	A/W	Issue No.	19
LM End	7.74	Issue Type +	Ma	Location *	WS
Category	Earthen Levee			GPS Latitude/Longitude	
				Start	End
Item	Erosion / Bank Caving			39.055986 °	39.056710 °
				-121.611301 °	-121.611331 °
DWR ID	LD1-S-03				
Comment Code					
E1 : Note and monitor erosion site.					
Inspector Comment					
This was a 2017 Storm Damage site for erosion.					
Site ID No:146					
Site Designation:LD1-S-03

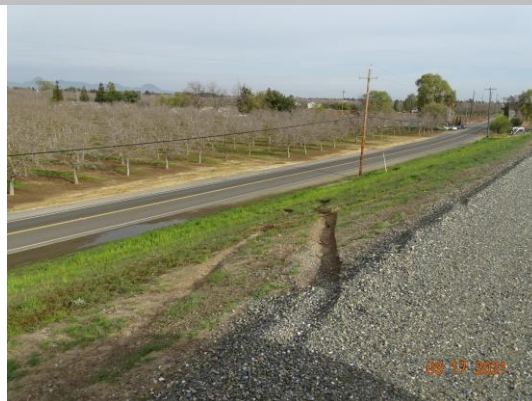
Photo 1 of 1 : SP_2021_LD0001S_433_27_20210318_00051.jpg

LM Start	9.04	Rating **	A/W	Issue No.	27
LM End	9.04	Issue Type +	Ma	Location *	LS
Category	Earthen Levee			GPS Latitude/Longitude	
				Start	End
Item	Slope Stability			39.074886 °	39.074886 °
				-121.606280 °	-121.606280 °
DWR ID	DWR_LD0001S_01_s_2021_27				
Comment Code					
S3 : Repair the levee slope damaged by vehicle traffic and prevent access where possible.					
Inspector Comment					
Ruts left from unauthorized vehicle access on land side slope should be repaired, Spring 2021.

Erosion of the landside slope due to unauthorized vehicle access, Spring 2021.
