**Flood Control Project Maintenance  
Levee Inspections**

**Maintenance Issue Types Only, Levee Inspection Report By Mile - Spring 2022**

**Levee District No. 0001 (Sutter County)**

Waterway	Bank	Unit Miles	Inspection Start/End	Inspector
Unit No. 01 Feather River	Right	16.11	04/18/2022 04/18/2022	Brooks Weisser

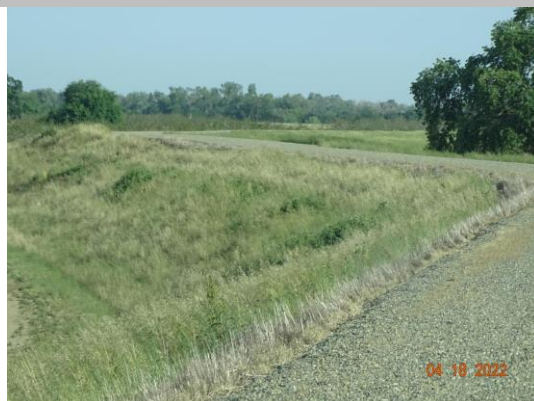
Photo 1 of 1 : SP\_2022\_LD0001S\_433\_16\_20220425\_00028.jpg

LM Start	0.00	Rating **	M	Issue No.	16
LM End	16.10	Issue Type +	Ma	Location *	LS
Category	Earthen Levee			GPS Latitude/Longitude	
				Start	End
Item	Vegetation			38.950934 °	39.168732 °
				-121.585756 °	-121.622687 °
DWR ID	DWR_LD0001S_01_f_2021_16				
Comment Code					
V1 : Control annual grass and weeds on the levee slopes and easements.					
Inspector Comment					
Control the annual vegetation, Spring 2022.

Control the annual vegetation, Spring 2022.

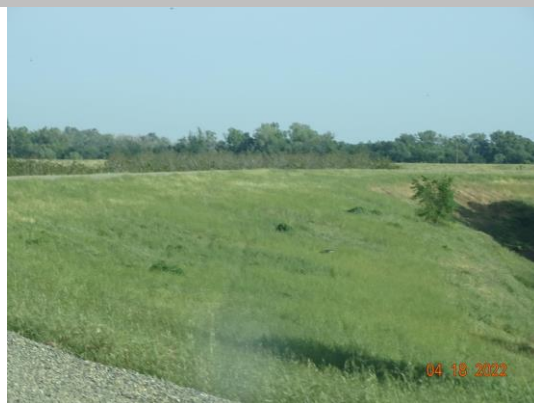
Photo 1 of 1 : SP\_2022\_LD0001S\_433\_17\_20220425\_00029.jpg

LM Start	0.00	Rating **	M	Issue No.	17
LM End	16.10	Issue Type +	Ma	Location *	WS
Category	Earthen Levee			GPS Latitude/Longitude	
				Start	End
Item	Vegetation			38.950934 °	39.168732 °
				-121.585756 °	-121.622687 °
DWR ID	DWR_LD0001S_01_f_2021_17				
Comment Code					
V1 : Control annual grass and weeds on the levee slopes and easements.					
Inspector Comment					
Control the annual vegetation, Spring 2022.

Control the annual vegetation, Spring 2022.

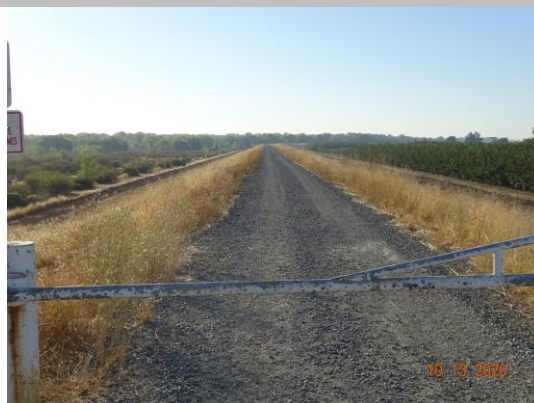
Photo 1 of 1 : SP\_2022\_LD0001S\_433\_15\_20220415\_00001.jpg

LM Start	0.00	Rating **	A/W	Issue No.	15
LM End	4.34	Issue Type +	Ma	Location *	CR
Category	Earthen Levee			GPS Latitude/Longitude	
				Start	End
Item	Crown Surface / Depressions / Rutting			38.950976 °	39.010657 °
				-121.585753 °	-121.602887 °
DWR ID	DWR_LD0001S_01_s_2020_15				
Comment Code					
C1 : Add appropriate material and re-grade the levee to bring the crown above the design elevation.					
Inspector Comment					
USACE Project completed, O&M manual and levee have not been turned over to LMA. This section is not maintained yet, Spring 2022.

View looking downstream of completed construction, but levee has not been turned over to LMA, Fall 2020.

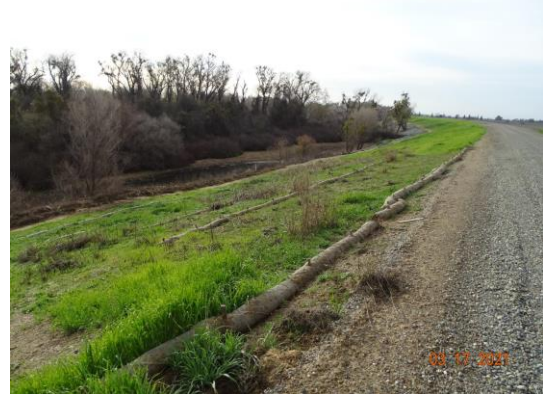
Photo 1 of 1 : SP\_2022\_LD0001S\_433\_26\_20220415\_00005.jpg

LM Start	5.43	Rating **	A/W	Issue No.	26
LM End	5.43	Issue Type +	Ma	Location *	WS
Category	Earthen Levee			GPS Latitude/Longitude	
				Start	End
Item	Slope Stability			39.023753 °	39.023753 °
				-121.613171 °	-121.613171 °
DWR ID	DWR_LD0001S_01_s_2021_26				
Comment Code					
S1 : Repair slope instability.					
Inspector Comment					
This site should be monitored as the wattles deteriorate to confirm the v ditches are no longer present. Contractor should removed wattles. Spring 2022.

View of wattles on waterside slope that should be monitored to ensure v-ditches are removed when wattles are removed or deteriorate, Spring 2021.

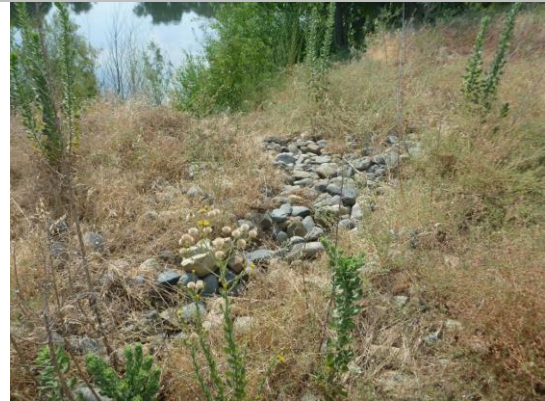
Photo 1 of 1 : LEVAL\_SP\_2022\_146\_4051.jpg

LM Start	7.69	Rating **	A/W	Issue No.	19
LM End	7.74	Issue Type +	Ma	Location *	WS
Category	Earthen Levee			GPS Latitude/Longitude	
				Start	End
Item	Slope Stability			39.055986 °	39.056710 °
				-121.611301 °	-121.611331 °
DWR ID	LD1-S-03				
Comment Code					
S1 : Repair slope instability.					
Inspector Comment					
This was a 2017 Storm Damage site for erosion.					
Site ID No:146					
Site Designation:LD1-S-03
