**Flood Control Project Maintenance
Levee Inspections**

Maintenance Issue Types Only, Levee Inspection Report By Mile - Spring 2023

Levee District No. 0001 (Sutter County)

Waterway	Bank	Unit Miles	Inspection Start/End	Inspector
Unit No. 01 Feather River	Right	16.11	04/14/2023 04/14/2023	Brooks Weisser

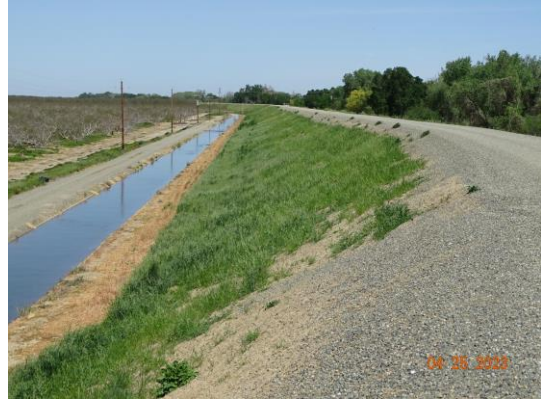
Photo 1 of 1 : SP_2023_LD0001S_433_12_20230425_00022.jpg

LM Start	0.01	Rating **	M	Issue No.	12
LM End	16.10	Issue Type +	Ma	Location *	LS
Category	Earthen Levee			GPS Latitude/Longitude	
				Start	End
Item	Vegetation			38.951075°	39.168732°
				-121.585711°	-121.622687°
DWR ID	DWR_LD0001S_01_s_2023_12				
Comment Code					
V1 : Control annual grass and weeds on the levee slopes and easements.					
Inspector Comment					
Annual vegetation needs to be maintained, Spring 2023.

View of annual vegetation on the landside slope, Spring 2023.

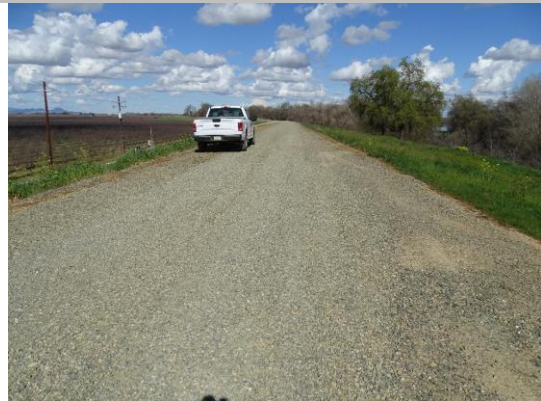
Photo 1 of 3 : UCIP_SP_2023_77099_113766.jpg

Comment Code						
Inspector Comment						
DS_ID:18668						
FS_ID:77099						
EP_NO: N/A						
Repair Type: Non-Urgent						
EVAL Issue:						
Crossing Status: Not Found						
UCIP Comments: 02/22/2022 Record has been updated to Non-Urgent.						
No drainage culvert located on the LS. Need to obtain as-built drawings to see if crossing has been removed. (M.Thao - DWR UCIP)						
FIELD_STRUCT_DESC: 10-inch corrugated iron gravity drainage culvert under the landside (LS) approach, at an unknown depth.						
Replacement for a 24-inch gravity drainage pipe of an unknown material under landside approach, at an unknown depth. Crossing not found in the O&M Manual.						
FS Date: 2/22/2022

Levee crown looking upstream.

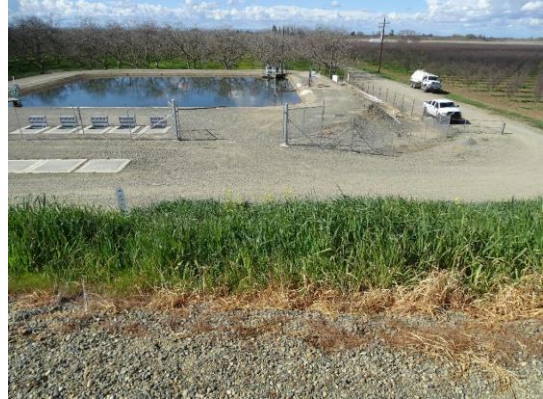
Photo 2 of 3 : UCIP_SP_2023_77099_113768.jpg

LS view: Looking from crown; general overview. Sump and vaults are not associated this record.

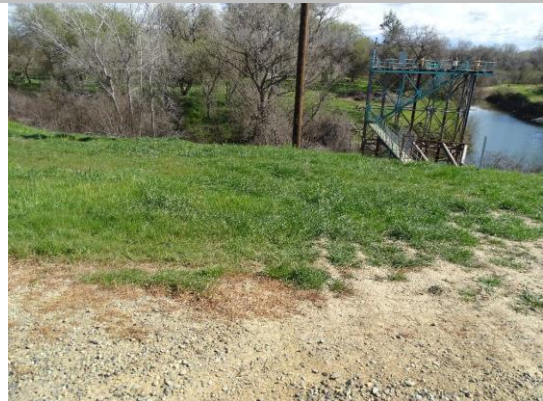
Photo 3 of 3 : UCIP_SP_2023_77099_113767.jpg

WS view: Looking from levee; general overview. Pole and pump station not associated with this record.

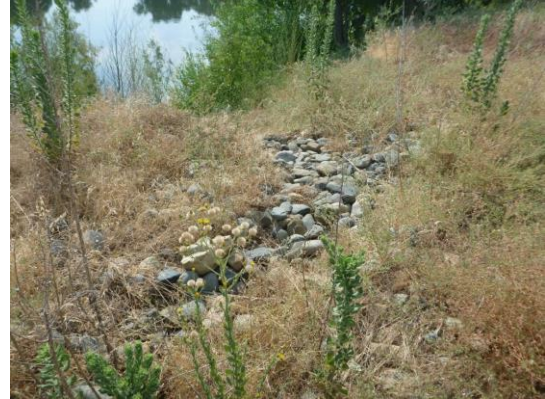
Photo 1 of 1 : LEVAL_SP_2023_146_4051.jpg

LM Start	7.69	Rating **	A/W	Issue No.	19
LM End	7.74	Issue Type +	Ma	Location *	WS
Category	Earthen Levee			GPS Latitude/Longitude	
				Start	End
Item	Erosion / Bank Caving			39.055986°	39.056710°
				-121.611301°	-121.611331°
DWR ID	LD1-S-03				
Comment Code					
E1 : Note and monitor erosion site.					
Inspector Comment					
This was a 2017 Storm Damage site for erosion.					
Site ID No:146					
Site Designation:LD1-S-03

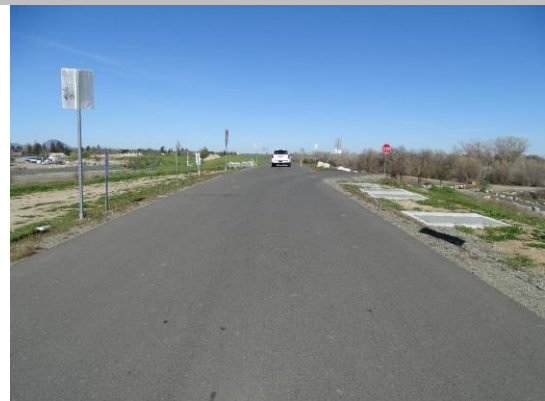
Photo 1 of 3 : UCIP_SP_2023_79240_114549.jpg

Comment Code					
Inspector Comment					
DS_ID:17924 FS_ID:79240 EP_NO: N/A Repair Type: Non-Urgent EVAL Issue: Crossing Status: Not Found UCIP Comments: 02/24/2022 Need to verify if pipe was grouted in place or removed. Permit application proposed pipe removal but a Reclamation Board suggests that abandonment might be safely and more economically accomplished by filling with concrete rather than opening a cut some 200 feet long and 40 feet deep in the levee. (M. Thao - DWR UCIP) 04/09/2013 Need verification pipe was grouted in place. (P. Amatya) FIELD_STRUCT_DESC: 36-inch corrugated metal gravity drainage pipe through the levee, 30 feet below the crown. Slide gate in a corrugated metal pipe (CMP) riser on the waterside (WS) slope. (Plans to remove a 36-inch pipe from under the levee authorized under Permit 1066, 1945 - Levee District No. 1 of Sutter County [LD0001S]). [Additional Reference(s): DWR Levee Log, 2005 (HLM 36-inch steel), listed as a 36-inch steel pipe. USACE Sacramento O&M Manual, Unit No. 144, August 1955, Revised 29 Dec 2016, (Station 1468+79), listed as a 36-inch corrugated metal pipe] FS Date: 2/24/2022

Levee crown looking upstream.

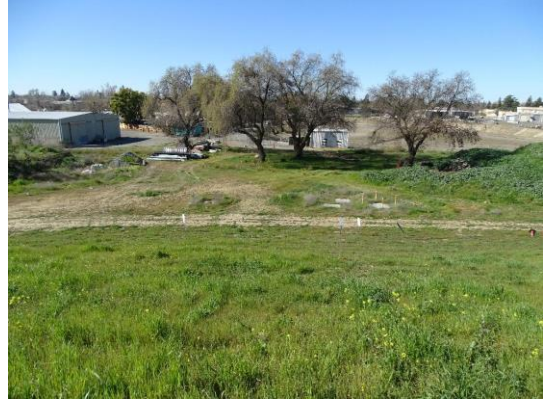
Photo 2 of 3 : UCIP_SP_2023_79240_114550.jpg

LS view: Looking from levee; general overview.

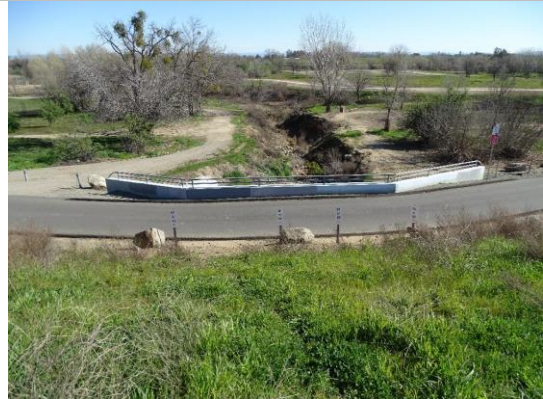
Photo 3 of 3 : UCIP_SP_2023_79240_114551.jpg

WS view: Looking from levee; general overview.
