**Flood Control Project Maintenance
Levee Inspections**

Maintenance Issue Types Only, Levee Inspection Report By Mile - Spring 2024

Levee District No. 0001 (Sutter County)

Waterway	Bank	Unit Miles	Inspection Start/End	Inspector
Unit No. 01 Feather River	Right	16.11	04/16/2024 04/16/2024	Brooks Weisser

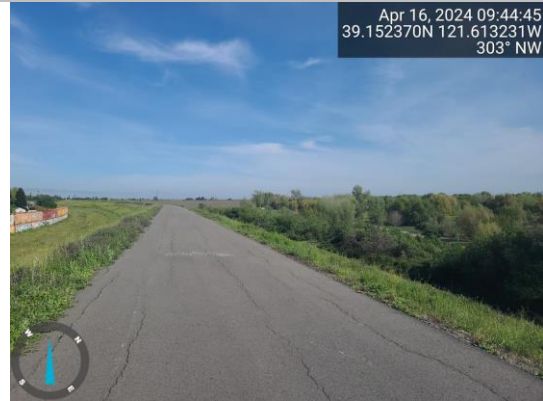
Photo 1 of 1 : SP_2024_LD0001S_433_13_20240422_00024.jpg

LM Start	0.03	Rating **	M	Issue No.	13
LM End	16.05	Issue Type +	Ma	Location *	WS
Category	Earthen Levee			GPS Latitude/Longitude	
				Start	End
Item	Vegetation			38.951380°	39.168008°
				-121.585601°	-121.622714°
DWR ID	DWR_LD0001S_01_s_2024_13				
Comment Code					
V1 : Control annual grass and weeds on the levee slopes and easements.					
Inspector Comment					
Vegetation on the waterside slope needs to be maintained, Spring 2024.

View of annual vegetation on the waterside slope, Spring 2024.

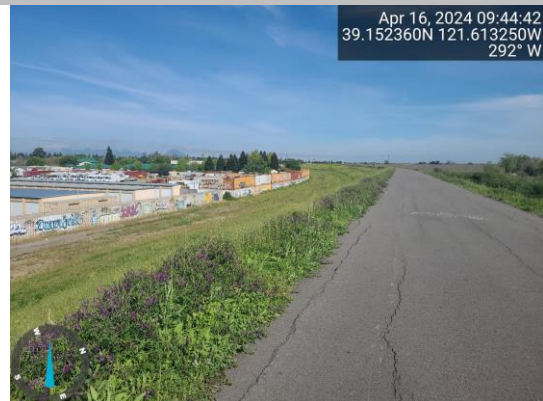
Photo 1 of 1 : SP_2024_LD0001S_433_12_20240422_00025.jpg

LM Start	0.03	Rating **	M	Issue No.	12
LM End	16.05	Issue Type +	Ma	Location *	LS
Category	Earthen Levee			GPS Latitude/Longitude	
				Start	End
Item	Vegetation			38.951385°	39.168008°
				-121.585594°	-121.622714°
DWR ID	DWR_LD0001S_01_s_2024_12				
Comment Code					
V1 : Control annual grass and weeds on the levee slopes and easements.					
Inspector Comment					
Vegetation on the landside slope needs to be maintained, Spring 2024

View of annual vegetation on the landside slope, Spring 2024.

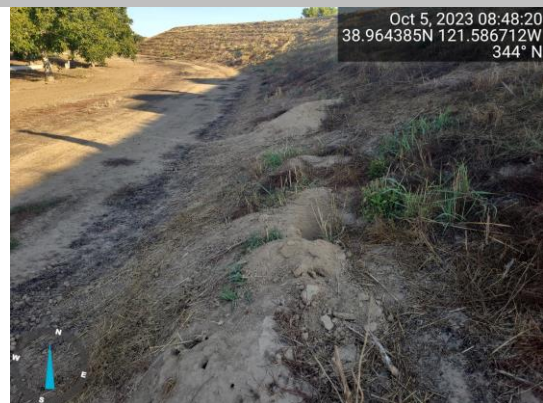
Photo 1 of 1 : SP_2024_LD0001S_433_14_20240326_00001.jpg

LM Start	0.94	Rating **	A/W	Issue No.	14
LM End	0.94	Issue Type +	Ma	Location *	LS
Category	Earthen Levee			GPS Latitude/Longitude	
				Start	End
Item	Animal Control			38.964534°	38.964534°
				-121.586570°	-121.586570°
DWR ID	DWR_LD0001S_01_f_2023_14				
Comment Code					
A3 : No rodents visible, but rodent burrows visible; need to backfill and compact or grout burrows.					
Inspector Comment					
Vegetation too high to observe. Check back in Fall. LMA stated they baited, fogged and backfilled. Spring 2024.

View of rodent holes on the landside slope, Fall 2023.

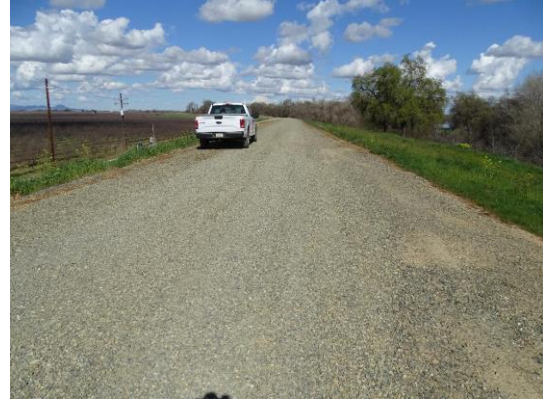
Photo 1 of 3 : UCIP_SP_2024_77099_113766.jpg

LM Start	2.47	Rating **	M	Issue No.	27
LM End	2.47	Issue Type +	Ma	Location *	
Category	Supplemental			GPS Latitude/Longitude	
				Start	End
Item	DWR UCIP LMA Responsibility			38.985845°	38.985845°
				-121.591912°	-121.591912°
DWR ID	18668

Comment Code					
Inspector Comment					
DS_ID:18668 FS_ID:77099 EP_NO: N/A Repair Type: Non-Urgent EVAL Issue: Crossing Status: Not Found UCIP Comments: 02/22/2022 Record has been updated to Non-Urgent. No drainage culvert located on the LS. Based on USACE As-Built Drawing No. 04-04-0205-1, pipe is described as crossing LS approach and does not indicate through the levee. Need to obtain recent Feather River West Levee Project as-built drawings to verify if pipe actually crosses the levee at this location. (M. Thao - DWR UCIP) FIELD_STRUCT_DESC: 8-inch corrugated iron gravity drainage culvert under the landside (LS) approach, at an unknown depth. [Additional Reference(s): USACE As-Built Drawing No. 04-04-0205-1, Station 627+00, July 1939]. FS Date: 2/22/2022

Levee crown looking upstream.

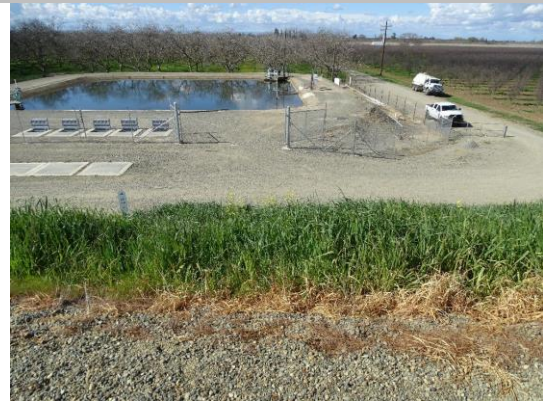
Photo 2 of 3 : UCIP_SP_2024_77099_113768.jpg

LS view: Looking from crown; general overview. Sump and vaults are not associated this record.

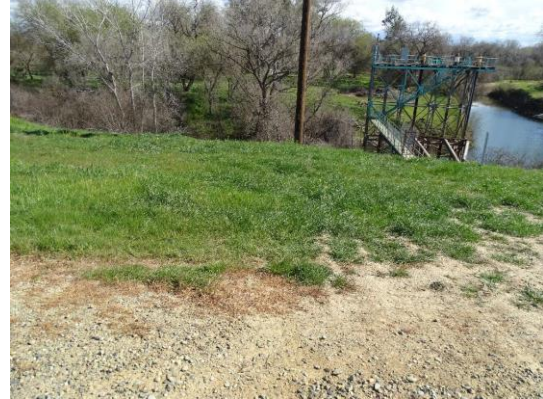
Photo 3 of 3 : UCIP_SP_2024_77099_113767.jpg

WS view: Looking from levee; general overview. Pole and pump station not associated with this record.

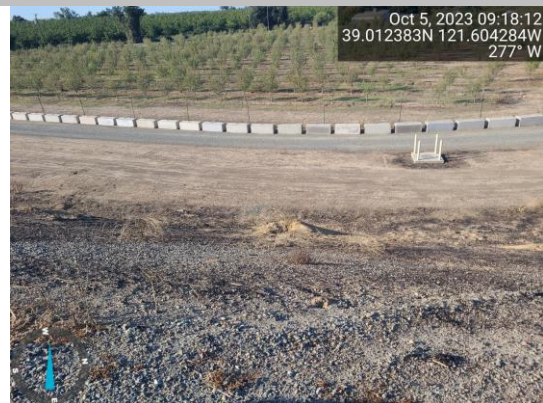
Photo 1 of 1 : SP_2024_LD0001S_433_15_20240326_00002.jpg

LM Start	4.48	Rating **	A/W	Issue No.	15
LM End	4.73	Issue Type +	Ma	Location *	LS
Category	Earthen Levee			GPS Latitude/Longitude	
				Start	End
Item	Animal Control			39.012365°	39.014601°
				-121.604267°	-121.607921°
DWR ID	DWR_LD0001S_01_f_2023_15				
Comment Code					
A1 : Exterminate rodents and backfill and compact or grout burrows.					
Inspector Comment					
Vegetation too high to observe. Check back in Fall. LMA stated they baited, fogged and backfilled. Spring 2024.

View of rodent holes on the landside slope, Fall 2023.

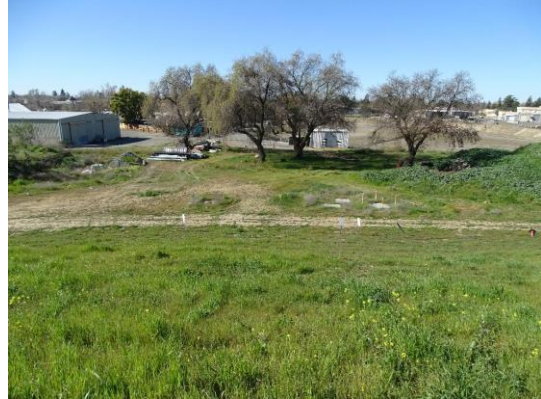
Photo 2 of 3 : UCIP_SP_2024_80013_114550.jpg

LS view: Looking from levee; general overview.

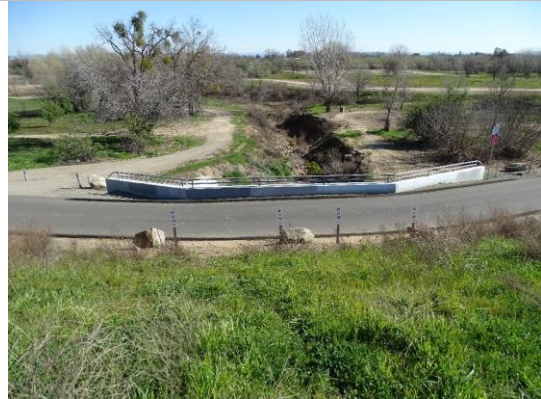
Photo 3 of 3 : UCIP_SP_2024_80013_114551.jpg

WS view: Looking from levee; general overview.

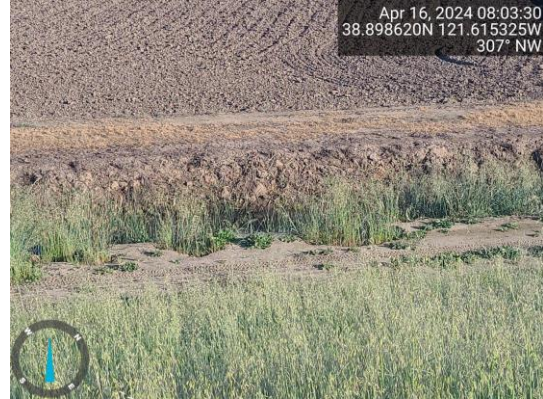
Photo 1 of 1 : SP_2024_MA0003_195_9_20240422_00003.jpg

LM Start	0.11	Rating **	M	Issue No.	9
LM End	0.11	Issue Type +	Ma	Location *	LS
Category	Earthen Levee			GPS Latitude/Longitude	
				Start	End
Item	Erosion / Bank Caving			38.898073°	38.898648°
				-121.616134°	-121.615162°
DWR ID	DWR_MA0003_01_f_2023_9				
Comment Code					
E1 : Note and monitor erosion site.					
Inspector Comment					
Erosion on the landside toe road needs be monitored and plans for repair need to be made, Spring 2024.

View of erosion of the landside toe road, Spring 2024.

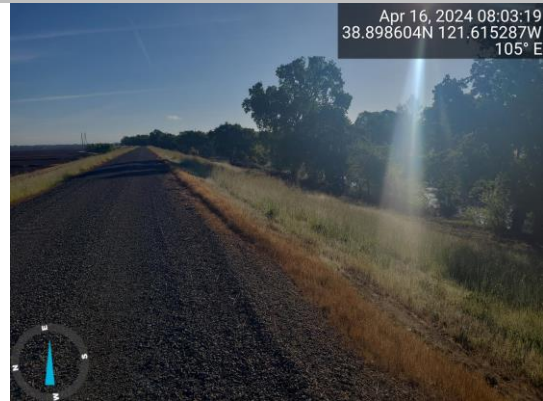
Photo 1 of 1 : SP_2024_MA0003_195_1_20240422_00004.jpg

LM Start	0.16	Rating **	M	Issue No.	1
LM End	5.11	Issue Type +	Ma	Location *	WS
Category	Earthen Levee			GPS Latitude/Longitude	
				Start	End
Item	Vegetation			38.898543°	38.950969°
				-121.615337°	-121.585712°
DWR ID	DWR_MA0003_01_s_2024_1				
Comment Code					
V1 : Control annual grass and weeds on the levee slopes and easements.					
Inspector Comment					
Vegetation on the waterside slope needs to be maintained, Spring 2024.

View of vegetation on the waterside slope, Spring 2024.

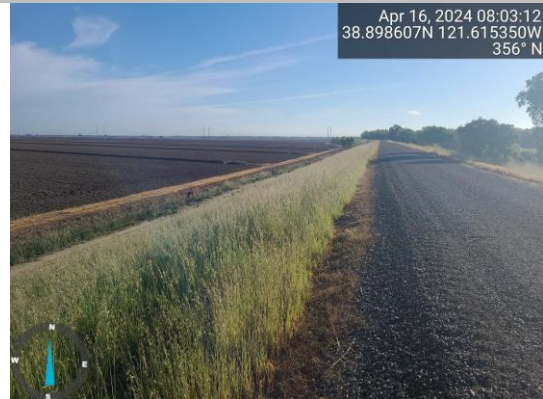
Photo 1 of 1 : SP_2024_MA0003_195_10_20240422_00005.jpg

LM Start	0.16	Rating **	M	Issue No.	10
LM End	5.11	Issue Type +	Ma	Location *	LS
Category	Earthen Levee			GPS Latitude/Longitude	
				Start	End
Item	Vegetation			38.898542°	38.950973°
				-121.615336°	-121.585708°
DWR ID	DWR_MA0003_01_f_2023_10				
Comment Code					
V1 : Control annual grass and weeds on the levee slopes and easements.					
Inspector Comment					
Vegetation on the landside slope needs to be maintained, Fall 2023.

View of annual vegetation on the landside slope, Spring 2024.

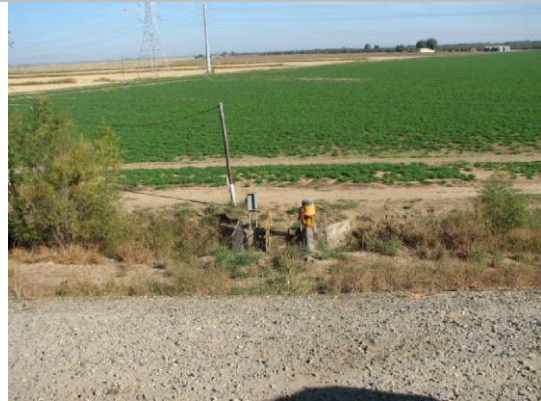
Photo 1 of 3 : UCIP_SP_2024_65596_64649.jpg

LM Start	0.81	Rating **	U	Issue No.	11
LM End	0.81	Issue Type +	Ma	Location *	
Category	Supplemental			GPS Latitude/Longitude	
				Start	End
Item	DWR UCIP LMA Responsibility			38.903264°	38.903264°
				-121.605698°	-121.605698°
DWR ID	17092

DS_ID:17092
FS_ID:65596
EP_NO: N/A
Repair Type: Urgent
EVAL Issue: 2b, Levee Integrity
Crossing Status: Found
UCIP Comments: 01/21/2021 Record remains Urgent. Potential levee integrity issues still remain at this location. This section of the levee under Feather River West Levee Project has not been completed yet. Will need to continue coordinating with DWR Sutter Yard Pipe Inspector, Andy Freitag, to obtain progress update. Need to request construction plans to review levee modifications at this location. The site inspection was completed with DWR Sutter Yard staff, Bob Duffey and Cory Hutton. (O. Magana - DWR UCIP)06/09/2020 Notified by Bob Duffey, DWR Sutter Yard Inspector, that MA0003 is currently under construction as part of the Feather River West Levee Project. Will need to coordinate with Andy Freitag, DWR Sutter Yard Pipe Inspector, once the As-builts are available to update UCIP Records. (O. Magana - DWR UCIP)05/01/2019 Same as last inspection, record remains Urgent due to the potential of levee integrity issues on the LS. Dense vegetation on both the WS and LS limits the inspection to determine if sink hole or erosion behind headwall on LS has progressed. No permit has been identified for this structure. Structure has been abandoned. (O. Magana - DWR UCIP)10/04/2018 Sink hole observed between the dual 18-inch pipes located on the LS near the concrete headwall. Erosion was also observed behind the concrete headwall located on the LS. Inlet of dual 18-inch pipes was still covered by filled sandbags. Crossing remains Urgent due to the sink hole and erosion visible on the LS. These crossings were recommended for replacement under the SBFCA project; however, no work has been done to date. Recommend monitoring site and coordinating with SBFCA to determine the status of the project. (O. Magana - DWR UCIP)04/11/2017 Water levels were high on WS during inspection so pipe ends could not be inspected. Believe that the sandbags are still in place and condition of flap gates is unknown. (A. Freitag - DWR Sutter Yard)10/10/2016 WS pipe end was underwater for inspection but the sandbags still appear to be in place. (A. Freitag - DWR Sutter Yard)04/18/2016 No repairs have been made to the pipe yet. (A. Freitag - DWR Sutter Yard)05/12/2015 Water level high in WS ditch so could not see WS end of crossing. Do not believe that repairs have been made yet. (A. Freitag - DWR Sutter Yard)11/17/2014 Same as last inspection. (A. Freitag - DWR Sutter Yard)05/14/2014 Same as last inspection. (A. Freitag - DWR Sutter Yard)10/30/2013 Same as last inspection. (A. Freitag - DWR Sutter Yard)05/21/2013 SBFCA project recommends replacing in accordance with title 23. High water levels in WS ditch have pipe ends underwater but repairs have not yet been completed but are planned for when water levels drop. (A.

Concrete headwall with walkway and slide gates at LS toe.

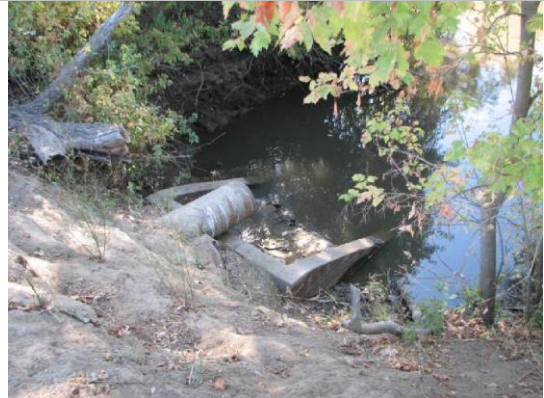
Photo 2 of 3 : UCIP_SP_2024_65596_64648.jpg

Freitag - DWR Sutter Yard)10/10/2012 Flap gates not visible on waterward headwall and it appears as though they have been replaced by sandbags. Slide gates on LS appear to be closed yet water leaks excessively from the WS at the sandbagged headwall. (W. Wylie - DWR UCIP)

Concrete U shaped headwall on WS toe filled in with Sandbags. 16-inch pipe shown over top of headwall.

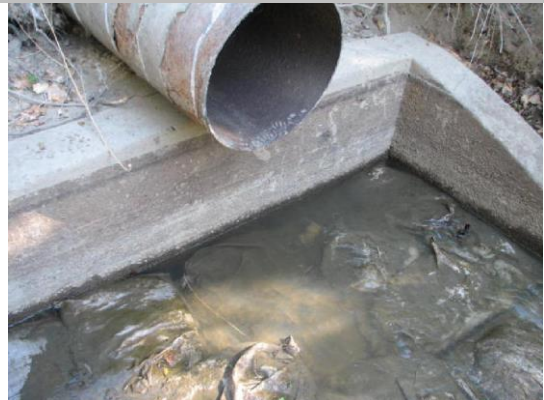
Photo 3 of 3 : UCIP_SP_2024_65596_64647.jpg

Concrete U shaped headwall filled in with sandbags on WS toe. Flap gates appear to be missing and water readily flows through the sandbags from LS.

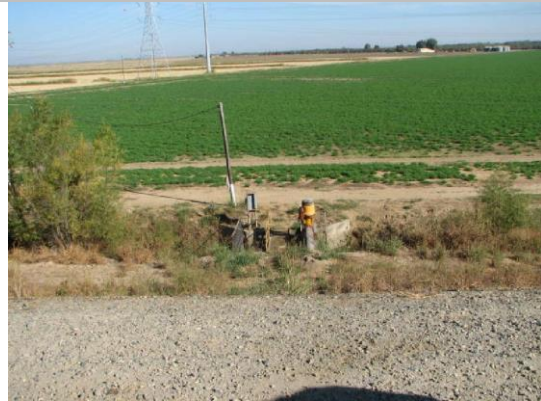
Photo 1 of 3 : UCIP_SP_2024_65597_64662.jpg

LM Start	0.81	Rating **	U	Issue No.	12
LM End	0.81	Issue Type +	Ma	Location *	
Category	Supplemental		GPS Latitude/Longitude		
			Start	End	
Item	DWR UCIP LMA Responsibility		38.903264°	38.903264°	
			-121.605698°	-121.605698°	
DWR ID	17136

DS_ID:17136
FS_ID:65597
EP_NO: N/A
Repair Type: Urgent
EVAL Issue: 2b, Levee Integrity
Crossing Status: Found
UCIP Comments: 01/21/2021 Record remains Urgent. Potential levee integrity issues are still present. This section of the levee under Feather River West Levee Project has not been completed yet. Will need to continue coordinating with DWR Sutter Yard Pipe Inspector, Andy Freitag, to obtain progress update. Need to request construction plans to review levee modifications at this location. The site inspection was completed with DWR Sutter Yard staff, Bob Duffey and Cory Hutton. (O. Magana - DWR UCIP)06/09/2020 Notified by Bob Duffey, DWR Sutter Yard Inspector, that MA0003 is currently under construction as part of the Feather River West Levee Project. Will need to coordinate with Andy Freitag, DWR Sutter Yard Pipe Inspector, once the As-builts are available to update UCIP Records. (O. Magana - DWR UCIP)05/01/2019 Same as last inspection, record remains Urgent due to the potential of levee integrity issues on the LS. Dense vegetation on both the WS and LS limits the inspection to determine if sink hole or erosion behind headwall on LS has progressed. No permit has been identified for this structure. Structure has been abandoned. (O. Magana - DWR UCIP)10/04/2018 Sink hole observed between the dual 18-inch pipes located on the LS near the concrete headwall. Erosion was also observed behind the concrete headwall located on the LS. Inlet of dual 18-inch pipes was still covered by filled sandbags. Crossing remains Urgent due to the sink hole and erosion visible on the LS. These crossings were recommended for replacement under the SBFCA project; however, no work has been done to date. Recommend monitoring site and coordinating with SBFCA to determine the status of the project. (O. Magana - DWR UCIP)04/11/2017 Water levels were high on WS during inspection so pipe ends could not be inspected. Believe that the sandbags are still in place and condition of flap gates is unknown. (A. Freitag - DWR Sutter Yard)10/10/2016 WS pipe end was underwater for the inspection but the sandbags appear to still be in place. (A. Freitag - DWR Sutter Yard)04/18/2016 No repairs have been made to the pipe yet. (A. Freitag - DWR Sutter Yard)05/12/2015 Water level high in WS ditch so could not see WS end of crossing. Do not believe that repairs have been made yet. (A. Freitag - DWR Sutter Yard)11/17/2014 Same as last inspection. (A. Freitag - DWR Sutter Yard)05/14/2014 Same as last inspection. (A. Freitag - DWR Sutter Yard)10/30/2013 Same as last inspection. (A. Freitag - DWR Sutter Yard)05/21/2013 SBFCA project recommends replacing in accordance with title 23. High water levels in WS ditch have pipe ends underwater but repairs have not yet been completed but are planned for when water levels drop. (A.

Concrete headwall, slidegates, and metal walkway on LS toe.

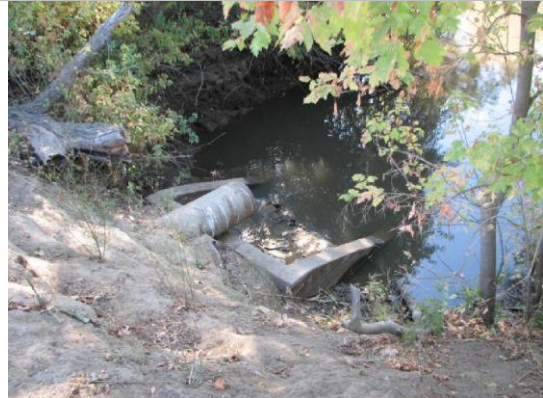
Photo 2 of 3 : UCIP_SP_2024_65597_64661.jpg

Freitag - DWR Sutter Yard)10/10/2012 Flap gates not visible on waterward headwall and it appears as though they have been replaced by sandbags. Slide gates on LS appear to be closed yet water leaks excessively from the WS at the sandbagged headwall. (W. Wylie - DWR UCIP)

Concrete U shaped headwall on WS toe filled with sandbags.

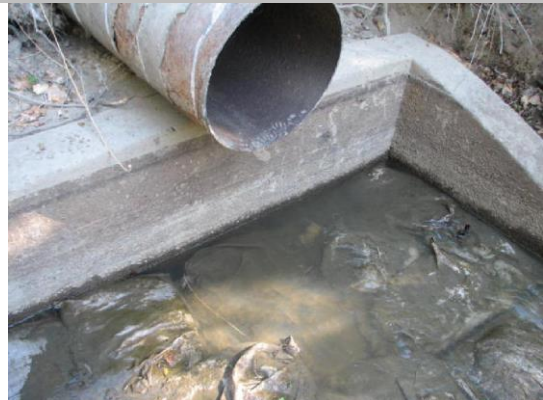
Photo 3 of 3 : UCIP_SP_2024_65597_64660.jpg

Flap gates appear to be missing from U shaped headwall. Sandbags fill headwall but water flows heavily from LS.
