**Flood Control Project Maintenance
Levee Inspections
LMA District Cover Sheet
Spring 2010 Levee Inspection Results**

Levee District No. 0001 (Sutter County)

Levee Inspection Report By Mile - Spring 2010

| Waterway | Bank | Unit Miles | Inspection Start/End | Inspector |
|---|---|---|---|---|
| Unit No. 01 Feather River | Right | 16.65 | 06/08/2010 06/08/2010 | Clay Thomas |

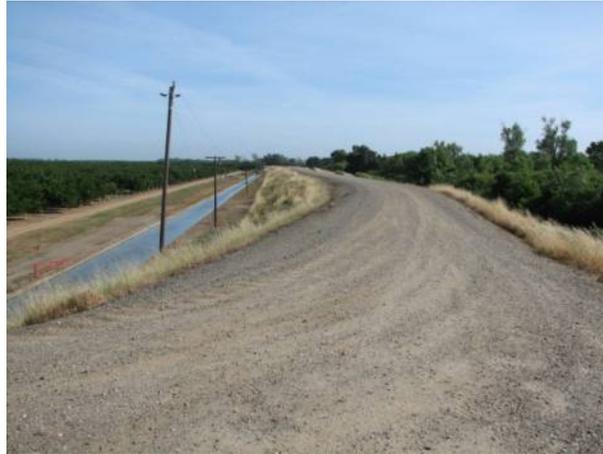
| Levee Mile Report Line | 1 |

| LMIR No | Levee Mile | | Category | Item | Location * | Rating ** | Action/Comment | GPS Latitude/Longitude | | Issue No. Photo |
|---|---|---|---|---|---|---|---|---|---|---|
| 1 | 0.00 | 16.65 | Earthen Levee | Vegetation | LS | M | Control annual grass and weeds on the levee slopes and easements. | 39.951120 ° ,569.000000 ° | 39.168900 ° -121.622620 ° | 1 Y |

| Land side vegetation levee mile 0.00. | |

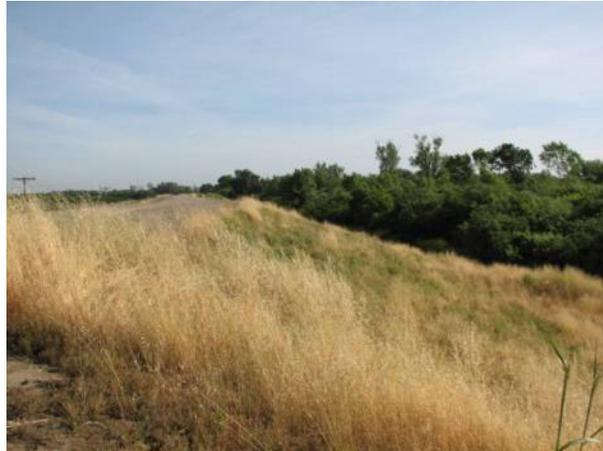
| Levee Mile Report Line | 2 |

| LMIR No | Levee Mile | | Category | Item | Location * | Rating ** | Action/Comment | GPS Latitude/Longitude | | Issue No. Photo |
|---|---|---|---|---|---|---|---|---|---|---|
| 2 | 0.00 | 16.65 | Earthen Levee | Vegetation | WS | M | Control annual grass and weeds on the levee slopes and easements. | 39.951120 ° -121.585690 ° | 39.168900 ° -121.622620 ° | 2 Y |

| Water side vegetation levee mile 0.00. | |

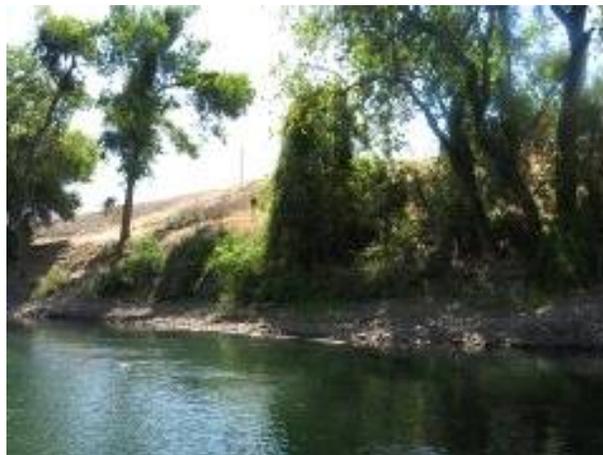
| Levee Mile Report Line | 5 |

| LMIR No | Levee Mile | | Category | Item | Location * | Rating ** | Action/Comment | GPS Latitude/Longitude | | Issue No. Photo |
|---|---|---|---|---|---|---|---|---|---|---|
| 5 | 14.03 | 14.25 | Supplemental | USACE Erosion Survey | WS | U | Inspector Comments: 2009: no berm, 1:1 slope, tree hazards, holes, seepage, clays and silts, 4.03 ft/s [2009 SiteID:FHR_28-5_R] | 39.138578 ° -121.606661 ° | 39.135647 ° -121.604278 ° | 6 Y |

| 2009: no berm, 1:1 slope, tree hazards, holes, seepage, clays and silts, 4.03 ft/s [2009 SiteID:FHR_28-5_R] | |
