**Flood Control Project Maintenance  
Levee Inspections  
LMA District Cover Sheet  
Spring 2013 Levee Inspection Results**

**Levee District No. 0001 (Sutter County)**

**Spring 2013 Levee Inspection Results**

**Levee Inspection Report By Mile - Spring 2013**

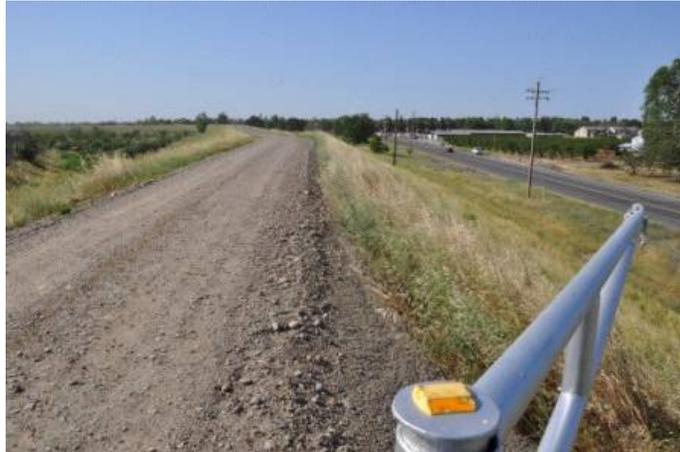
Levee Mile Report Line	4
Start Levee Mile	0.00
End Levee Mile	16.62
Location	Land Side
Category	
Item	Vegetation
Typical L/S seasonal vegetation.	
rburnett_s_20130422_246.JPG

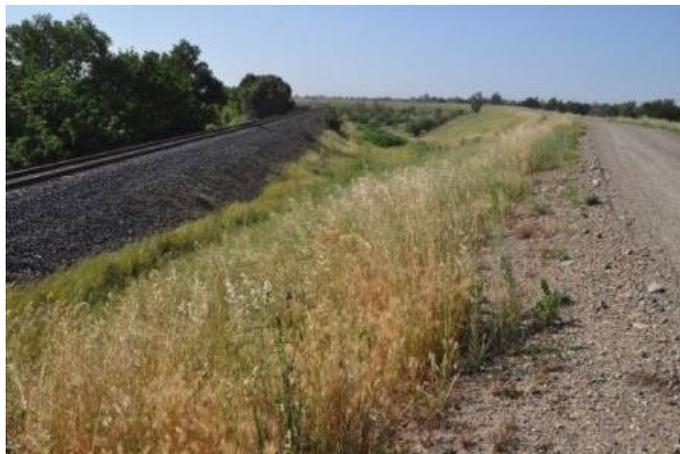
Levee Mile Report Line	5
Start Levee Mile	0.00
End Levee Mile	16.62
Location	Water Side
Category	
Item	Vegetation
Typical W/S seasonal vegetation.	
rburnett_s_20130422_245.JPG

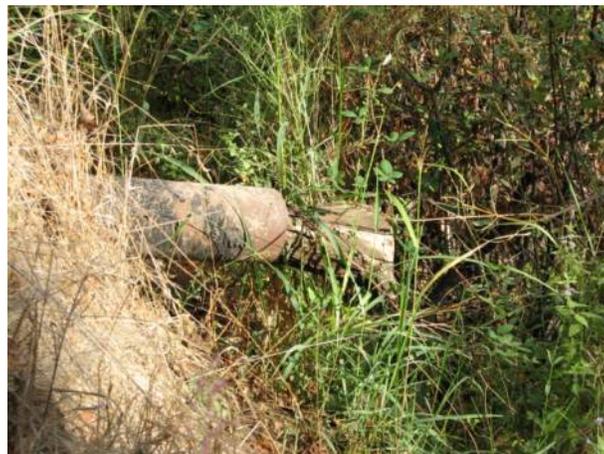
Levee Mile Report Line	10
Start Levee Mile	1.84
End Levee Mile	1.84
Location	Land Side
Category	Interior Drainage & Piping Systems
Item	Metal Pipes
This photo shows the abandoned pipe on the waterside berm, note the piece of wood stuck in the pipe.	
jhirabay_s_20130314_001.jpg
