**Flood Control Project Maintenance  
Levee Inspections**

**Fall 2010 Levee Maintenance Deficiency Summary Report**

Waterway	Bank	Unit Miles
Unit No. 01 Glenn County Sacramento River	Right	4.89

**Levee District No. 0002 (Glenn County)**

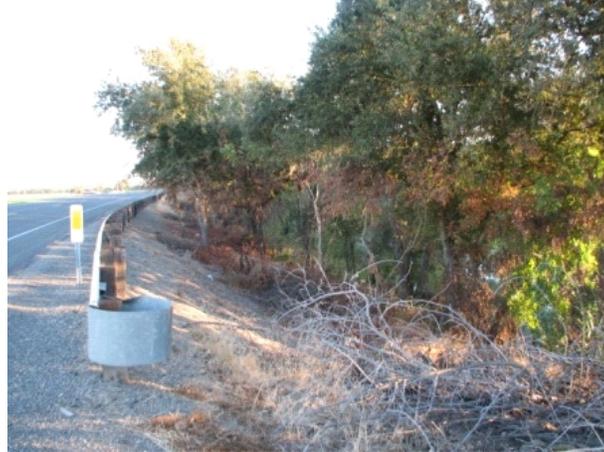
Levee Mile Report Line	1
Start Levee Mile	0.66
End Levee Mile	0.80
Location	Water Side
Category	Earthen Levee
Item	Vegetation
View of the vegetation on the w/s slope.	
rduffey_f_20101101_242.jpg

LMR No.	Levee Mile		Category	Item	* Location	** Rating	Action/Comment	GPS Latitude/Longitude		Issue No. Photo
	Start	End						Start	End	
1	0.66	0.80	Earthen Levee	Vegetation	WS	M	Remove the wild growth other than native grasses from the levee slopes.	39.422844 ° -122.011637 °	39.424829 ° -122.011467 °	1 Y
2	1.04	1.04	Earthen Levee	Encroachments	WS	PO	Buildings	39.428322 ° -122.010973 °	39.428322 ° -122.010973 °	8 Y
3	1.09	1.09	Earthen Levee	Animal Control	WS	M	No rodents visible, but rodent burrows visible; need to backfill and compact or grout borrows.	39.454387 ° -122.014835 °	39.428972 ° -122.010887 °	4
4	2.95	3.00	Earthen Levee	Animal Control	LS	M	No rodents visible, but rodent burrows visible; need to backfill and compact or grout borrows.	39.453595 ° -122.016273 °	39.454003 ° -122.015503 °	2
5	3.08	3.08	Earthen Levee	Animal Control	LS	C	No rodents visible, but rodent burrows visible; need to backfill and compact or grout borrows.	39.454957 ° -122.014460 °	39.454959 ° -122.014454 °	5

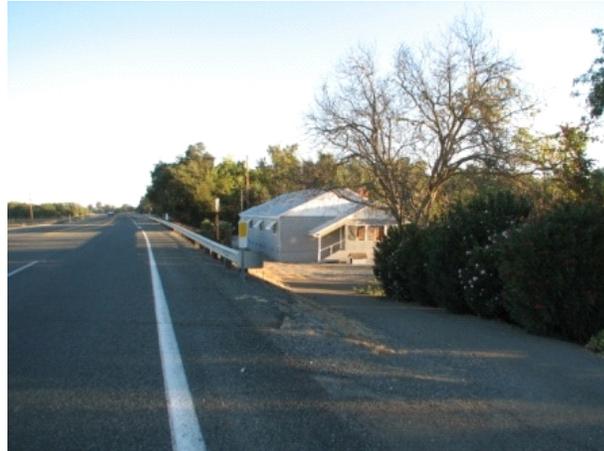
Levee Mile Report Line	2
Start Levee Mile	1.04
End Levee Mile	1.04
Location	Water Side
Category	Earthen Levee
Item	Encroachments
View of house along w/s toe.	
rduffey_f_20101101_238.jpg
