**Flood Control Project Maintenance  
Levee Inspections**

**Fall 2012 Levee Maintenance Deficiency Summary Report**

**Flood Control Project Maintenance  
Levee Inspections  
LMA District Cover Sheet  
Fall 2012 Levee Inspection Results**

**Levee District No. 0002 (Glenn County)**

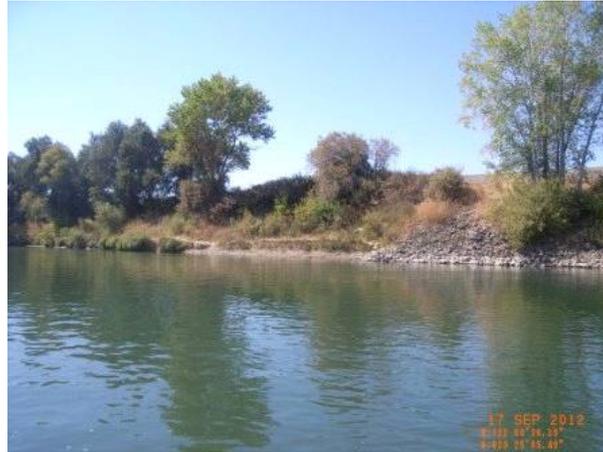
USACE 2012 Photo #1

Levee Mile Report Line	4
Start Levee Mile	0.08
End Levee Mile	0.08
Location	Water Side
Category	Supplemental
Item	USACE Erosion Survey

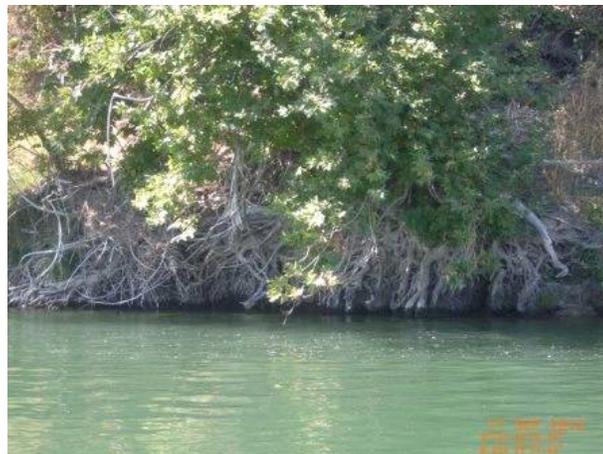
USACE 2012 Photo #2

Levee Mile Report Line	4
Start Levee Mile	0.08
End Levee Mile	0.08
Location	Water Side
Category	Supplemental
Item	USACE Erosion Survey

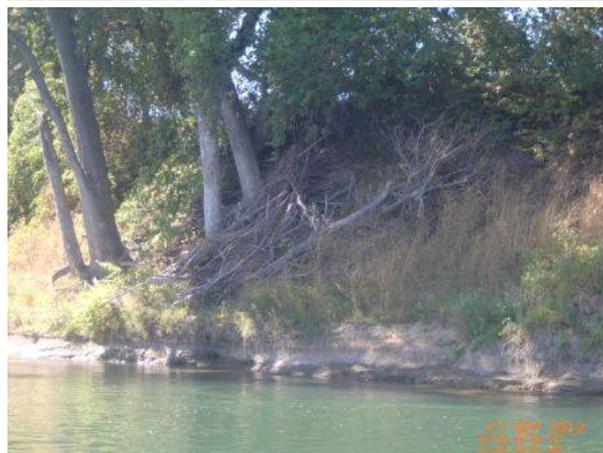
USACE 2012 Photo #3

Levee Mile Report Line	4
Start Levee Mile	0.08
End Levee Mile	0.08
Location	Water Side
Category	Supplemental
Item	USACE Erosion Survey

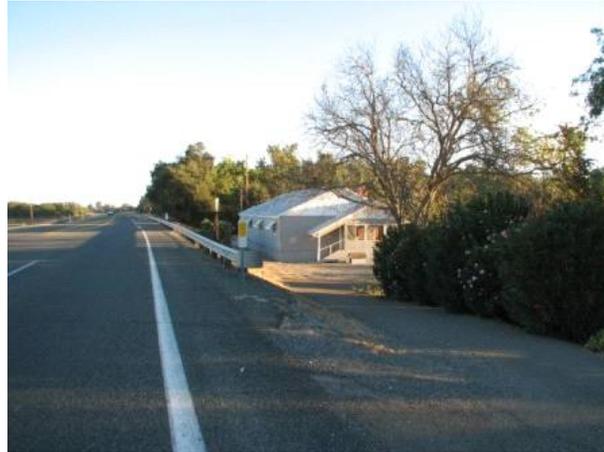
Levee Mile Report Line	5
Start Levee Mile	1.04
End Levee Mile	1.04
Location	Water Side
Category	Earthen Levee
Item	Encroachments

View of house along w/s toe.

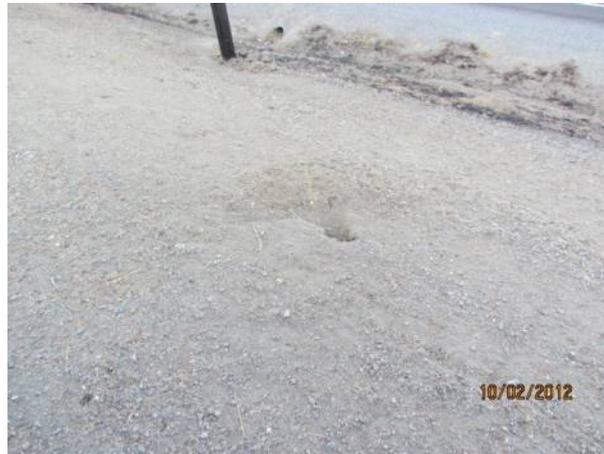
Levee Mile Report Line	6
Start Levee Mile	1.45
End Levee Mile	1.45
Location	Land Side
Category	Earthen Levee
Item	Animal Control

6	1.45	1.45	Earthen Levee	Animal Control	LS	M Ma	A3 : No rodents visible, but rodent burrows visible; need to backfill and compact or grout burrows.	39.434157 ° -122.010760 °	39.434157 ° -122.010760 °	4 Y
DWR ID: DWR_LD0002_01_f_2012_4										
7	1.54	1.62	Earthen Levee	Animal Control	LS	M Ma	A3 : No rodents visible, but rodent burrows visible; need to backfill and compact or grout burrows.	39.435485 ° -122.010640 °	39.436643 ° -122.010498 °	15 Y
DWR ID: DWR_LD0002_01_f_2012_15										
8	1.91	1.91	Earthen Levee	Animal Control	LS	C Ma	A3 : No rodents visible, but rodent burrows visible; need to backfill and compact or grout burrows.	39.440531 ° -122.011091 °	39.440531 ° -122.011091 °	149
DWR ID: DWR_LD0002_01_s_2012_149										
9	2.95	3.00	Earthen Levee	Animal Control	LS	M Ma	A3 : No rodents visible, but rodent burrows visible; need to backfill and compact or grout burrows.	39.453595 ° -122.016273 °	39.454003 ° -122.015503 °	2

View of the rodent holes along the landside slope.

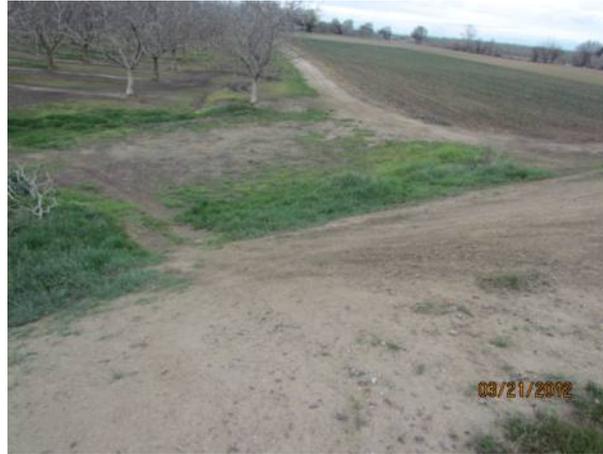
Levee Mile Report Line	15
Start Levee Mile	3.65
End Levee Mile	3.65
Location	Land Side
Category	Earthen Levee
Item	Slope Stability

LMIR No.	Levee Mile		Category	Item	* Location	+ Rating	Action/Comment	GPS Latitude/Longitude		Issue No. Photo
	Start	End						Start	End	
15	3.65	3.65	Earthen Levee	Slope Stability	LS	M	S3 : Repair the levee slope damaged by vehicle traffic and prevent access where possible.	39.459885 ° -122.010930 °	39.459885 ° -122.010930 °	10 Y
								DWR ID: DWR_LD0002_01_s_2012_10		
16	4.87	4.87	Earthen Levee	Animal Control	LS	M	A3 : No rodents visible, but rodent burrows visible; need to backfill and compact or grout burrows.	39.476676 ° -122.017439 °	39.476676 ° -122.017439 °	11 Y
								DWR ID: DWR_LD0002_01_s_2012_11

View of vehicle traffic driving up and down the slope of the levee.

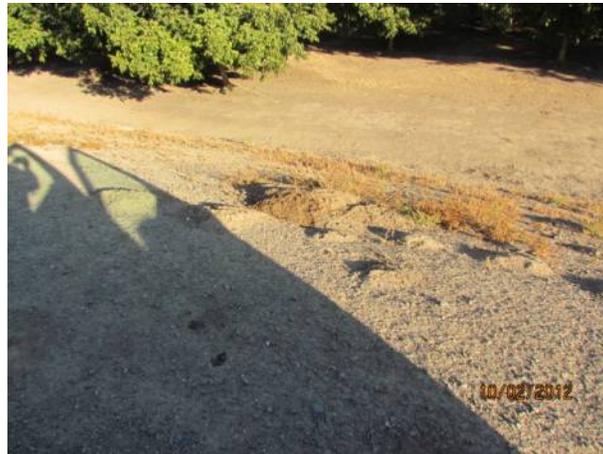
Levee Mile Report Line	16
Start Levee Mile	4.87
End Levee Mile	4.87
Location	Land Side
Category	Earthen Levee
Item	Animal Control

View of the rodent holes along the Levee slope.
