**Flood Control Project Maintenance  
Levee Inspections**

**Fall 2011 Levee Maintenance Deficiency Summary Report**

**Levee Inspection Report By Mile - Fall 2011**

**Levee District No. 0002 (Glenn County)**

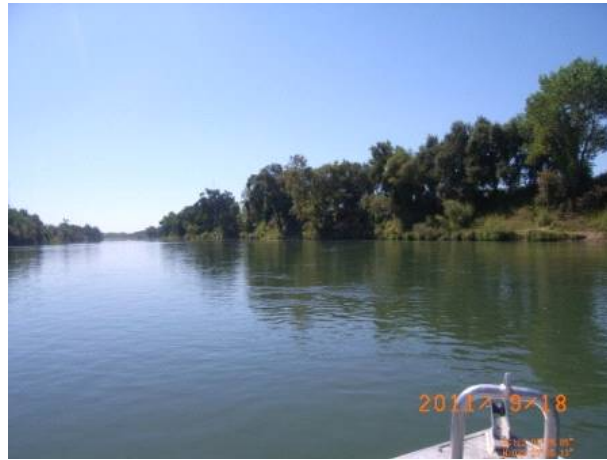
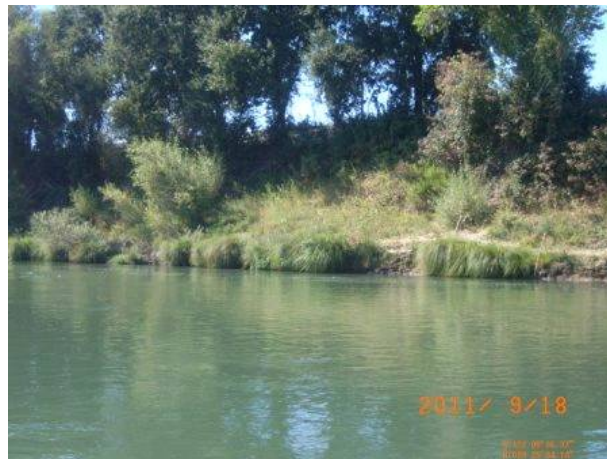
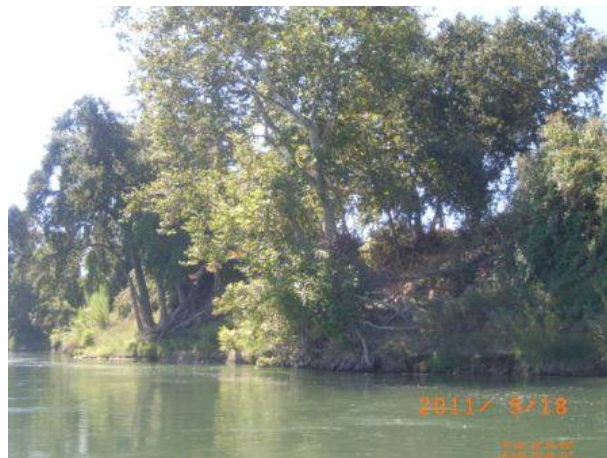
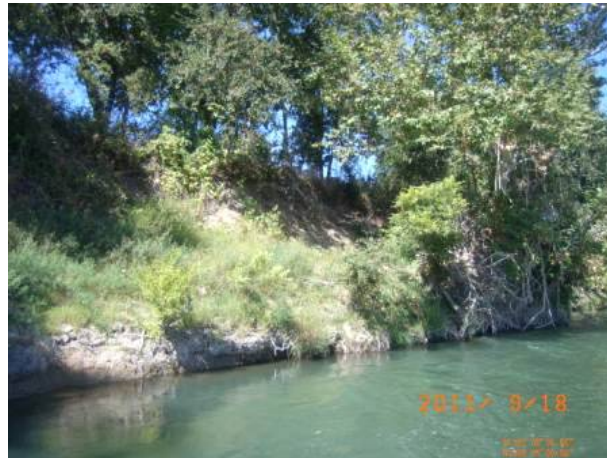
| LMR No. | Levee Mile | | Category | Item | Location * | Rating ** | Action/Comment | GPS Latitude/Longitude | | Issue No. |
|---|---|---|---|---|---|---|---|---|---|---|
| 1 | 0.02 | 0.02 | Supplemental | USACE Erosion Survey | WS | M | Inspector Comments: 2009 - Very slow retreat, hard toe, encroaching into the levee projection. 2010 - Slowly eroding. 2011: Site extended downstream. [2011 Site ID: SAC_164-7_R] | 39.414649 °<br>-122.009853 ° | 39.417689 °<br>-122.010369 ° | 6<br>Y |

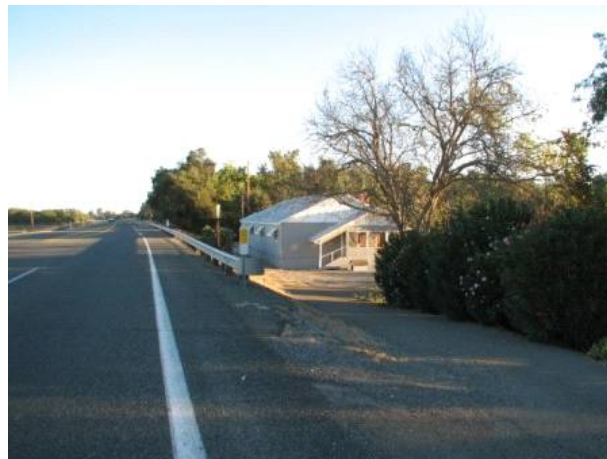
| Levee Mile Report Line | 3 |

| LMR No. | Levee Mile | | Category | Item | Location * | Rating ** | Action/Comment | GPS Latitude/Longitude | | Issue No. |
|---|---|---|---|---|---|---|---|---|---|---|
| 3 | 1.04 | 1.04 | Earthen Levee | Encroachments | WS | PO | Buildings | 39.428322 °<br>-122.010973 ° | 39.428322 °<br>-122.010973 ° | 8<br>Y |

View of house along w/s toe.

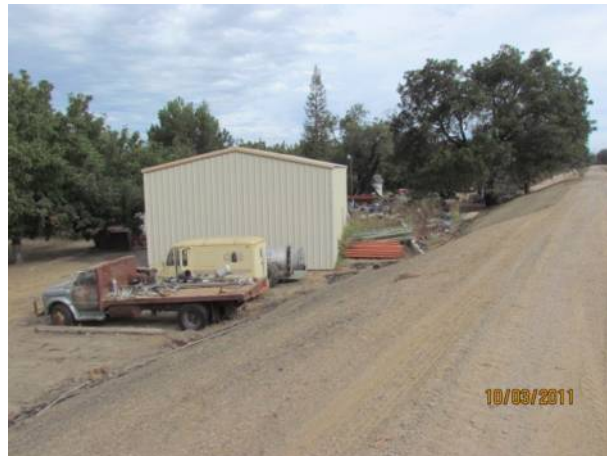
| Levee Mile Report Line | 4 |

| LMR No. | Levee Mile | | Category | Item | Location * | Rating ** | Action/Comment | GPS Latitude/Longitude | | Issue No. |
|---|---|---|---|---|---|---|---|---|---|---|
| 4 | 1.09 | 1.09 | Earthen Levee | Animal Control | WS | M | No rodents visible, but rodent burrows visible; need to backfill and compact or grout burrows. | 39.454387 °<br>-122.014835 ° | 39.428972 °<br>-122.010887 ° | 4<br>Y |

View of the rodent holes.

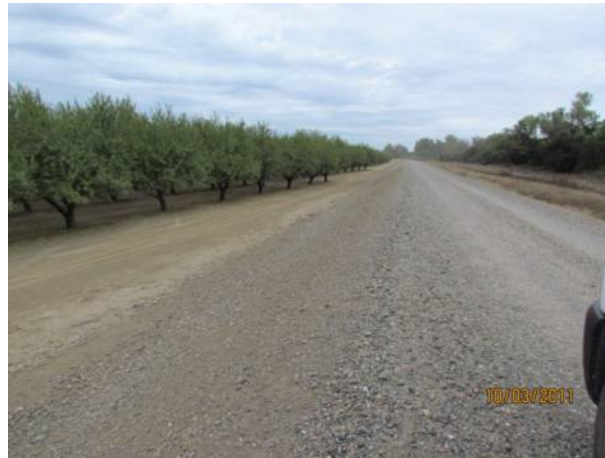
| Levee Mile Report Line | 5 |

| LMR No. | Levee Mile | | Category | Item | Location * | Rating ** | Action/Comment | GPS Latitude/Longitude | | Issue No. |
|---|---|---|---|---|---|---|---|---|---|---|
| 5 | 1.91 | 1.91 | Earthen Levee | Animal Control | LS | M | No rodents visible, but rodent burrows visible; need to backfill and compact or grout burrows. | 39.440531 °<br>-122.011091 ° | 39.440531 °<br>-122.011091 ° | 149<br>Y |

View of the rodent holes along the L/S slope.

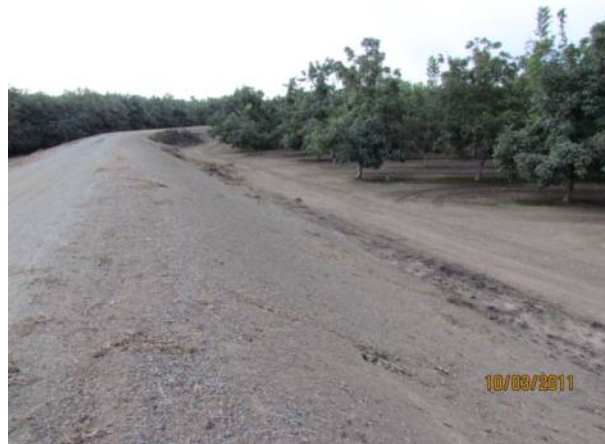
| Levee Mile Report Line | 8 |

| LMR No. | Levee Mile | | Category | Item | Location * | Rating ** | Action/Comment | GPS Latitude/Longitude | | Issue No. |
|---|---|---|---|---|---|---|---|---|---|---|
| 8 | 3.59 | 3.59 | Earthen Levee | Vegetation | LS | M | Remove the wild growth other than native grasses from the levee slopes. | 39.459103 °<br>-122.010313 ° | 39.459103 °<br>-122.010313 ° | 148<br>Y |

View of the vegetation along the L/S toe.

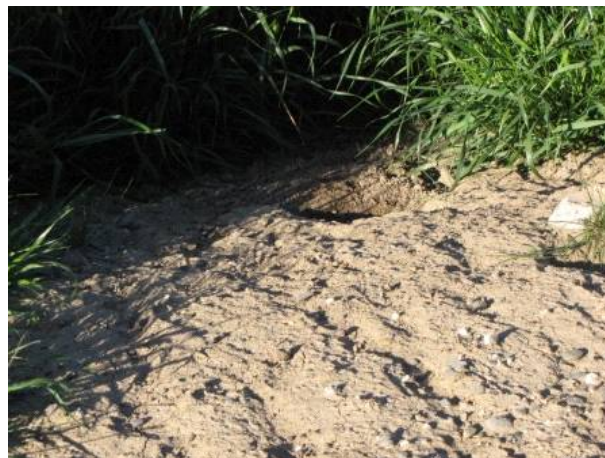
| Levee Mile Report Line | 9 |

| LMR No. | Levee Mile | | Category | Item | Location * | Rating ** | Action/Comment | GPS Latitude/Longitude | | Issue No. |
|---|---|---|---|---|---|---|---|---|---|---|
| 9 | 3.61 | 3.61 | Earthen Levee | Animal Control | LS | M | Repair the levee slope damaged by livestock and prevent large animal access. | 39.459348 °<br>-122.010500 ° | 39.459348 °<br>-122.010500 ° | 5<br>Y |

View of rodents burrows along L/S slope.
