**Flood Control Project Maintenance
Levee Inspections**

Fall 2013 Levee Maintenance Deficiency Summary Report

Sacramento River Basin

Levee District No. 0002 (Glenn County)

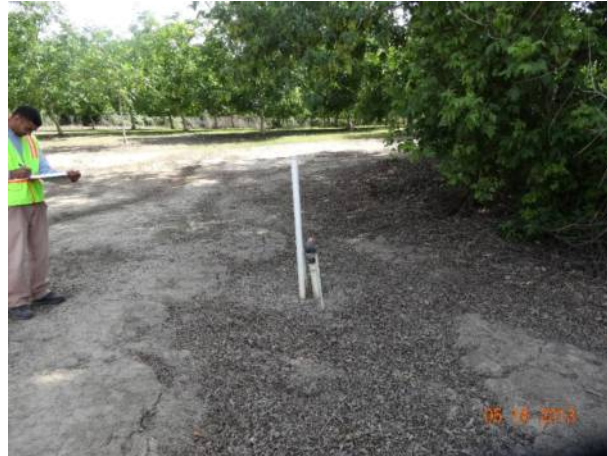
Levee Mile Report Line	6
Start Levee Mile	0.00
End Levee Mile	0.00
Location	Water Side
Category	Supplemental
Item	DWR UCIP Field Study
3-inch PVC pipe exposed on waterward toe.	
UCIP_12117.jpg

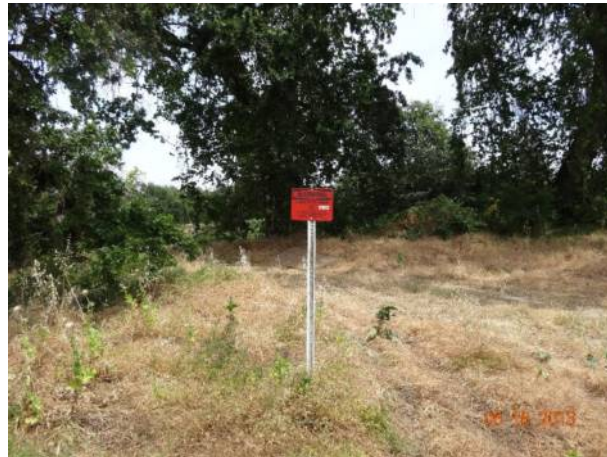
Levee Mile Report Line	9
Start Levee Mile	0.00
End Levee Mile	0.00
Location	Water Side
Category	Supplemental
Item	DWR UCIP Field Study
Indicator found on WS.	
UCIP_10132.jpg

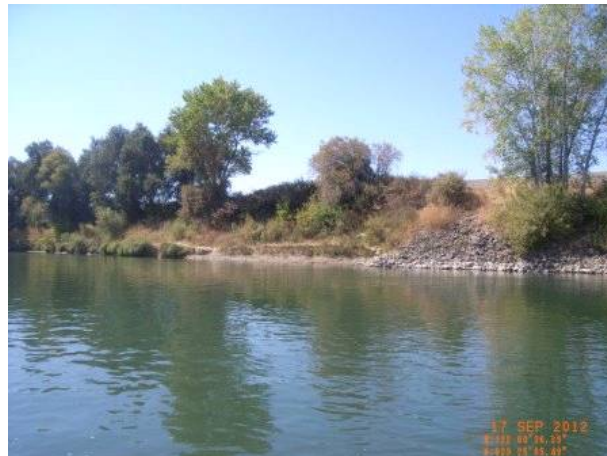
Levee Mile Report Line	10
Start Levee Mile	0.08
End Levee Mile	0.08
Location	Water Side
Category	Supplemental
Item	USACE Erosion Survey
USACE 2012 Photo #1	
USACE2013_SAC_164-7_R_1.jpg

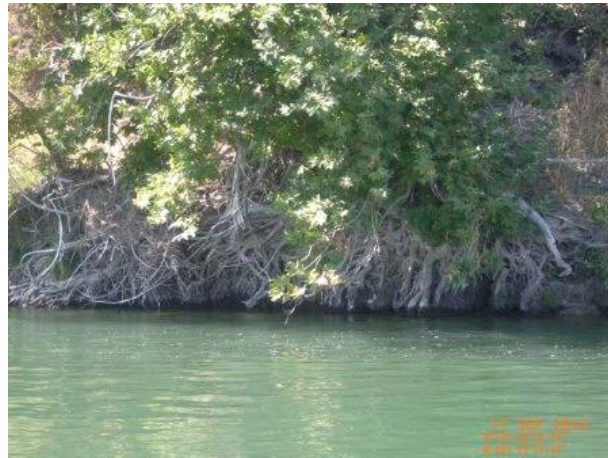
USACE 2012 Photo #2

Levee Mile Report Line	10
Start Levee Mile	0.08
End Levee Mile	0.08
Location	Water Side
Category	Supplemental
Item	USACE Erosion Survey

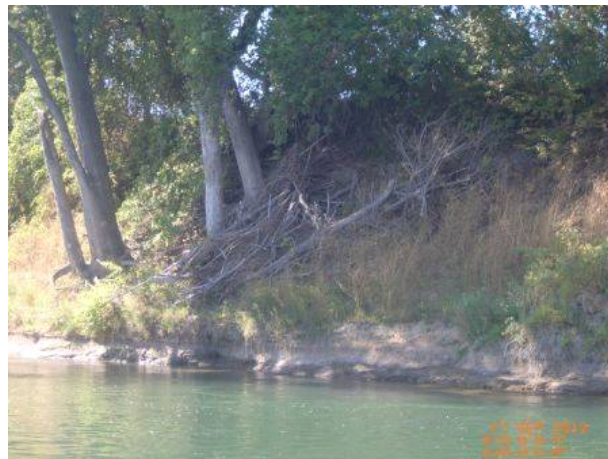
USACE 2012 Photo #3

Levee Mile Report Line	10
Start Levee Mile	0.08
End Levee Mile	0.08
Location	Water Side
Category	Supplemental
Item	USACE Erosion Survey

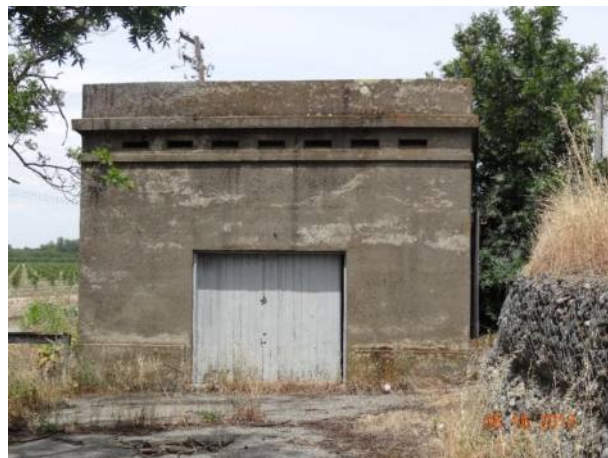
UCIP_12131.jpg

14	0.62	0.62	Supplemental	DWR UCIP Field Study	WS	M En	Inspector Comments: FS_ID:17993 EP_NO: N/A Repair Type: Non-Urgent Crossing Status: Found UCIP Comments: 3 pipes found in the pump house. Pump house seems abandoned. Unable to locate pipes on the WS. FIELD_STRUCT_DESC: [Princeton-Cordora-Glenn Irrigation District: Schaad Pumping Plant] 2 of 3: 34-inch steel pipe sleeved through 36-inch steel pipe through the levee, 20.0 feet below the crown. Annular gap is grouted. Flap gate on landward end. Pump in pump house on landward slope. Rock revetment around outlet on waterward slope. (USACE-1955). This entry matches the Drainage or Irrigation Structure referenced in O&M manual (Station 41+47). Pipes sleeved through pre-existing pipes, pump and parallel 28-inch pipe installed. FS Date: 5/16/2013	39.422314 °	39.422314 °	28
								-122.011803 °	-122.011803 °	Y

View of Princeton-Cordora-Glenn Irrigation District--Schaad Pumping Plant.

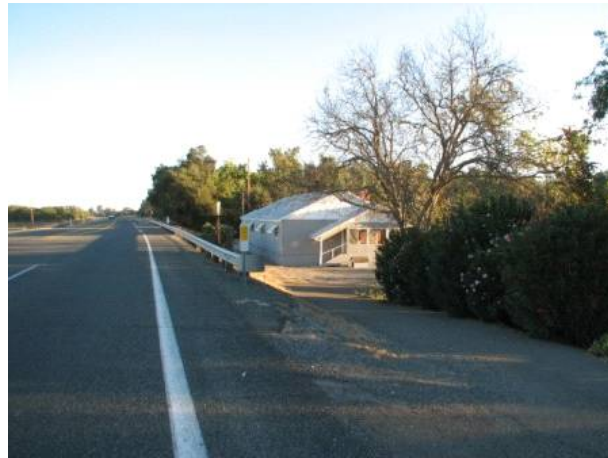
rduffey_f_20130919_701.jpg

Levee Mile Report Line	21
Start Levee Mile	1.04
End Levee Mile	1.04
Location	Water Side
Category	Earthen Levee
Item	Encroachments

View of house along w/s toe.

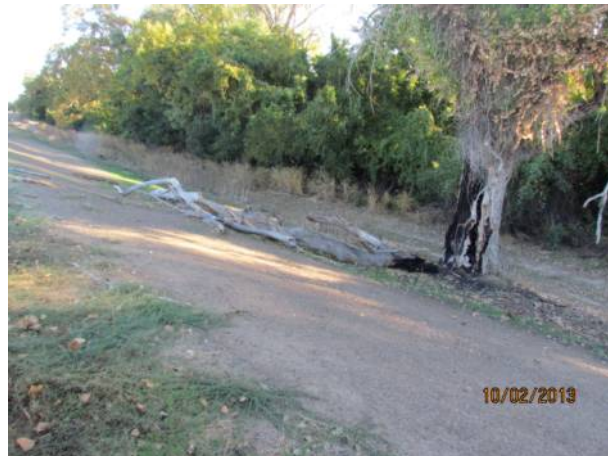
rduffey_f_20131021_098.JPG

DWR ID: DWR_LD0002_01_f_2013_37										
25	1.26	1.26	Earthen Levee	Encroachments	WS	M En	TR : Tree or limb	39.431499 ° -122.010803 °	39.431499 ° -122.010803 °	40 Y
DWR ID: DWR_LD0002_01_f_2013_40

View of the downed tree limb along the slope of the levee.

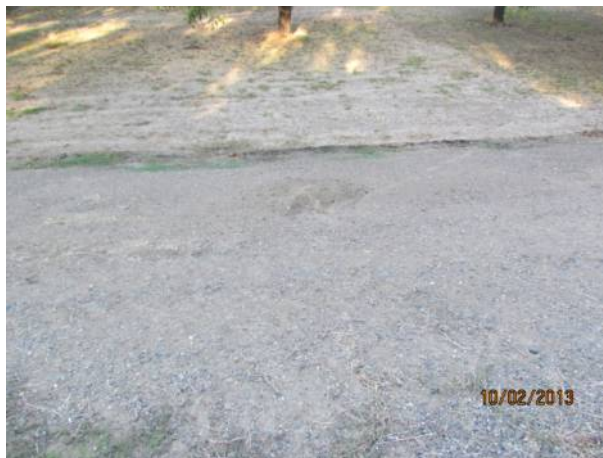
rduffey_f_20131021_099.JPG

Levee Mile Report Line	28
Start Levee Mile	1.58
End Levee Mile	1.58
Location	Land Side
Category	Earthen Levee
Item	Animal Control

View of the rodent holes along the slope of the levee.

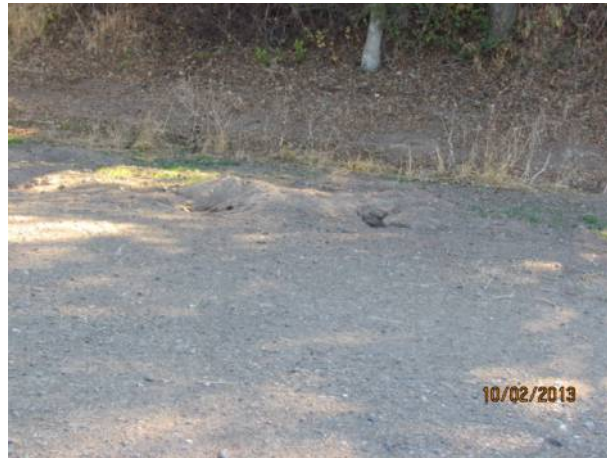
rduffey_f_20131021_100.JPG

Levee Mile Report Line	29
Start Levee Mile	2.81
End Levee Mile	2.81
Location	Water Side
Category	Earthen Levee
Item	Animal Control

View of the rodent holes along the slope of the levee.

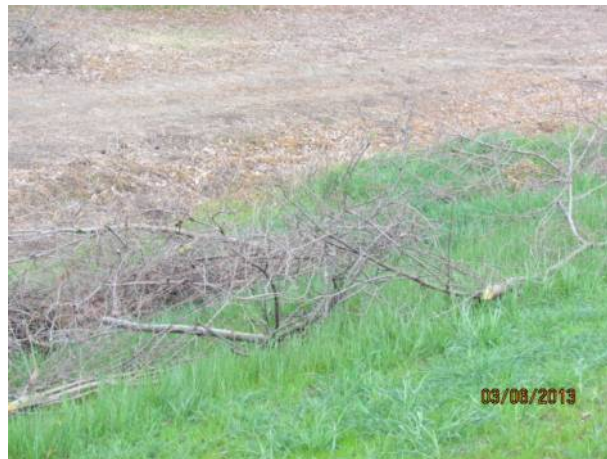
rduffey_f_20130919_697.JPG

Levee Mile Report Line	30
Start Levee Mile	2.93
End Levee Mile	2.93
Location	Land Side
Category	Earthen Levee
Item	Encroachments

View of the prunings along the landside toe.

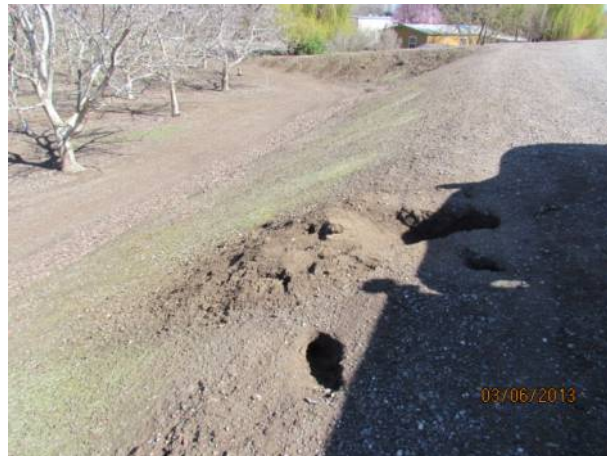
rduffey_f_20130919_705.JPG

Levee Mile Report Line	33
Start Levee Mile	3.20
End Levee Mile	3.20
Location	Water Side
Category	Earthen Levee
Item	Animal Control

View of the rodent activity along the landside slope.

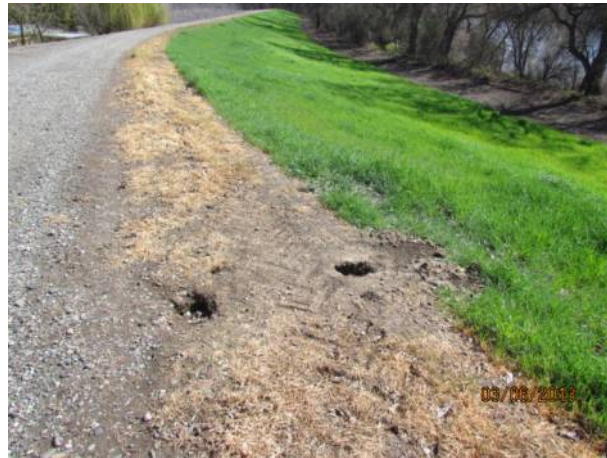
rduffey_f_20130919_702.JPG

34	3.20	3.20	Earthen Levee	Animal Control	LS	M Ma	A3 : No rodents visible, but rodent burrows visible; need to backfill and compact or grout burrows.	39.455992 ° -122.012808 °	39.455992 ° -122.012808 °	9 Y
DWR ID: DWR_LD0002_01_s_2013_9										
35	3.32	3.34	Earthen Levee	Animal Control	LS	M Ma	A3 : No rodents visible, but rodent burrows visible; need to backfill and compact or grout burrows.	39.456237 ° -122.010640 °	39.456272 ° -122.010163 °	16 Y
DWR ID: DWR_LD0002_01_f_2012_16										
36	3.56	3.61	Earthen Levee	Animal Control	LS	M Ma	A1 : Exterminate rodents and backfill and compact or grout burrows.	39.458803 ° -122.009980 °	39.459305 ° -122.010511 °	13 Y
DWR ID: DWR_LD0002_01_s_2013_13										
37	3.65	3.65	Earthen Levee	Slope Stability	LS	C Ma	S3 : Repair the levee slope damaged by vehicle traffic and prevent access where possible.	39.459885 ° -122.010930 °	39.459885 ° -122.010930 °	10 Y

View of the rodent activity along the waterside slope.

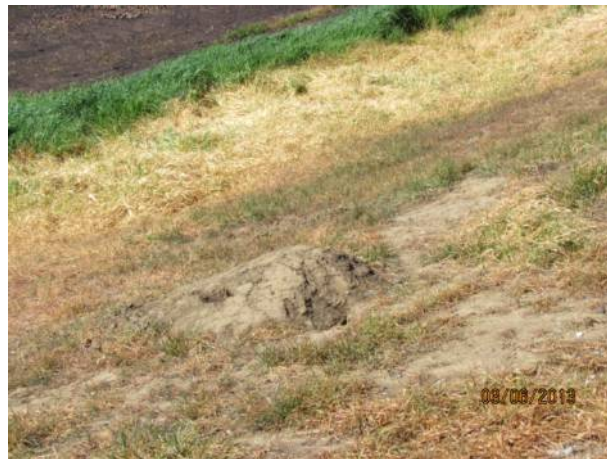
rduffey_f_20130919_706.JPG

Levee Mile Report Line	36
Start Levee Mile	3.56
End Levee Mile	3.61
Location	Land Side
Category	Earthen Levee
Item	Animal Control

View of the rodent activity along the landside slope.

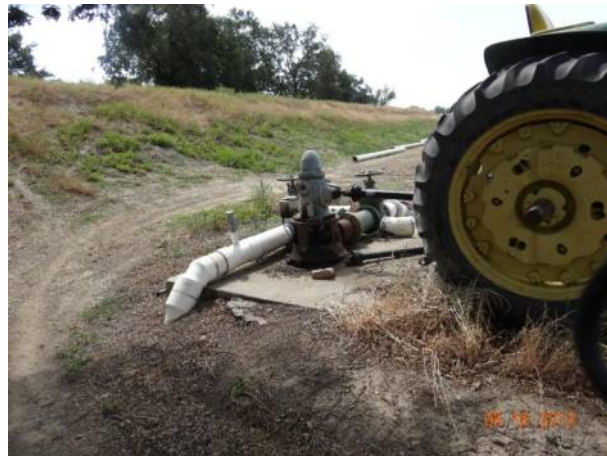
UCIP_12171.jpg

LMR No.	Levee Mile		Category	Item	Location	Rating	Action/Comment	GPS Latitude/Longitude		Issue No.
	Start	End						Start	End	
38	3.70	3.70	Supplemental	DWR UCIP Field Study	LS	M En	Inspector Comments: FS_ID:18011 EP_NO: 16931 Repair Type: Non-Urgent Crossing Status: Indicator Found UCIP Comments: Believed that steel pipe was not installed but PVC was installed and connect over the levee. Remove entry. FIELD_STRUCT_DESC: 8-inch steel irrigation pipe through the levee, 2.0 feet below the levee. Siphon breaker on waterward shoulder. Cutoff valve on landward side. Pipe connects to 8-inch PVC pipe extending past landward toe. (Permit No. 16931-2005) FS Date: 5/16/2013	39.461509 ° -122.011218 °	39.461509 ° -122.011218 °	38 Y
DWR ID: DWR_LD0002_01_f_2013_38										
39	4.34	4.34	Supplemental	DWR UCIP Field Study	LS	M En	Inspector Comments: FS_ID:19703 EP_NO: 18072 Repair Type: Non-Urgent Crossing Status: Indicator Found UCIP Comments: Disturbed soil on the WS toe near the 3" PVC pipe. FIELD_STRUCT_DESC: 6-inch steel irrigation pipe through the levee, 2.0 feet below the levee. Provide a field description of this crossing. (Permit No. 18072-2006) FS Date: 5/16/2013	39.469908 ° -122.012117 °	39.469908 ° -122.012117 °	39 Y

Pump system located near landward toe.

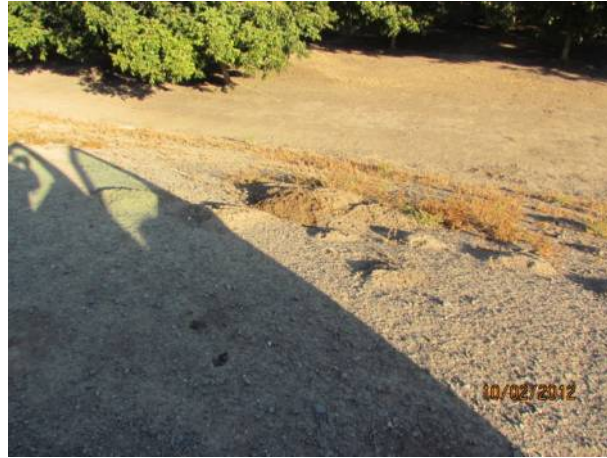
rduffey_f_20130919_704.JPG

DWR ID: DWR_LD0002_01_f_2013_39										
40	4.87	4.87	Earthen Levee	Animal Control	LS	M Ma	A3 : No rodents visible, but rodent burrows visible; need to backfill and compact or grout burrows.	39.476676 ° -122.017439 °	39.476676 ° -122.017439 °	11 Y
DWR ID: DWR_LD0002_01_s_2012_11

View of the rodent holes along the levee slope.
