**Flood Control Project Maintenance
Levee Inspections**

Fall 2014 Levee Maintenance Deficiency Summary Report

Levee District No. 0002 (Glenn County)

Levee Inspection Report By Mile - Fall 2014

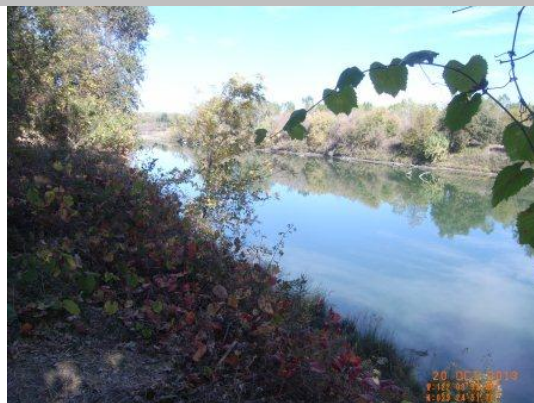
Photo 1 of 2 : FA_2014_LD0002_28_6_20141013_00003.jpg

LM Start	0.02	Rating **	M	Issue No.	6
LM End	0.02	Issue Type +	Ma	Location *	WS
Category	Supplemental			GPS Latitude/Longitude	
				Start	End
Item	USACE Erosion Survey			39.414649 °	39.417689 °
				-122.009853 °	-122.010369 °
DWR ID	DWR_LD0002_01_f_2014_6				
Action/Comments					
Inspector Comments: 2009 - Very slow retreat, hard toe, encroaching into the levee projection. 2010 - Slowly eroding. 2011 - Site extended downstream. 2013: No observed changes. [2013 Site ID: SAC_164-7_R]

USACE 2013 Photo #1

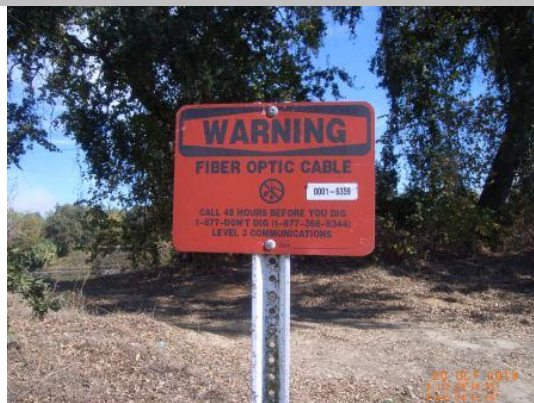
Photo 2 of 2 : FA_2014_LD0002_28_6_20141013_00004.jpg

USACE 2013 Photo #2

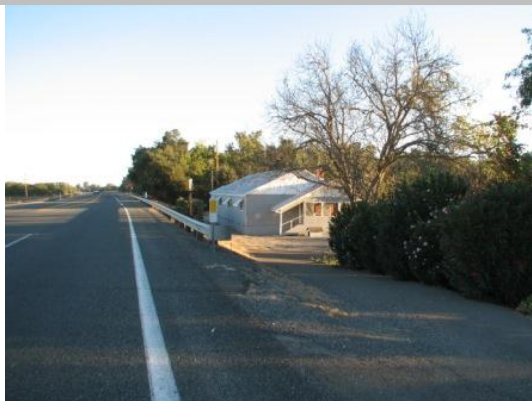
Photo 1 of 1 : FA_2014_LD0002_28_8_20141013_00005.jpg

LM Start	1.04	Rating **	M	Issue No.	8
LM End	1.04	Issue Type +	En	Location *	WS
Category	Earthen Levee			GPS Latitude/Longitude	
				Start	End
Item	Encroachments			39.428322 °	39.428322 °
				-122.010973 °	-122.010973 °
DWR ID	DWR_LD0002_01_s_2012_8				
Action/Comments					
Building

View of house along w/s toe.

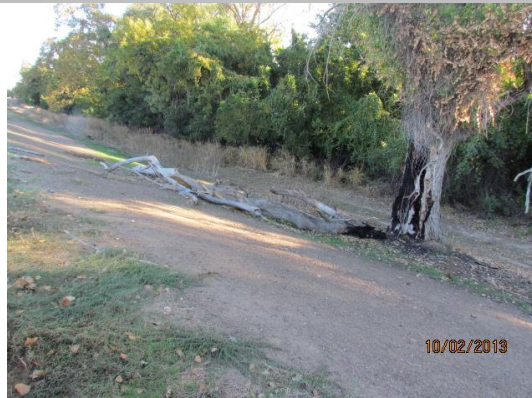
Photo 1 of 1 : FA_2014_LD0002_28_40_20141013_00012.jpg

LM Start	1.26	Rating **	M	Issue No.	40
LM End	1.26	Issue Type +	En	Location *	WS
Category	Earthen Levee			GPS Latitude/Longitude	
				Start	End
Item	Encroachments			39.431499 °	39.431499 °
				-122.010803 °	-122.010803 °
DWR ID	DWR_LD0002_01_f_2013_40				
Action/Comments					
Tree or limb

View of the downed tree limb along the slope of the levee.

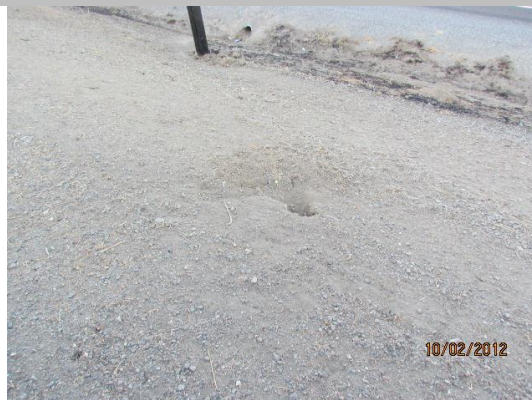
Photo 1 of 1 : FA_2014_LD0002_28_4_20141013_00001.jpg

LM Start	1.45	Rating **	M	Issue No.	4
LM End	1.45	Issue Type +	Ma	Location *	LS
Category	Earthen Levee			GPS Latitude/Longitude	
				Start	End
Item	Animal Control			39.434157 °	39.434157 °
				-122.010760 °	-122.010760 °
DWR ID	DWR_LD0002_01_f_2012_4				
Action/Comments					
No rodents visible, but rodent burrows visible; need to backfill and compact or grout burrows.

View of the rodent holes along the landside slope.

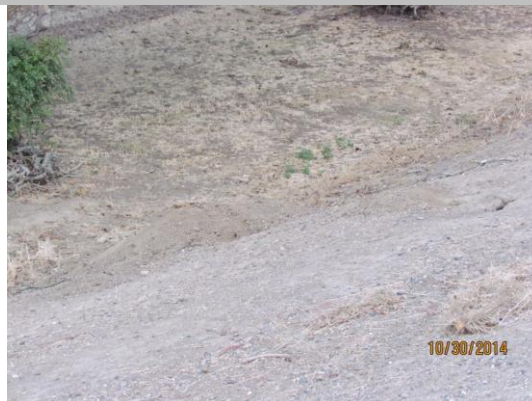
Photo 1 of 1 : FA_2014_LD0002_28_15_20141121_00015.jpg

LM Start	1.54	Rating **	M	Issue No.	15
LM End	1.62	Issue Type +	Ma	Location *	LS
Category	Earthen Levee			GPS Latitude/Longitude	
				Start	End
Item	Animal Control			39.435485 °	39.436643 °
				-122.010640 °	-122.010498 °
DWR ID	DWR_LD0002_01_f_2012_15				
Action/Comments					
No rodents visible, but rodent burrows visible; need to backfill and compact or grout burrows.

View of the rodent holes along the landside slope.

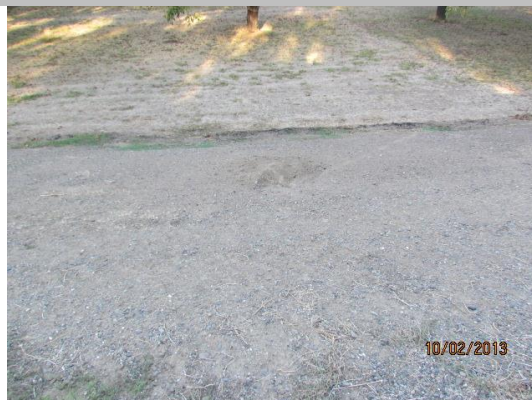
Photo 1 of 1 : FA_2014_LD0002_28_41_20141013_00013.jpg

LM Start	1.58	Rating **	A/W	Issue No.	41
LM End	1.58	Issue Type +	Ma	Location *	LS
Category	Earthen Levee			GPS Latitude/Longitude	
				Start	End
Item	Animal Control			39.436149 °	39.436149 °
				-122.010525 °	-122.010525 °
DWR ID	DWR_LD0002_01_f_2013_41				
Action/Comments					
No rodents visible, but rodent burrows visible; need to backfill and compact or grout burrows.

View of the rodent holes along the slope of the levee.

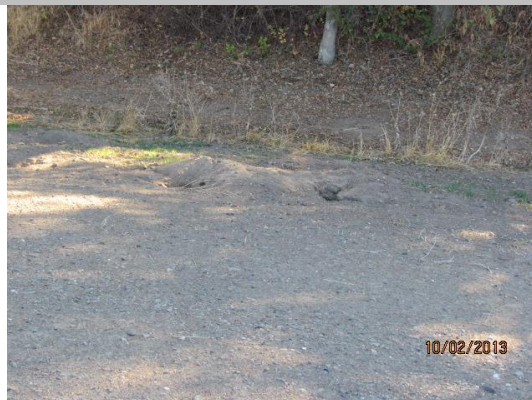
Photo 1 of 1 : FA_2014_LD0002_28_42_20141013_00014.jpg

LM Start	2.81	Rating **	A/W	Issue No.	42
LM End	2.81	Issue Type +	Ma	Location *	WS
Category	Earthen Levee			GPS Latitude/Longitude	
				Start	End
Item	Animal Control			39.451841 °	39.451841 °
				-122.017120 °	-122.017120 °
DWR ID	DWR_LD0002_01_f_2013_42				
Action/Comments					
No rodents visible, but rodent burrows visible; need to backfill and compact or grout burrows.

View of the rodent holes along the slope of the levee.

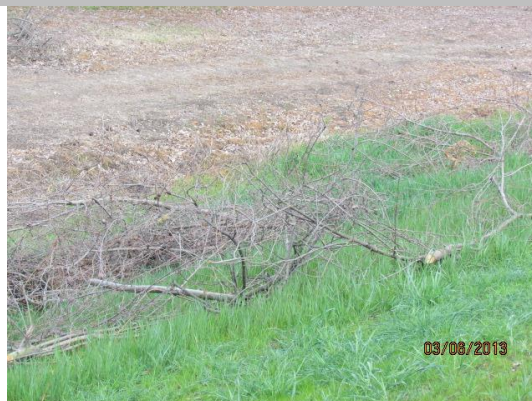
Photo 1 of 1 : FA_2014_LD0002_28_5_20141013_00002.jpg

LM Start	2.93	Rating **	M	Issue No.	5
LM End	2.93	Issue Type +	En	Location *	LS
Category	Earthen Levee			GPS Latitude/Longitude	
				Start	End
Item	Encroachments			39.453490 °	39.453490 °
				-122.016457 °	-122.016457 °
DWR ID	DWR_LD0002_01_s _ 2013_5				
Action/Comments					
Prunings

View of the prunings along the landside toe.

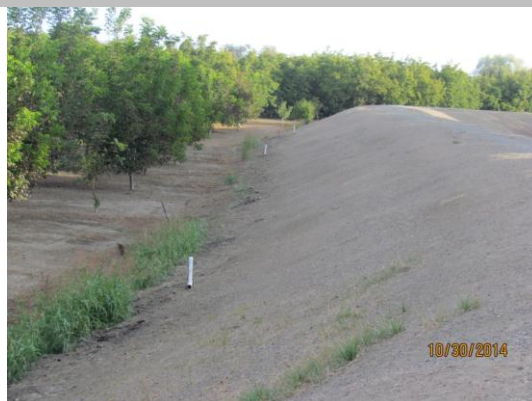
Photo 1 of 1 : FA_2014_LD0002_28_2_20141121_00016.jpg

LM Start	2.95	Rating **	A/W	Issue No.	2
LM End	3.00	Issue Type +	Ma	Location *	LS
Category	Earthen Levee			GPS Latitude/Longitude	
				Start	End
Item	Animal Control			39.453595 °	39.454003 °
				-122.016273 °	-122.015503 °
DWR ID	DWR_LD0002_01_s _ 2012_2				
Action/Comments					
No rodents visible, but rodent burrows visible; need to backfill and compact or grout burrows.

View of the rodent holes and bait station along the landside slope.

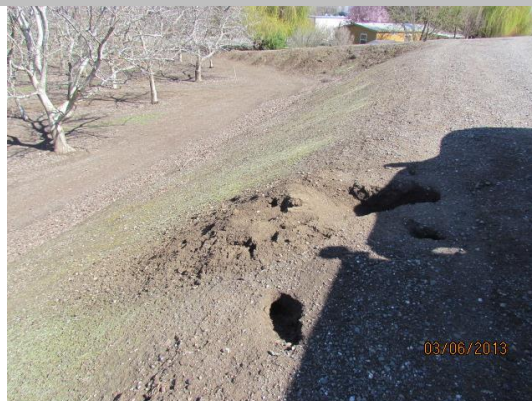
Photo 1 of 1 : FA_2014_LD0002_28_12_20141013_00008.jpg

LM Start	3.20	Rating **	M	Issue No.	12
LM End	3.20	Issue Type +	Ma	Location *	WS
Category	Earthen Levee			GPS Latitude/Longitude	
				Start	End
Item	Animal Control			39.455992 °	39.455992 °
				-122.012809 °	-122.012809 °
DWR ID	DWR_LD0002_01_s _ 2013_12				
Action/Comments					
Exterminate rodents and backfill and compact or grout burrows.

View of the rodent activity along the landside slope.

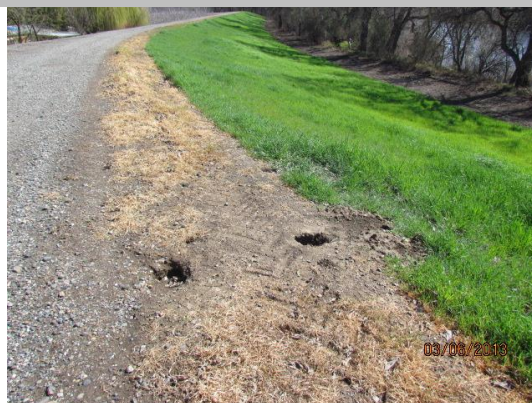
Photo 1 of 1 : FA_2014_LD0002_28_9_20141013_00006.jpg

LM Start	3.20	Rating **	M	Issue No.	9
LM End	3.20	Issue Type +	Ma	Location *	LS
Category	Earthen Levee			GPS Latitude/Longitude	
				Start	End
Item	Animal Control			39.455992 °	39.455992 °
				-122.012808 °	-122.012808 °
DWR ID	DWR_LD0002_01_s _ 2013_9				
Action/Comments					
No rodents visible, but rodent burrows visible; need to backfill and compact or grout burrows.

View of the rodent activity along the waterside slope.

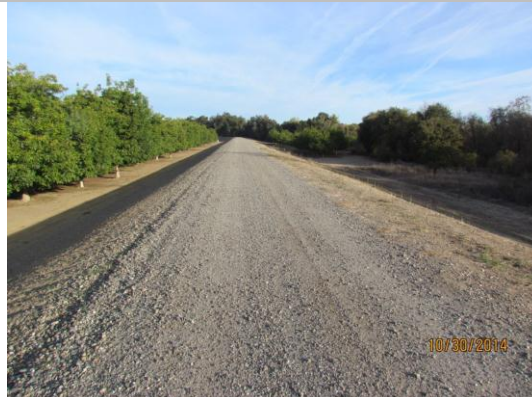
Photo 1 of 1 : FA_2014_LD0002_28_28_20141121_00017.jpg

LM Start	4.13	Rating **	A	Issue No.	28
LM End	4.13	Issue Type +	Ma	Location *	LS
Category	Earthen Levee			GPS Latitude/Longitude	
				Start	End
Item	Vegetation			39.466840 °	39.466840 °
				-122.011457 °	-122.011457 °
DWR ID	DWR_LD0002_01_f_2014_28				
Action/Comments					
Control annual grass and weeds on the levee slopes and easements.

View of the controled vegetation on both slopes.

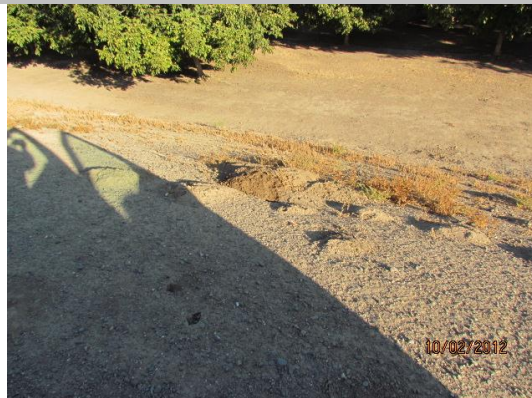
Photo 1 of 1 : FA_2014_LD0002_28_11_20141013_00007.jpg

LM Start	4.87	Rating **	M	Issue No.	11
LM End	4.87	Issue Type +	Ma	Location *	LS
Category	Earthen Levee			GPS Latitude/Longitude	
				Start	End
Item	Animal Control			39.476676 °	39.476676 °
				-122.017439 °	-122.017439 °
DWR ID	DWR_LD0002_01_s_2012_11				
Action/Comments					
No rodents visible, but rodent burrows visible; need to backfill and compact or grout burrows.

View of the rodent holes along the levee slope.
