**Flood Control Project Maintenance
Levee Inspections**

Fall 2015 Levee Maintenance Deficiency Summary Report

Sacramento River Basin

Levee District No. 0002 (Glenn County)

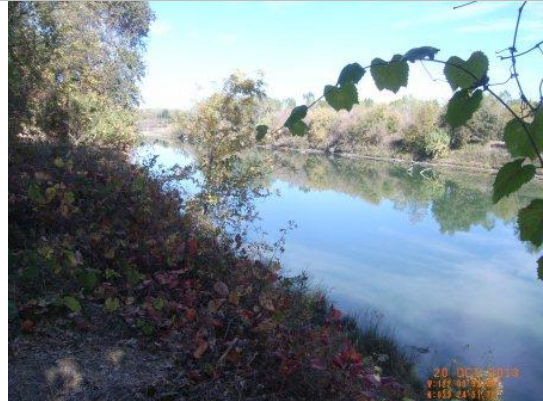
Photo 1 of 2 : USACE2013A_SAC_164-7_R_1.jpg

LM Start	0.07	Rating **	M	Issue No.	6
LM End	0.28	Issue Type +	Ma	Location *	WS
Category	Supplemental			GPS Latitude/Longitude	
				Start	End
Item	2015 USACE Erosion Survey, DRAFT			39.414649 °	39.417689 °
				-122.009853 °	-122.010369 °
DWR ID					
Action/Comments					
Inspector Comments: 2009 - Very slow retreat, hard toe, encroaching into the levee projection. 2010 - Slowly eroding. 2011 - Site extended downstream. 2015: Last observed in 2013. [2015 Site ID: SAC_164-7_R]

USACE 2013 Photo #1

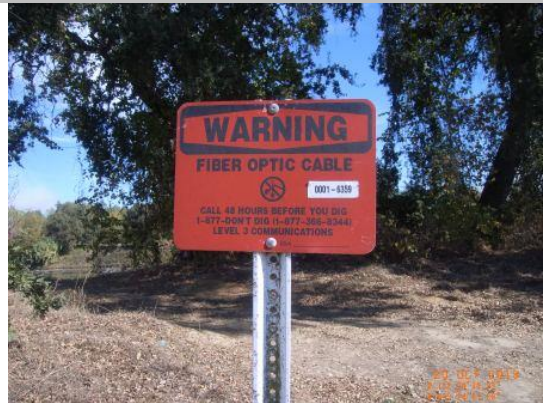
Photo 2 of 2 : USACE2013A_SAC_164-7_R_3.jpg

USACE 2013 Photo #2

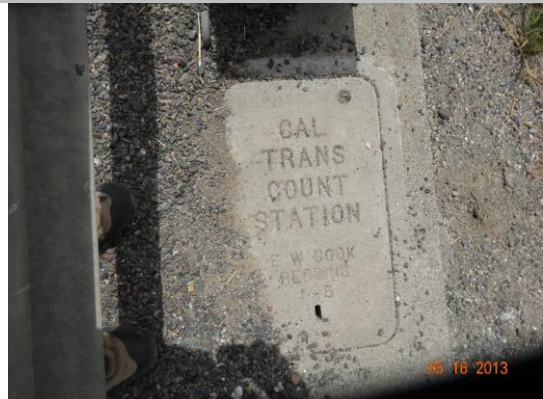
Photo 1 of 3 : UCIP_FA_2015_6687.jpg

LM Start	0.59	Rating **	M	Issue No.	43
LM End	0.59	Issue Type +	En	Location *	WS
Category	Supplemental			GPS Latitude/Longitude	
				Start	End
Item	DWR UCIP Field Study			39.422088 °	39.422088 °
				-122.011615 °	-122.011615 °
DWR ID					
Action/Comments					
Inspector Comments: FS_ID:42083 DS_ID:24877 EP_NO: N/A FS_HLM: 0.6 Repair Type: Non-Urgent Crossing Status: Indicator Found

Service box located on landward shoulder.

Action/Comments					
Inspector Comments: FS_ID:42083 DS_ID:24877 EP_NO: N/A FS_HLM: 0.6 Repair Type: Non-Urgent Crossing Status: Indicator Found UCIP Comments: Need to contact owner to determine if conduit goes through levee crown. If it does, will need to obtain permit number issued for encroachment. FIELD_STRUCT_DESC: Caltrans traffic control box located on the landward side shoulder. Unable to determine if crossing goes through levee. FS Date: 05/16/2013

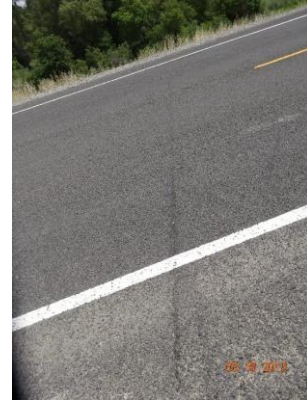
Photo 2 of 3 : UCIP_FA_2015_6688.jpg

View of levee crown at crossing.

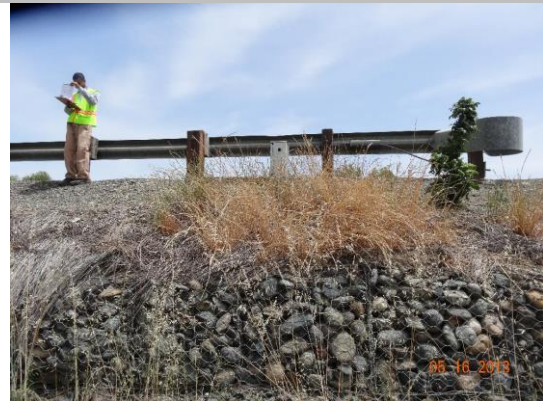
Photo 3 of 3 : UCIP_FA_2015_6689.jpg

View of landward slope.

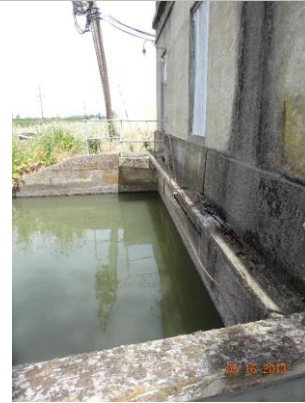
Photo 1 of 3 : UCIP_FA_2015_6552.jpg

LM Start	0.61	Rating **	M	Issue No.	44
LM End	0.61	Issue Type +	En	Location *	WS
Category	Supplemental			GPS Latitude/Longitude	
				Start	End
Item	DWR UCIP Field Study			39.422282 °	39.422282 °
				-122.011634 °	-122.011634 °
DWR ID					
Action/Comments					
Inspector Comments: FS_ID:38165					
DS_ID:21185					
EP_NO: 2356					
FS_HLM: 0.619					
Repair Type: Non-Urgent					
Crossing Status: Found

View of landward side--outlet.

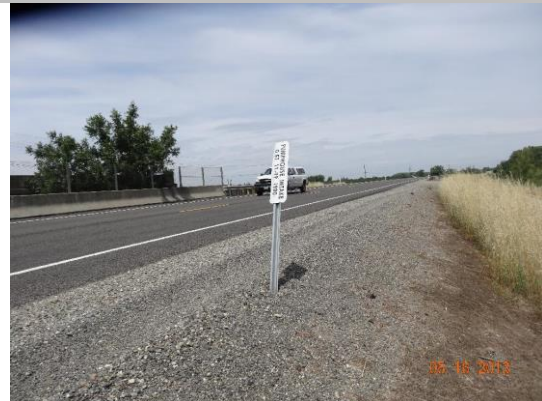
Photo 2 of 3 : UCIP_FA_2015_6658.jpg

View of levee crown at crossing.

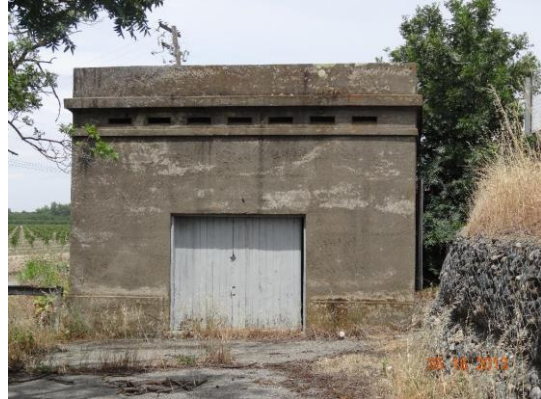
Photo 3 of 3 : UCIP_FA_2015_6659.jpg

View of Princeton-Cordora-Glenn Irrigation District--Schaad Pumping Plant.

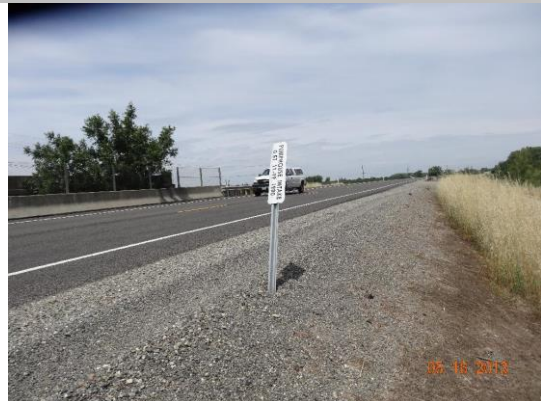
Photo 1 of 3 : UCIP_FA_2015_6660.jpg

LM Start	0.61	Rating **	M	Issue No.	45
LM End	0.61	Issue Type +	En	Location *	WS
Category	Supplemental			GPS Latitude/Longitude	
				Start	End
Item	DWR UCIP Field Study			39.422302 °	39.422302 °
				-122.011635 °	-122.011635 °
DWR ID					
Action/Comments					
Inspector Comments: FS_ID:38166 DS_ID:21184 EP_NO: N/A FS_HLM: 0.62 Repair Type: Non-Urgent Crossing Status: Found UCIP Comments: Three pipes found in the pump house on landward side. Pump house appears to be no longer in use. Unable to locate pipes on waterward side. Will need to contact owner to determine status. Owner will need to coordinate with CVFPB regarding proper removal per Title 23 requirements. FIELD_STRUCT_DESC: [Princeton-Cordora-Glenn Irrigation District: Schaad Pumping Plant] 2 of 3: 34-inch steel pipe sleeved through 36-inch steel pipe through the levee, 20.0 feet below the crown. Annular gap is grouted. Flap gate on landward end. Pump in pump house on landward slope. Rock revetment around outlet on waterward slope. (USACE-1955). This entry matches the Drainage or Irrigation Structure referenced in O&M manual (Station 41+47). Pipes sleeved through pre-existing pipes, pump and parallel 28-inch pipe installed. FS Date: 05/16/2013

View of levee crown at crossing.

Inspector Comments: FS_ID:38166
 DS_ID:21184
 EP_NO: N/A
 FS_HLM: 0.62
 Repair Type: Non-Urgent
 Crossing Status: Found
 UCIP Comments: Three pipes found in the pump house on landward side. Pump house appears to be no longer in use. Unable to locate pipes on waterward side. Will need to contact owner to determine status. Owner will need to coordinate with CVFPB regarding proper removal per Title 23 requirements.
 FIELD_STRUCT_DESC: [Princeton-Cordora-Glenn Irrigation District: Schaad Pumping Plant] 2 of 3: 34-inch steel pipe sleeved through 36-inch steel pipe through the levee, 20.0 feet below the crown. Annular gap is grouted. Flap gate on landward end. Pump in pump house on landward slope. Rock revetment around outlet on waterward slope. (USACE-1955). This entry matches the Drainage or Irrigation Structure referenced in O&M manual (Station 41+47). Pipes sleeved through pre-existing pipes, pump and parallel 28-inch pipe installed.

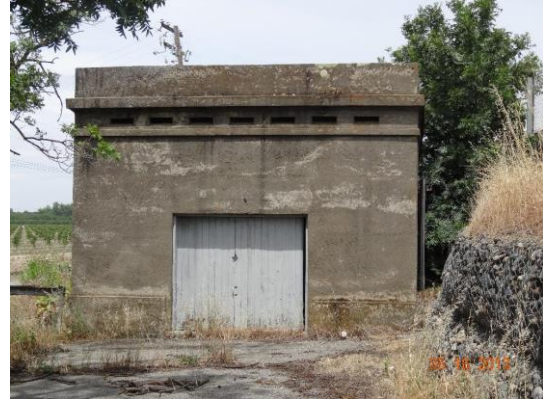
Photo 2 of 3 : UCIP_FA_2015_6661.jpg

View of Princeton-Cordora-Glenn Irrigation District--Schaad Pumping Plant.

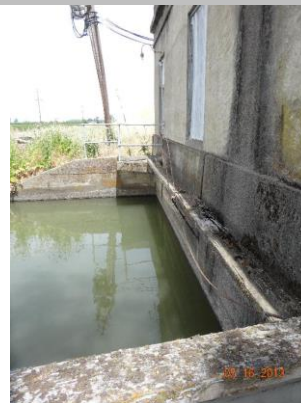
Photo 3 of 3 : UCIP_FA_2015_6662.jpg

View of landward side--outlet.

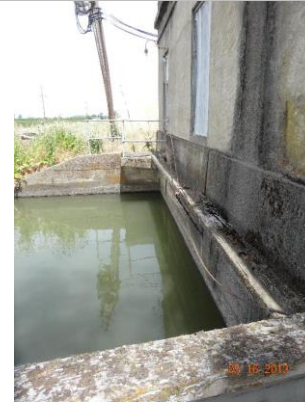
Photo 1 of 3 : UCIP_FA_2015_6663.jpg

UCIP Comments: Three pipes found in the pump house on landward side. Pump house appears to be no longer in use. Unable to locate pipes on waterward side. Will need to contact owner to determine status. Owner will need to coordinate with CVFPB regarding proper removal per Title 23 requirements.

View of landward side--outlet.

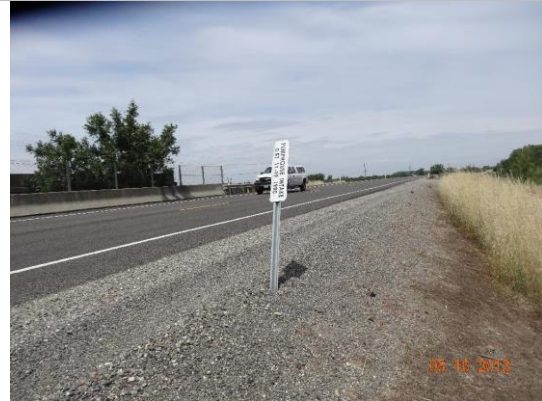
Photo 2 of 3 : UCIP_FA_2015_6664.jpg

View of levee crown with marker on waterward side.

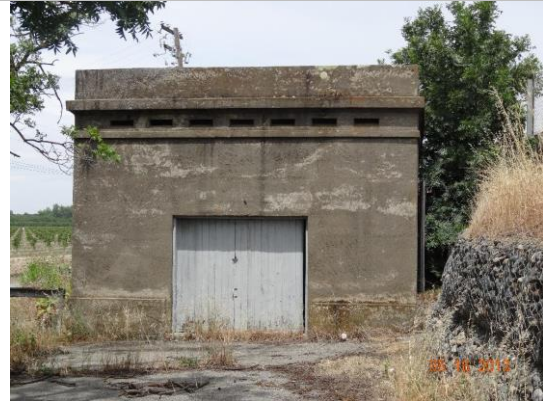
Photo 3 of 3 : UCIP_FA_2015_6665.jpg

UCIP Comments: Three pipes found in the pump house on landward side. Pump house appears to be no longer in use. Unable to locate pipes on waterward side. Will need to contact owner to determine status. Owner will need to coordinate with CVFPB regarding proper removal per Title 23 requirements.

View of Princeton-Cordora-Glenn Irrigation District-Schaad Pumping Plant.

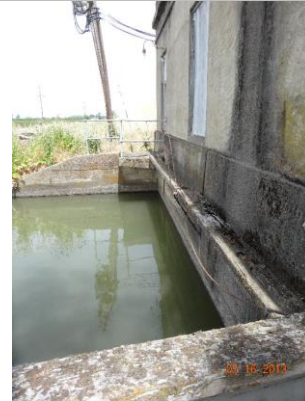
Photo 1 of 3 : UCIP_FA_2015_6666.jpg

Inspector Comments: FS_ID:38168
DS_ID:21182
EP_NO: N/A
FS_HLM: 0.623
Repair Type: Non-Urgent
Crossing Status: Indicator Found
UCIP Comments: Unable to verify if the pipes inside the existing pump house correlate to 24-inch installed in 1955. Three pipes found in the pump house on landward side. Pump house appears to be no longer in use. Unable to locate pipes on waterward side. Will need to contact owner to determine status.
FIELD_STRUCT_DESC: [Pumping Plant] 24-inch steel pipe through the levee, 27.3 feet below the crown. Flap gate on landward side. Pump in pump house on landward side. (USACE-1955). This entry matches the Drainage or Irrigation Structure referenced in O&M manual (Station 41+47).
FS Date: 05/16/2013

View of landward side--outlet.

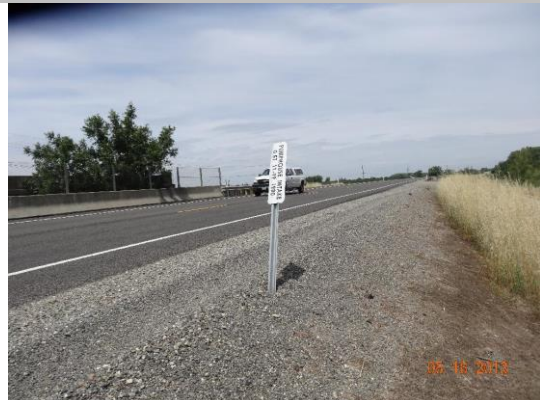
Photo 2 of 3 : UCIP_FA_2015_6706.jpg

View of levee crown with marker on waterward side.

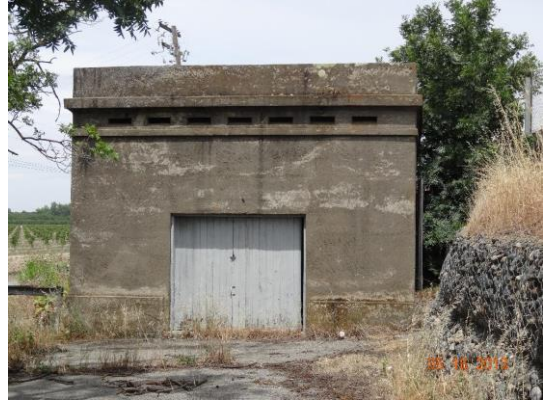
Photo 3 of 3 : UCIP_FA_2015_6707.jpg

View of Princeton-Cordora-Glenn Irrigation District-Schaad Pumping Plant.

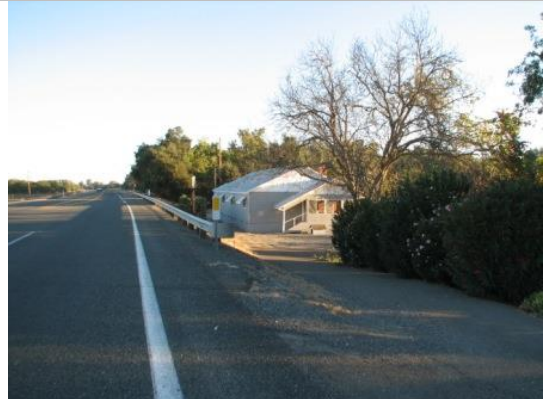
Photo 1 of 2 : FA_2015_LD0002_28_8_20150910_00006.jpg

LM Start	1.02	Rating **	M	Issue No.	8
LM End	1.02	Issue Type +	En	Location *	WS
Category	Earthen Levee			GPS Latitude/Longitude	
				Start	End
Item	Encroachments			39.428322 °	39.428322 °
				-122.010973 °	-122.010973 °
DWR ID	DWR_LD0002_01_s_2012_8				
Action/Comments					
Building

View of a house along the waterside toe.

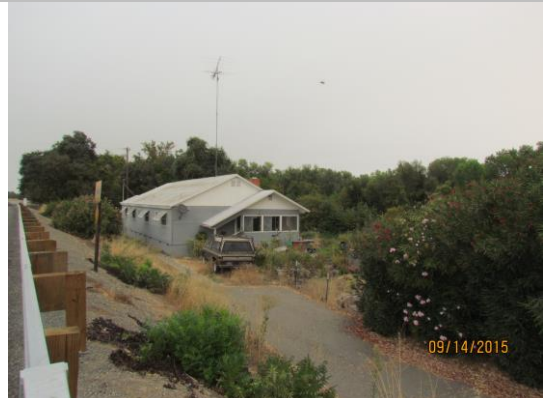
Photo 2 of 2 : FA_2015_LD0002_28_8_20151013_00018.jpg

View of the house along the waterside toe.

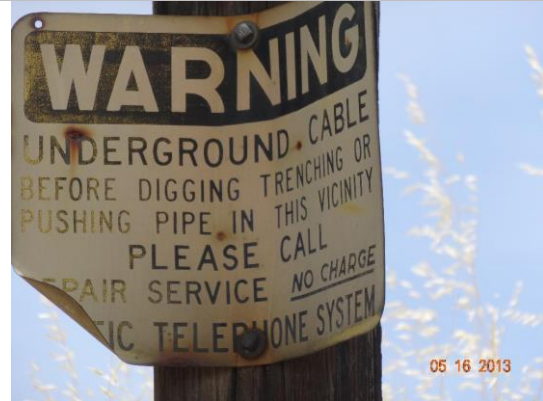
Photo 1 of 3 : UCIP_FA_2015_5990.jpg

LM Start	1.03	Rating **	M	Issue No.	48
LM End	1.03	Issue Type +	En	Location *	WS
Category	Supplemental			GPS Latitude/Longitude	
				Start	End
Item	DWR UCIP Field Study			39.428441 °	39.428441 °
				-122.011032 °	-122.011032 °
DWR ID					
Action/Comments					
Inspector Comments: FS_ID:44170					
DS_ID:21177					
EP_NO: 9723					
FS_HLM: 1.05					
Repair Type: Non-Urgent					
Crossing Status: Indicator Found

Sign lists Pacific Telephone system.

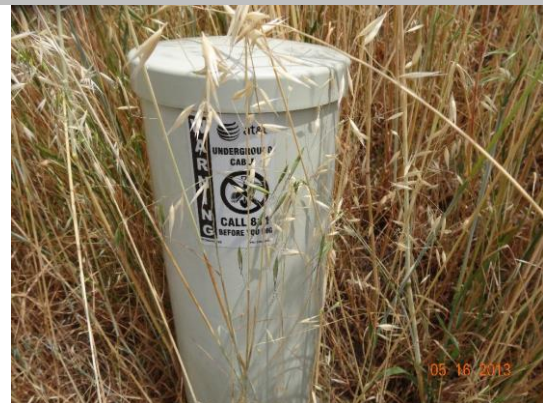
Photo 2 of 3 : UCIP_FA_2015_5991.jpg

AT&T underground cable line.

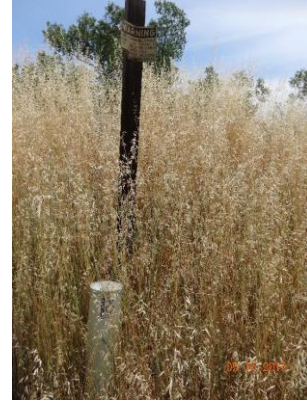
Photo 3 of 3 : UCIP_FA_2015_5992.jpg

Indicators of existing line visible on slope.

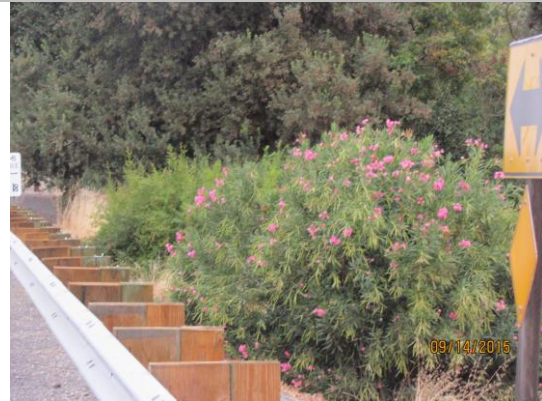
Photo 1 of 1 : FA_2015_LD0002_28_30_20151013_00019.jpg

LM Start	1.03	Rating **	M	Issue No.	30
LM End	1.03	Issue Type +	Ma	Location *	WS
Category	Earthen Levee			GPS Latitude/Longitude	
				Start	End
Item	Trim / Thin Trees			39.428445 °	39.428445 °
				-122.010972 °	-122.010972 °
DWR ID	DWR_LD0002_01_f_2015_30				
Action/Comments					
Thin trees to allow visibility of the ground and room to flood fight. Inspector Comments: Remove the oleanders from the waterside slope.

View of the oleanders along the waterside slope.

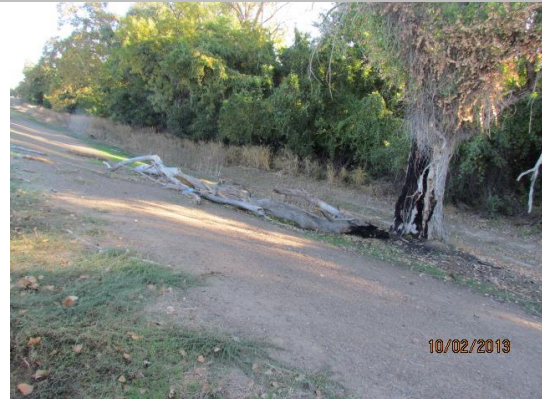
Photo 1 of 2 : FA_2015_LD0002_28_40_20150910_00015.jpg

LM Start	1.24	Rating **	M	Issue No.	40
LM End	1.24	Issue Type +	Ma	Location *	WS
Category	Earthen Levee			GPS Latitude/Longitude	
				Start	End
Item	Encroachments			39.431499 °	39.431499 °
				-122.010803 °	-122.010803 °
DWR ID	DWR_LD0002_01_f_2013_40				
Action/Comments					
Tree or limb					
Inspector Comments: Remove the tree limbs from the waterside slope.

View of the downed tree limb along the slope of the levee.

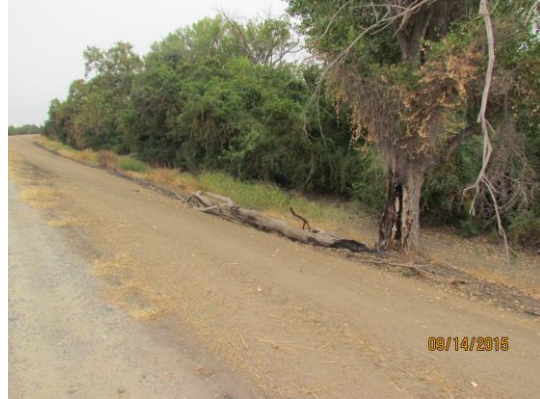
Photo 2 of 2 : FA_2015_LD0002_28_40_20151013_00020.jpg

View of the tree limbs along the waterside slope.

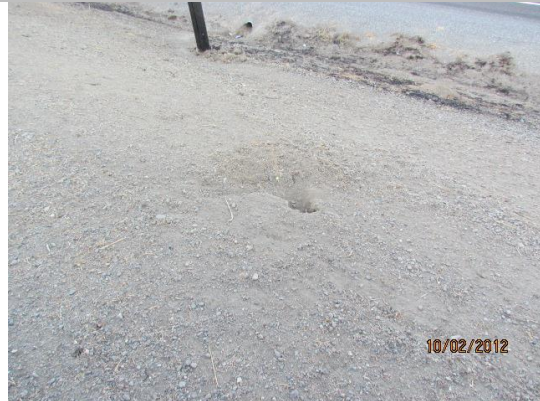
Photo 1 of 1 : FA_2015_LD0002_28_4_20150910_00002.jpg

LM Start	1.43	Rating **	M	Issue No.	4
LM End	1.43	Issue Type +	Ma	Location *	LS
Category	Earthen Levee			GPS Latitude/Longitude	
				Start	End
Item	Animal Control			39.434157 °	39.434157 °
				-122.010760 °	-122.010760 °
DWR ID	DWR_LD0002_01_f_2012_4				
Action/Comments					
No rodents visible, but rodent burrows visible; need to backfill and compact or grout burrows.

View of the rodent holes along the landside slope.

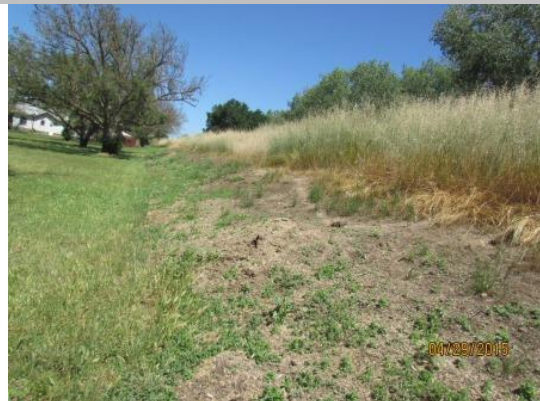
Photo 1 of 2 : FA_2015_LD0002_28_15_20150910_00011.jpg

LM Start	1.52	Rating **	M	Issue No.	15
LM End	1.60	Issue Type +	Ma	Location *	LS
Category	Earthen Levee			GPS Latitude/Longitude	
				Start	End
Item	Animal Control			39.435485 °	39.436643 °
				-122.010640 °	-122.010498 °
DWR ID	DWR_LD0002_01_f_2012_15				
Action/Comments					
No rodents visible, but rodent burrows visible; need to backfill and compact or grout burrows.					
Inspector Comments: LMA needs to repair the rodent holes.

View of the rodent holes along the landside slope.

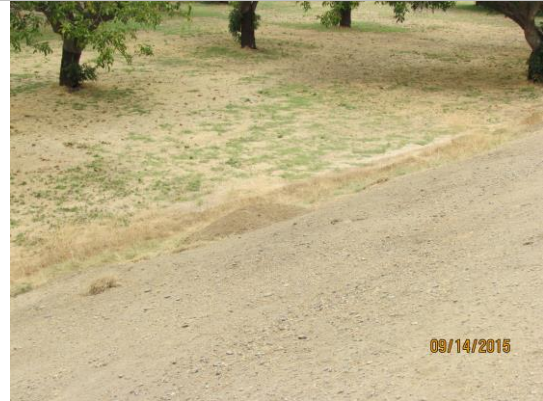
Photo 2 of 2 : FA_2015_LD0002_28_15_20151013_00021.jpg

LM Start	1.52	Rating **	M	Issue No.	15 (cont)
LM End	1.60	Issue Type +	Ma	Location *	LS
Category	Earthen Levee			GPS Latitude/Longitude	
				Start	End
Item	Animal Control			39.435485 °	39.436643 °
				-122.010640 °	-122.010498 °
DWR ID	DWR_LD0002_01_f_2012_15				
Action/Comments					
No rodents visible, but rodent burrows visible; need to backfill and compact or grout burrows. Inspector Comments: LMA needs to repair the rodent holes.

View of the rodent holes along the landside slope.

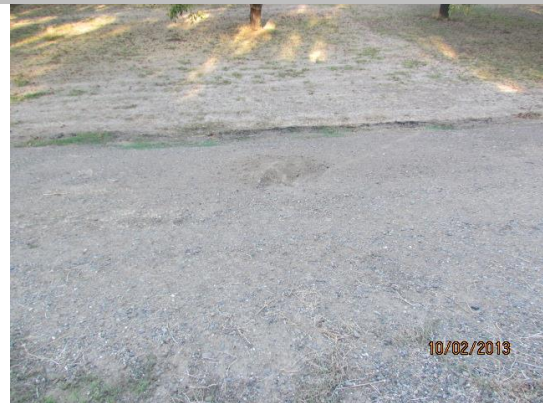
Photo 1 of 1 : FA_2015_LD0002_28_41_20150910_00016.jpg

LM Start	1.57	Rating **	M	Issue No.	41
LM End	1.57	Issue Type +	Ma	Location *	LS
Category	Earthen Levee			GPS Latitude/Longitude	
				Start	End
Item	Animal Control			39.436149 °	39.436149
				-122.010525 °	-122.010525
DWR ID	DWR_LD0002_01_f_2013_41				
Action/Comments					
No rodents visible, but rodent burrows visible; need to backfill and compact or grout burrows.

View of the rodent holes along the slope of the levee.

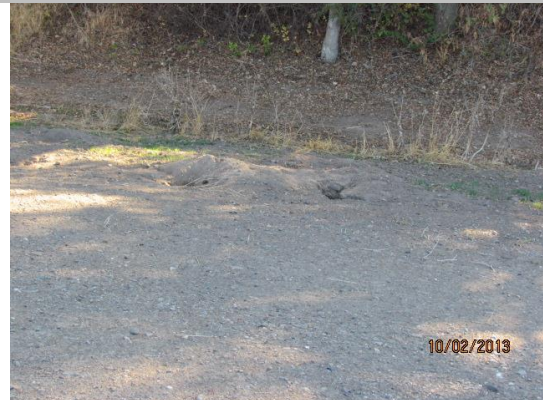
Photo 1 of 1 : FA_2015_LD0002_28_42_20150910_00017.jpg

View of the rodent holes along the slope of the levee.

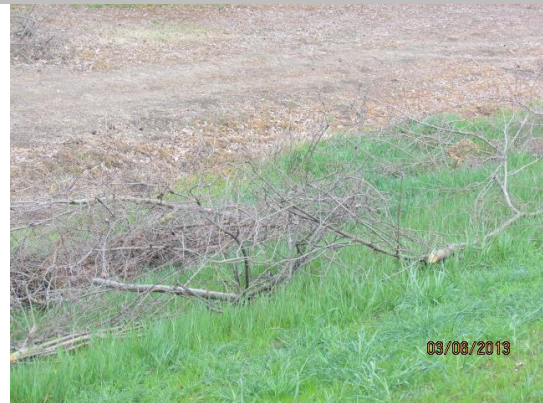
Photo 1 of 1 : FA_2015_LD0002_28_5_20150910_00003.jpg

View of the prunings along the landside toe.

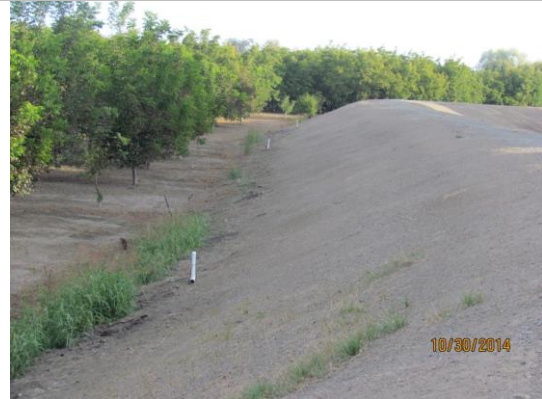
Photo 1 of 1 : FA_2015_LD0002_28_2_20150910_00001.jpg

View of the rodent holes and bait station along the landside slope.

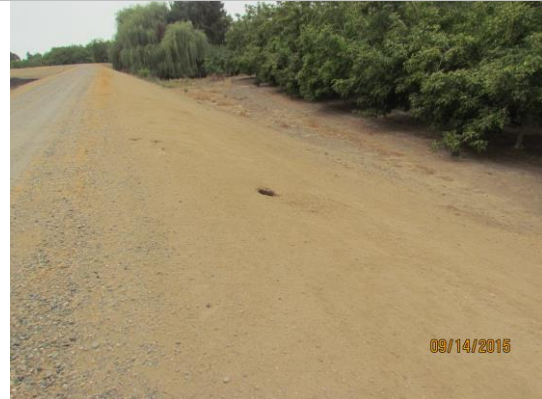
Photo 1 of 1 : FA_2015_LD0002_28_3_20151013_00024.jpg

LM Start	3.06	Rating **	M	Issue No.	3
LM End	3.13	Issue Type +	Ma	Location *	WS
Category	Earthen Levee			GPS Latitude/Longitude	
				Start	End
Item	Animal Control			39.455145 °	39.455813 °
				-122.014287 °	-122.013205 °
DWR ID	DWR_LD0002_01_s _ 2012_3				
Action/Comments					
No rodents visible, but rodent burrows visible; need to backfill and compact or grout burrows.					
Inspector Comments: Repair the rodent holes along the waterside slope.

View of the rodent holes along the waterside slope.

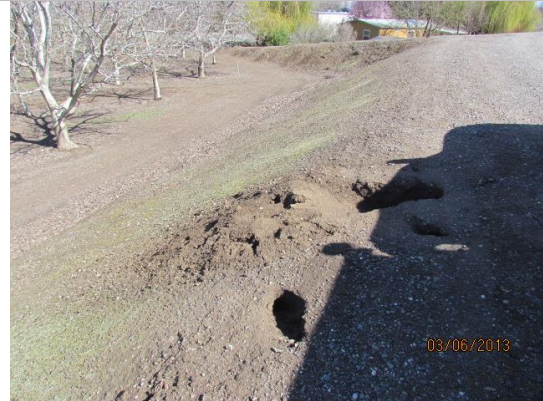
Photo 1 of 1 : FA_2015_LD0002_28_12_20150910_00009.jpg

LM Start	3.16	Rating **	U	Issue No.	12
LM End	3.16	Issue Type +	Ma	Location *	LS
Category	Earthen Levee	GPS Latitude/Longitude			
		Start		End	
Item	Animal Control	39.455992 °		39.455992 °	
		-122.012809 °		-122.012809 °	
DWR ID	DWR_LD0002_01_s _ 2013_12				
Action/Comments					
Exterminate rodents and backfill and compact or grout burrows. Inspector Comments: Repair the rodent holes along landside slope.

View of the rodent activity along the landside slope.

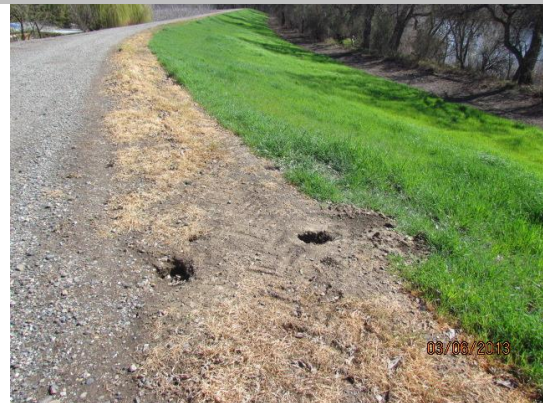
Photo 1 of 1 : FA_2015_LD0002_28_9_20150910_00007.jpg

View of the rodent activity along the waterside slope.

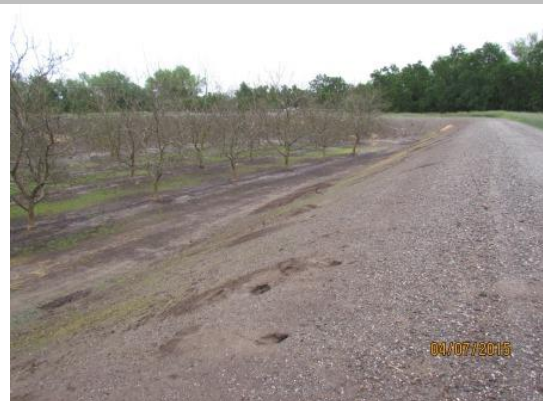
Photo 1 of 1 : FA_2015_LD0002_28_16_20150910_00012.jpg

View of the rodent holes along the landside slope.

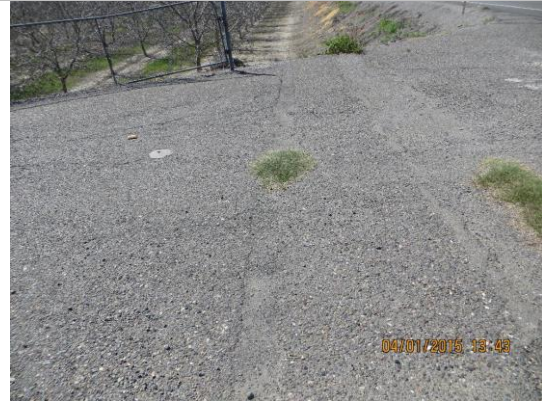
Photo 1 of 2 : UCIP_FA_2015_5840.jpg

Action/Comments					
Inspector Comments: FS_ID:44186 DS_ID:21188 EP_NO: 12444 FS_HLM: 3.41 Repair Type: Non-Urgent Crossing Status: Indicator Found UCIP Comments: Needs markers 10-feet off both levee toes. FIELD_STRUCT_DESC: Steel conduit through the levee, 2.5 feet below the crown. Conduit extends to pole on waterward side. Cut in pavement visible at levee crown (Permit No. 12444-1978) FS Date: 04/01/2015

Cut in pavement at levee crown good indicator of crossing.

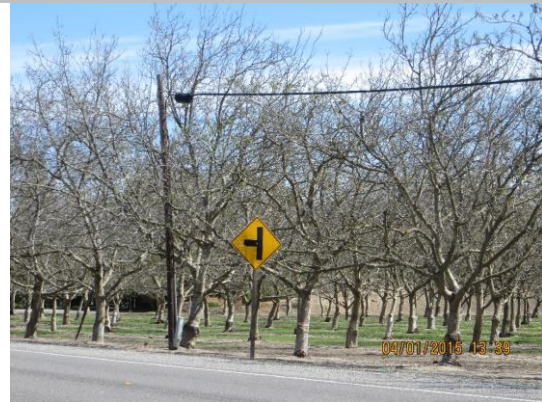
Photo 2 of 2 : UCIP_FA_2015_5841.jpg

Conduit may be visible on pole about 1000-feet west of levee crown.

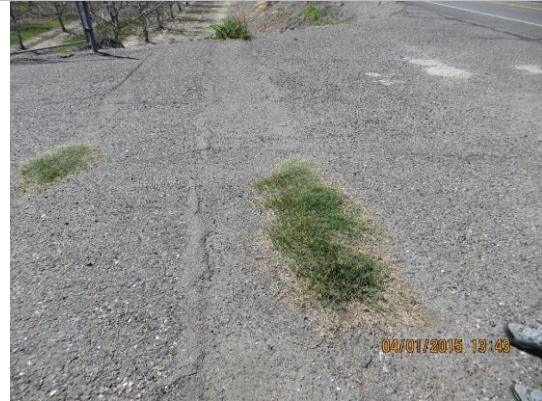
Photo 1 of 2 : UCIP_FA_2015_5842.jpg

LM Start	3.37	Rating **	M	Issue No.	52
LM End	3.37	Issue Type +	En	Location *	LS
Category	Supplemental			GPS Latitude/Longitude	
				Start	End
Item	DWR UCIP Field Study			39.456720 °	39.456720 °
				-122.009630 °	-122.009630 °
DWR ID					
Action/Comments					
Inspector Comments: FS_ID:44185 DS_ID:21175 EP_NO: 5376 FS_HLM: 3.412 Repair Type: Non-Urgent Crossing Status: Indicator Found

Cut in pavement visible at crown good indicator of crossing location.

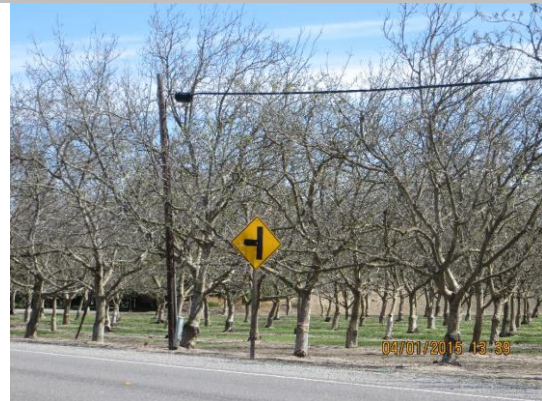
Photo 2 of 2 : UCIP_FA_2015_5843.jpg

Conduit may be visible at pole about 1000-feet west of crown.

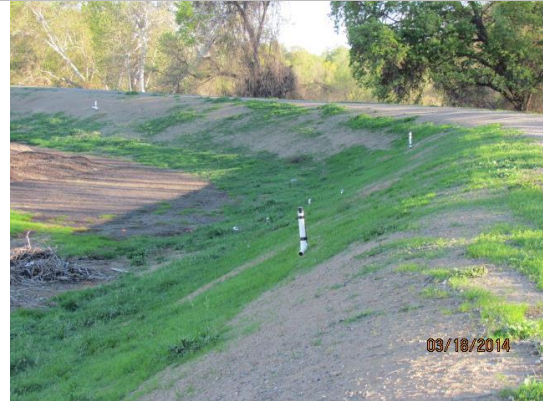
Photo 1 of 1 : FA_2015_LD0002_28_27_20150910_00013.jpg

View of the rodent activity along the l/s slope.

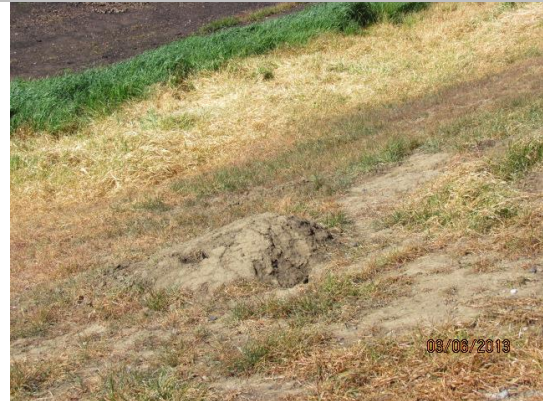
Photo 1 of 1 : FA_2015_LD0002_28_13_20150910_00010.jpg

View of the rodent activity along the landside slope.

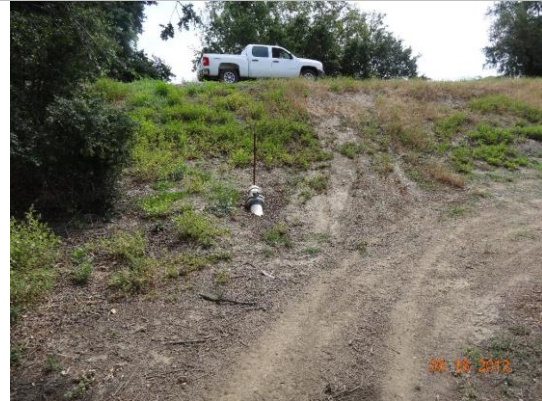
Photo 1 of 3 : UCIP_FA_2015_6708.jpg

Pipe connection capped with control valve located on landward toe.

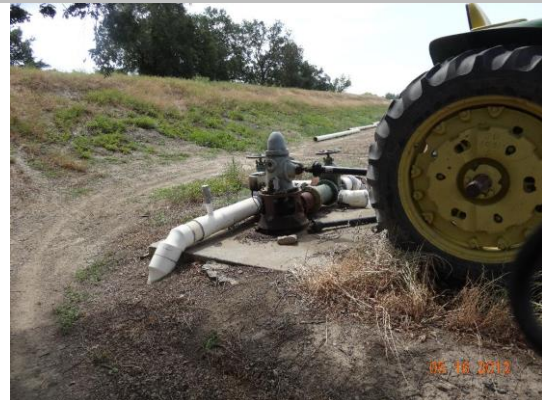
Photo 2 of 3 : UCIP_FA_2015_6709.jpg

Pump system located near landward toe.

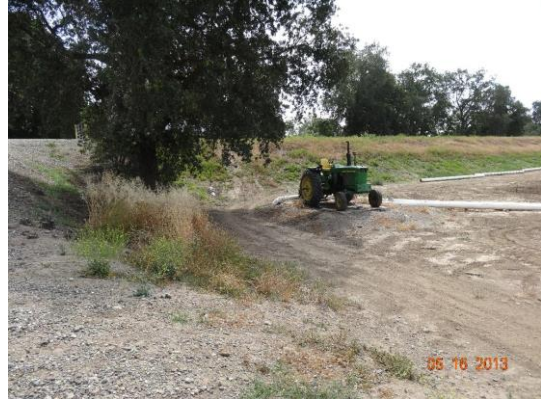
Photo 3 of 3 : UCIP_FA_2015_6710.jpg

View of pump system on landward side located behind tracker.

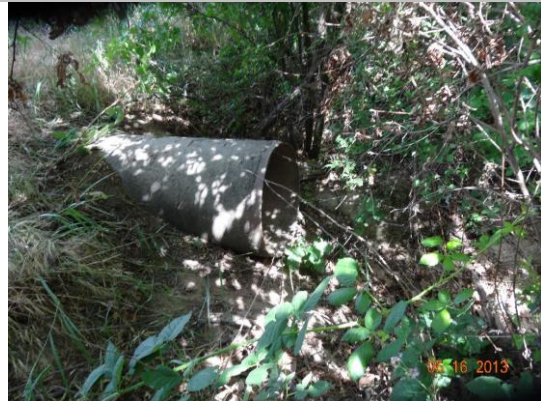
Photo 1 of 3 : UCIP_FA_2015_4722.jpg

Pipe visible on waterward side.

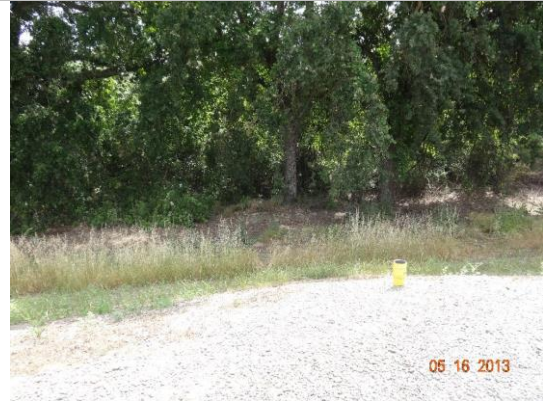
Photo 2 of 3 : UCIP_FA_2015_4746.jpg

View of waterward side.

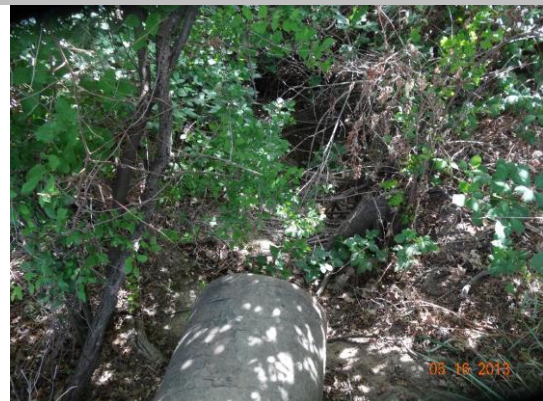
Photo 3 of 3 : UCIP_FA_2015_4747.jpg

View of channel on waterward side.

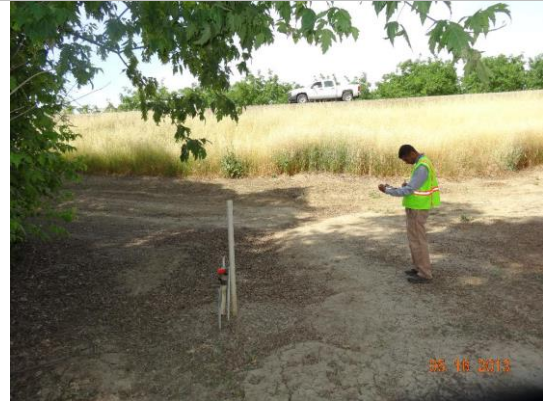
Photo 1 of 3 : UCIP_FA_2015_4749.jpg

3-inch PVC pipe and vent exposed on waterward toe, likely in alignment with this crossing.

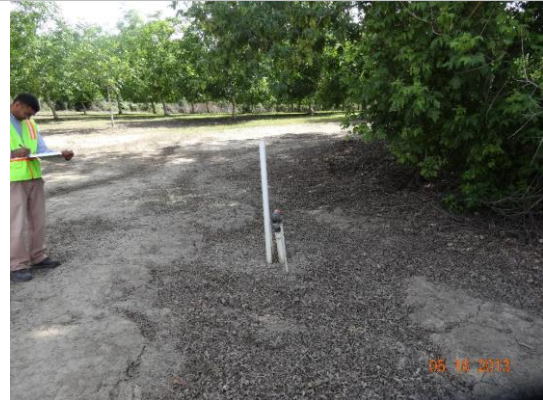
Photo 2 of 3 : UCIP_FA_2015_4750.jpg

3-inch PVC pipe and vent exposed on waterward toe, likely in alignment with this crossing.

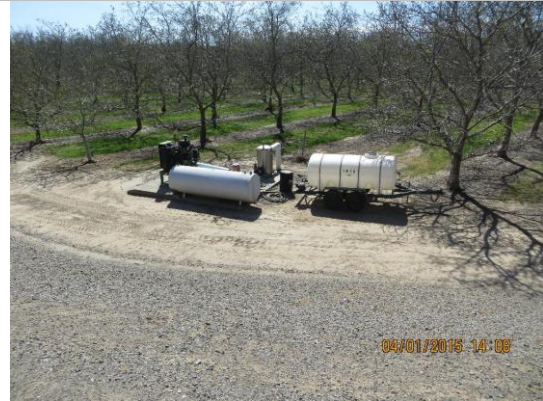
Photo 3 of 3 : UCIP_FA_2015_5844.jpg

Well and pump visible on LS toe.

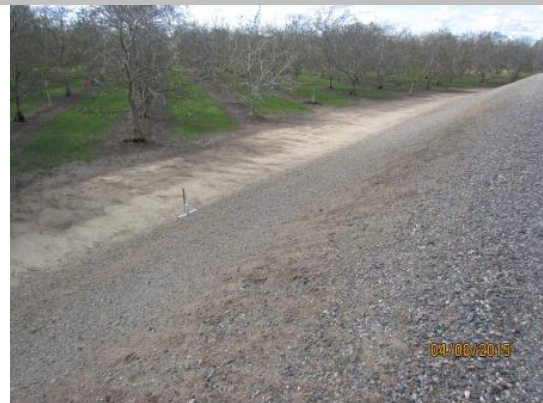
Photo 1 of 1 : FA_2015_LD0002_28_11_20150910_00008.jpg

View of the removed rodent holes and bait station.
