**Flood Control Project Maintenance
Levee Inspections**

Fall 2016 Levee Maintenance Deficiency Summary Report

Sacramento River Basin

Levee District No. 0002 (Glenn County)

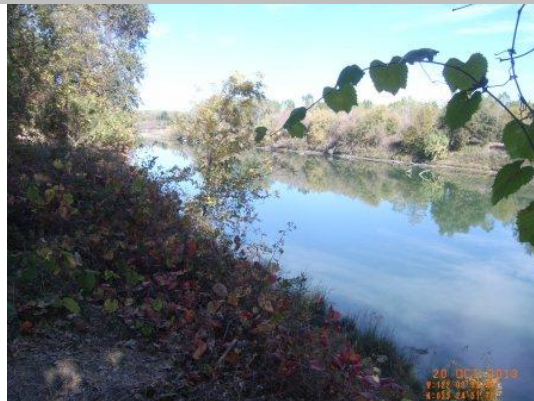
Photo 1 of 2 : FA_2016_LD0002_28_6_20160823_00005.jpg

LM Start	0.07	Rating **	M	Issue No.	6
LM End	0.28	Issue Type +	Ma	Location *	WS
Category	Supplemental			GPS Latitude/Longitude	
				Start	End
Item	2015 USACE Erosion Survey, DRAFT			39.414649 °	39.417689 °
				-122.009853 °	-122.010369 °
DWR ID	DWR_LD0002_01_s_ 2016_6				
Comment Code					
Inspector Comment					
2009 - Very slow retreat, hard toe, encroaching into the levee projection. 2010 - Slowly eroding. 2011 - Site extended downstream. 2015: Last observed in 2013. [2015 Site ID: SAC_164-7_R]

USACE 2013 Photo #1

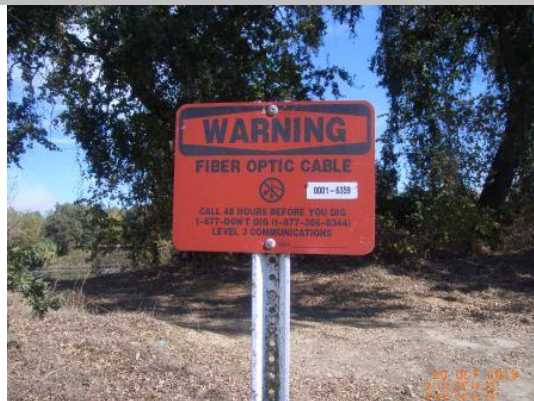
Photo 2 of 2 : FA_2016_LD0002_28_6_20160823_00006.jpg

USACE 2013 Photo #2

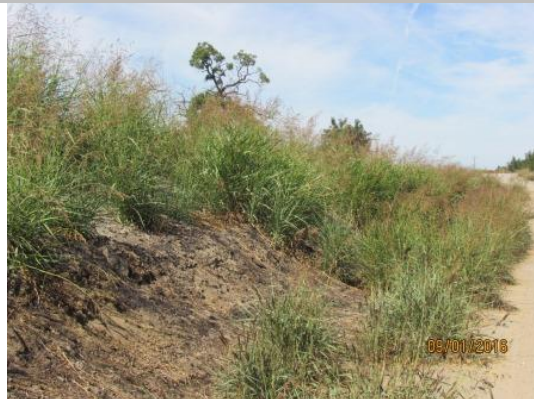
Photo 1 of 1 : FA_2016_LD0002_28_32_20160902_00049.jpg

LM Start	0.54	Rating **	M	Issue No.	32
LM End	0.59	Issue Type +	Ma	Location *	WS
Category	Earthen Levee			GPS Latitude/Longitude	
				Start	End
Item	Vegetation			39.421335 °	39.422073 °
				-122.011389 °	-122.011449 °
DWR ID	DWR_LD0002_01_f_ 2016_32				
Comment Code					
V1 : Control annual grass and weeds on the levee slopes and easements.					
Inspector Comment

View of the waterside vegetation looking upstream.

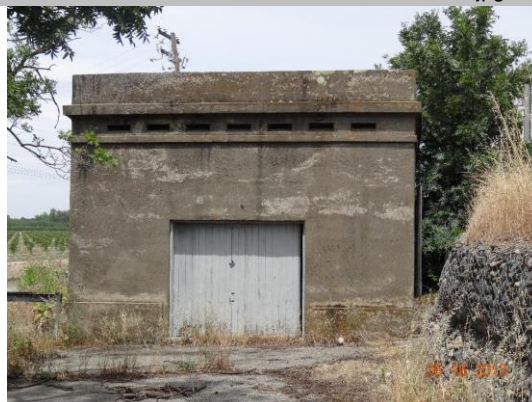
Photo 2 of 2 : UCIP_FA_2016_38166_69476.jpg

UCIP Comments: Three pipes found in the pump house on landward side. Pump house appears to be no longer in use. Unable to locate pipes on waterward side. Will need to contact owner to determine status. Owner will need to coordinate with CVFPB regarding proper removal per Title 23 requirements.

View of Princeton-Cordora-Glenn Irrigation District--Schaad Pumping Plant.

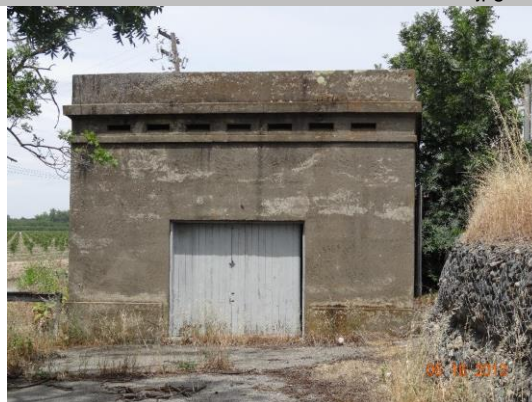
Photo 2 of 2 : UCIP_FA_2016_38167_69484.jpg

FS_ID:38167
DS_ID:21171
EP_NO: N/A
Repair Type: Non-Urgent
Crossing Status: Found
UCIP Comments: Three pipes found in the pump house on landward side. Pump house appears to be no longer in use. Unable to locate pipes on waterward side. Will need to contact owner to determine status. Owner will need to coordinate with CVFPB regarding proper removal per Title 23 requirements.
FIELD_STRUCT_DESC: [Princeton-Cordora-Glenn Irrigation District: Schaad Pumping Plant] 3 of 3: 34-inch steel pipe sleeved through 36-inch steel pipe through the levee, 20.0 feet below the crown. Annular gap is grouted. Flap gate on landside (LS) end. Pump in pump house on LS slope. Rock revetment around outlet on waterside (WS) slope. (USACE-1955). This entry matches the Drainage or Irrigation Structure referenced in O&M manual (Station 41+47). Pipes sleeved through pre-existing pipes installed under Permit No. 2356 (1956). (Permit No. 2356-1956, Princeton-Codora-Glenn Irrigation District)

View of Princeton-Cordora-Glenn Irrigation District-Schaad Pumping Plant.

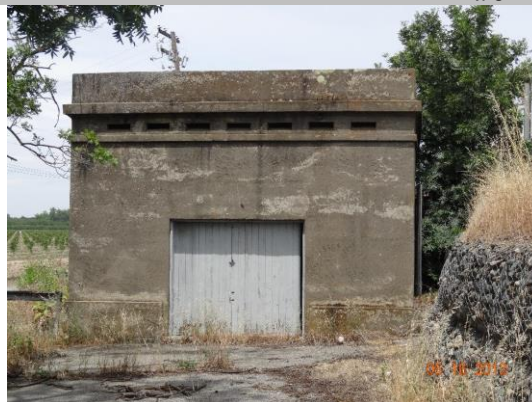
Photo 2 of 2 : UCIP_FA_2016_38168_69493.jpg

Comment Code					
Inspector Comment					
FS_ID:38168					
DS_ID:21182					
EP_NO: N/A					
Repair Type: Non-Urgent					
Crossing Status: Indicator Found					
UCIP Comments: Unable to verify if the pipes inside the existing pump house correlate to 24-inch installed in 1955. Three pipes found in the pump house on landward side. Pump house appears to be no longer in use. Unable to locate pipes on waterward side. Will need to contact owner to determine status.					
FIELD_STRUCT_DESC: [Pumping Plant] 24-inch steel pipe through the levee, 27.3 feet below the crown. Flap gate on landside (LS). Pump in pump house on landside (LS). (USACE-1955). This entry matches the Drainage or Irrigation Structure referenced in O&M manual (Station 41+47).					
FS Date: 5/16/2013

View of Princeton-Cordora-Glenn Irrigation District-Schaad Pumping Plant.

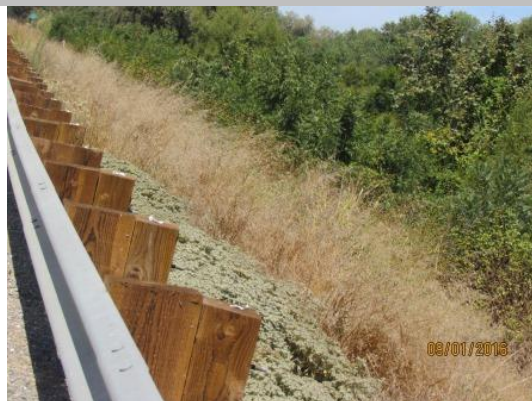
Photo 1 of 1 : FA_2016_LD0002_28_33_20160906_00050.jpg

View of the waterside vegetation looking upstream.

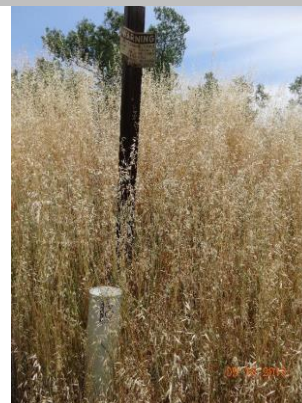
Photo 1 of 2 : UCIP_FA_2016_44170_72602.jpg

LM Start	1.03	Rating **	M	Issue No.	58
LM End	1.03	Issue Type +	En	Location *	WS
Category	Supplemental			GPS Latitude/Longitude	
				Start	End
Item	DWR UCIP Field Study			39.428441 °	39.428441 °
				-122.011032 °	-122.011032 °
DWR ID					
Comment Code					
Inspector Comment					
FS_ID:44170 DS_ID:21177 EP_NO: 9723 Repair Type: Non-Urgent Crossing Status: Indicator Found UCIP Comments: Owner is listed as Pacific Bell however sign lists AT&T as owner, need to contact owner to determine if permit was updated or if this crossing is listed under new permit. Unable to confirm if 2 crossings are present at this site. FIELD_STRUCT_DESC: Buried telephone cable through the levee at unknown depth. Telephone pole and junction box on landside (LS) toe. This line was retained under an automatic board order (ABO) (Permit No. 9723-1974, Pacific Telephone Company). FS Date: 5/16/2013

Indicators of existing line visible on slope.

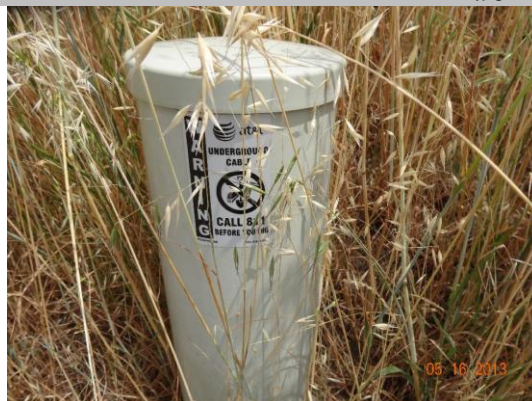
Photo 2 of 2 : UCIP_FA_2016_44170_72601.jpg

Comment Code						
Inspector Comment						
FS_ID:44170 DS_ID:21177 EP_NO: 9723 Repair Type: Non-Urgent Crossing Status: Indicator Found UCIP Comments: Owner is listed as Pacific Bell however sign lists AT&T as owner, need to contact owner to determine if permit was updated or if this crossing is listed under new permit. Unable to confirm if 2 crossings are present at this site. FIELD_STRUCT_DESC: Buried telephone cable through the levee at unknown depth. Telephone pole and junction box on landside (LS) toe. This line was retained under an automatic board order (ABO) (Permit No. 9723-1974, Pacific Telephone Company). FS Date: 5/16/2013

AT&T underground cable line.

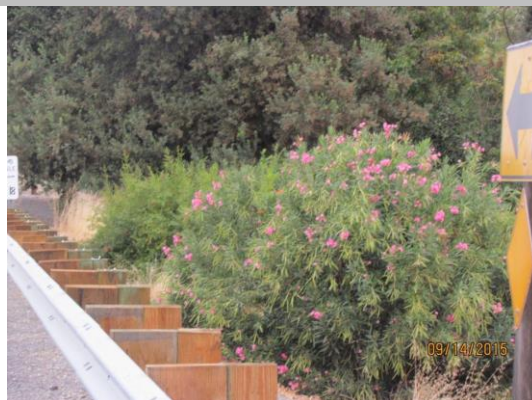
Photo 1 of 1 : FA_2016_LD0002_28_30_20160823_00014.jpg

LM Start	1.03	Rating **	M	Issue No.	30
LM End	1.03	Issue Type +	En	Location *	WS
Category	Earthen Levee			GPS Latitude/Longitude	
				Start	End
Item	Vegetation			39.428445 °	39.428445 °
				-122.010972 °	-122.010972 °
DWR ID	DWR_LD0002_01_f_2015_30				
Comment Code					
V6 : Landscaping					
Inspector Comment					
Remove the oleanders from the waterside slope.

View of the oleanders along the waterside slope.

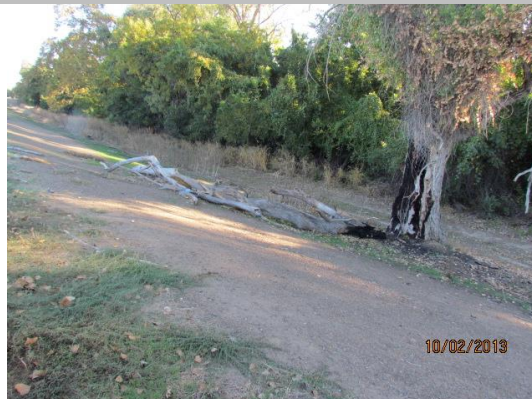
Photo 1 of 2 : FA_2016_LD0002_28_40_20160823_00015.jpg

View of the downed tree limb along the slope of the levee.

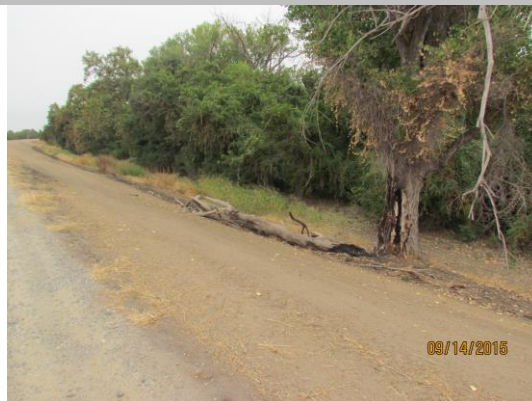
Photo 2 of 2 : FA_2016_LD0002_28_40_20160823_00016.jpg

View of the tree limbs along the waterside slope.

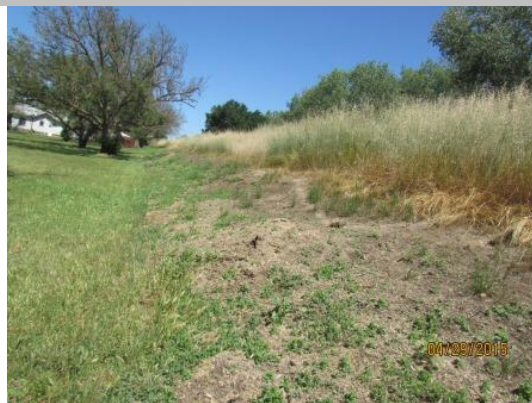
Photo 1 of 2 : FA_2016_LD0002_28_15_20160823_00010.jpg

LM Start	1.52	Rating **	M	Issue No.	15
LM End	1.60	Issue Type +	Ma	Location *	LS
Category	Earthen Levee			GPS Latitude/Longitude	
				Start	End
Item	Animal Control			39.435485 °	39.436643 °
				-122.010640 °	-122.010498 °
DWR ID	DWR_LD0002_01_f_2012_15				
Comment Code					
A3 : No rodents visible, but rodent burrows visible; need to backfill and compact or grout burrows.					
Inspector Comment					
LMA needs to repair the rodent holes.

View of the rodent holes along the landside slope.

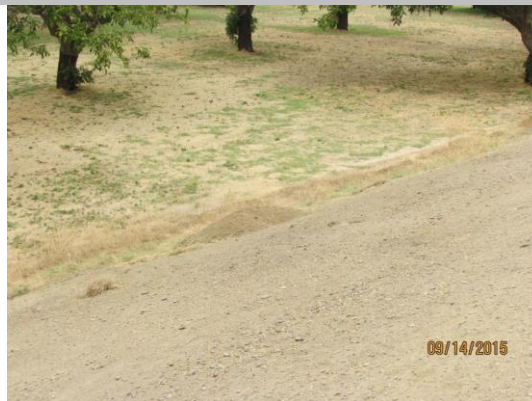
Photo 2 of 2 : FA_2016_LD0002_28_15_20160823_00011.jpg

View of the rodent holes along the landside slope.

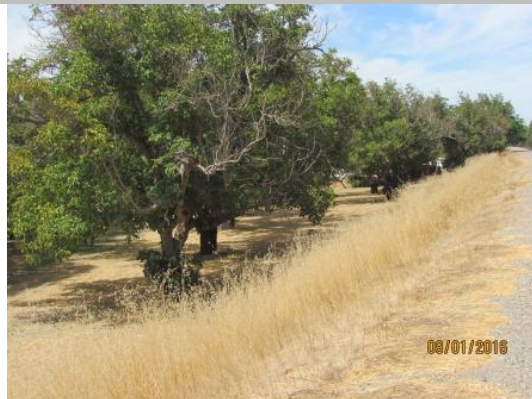
Photo 1 of 1 : FA_2016_LD0002_28_35_20160906_00052.jpg

View of the landside vegetation looking upstream.

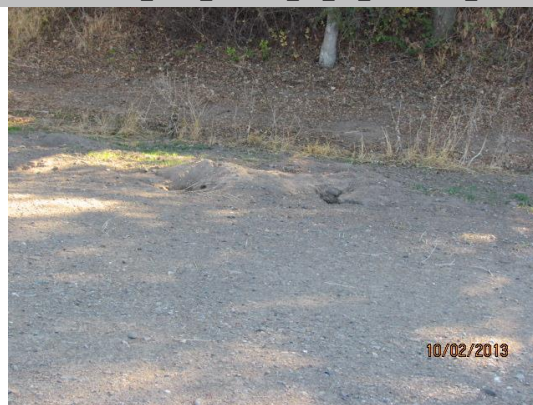
Photo 1 of 1 : FA_2016_LD0002_28_42_20160823_00017.jpg

View of the rodent holes along the slope of the levee.

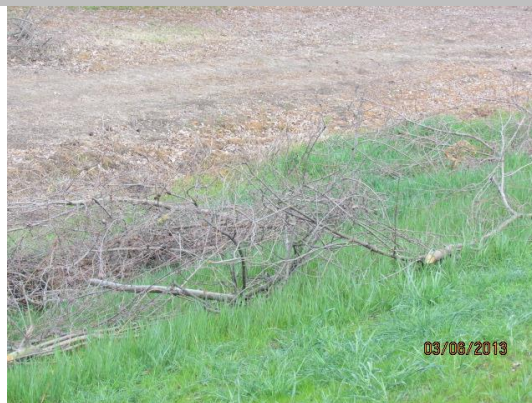
Photo 1 of 1 : FA_2016_LD0002_28_5_20160823_00004.jpg

View of the prunings along the landside toe.

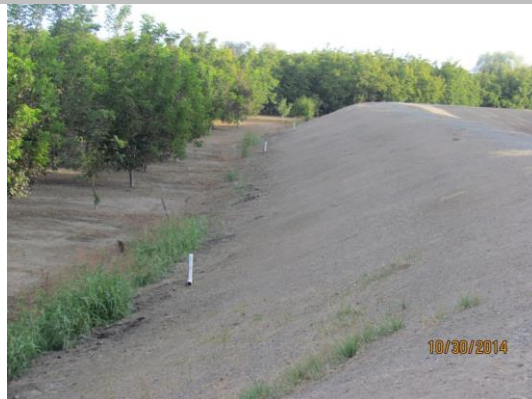
Photo 1 of 1 : FA_2016_LD0002_28_2_20160823_00001.jpg

View of the rodent holes and bait station along the landside slope.

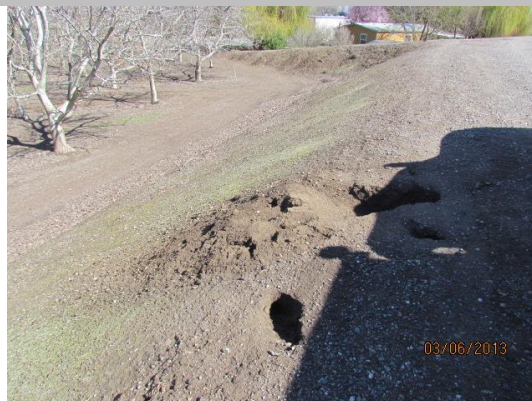
Photo 1 of 1 : FA_2016_LD0002_28_12_20160823_00008.jpg

LM Start	3.16	Rating **	U	Issue No.	12
LM End	3.16	Issue Type +	Ma	Location *	LS
Category	Earthen Levee			GPS Latitude/Longitude	
				Start	End
Item	Animal Control			39.456004 °	39.456004 °
				-122.012776 °	-122.012776 °
DWR ID	DWR_LD0002_01_s_2013_12				
Comment Code					
A1 : Exterminate rodents and backfill and compact or grout burrows.					
Inspector Comment					
Repair the rodent holes along landside slope.

View of the rodent activity along the landside slope.

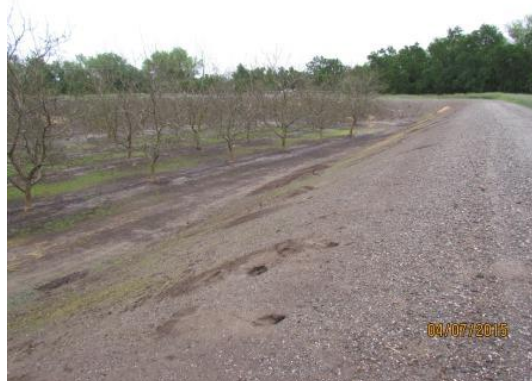
Photo 1 of 2 : FA_2016_LD0002_28_16_20160823_00012.jpg

View of the rodent holes along the landside slope.

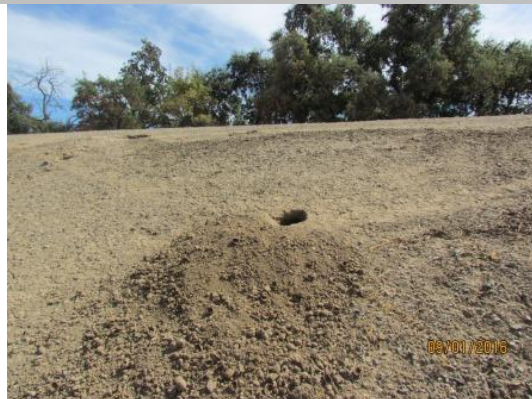
Photo 2 of 2 : FA_2016_LD0002_28_16_20160906_00053.jpg

View of the rodent holes along the landside slope.

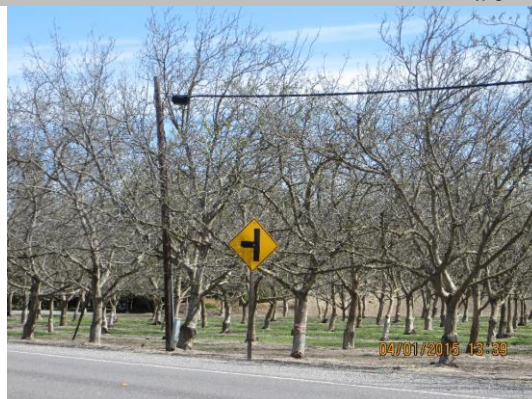
Photo 1 of 2 : UCIP_FA_2016_44186_73606.jpg

FS_ID:44186
DS_ID:21188
EP_NO: 12444
Repair Type: Non-Urgent
Crossing Status: Indicator Found
UCIP Comments: Needs markers 10-feet off both levee toes.
FIELD_STRUCT_DESC: Steel conduit through the levee, 2.5 feet below the crown. Conduit extends to pole on waterside (WS). Cut in pavement visible at levee crown (Permit No. 12444-1978)
FS Date: 4/1/2015

Conduit may be visible on pole about 1000-feet west of levee crown.

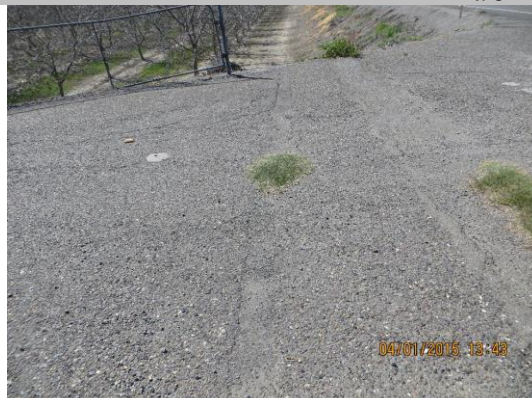
Photo 2 of 2 : UCIP_FA_2016_44186_73605.jpg

Cut in pavement at levee crown good indicator of crossing.

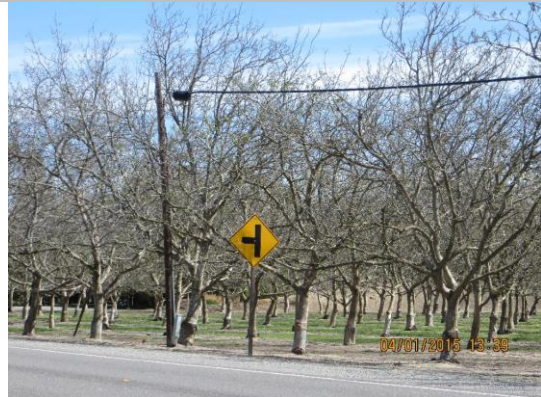
Photo 1 of 2 : UCIP_FA_2016_44185_73608.jpg

Comment Code					
Inspector Comment					
FS_ID:44185					
DS_ID:21175					
EP_NO: 5376					
Repair Type: Non-Urgent					
Crossing Status: Indicator Found					
UCIP Comments: Conduit needs markers ten feet off both levee toes.					
FIELD_STRUCT_DESC: Three 3.5-inch steel conduits through the					
levee, 3.0 feet below the crown. Metal cutoff wall around conduits near					
center of levee. Conduits are welded to the cutoff wall, extending only					
between the levee shoulders under the crown. Cut in pavement visible					
at crown. Cables extend to pole on waterside (WS). (Permit No. 5376-					
1967, Pacific Telephone & Telegraph Co.)					
FS Date: 4/1/2015

Conduit may be visible at pole about 1000-feet west of crown.

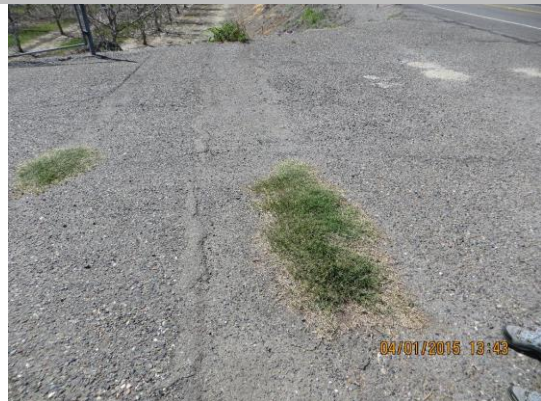
Photo 2 of 2 : UCIP_FA_2016_44185_73607.jpg

Cut in pavement visible at crown good indicator of crossing location.

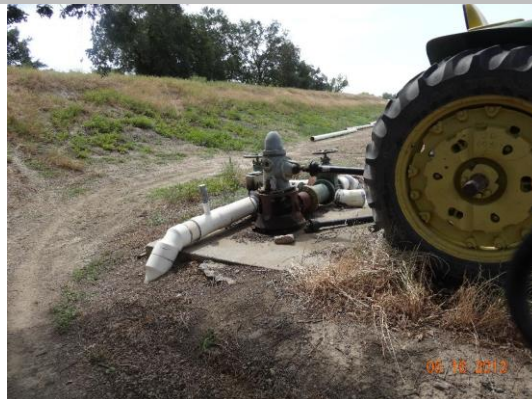
Photo 2 of 2 : UCIP_FA_2016_38178_69501.jpg

Comment Code					
Inspector Comment					
FS_ID:38178 DS_ID:21178 EP_NO: 16931 Repair Type: Non-Urgent Crossing Status: Indicator Found UCIP Comments: Inspector notes indicate that pipe was never installed through levee and application was closed. Steel pipe was not installed but detachable section was installed. The pipe section goes up and over levee. Permit 16931 file was closed in 2005 owner was unable to install pipe due to costs. Permit indicates that pipe was to be used for winter supply of irrigation water to landward side. Need to coordinate with DWR inspector--permit revised for this type of structure. FIELD_STRUCT_DESC: Crossing visible at location. Current structure differs from original request in Permit No. 16931. PVC connection visible on landside (LS) toe with cutoff valve. Pipe connects to 8-inch PVC pipe extending past LS toe. FS Date: 5/16/2013

Pump system located near landward toe.

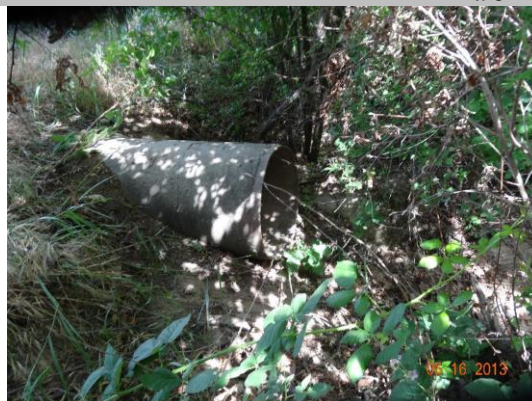
Photo 2 of 2 : UCIP_FA_2016_38182_69533.jpg

LM Start	3.74	Rating **	M	Issue No.	54 (cont)
LM End	3.74	Issue Type +	En	Location *	LS
Category	Supplemental			GPS Latitude/Longitude	
				Start	End
Item	DWR UCIP Field Study			39.461674 °	39.461674 °
				-122.011507 °	-122.011507 °
DWR ID					
Comment Code					
Inspector Comment					
FS_ID:38182 DS_ID:24659 EP_NO: N/A Repair Type: Non-Urgent Crossing Status: Found UCIP Comments: Need to contact owner to determine status of crossing. FIELD_STRUCT_DESC: 24-inch steel drainage pipe through levee at 2-feet below the crown. Pipe is exposed on waterside (WS) with air vent on the WS levee shoulder. Open pump is approximately 550 feet on the landside (LS) of the levee toe and concrete distribution pipe. (Permit No. 16280-1995, Mathew J. Southam/McGowan) FS Date: 5/16/2013

Pipe visible on waterward side.

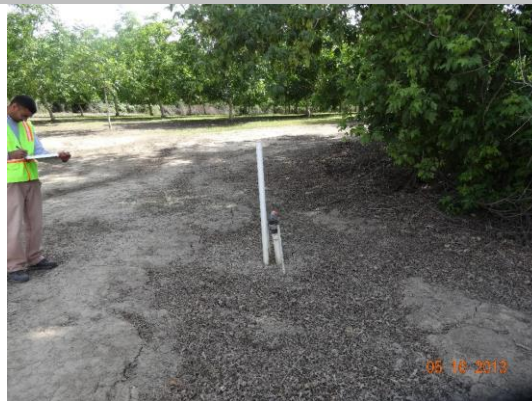
Photo 1 of 2 : UCIP_FA_2016_44188_69544.jpg

LM Start	4.32	Rating **	M	Issue No.	61
LM End	4.32	Issue Type +	En	Location *	WS
Category	Supplemental			GPS Latitude/Longitude	
				Start	End
Item	DWR UCIP Field Study			39.469908 °	39.469908 °
				-122.012117 °	-122.012117 °
DWR ID					
Comment Code					
Inspector Comment					
FS_ID:44188 DS_ID:21181 EP_NO: 18072 Repair Type: Non-Urgent Crossing Status: Indicator Found UCIP Comments: Pipe needs better markers at pipe crossing. FIELD_STRUCT_DESC: 6-inch steel irrigation pipe through the levee, 2.0 feet below the levee. Well, pump, and vent visible on landside (LS) toe. Vent visible just off waterside (WS) toe. (Permit No. 18072-2006, McCowan & Southam) FS Date: 4/1/2015

3-inch PVC pipe and vent exposed on waterward toe, likely in alignment with this crossing.
