**Flood Control Project Maintenance
Levee Inspections**

Fall 2017 Levee Maintenance Deficiency Summary Report

Levee District No. 0002 (Glenn County)

Levee Inspection Report By Mile - Fall 2017

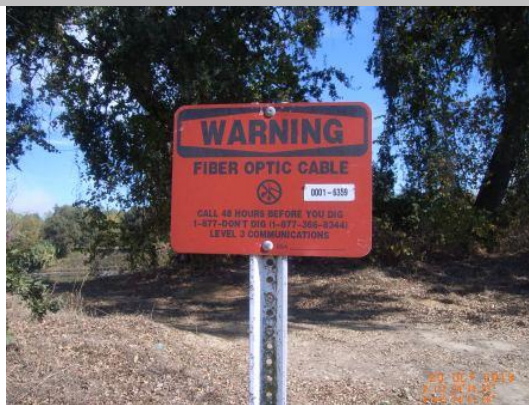
Photo 2 of 2 : FA_2017_LD0002_28_6_20170911_00004.jpg

USACE 2013 Photo #2

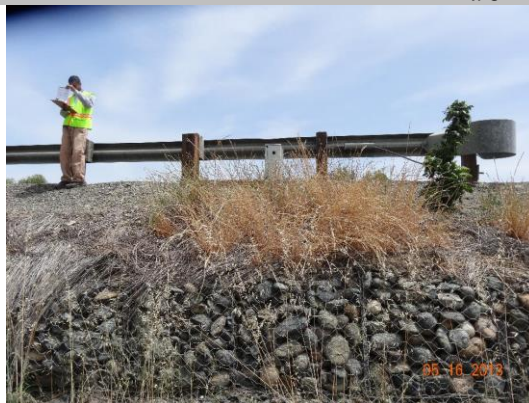
Photo 1 of 3 : UCIP_FA_2017_42083_72882.jpg

LM Start	0.59	Rating **	M	Issue No.	53	
LM End	0.59	Issue Type +	En	Location *		
Category	Supplemental			GPS Latitude/Longitude		
				Start	End	
Item	DWR UCIP Field Study			39.422088 °	39.422088 °	
				-122.011615 °	-122.011615 °	
DWR ID						
Comment Code						
Inspector Comment						
FS_ID:42083						
DS_ID:24877						
EP_NO: N/A						
Repair Type: Non-Urgent						
Crossing Status: Indicator Found						
UCIP Comments: Need to contact owner to determine if conduit goes through levee crown. If it does, will need to obtain permit number issued for encroachment.						
FIELD_STRUCT_DESC: Caltrans traffic control box located on the landside (LS) shoulder. Unable to determine if crossing goes through levee.						
FS Date: 5/16/2013

View of landward slope.

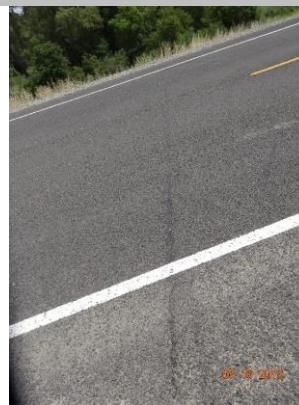
Photo 2 of 3 : UCIP_FA_2017_42083_72881.jpg

View of levee crown at crossing.

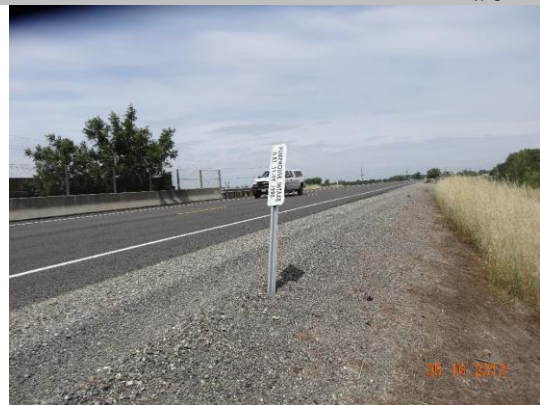
Photo 1 of 3 : UCIP_FA_2017_38165_69467.jpg

Comment Code					
Inspector Comment					
FS_ID:38165 DS_ID:21185 EP_NO: 2356 Repair Type: Non-Urgent Crossing Status: Found UCIP Comments: Three pipes found in the pump house on landward side. Pump house appears to be no longer in use. Unable to locate pipes on waterward side. Will need to contact owner to determine status. Owner will need to coordinate with CVFPB regarding proper removal per Title 23 requirements. FIELD_STRUCT_DESC: [Princeton-Cordora-Glenn Irrigation District: Schaad Pumping Plant] 1 of 3: 28-inch steel pipe sleeved through 30-inch steel pipe through the levee, 20.0 feet below the crown. Annular gap is grouted. Flap gate on landside (LS) end. Pump in pump house on LS slope. Rock revetment around outlet on waterside (WS) slope. (Permit No. 2356-1956, Princeton-Cordora-Glenn Irrigation District) FS Date: 5/16/2013

View of levee crown at crossing.

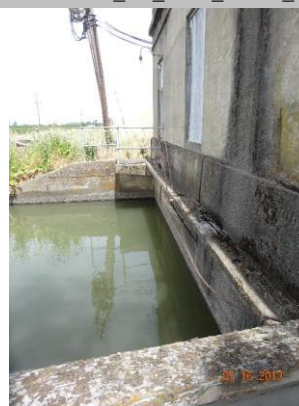
Photo 3 of 3 : UCIP_FA_2017_38166_69477.jpg

Comment Code						
Inspector Comment						
FS_ID:38166 DS_ID:21184 EP_NO: N/A Repair Type: Non-Urgent Crossing Status: Found UCIP Comments: Three pipes found in the pump house on landward side. Pump house appears to be no longer in use. Unable to locate pipes on waterward side. Will need to contact owner to determine status. Owner will need to coordinate with CVFPB regarding proper removal per Title 23 requirements. FIELD_STRUCT_DESC: [Princeton-Cordora-Glenn Irrigation District: Schaad Pumping Plant] 2 of 3: 34-inch steel pipe sleeved through 36-inch steel pipe through the levee, 20.0 feet below the crown. Annular gap is grouted. Flap gate on landside (LS) end. Pump in pump house on LS slope. Rock revetment around outlet on waterside (WS) slope. (USACE-1955). This entry matches the Drainage or Irrigation Structure referenced in O&M manual (Station 41+47). Pipes sleeved through pre-existing pipes installed under Permit No. 2356 (1956). (Permit No. 2356-1956, Princeton-Codora-Glenn Irrigation District) FS Date: 5/16/2013

View of landward side--outlet.

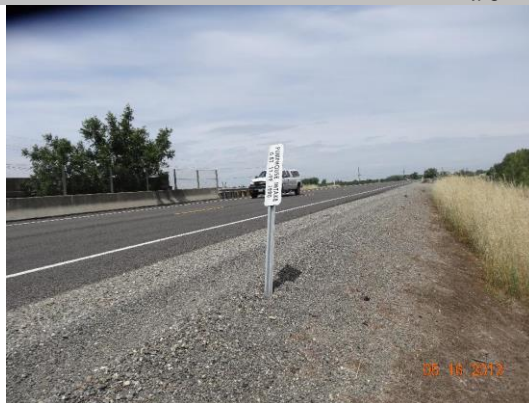
Photo 1 of 3 : UCIP_FA_2017_38168_69491.jpg

Comment Code					
Inspector Comment					
FS_ID:38168					
DS_ID:21182					
EP_NO: N/A					
Repair Type: Non-Urgent					
Crossing Status: Indicator Found					
UCIP Comments: Unable to verify if the pipes inside the existing pump house correlate to 24-inch installed in 1955. Three pipes found in the pump house on landward side. Pump house appears to be no longer in use. Unable to locate pipes on waterward side. Will need to contact owner to determine status.					
FIELD_STRUCT_DESC: [Pumping Plant] 24-inch steel pipe through the levee, 27.3 feet below the crown. Flap gate on landside (LS). Pump in pump house on landside (LS). (USACE-1955). This entry matches the Drainage or Irrigation Structure referenced in O&M manual (Station 41+47).					
FS Date: 5/16/2013

View of levee crown with marker on waterward side.

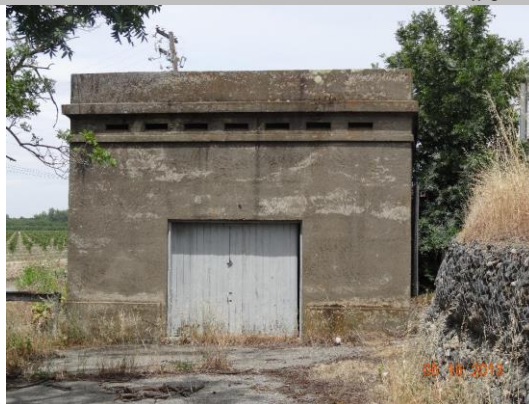
Photo 2 of 3 : UCIP_FA_2017_38168_69493.jpg

View of Princeton-Cordora-Glenn Irrigation District-Schaad Pumping Plant.

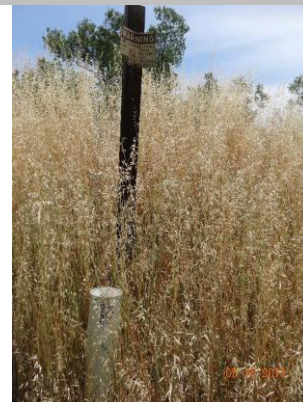
Photo 1 of 3 : UCIP_FA_2017_44170_72602.jpg

LM Start	1.03	Rating **	M	Issue No.	58
LM End	1.03	Issue Type +	En	Location *	
Category	Supplemental			GPS Latitude/Longitude	
				Start	End
Item	DWR UCIP Field Study			39.428441 °	39.428441 °
				-122.011032 °	-122.011032 °
DWR ID					
Comment Code					
Inspector Comment					
FS_ID:44170 DS_ID:21177 EP_NO: 9723 Repair Type: Non-Urgent Crossing Status: Indicator Found UCIP Comments: Owner is listed as Pacific Bell however sign lists AT&T as owner, need to contact owner to determine if permit was updated or if this crossing is listed under new permit. Unable to confirm if 2 crossings are present at this site. FIELD_STRUCT_DESC: Buried telephone cable through the levee at unknown depth. Telephone pole and junction box on landside (LS) toe. This line was retained under an automatic board order (ABO) (Permit No. 9723-1974, Pacific Telephone Company). FS Date: 5/16/2013

Indicators of existing line visible on slope.

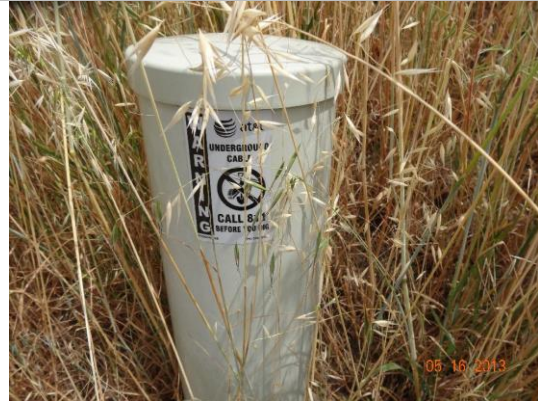
Photo 2 of 3 : UCIP_FA_2017_44170_72601.jpg

Comment Code						
Inspector Comment						
FS_ID:44170						
DS_ID:21177						
EP_NO: 9723						
Repair Type: Non-Urgent						
Crossing Status: Indicator Found						
UCIP Comments: Owner is listed as Pacific Bell however sign lists AT&T as owner, need to contact owner to determine if permit was updated or if this crossing is listed under new permit. Unable to confirm if 2 crossings are present at this site.						
FIELD_STRUCT_DESC: Buried telephone cable through the levee at unknown depth. Telephone pole and junction box on landside (LS) toe. This line was retained under an automatic board order (ABO) (Permit No. 9723-1974, Pacific Telephone Company).						
FS Date: 5/16/2013

AT&T underground cable line.

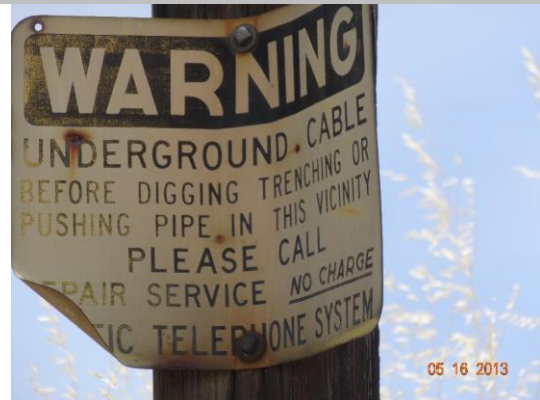
Photo 3 of 3 : UCIP_FA_2017_44170_72600.jpg

Sign lists Pacific Telephone system.

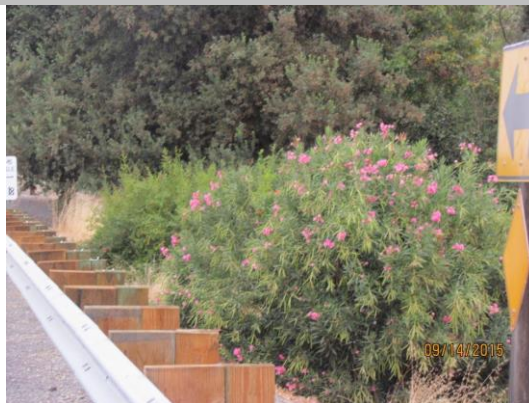
Photo 1 of 1 : FA_2017_LD0002_28_30_20170911_00015.jpg

View of the oleanders along the waterside slope.

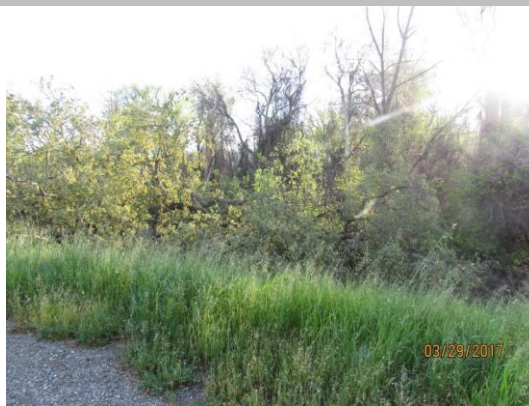
Photo 1 of 1 : FA_2017_LD0002_28_29_20170911_00014.jpg

LM Start	1.15	Rating **	M	Issue No.	29
LM End	1.15	Issue Type +	En	Location *	WS
Category	Earthen Levee			GPS Latitude/Longitude	
				Start	End
Item	Encroachments			39.430098 °	39.430098 °
				-122.010828 °	-122.010828 °
DWR ID	DWR_LD0002_01_s_2017_29				
Comment Code					
TR : Tree or limb					
Inspector Comment					
Remove the tree from the waterside slope and toe.

View of the tree on the water side slope and toe.

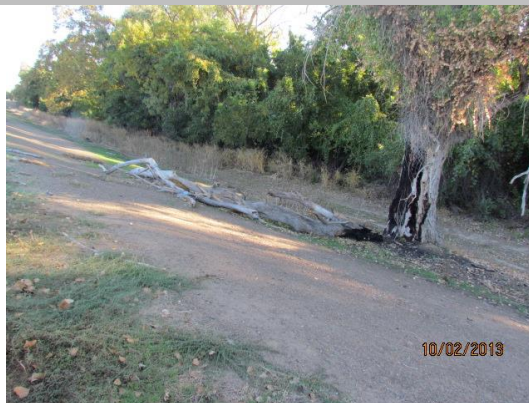
Photo 1 of 2 : FA_2017_LD0002_28_40_20170911_00018.jpg

LM Start	1.24	Rating **	M	Issue No.	40
LM End	1.24	Issue Type +	Ma	Location *	WS
Category	Earthen Levee			GPS Latitude/Longitude	
				Start	End
Item	Encroachments			39.431499 °	39.431499 °
				-122.010803 °	-122.010803 °
DWR ID	DWR_LD0002_01_f_2013_40				
Comment Code					
TR : Tree or limb					
Inspector Comment					
Remove the tree limbs from the waterside slope.

View of the downed tree limb along the slope of the levee.

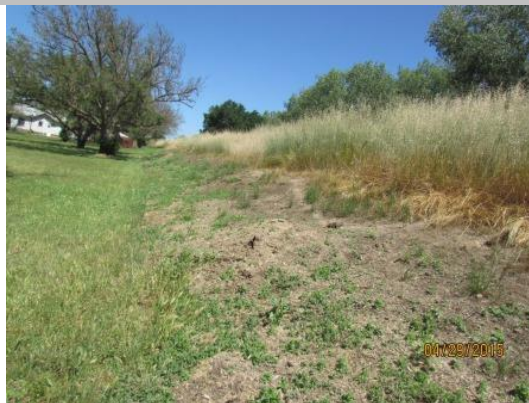
Photo 2 of 2 : FA_2017_LD0002_28_15_20170911_00008.jpg

LM Start	1.52	Rating **	U	Issue No.	15 (cont)	
LM End	1.60	Issue Type +	Ma	Location *	LS	
Category	Earthen Levee			GPS Latitude/Longitude		
				Start		End
Item	Animal Control			39.435485 °		39.436643 °
				-122.010640 °		-122.010498 °
DWR ID	DWR_LD0002_01_f_2012_15					
Comment Code						
A3 : No rodents visible, but rodent burrows visible; need to backfill and compact or grout burrows.						
Inspector Comment						
Repair the rodent holes along the landside slope.

View of the rodent holes along the landside slope.

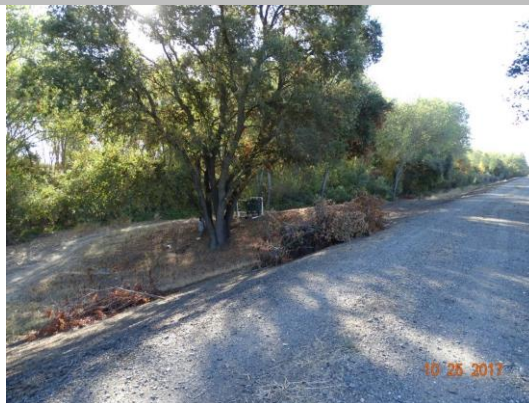
Photo 1 of 1 : FA_2017_LD0002_28_32_20171030_00056.jpg

View of the prunings along the waterside slope.

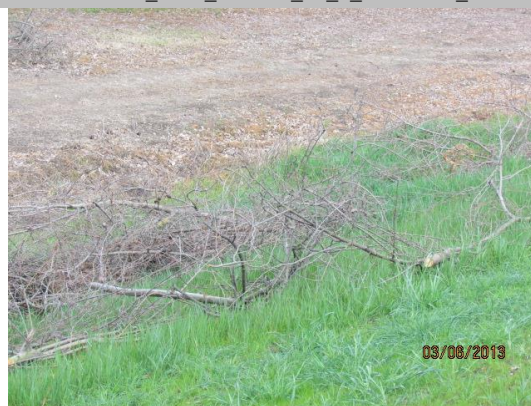
Photo 1 of 1 : FA_2017_LD0002_28_5_20170911_00002.jpg

View of the prunings along the landside toe.

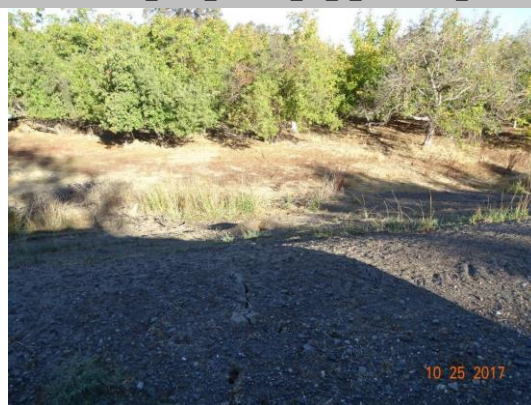
Photo 1 of 2 : FA_2017_LD0002_28_2_20171030_00058.jpg

LM Start	2.91	Rating **	U	Issue No.	2
LM End	2.96	Issue Type +	Ma	Location *	LS
Category	Earthen Levee			GPS Latitude/Longitude	
				Start	End
Item	Animal Control			39.453595 °	39.454003 °
				-122.016273 °	-122.015503 °
DWR ID	DWR_LD0002_01_f_2015_2				
Comment Code					
A3 : No rodents visible, but rodent burrows visible; need to backfill and compact or grout burrows.					
Inspector Comment					
Repair the rodent holes along the landside slope.

View of the rodent holes along the landside slope.

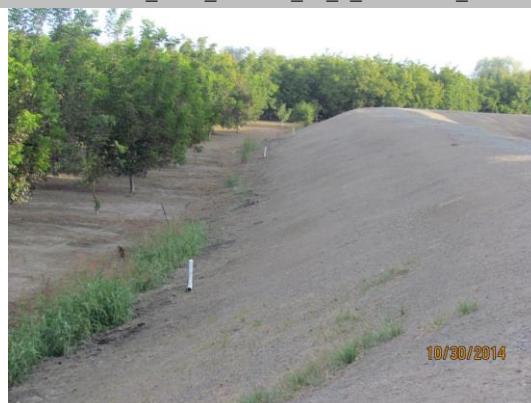
Photo 2 of 2 : FA_2017_LD0002_28_2_20170911_00001.jpg

View of the rodent holes and bait station along the landside slope.

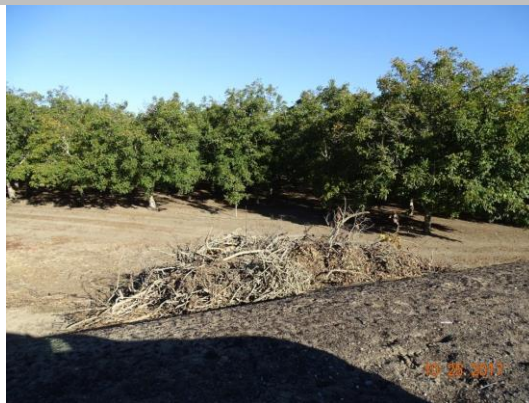
Photo 1 of 1 : FA_2017_LD0002_28_33_20171030_00059.jpg

View of the prunings along the landside toe.

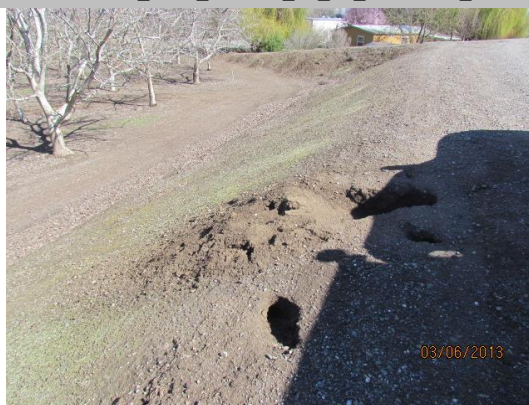
Photo 1 of 1 : FA_2017_LD0002_28_12_20170911_00006.jpg

LM Start	3.16	Rating **	U	Issue No.	12
LM End	3.16	Issue Type +	Ma	Location *	LS
Category	Earthen Levee			GPS Latitude/Longitude	
				Start	End
Item	Animal Control			39.456004 °	39.456004 °
				-122.012776 °	-122.012776 °
DWR ID	DWR_LD0002_01_s_2013_12				
Comment Code					
A1 : Exterminate rodents and backfill and compact or grout burrows.					
Inspector Comment					
Repair the rodent holes along landside slope.

View of the rodent activity along the landside slope.

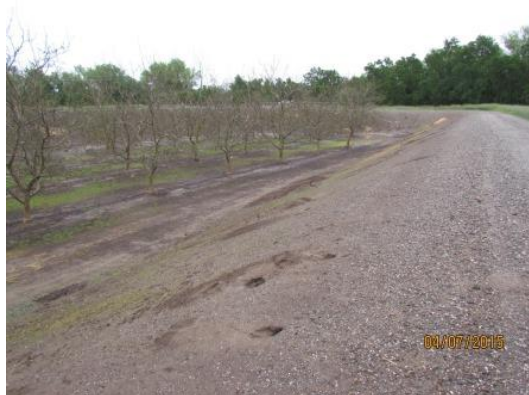
Photo 1 of 2 : FA_2017_LD0002_28_16_20170911_00010.jpg

View of the rodent holes along the landside slope.

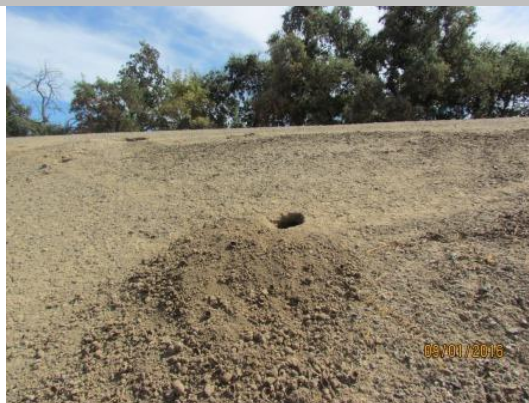
Photo 2 of 2 : FA_2017_LD0002_28_16_20170911_00011.jpg

View of the rodent holes along the landside slope.

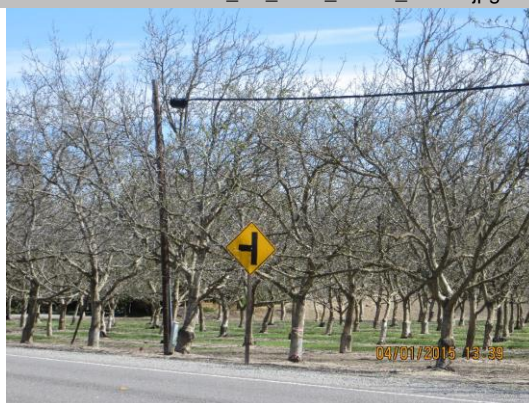
Photo 1 of 2 : UCIP_FA_2017_44186_73606.jpg

LM Start	3.37	Rating **	M	Issue No.	61
LM End	3.37	Issue Type +	En	Location *	
Category	Supplemental			GPS Latitude/Longitude	
				Start	End
Item	DWR UCIP Field Study			39.456704 °	39.456704 °
				-122.009621 °	-122.009621 °
DWR ID					
Comment Code					
Inspector Comment					
FS_ID:44186 DS_ID:21188 EP_NO: 12444 Repair Type: Non-Urgent Crossing Status: Indicator Found UCIP Comments: Needs markers 10-feet off both levee toes. FIELD_STRUCT_DESC: Steel conduit through the levee, 2.5 feet below the crown. Conduit extends to pole on waterside (WS). Cut in pavement visible at levee crown (Permit No. 12444-1978) FS Date: 4/1/2015

Conduit may be visible on pole about 1000-feet west of levee crown.

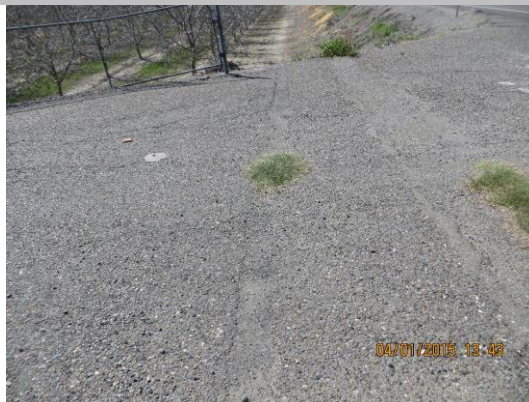
Photo 2 of 2 : UCIP_FA_2017_44186_73605.jpg

Cut in pavement at levee crown good indicator of crossing.

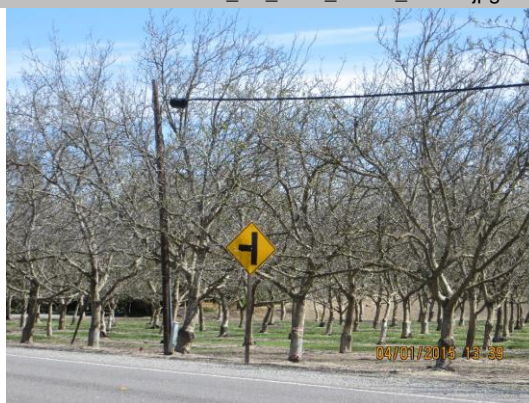
Photo 1 of 2 : UCIP_FA_2017_44185_73608.jpg

LM Start	3.37	Rating **	M	Issue No.	62
LM End	3.37	Issue Type +	En	Location *	
Category	Supplemental			GPS Latitude/Longitude	
				Start	End
Item	DWR UCIP Field Study			39.456720 °	39.456720 °
				-122.009630 °	-122.009630 °
DWR ID					
Comment Code					
Inspector Comment					
FS_ID:44185 DS_ID:21175 EP_NO: 5376 Repair Type: Non-Urgent Crossing Status: Indicator Found UCIP Comments: Conduit needs markers ten feet off both levee toes. FIELD_STRUCT_DESC: Three 3.5-inch steel conduits through the levee, 3.0 feet below the crown. Metal cutoff wall around conduits near center of levee. Conduits are welded to the cutoff wall, extending only between the levee shoulders under the crown. Cut in pavement visible at crown. Cables extend to pole on waterside (WS). (Permit No. 5376-1967, Pacific Telephone & Telegraph Co.) FS Date: 4/1/2015

Conduit may be visible at pole about 1000-feet west of crown.

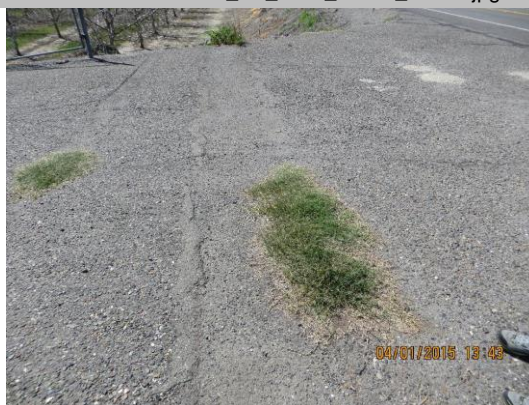
Photo 2 of 2 : UCIP_FA_2017_44185_73607.jpg

Cut in pavement visible at crown good indicator of crossing location.

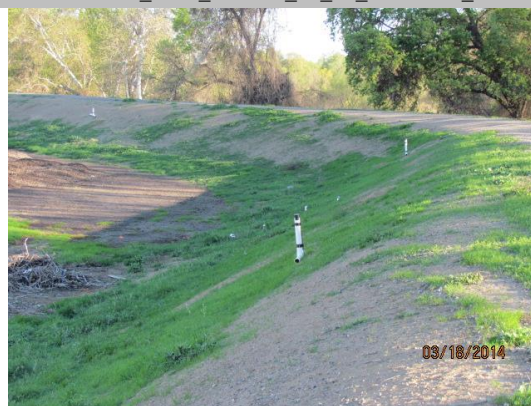
Photo 1 of 2 : FA_2017_LD0002_28_27_20170911_00012.jpg

LM Start	3.44	Rating **	U	Issue No.	27
LM End	3.52	Issue Type +	Ma	Location *	LS
Category	Earthen Levee			GPS Latitude/Longitude	
				Start	End
Item	Animal Control			39.457692 °	39.458705 °
				-122.009517 °	-122.009872 °
DWR ID	DWR_LD0002_01_s_2014_27				
Comment Code					
A3 : No rodents visible, but rodent burrows visible; need to backfill and compact or grout burrows.					
Inspector Comment					
Repair the rodent holes on landside slope.

View of the rodent activity along the landside slope.

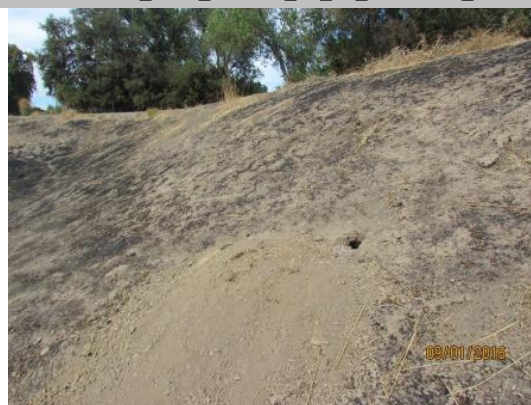
Photo 2 of 2 : FA_2017_LD0002_28_27_20170911_00013.jpg

View of the rodent holes along the landside slope.

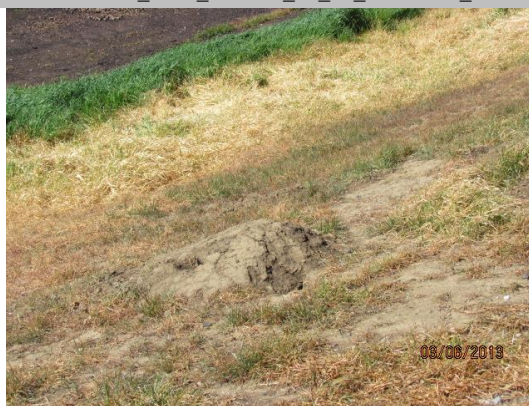
Photo 1 of 1 : FA_2017_LD0002_28_13_20170911_00007.jpg

View of the rodent activity along the landside slope.

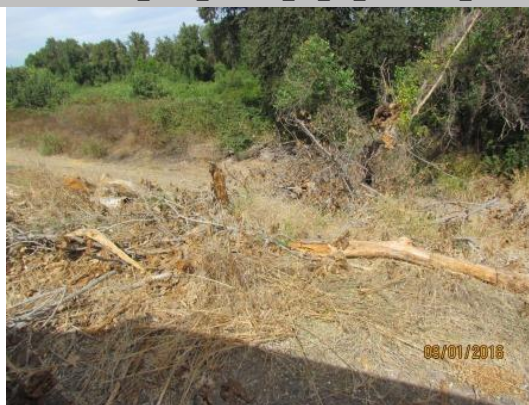
Photo 1 of 2 : FA_2017_LD0002_28_46_20170911_00021.jpg

View of a fallen tree along the waterside slope.

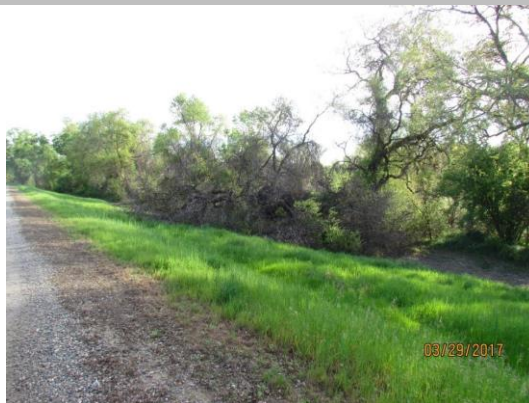
Photo 2 of 2 : FA_2017_LD0002_28_46_20170911_00022.jpg

View of the tree along the waterside slope and toe.

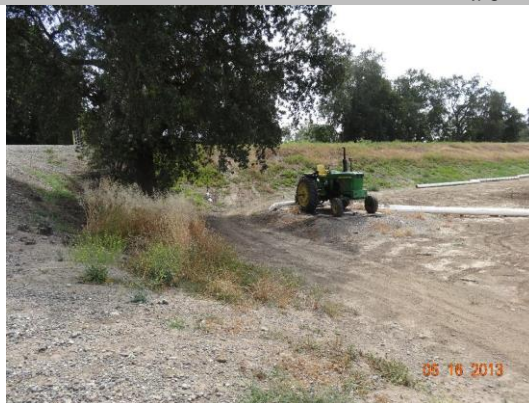
Photo 1 of 3 : UCIP_FA_2017_38178_69502.jpg

View of pump system on landward side located behind tracker.

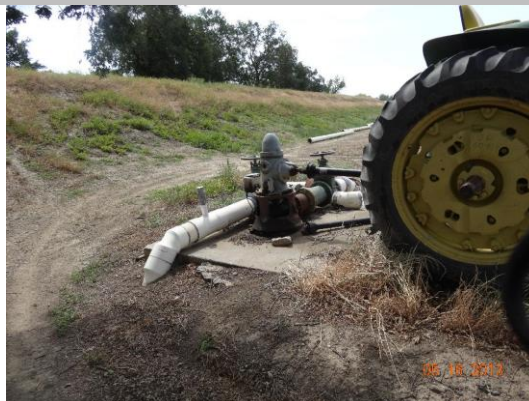
Photo 2 of 3 : UCIP_FA_2017_38178_69501.jpg

Pump system located near landward toe.

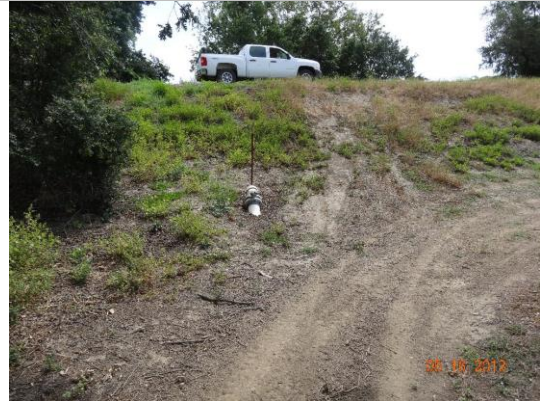
Photo 3 of 3 : UCIP_FA_2017_38178_69500.jpg

Pipe connection capped with control valve located on landward toe.

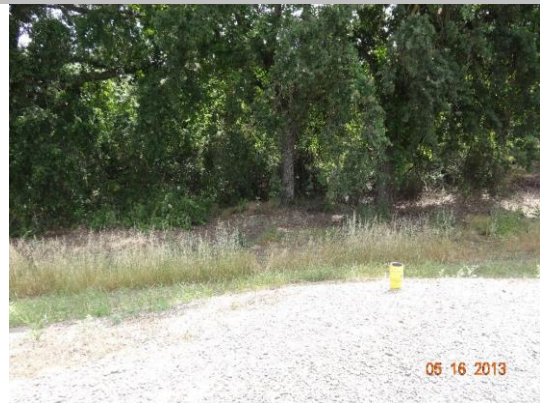
Photo 1 of 3 : UCIP_FA_2017_38182_69537.jpg

View of waterward side.

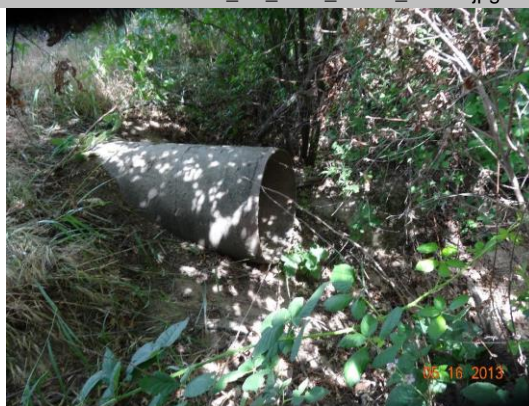
Photo 2 of 3 : UCIP_FA_2017_38182_69533.jpg

Pipe visible on waterward side.

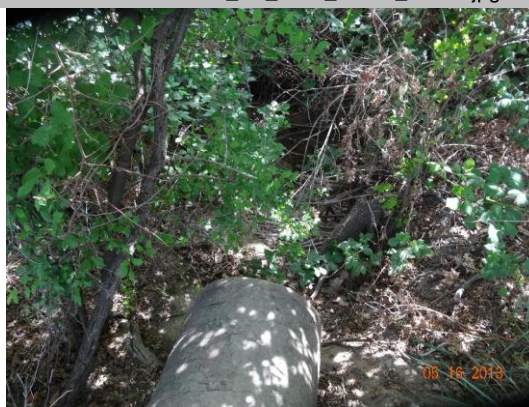
Photo 3 of 3 : UCIP_FA_2017_38182_69541.jpg

View of channel on waterward side.

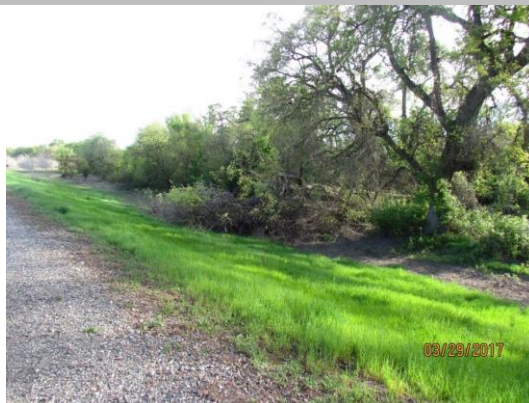
Photo 1 of 1 : FA_2017_LD0002_28_31_20170911_00016.jpg

View of the tree along the waterside slope and toe.

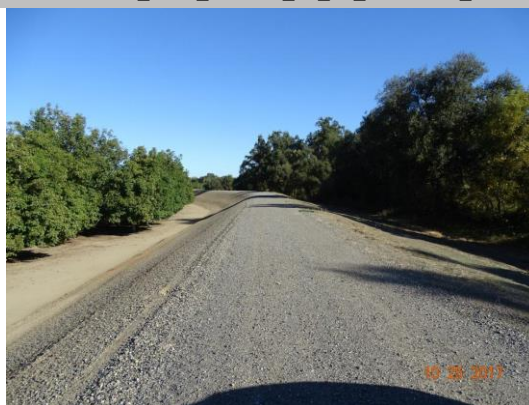
Photo 1 of 1 : FA_2017_LD0002_28_35_20171030_00060.jpg

View of no vegetation on both slopes.

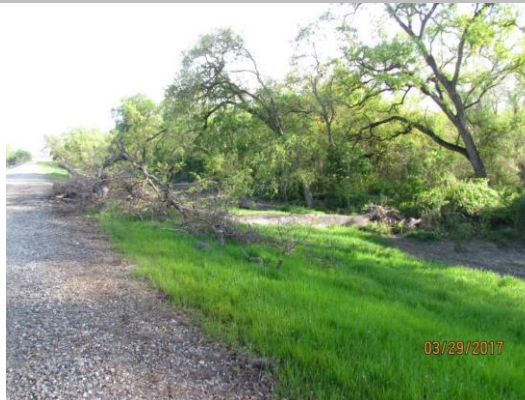
Photo 1 of 1 : FA_2017_LD0002_28_50_20170911_00023.jpg

View of the tree on the water sideslope and toe.

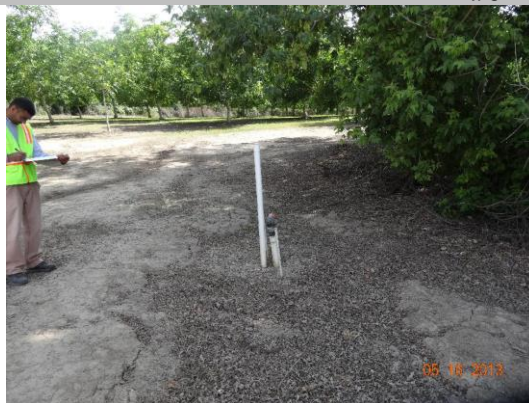
Photo 1 of 3 : UCIP_FA_2017_44188_69544.jpg

3-inch PVC pipe and vent exposed on waterward toe, likely in alignment with this crossing.

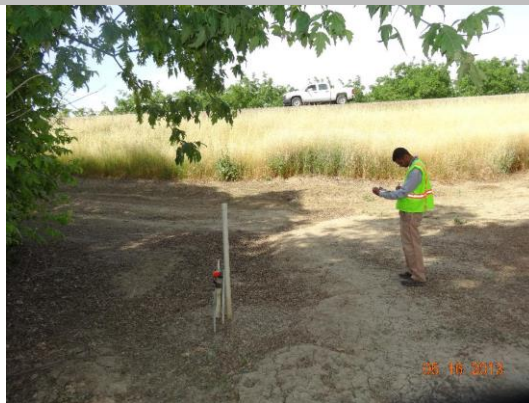
Photo 2 of 3 : UCIP_FA_2017_44188_69543.jpg

3-inch PVC pipe and vent exposed on waterward toe, likely in alignment with this crossing.

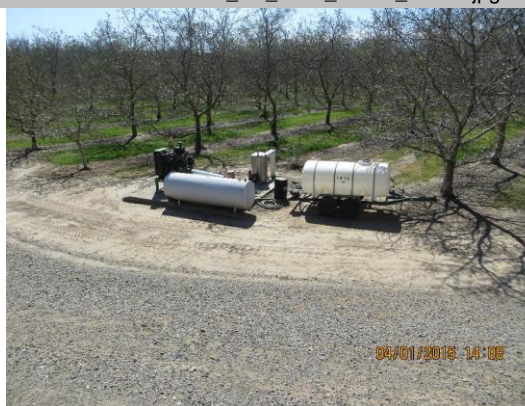
Photo 3 of 3 : UCIP_FA_2017_44188_73609.jpg

Well and pump visible on LS toe.

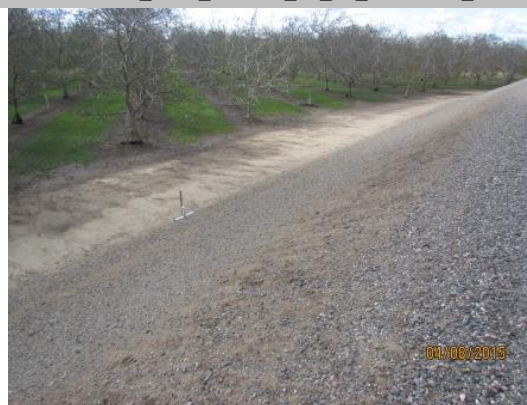
Photo 1 of 1 : FA_2017_LD0002_28_11_20170911_00005.jpg

View of the removed rodent holes and bait station.
