**Flood Control Project Maintenance  
Levee Inspections**

**Fall 2018 Levee Maintenance Deficiency Summary Report**

**Flood Control Project Maintenance  
Levee Inspections****LMA District Cover Sheet****Fall 2018 Levee Inspection Results****Levee District No. 0002 (Glenn County)**

**Levee District No. 0002 (Glenn County)**

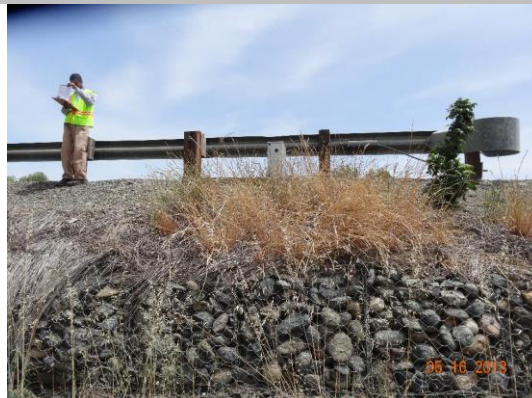
Photo 1 of 3 : UCIP\_FA\_2018\_42083\_72882.jpg

LM Start	0.59	Rating **	M	Issue No.	53	
LM End	0.59	Issue Type +	En	Location *		
Category	Supplemental			GPS Latitude/Longitude		
				Start	End	
Item	DWR UCIP Field Study			39.422088 °	39.422088 °	
				-122.011615 °	-122.011615 °	
DWR ID	24877					
Comment Code						
Inspector Comment						
FS_ID:42083 DS_ID:24877 EP_NO: N/A Repair Type: Non-Urgent Crossing Status: Indicator Found UCIP Comments: Need to contact owner to determine if conduit goes through levee crown. If it does, will need to obtain permit number issued for encroachment. FIELD_STRUCT_DESC: Caltrans traffic control box located on the landside (LS) shoulder. FS Date: 5/16/2013

View of landward slope.

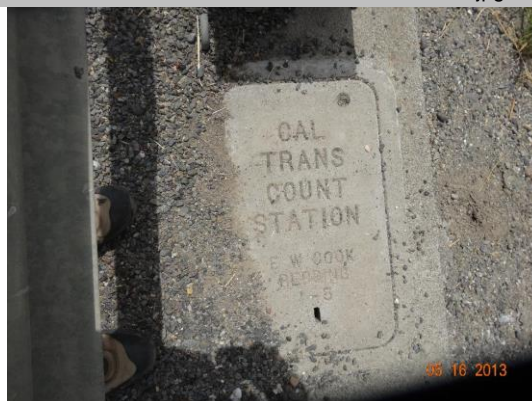
Photo 3 of 3 : UCIP\_FA\_2018\_42083\_72880.jpg

LM Start	0.59	Rating **	M	Issue No.	53 (cont)	
LM End	0.59	Issue Type +	En	Location *		
Category	Supplemental			GPS Latitude/Longitude		
				Start	End	
Item	DWR UCIP Field Study			39.422088 °	39.422088 °	
				-122.011615 °	-122.011615 °	
DWR ID	24877					
Comment Code						
Inspector Comment						
FS_ID:42083 DS_ID:24877 EP_NO: N/A Repair Type: Non-Urgent Crossing Status: Indicator Found UCIP Comments: Need to contact owner to determine if conduit goes through levee crown. If it does, will need to obtain permit number issued for encroachment. FIELD_STRUCT_DESC: Caltrans traffic control box located on the landside (LS) shoulder. FS Date: 5/16/2013

Service box located on landward shoulder.

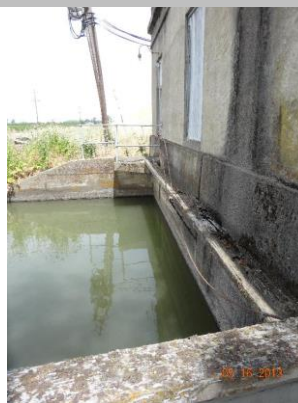
Photo 3 of 3 : UCIP\_FA\_2018\_38165\_69463.jpg

Comment Code						
Inspector Comment						
FS_ID:38165 DS_ID:21185 EP_NO: 2356 Repair Type: Non-Urgent Crossing Status: Found UCIP Comments: Three pipes found in the pump house on landward side. Pump house appears to be no longer in use. Unable to locate pipes on waterward side. Will need to contact owner to determine status. Owner will need to coordinate with CVFPB regarding proper removal per Title 23 requirements. FIELD_STRUCT_DESC: [Princeton-Cordora-Glenn Irrigation District: Schaad Pumping Plant] 1 of 3: 28-inch steel pipe sleeved through 30-inch steel pipe through the levee, 20 feet below the crown. Annular gap is grouted. Flap gate on landside (LS) end. Pump in pump house on LS slope. Rock revetment around outlet on waterside (WS) slope. (28- and 34-inch pipes sleeved through existing 30- and 36-inch pipes, permit shows three 36-inch pipes as part of Schaad Pumping Plant p. 17 of 19, authorized under Permit No. 2356, 1956, Princeton-Cordora-Glenn Irrigation District) [Additional Reference(s): DWR Levee Logs, 2005. USACE Sacramento O&M Manual Unit No. 151, November 1953, (Station 41+47), two 36-inch pipes] FS Date: 5/16/2013

View of landward side--outlet.

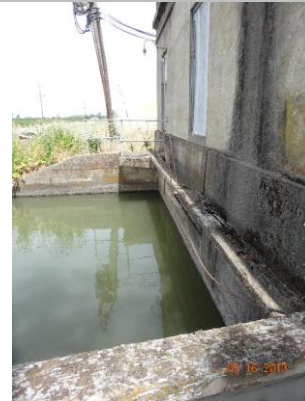
Photo 3 of 3 : UCIP\_FA\_2018\_38166\_69477.jpg

Comment Code					
Inspector Comment					
FS_ID:38166 DS_ID:21184 EP_NO: N/A Repair Type: Non-Urgent Crossing Status: Found UCIP Comments: Three pipes found in the pump house on landward side. Pump house appears to be no longer in use. Unable to locate pipes on waterward side. Will need to contact owner to determine status. Owner will need to coordinate with CVFPB regarding proper removal per Title 23 requirements. FIELD_STRUCT_DESC: [Princeton-Cordora-Glenn Irrigation District: Schaad Pumping Plant] 2 of 3: 34-inch steel pipe sleeved through 36-inch steel pipe through the levee, 20 feet below the crown. Annular gap is grouted. Flap gate on landside (LS) end. Pump in pump house on LS slope. Rock revetment around outlet on waterside (WS) slope. (28- and 34-inch pipes sleeved through existing 30- and 36-inch pipes, permit shows three 36-inch pipes as part of Schaad Pumping Plant p. 17 of 19, authorized under Permit No. 2356, 1956, Princeton-Cordora-Glenn Irrigation District) [Additional Reference(s): DWR Levee Logs, 2005. USACE Sacramento O&M Manual Unit No. 151, November 1953, (Station 41+47), two 36-inch pipes] FS Date: 5/16/2013

View of landward side--outlet.

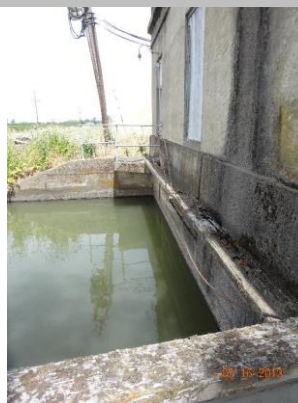
Photo 3 of 3 : UCIP\_FA\_2018\_38167\_69478.jpg

Comment Code						
Inspector Comment						
FS_ID:38167 DS_ID:21171 EP_NO: N/A Repair Type: Non-Urgent Crossing Status: Found UCIP Comments: Three pipes found in the pump house on landward side. Pump house appears to be no longer in use. Unable to locate pipes on waterward side. Will need to contact owner to determine status. Owner will need to coordinate with CVFPB regarding proper removal per Title 23 requirements. FIELD_STRUCT_DESC: [Princeton-Cordora-Glenn Irrigation District: Schaad Pumping Plant] 3 of 3: 34-inch steel pipe sleeved through 36-inch steel pipe through the levee, 20 feet below the crown. Annular gap is grouted. Flap gate on landside (LS) end. Pump in pump house on LS slope. Rock revetment around outlet on waterside (WS) slope. (28- and 34-inch pipes sleeved through existing 30- and 36-inch pipes, permit shows three 36-inch pipes as part of Schaad Pumping Plant p. 17 of 19, authorized under Permit No. 2356, 1956, Princeton-Cordora-Glenn Irrigation District) [Additional Reference(s): DWR Levee Logs, 2005. USACE Sacramento O&M Manual Unit No. 151, November 1953, (Station 41+47), two 36-inch pipes] FS Date: 5/16/2013

View of landward side--outlet.

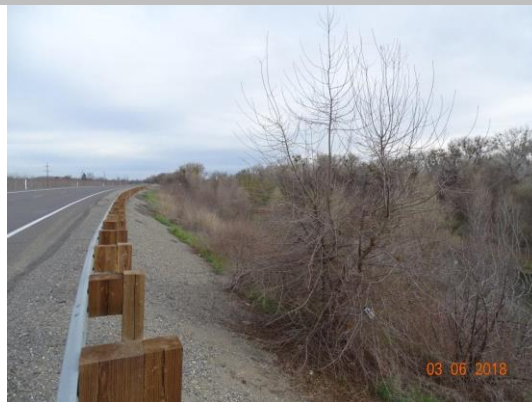
Photo 1 of 1 : FA\_2018\_LD0002\_28\_35\_20180905\_00018.jpg

LM Start	0.64	Rating **	M	Issue No.	35
LM End	0.77	Issue Type +	Ma	Location *	WS
Category	Earthen Levee			GPS Latitude/Longitude	
				Start	End
Item	Vegetation			39.422805 °	39.424597 °
				-122.011640 °	-122.011527 °
DWR ID	DWR_LD0002_01_s_2018_35				
Comment Code					
V2 : Remove the wild growth other than native grasses from the levee slopes.					
Inspector Comment					
Remove the vegetation from the waterside slope.

View of the vegetation along the waterside slope.

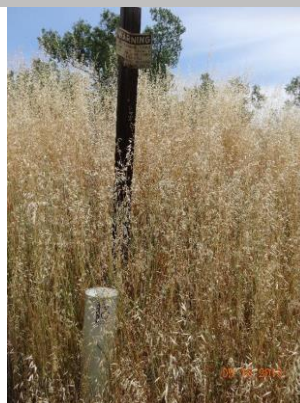
Photo 1 of 3 : UCIP\_FA\_2018\_44170\_72602.jpg

Comment Code						
Inspector Comment						
FS_ID:44170						
DS_ID:21177						
EP_NO: 9723						
Repair Type: Non-Urgent						
Crossing Status: Indicator Found						
UCIP Comments: Owner is listed as Pacific Bell however sign lists AT&T as owner, need to contact owner to determine if permit was updated or if this crossing is listed under new permit. Unable to confirm if 2 crossings are present at this site.						
FIELD_STRUCT_DESC: Buried telephone cable through the levee at unknown depth. Telephone pole and junction box on landside (LS) toe. (telephone cable authorized under Automatic Board Order (ABO) issued as Permit No. 9723-1974, Pacific Telephone Company).						
FS Date: 5/16/2013

Indicators of existing line visible on slope.

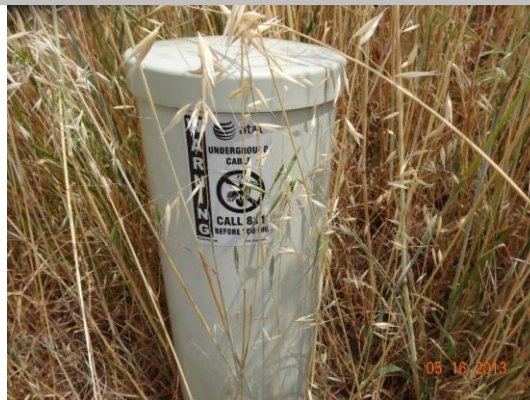
Photo 2 of 3 : UCIP\_FA\_2018\_44170\_72601.jpg

AT&T underground cable line.

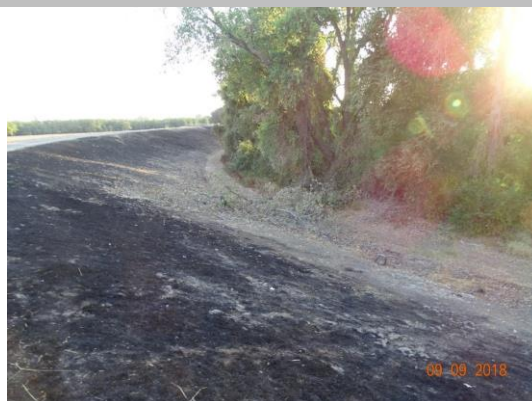
Photo 1 of 1 : FA\_2018\_LD0002\_28\_26\_20181001\_00058.jpg

View of the tree limbs along the land waterside slope.

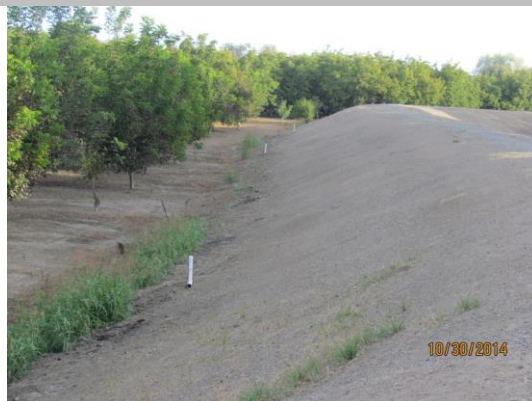
Photo 2 of 2 : FA\_2018\_LD0002\_28\_2\_20180905\_00002.jpg

LM Start	<b>2.91</b>	Rating **	U	Issue No.	<b>2 (cont)</b>
LM End	<b>2.96</b>	Issue Type +	Ma	Location *	LS

View of the rodent holes and bait station along the landside slope.

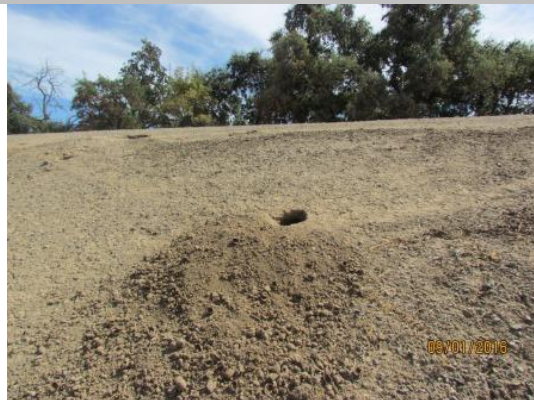
Photo 2 of 2 : FA\_2018\_LD0002\_28\_16\_20180905\_00010.jpg

View of the rodent holes along the landside slope.

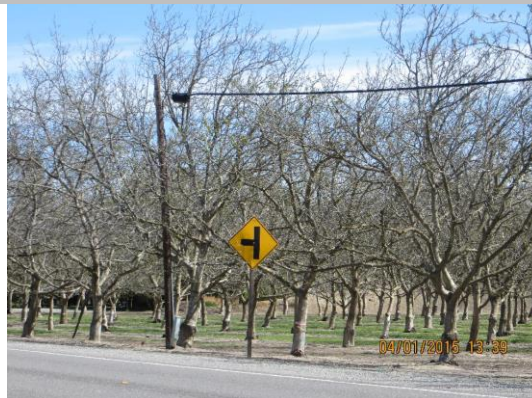
Photo 1 of 2 : UCIP\_FA\_2018\_44186\_73606.jpg

Comment Code						
Inspector Comment						
FS_ID:44186						
DS_ID:21188						
EP_NO: 12444						
Repair Type: Non-Urgent						
Crossing Status: Indicator Found						
UCIP Comments: Needs markers 10-feet off both levee toes.						
FIELD_STRUCT_DESC: Buried cable steel conduit through the levee, 2.5 feet below the crown. Conduit extends to pole on waterside (WS). Cut in pavement visible at levee crown (aerial communication cable across left bank levee and channel of the Sacramento River and buried cable across the right bank overflow and through the right bank levee authorized under Permit No. 12444, 1978-Pacific Telephone and Telegraph Company) [Additional Reference(s): DWR Levee Logs, 2005]						
FS Date: 4/1/2015

Conduit may be visible on pole about 1000-feet west of levee crown.

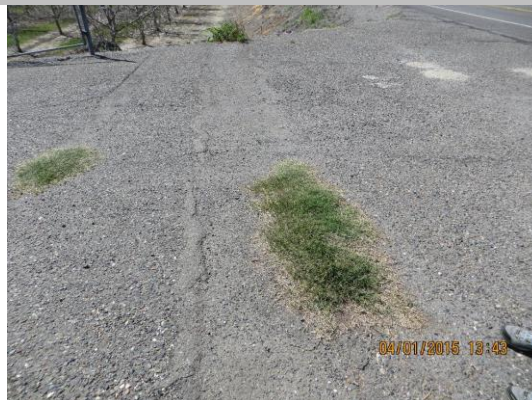
Photo 2 of 2 : UCIP\_FA\_2018\_44185\_73607.jpg

Comment Code						
Inspector Comment						
FS_ID:44185 DS_ID:21175 EP_NO: 5376 Repair Type: Non-Urgent Crossing Status: Indicator Found UCIP Comments: Conduit needs markers ten feet off both levee toes. FIELD_STRUCT_DESC: Three 3.5-inch steel cables sleeved through conduit through the levee, 3 feet below the crown. Metal cutoff wall around conduits near center of levee. Conduits are welded to the cutoff wall, extending only between the levee shoulders under the crown. Cut in pavement visible at crown. Cables extend to pole on waterside (WS). (replace existing aerial telephone cables with two buried cables authorized under Permit No. 5376, 1967-Pacific Telephone & Telegraph Co.) [Additional Reference(s): DWR Levee Logs, 2005] FS Date: 4/1/2015

Cut in pavement visible at crown good indicator of crossing location.

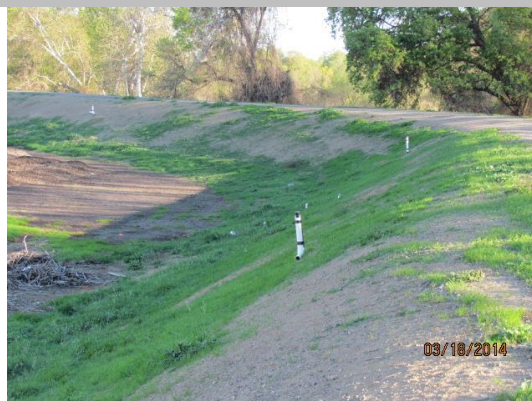
Photo 1 of 2 : FA\_2018\_LD0002\_28\_27\_20180905\_00011.jpg

LM Start	3.44	Rating **	U	Issue No.	27
LM End	3.52	Issue Type +	Ma	Location *	LS
Category	Earthen Levee			GPS Latitude/Longitude	
				Start	End
Item	Animal Control			39.457692 °	39.458705 °
				-122.009517 °	-122.009872 °
DWR ID	DWR_LD0002_01_s_2014_27				
Comment Code					
A3 : No rodents visible, but rodent burrows visible; need to backfill and compact or grout burrows.					
Inspector Comment					
Repair the rodent holes on landside slope.

View of the rodent activity along the landside slope.

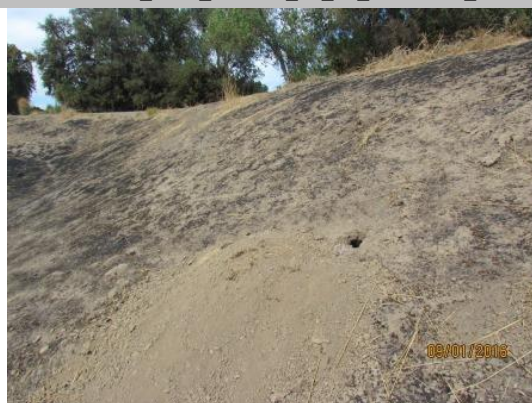
Photo 2 of 2 : FA\_2018\_LD0002\_28\_27\_20180905\_00012.jpg

LM Start	<b>3.44</b>	Rating **	U	Issue No.	<b>27 (cont)</b>
LM End	<b>3.52</b>	Issue Type +	Ma	Location *	LS

View of the rodent holes along the landside slope.

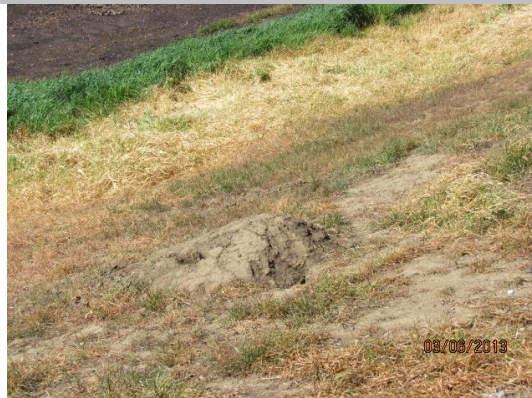
Photo 1 of 1 : FA\_2018\_LD0002\_28\_13\_20180905\_00006.jpg

View of the rodent activity along the landside slope.

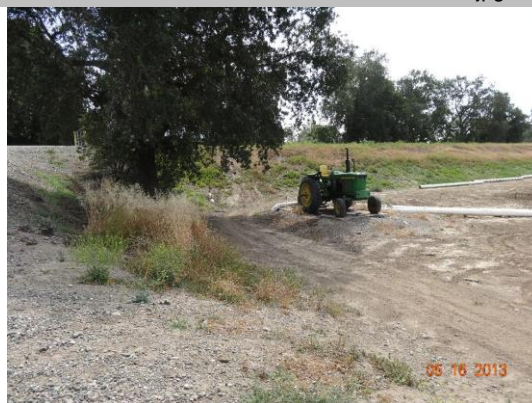
Photo 1 of 3 : UCIP\_FA\_2018\_38178\_69502.jpg

Comment Code						
Inspector Comment						
FS_ID:38178 DS_ID:21178 EP_NO: 16931 Repair Type: Non-Urgent Crossing Status: Indicator Found UCIP Comments: Inspector notes indicate that pipe was never installed through levee and application was closed. Steel pipe was not installed but detachable section was installed. The pipe section goes up and over levee. Permit 16931 file was closed in 2005 owner was unable to install pipe due to costs. Permit indicates that pipe was to be used for winter supply of irrigation water to landward side. Need to coordinate with DWR inspector--permit revised for this type of structure. FIELD_STRUCT_DESC: Crossing visible at location. Current structure differs from original request in Permit No. 16931. PVC connection visible on landside (LS) toe with cutoff valve. Pipe connects to 8-inch PVC pipe extending past LS toe. FS Date: 5/16/2013

View of pump system on landward side located behind tracker.

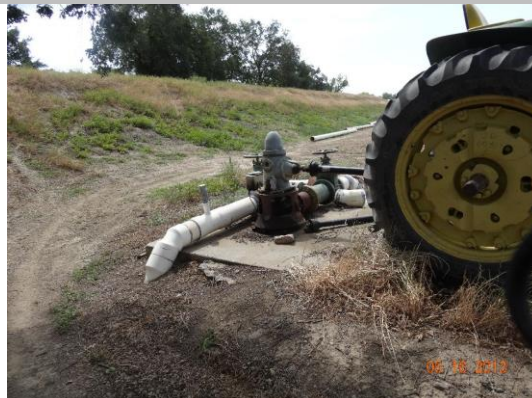
Photo 2 of 3 : UCIP\_FA\_2018\_38178\_69501.jpg

Comment Code						
Inspector Comment						
FS_ID:38178 DS_ID:21178 EP_NO: 16931 Repair Type: Non-Urgent Crossing Status: Indicator Found UCIP Comments: Inspector notes indicate that pipe was never installed through levee and application was closed. Steel pipe was not installed but detachable section was installed. The pipe section goes up and over levee. Permit 16931 file was closed in 2005 owner was unable to install pipe due to costs. Permit indicates that pipe was to be used for winter supply of irrigation water to landward side. Need to coordinate with DWR inspector--permit revised for this type of structure. FIELD_STRUCT_DESC: Crossing visible at location. Current structure differs from original request in Permit No. 16931. PVC connection visible on landside (LS) toe with cutoff valve. Pipe connects to 8-inch PVC pipe extending past LS toe. FS Date: 5/16/2013

Pump system located near landward toe.

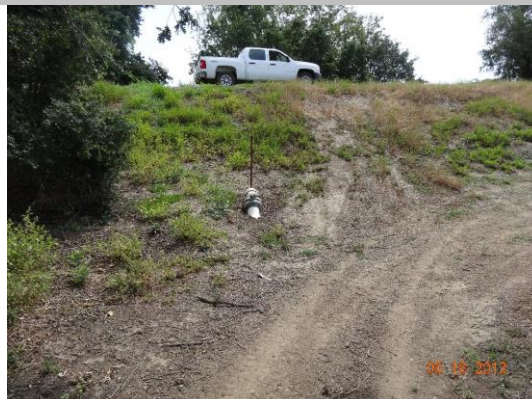
Photo 3 of 3 : UCIP\_FA\_2018\_38178\_69500.jpg

Pipe connection capped with control valve located on landward toe.

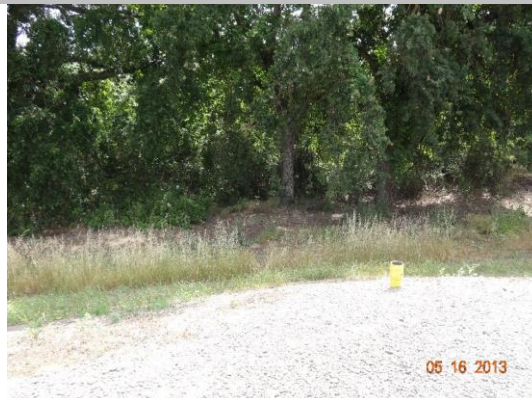
Photo 1 of 3 : UCIP\_FA\_2018\_38182\_69537.jpg

View of waterward side.

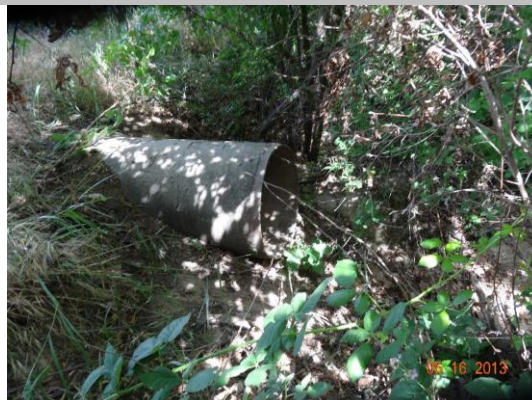
Photo 2 of 3 : UCIP\_FA\_2018\_38182\_69533.jpg

Pipe visible on waterward side.

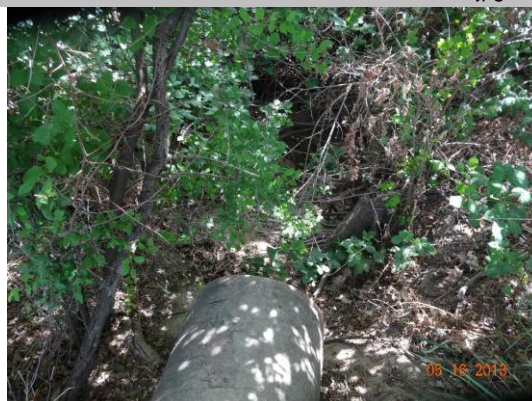
Photo 3 of 3 : UCIP\_FA\_2018\_38182\_69541.jpg

View of channel on waterward side.

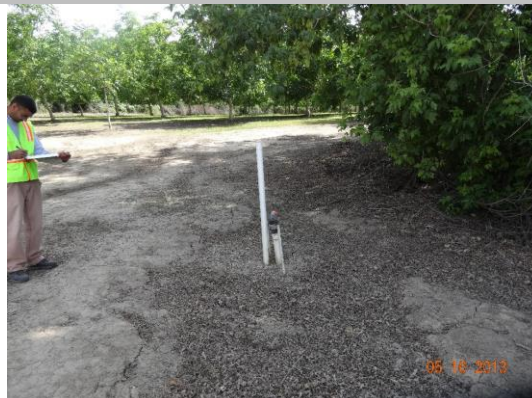
Photo 1 of 3 : UCIP\_FA\_2018\_44188\_69544.jpg

3-inch PVC pipe and vent exposed on waterward toe, likely in alignment with this crossing.

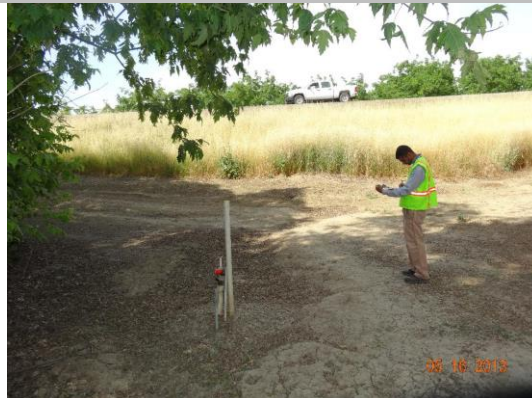
Photo 2 of 3 : UCIP\_FA\_2018\_44188\_69543.jpg

3-inch PVC pipe and vent exposed on waterward toe, likely in alignment with this crossing.
